Preliminary report

concerning the **Serious incident**
to the CESSNA Citation 525 CJ1
registered **F-HJAV**
on Friday 14 March 2025
en route

Failure of an air data system, undetected altitude deviation, activation of a TAWS³ warning during approach

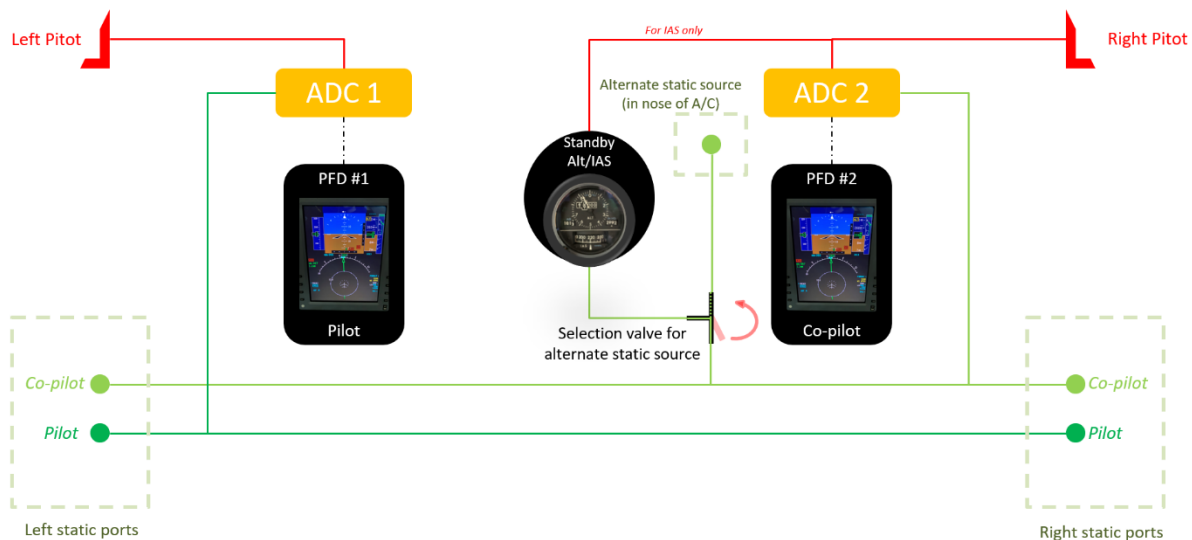
Figure 3: schematic diagram of F-HJAV air data system (Source: BEA)

System 1 (captain’s side) is composed of a Pitot tube located on the LH side of the fuselage and a static pressure port on each side of the fuselage. The altimetric information displayed on the captain’s PFD comes from ADC 1.

System 2 (co-pilot’s side) is composed of a Pitot tube located on the RH side of the fuselage and a static pressure port on each side of the fuselage. The altimetric information displayed on the co-pilot's PFD comes from ADC 2. A standby altimeter and a standby airspeed indicator are also connected to system 2 without passing through ADC 2. F-HJAV is equipped with an option whereby the standby altimeter can be manually changed to another static port situated in a nose compartment (alternate static source) using a selector in the cockpit.

Transponder 1 of the aeroplane (captain's side) receives altitude information from ADC 1 and transponder 2 (co-pilot's side) is connected to ADC 2. The transponder altimetric sources are not interchangeable. During the incident flight, the active transponder was transponder 1.

The erroneous indications of the standby altimeter mentioned by the crew (see paragraph 4.2) could not be reproduced during these tests. At this stage of the investigation, the BEA has not been able to rule out the possibility of an intermittent failure on air data system 2.

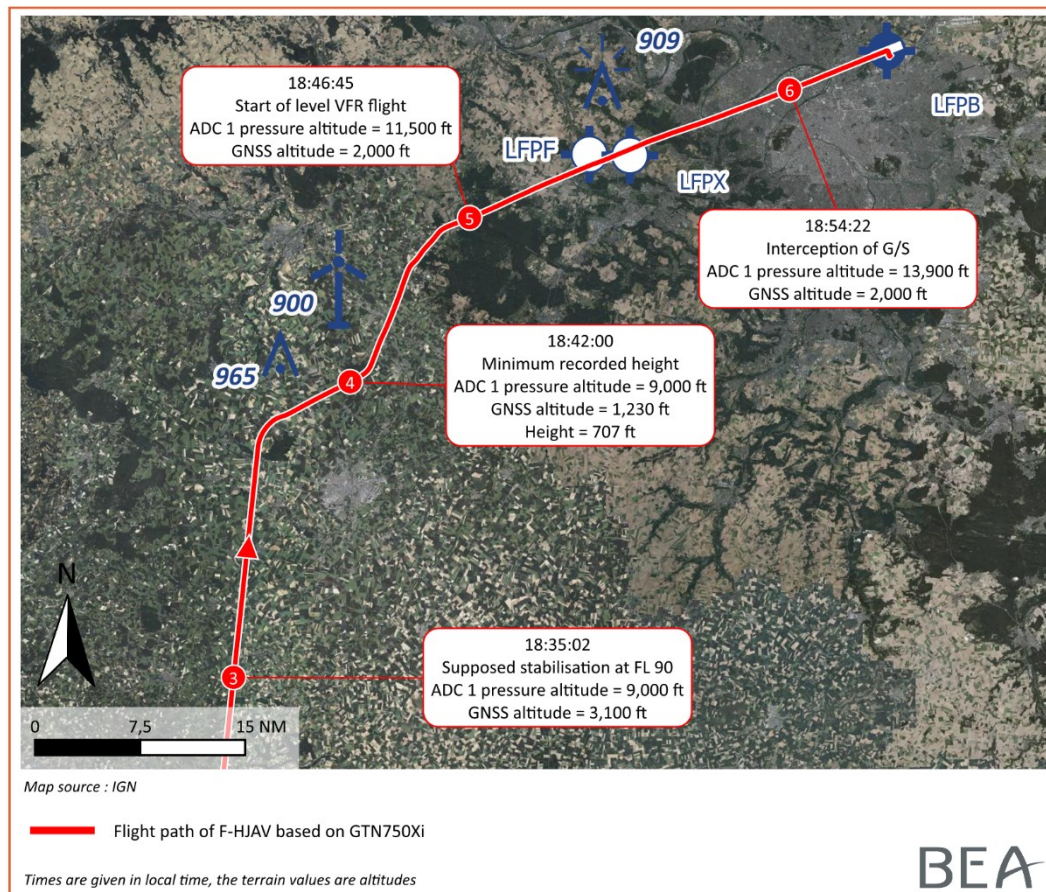
Figure 4: horizontal flight path of F-HJAV in the last 30 flight minutes

During the flight, F-HJAV crossed the following airspaces: Limoges (ANS/south), ACC/south-west, ACC/north, CDG approach and then Le Bourget approach, as well as the Orléans and Paris-Orly airspaces, Seine FIS, Paris FIS and Chevreuse FIS. The Orléans zones were not active at the time of the serious incident, and were managed by the Seine FIS. Likewise, the Chevreuse zones were not active and were managed by ACC/North for the IFR flights and by Paris FIS for the VFR flights.

The analysis of the radar and GNSS data found that F-HJAV flew close to several VFR traffic during the last twenty minutes of flight, while flying at an altitude below 2,500 ft. The precise separations between F-HJAV and these other flights are currently being determined.
