**Accident** to the MUDRY CAP232  
registered **F-HKAP**  
on Sunday 15 June 2025  
at Villepreux

**Opening and loss of canopy mid-air, turn around, collision with ground on final**

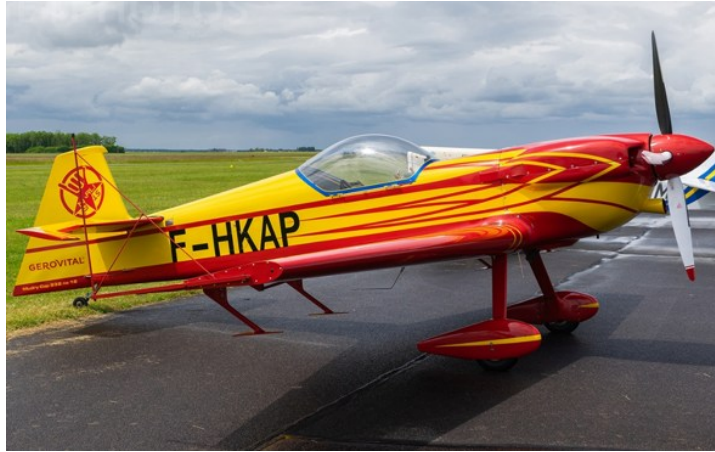
Figure 2: Cap 232 registered F-HKAP (source: Matteo, [jetphotos.com](http://jetphotos.com))

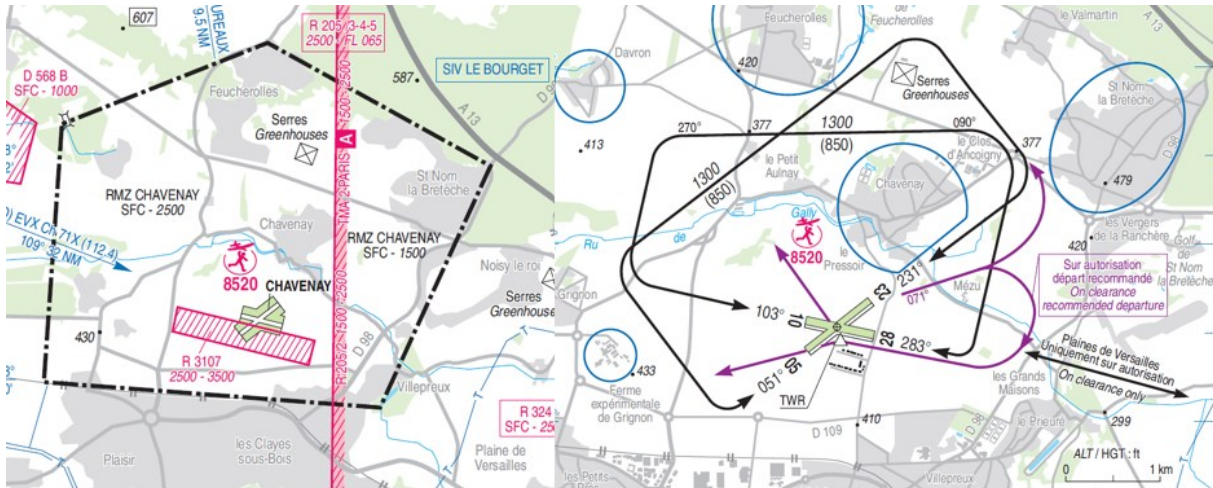
Chavenay - Villepreux aerodrome is a controlled aerodrome but does not have a CTR: a RMZ has been defined around the aerodrome. It has two unpaved runways oriented 05/23 and 10/28. The runway circuits are carried out in the north, therefore right-hand for runway 28. The control tower is south of the intersection of the two runways (TWR shown by a triangle on the VAC chart, see Figure 5).

Figure 5: excerpts from Chavenay - Villepreux aerodrome VAC chart, RMZ shown by line of dashes on left side, runway circuits on right side (source: SIA)
