Accident to the ROBINSON R44 II
registered **F-HLOU**
on 31 October 2023
at Salazie (La Réunion)

This is a courtesy translation by the BEA of the Final Report on the Safety Investigation. As accurate as the translation may be, the original text in French is the work of reference.

Loss of control in flight, collision with the terrain

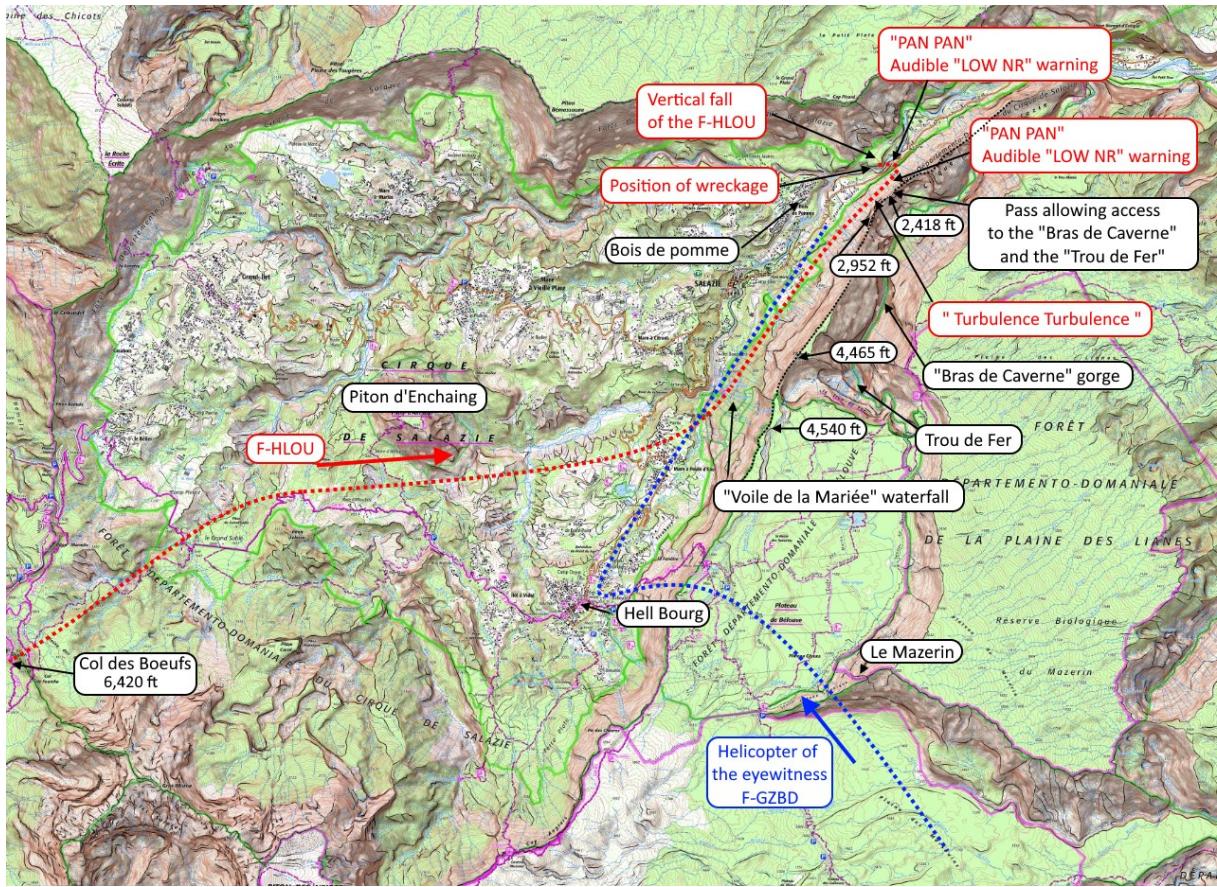
The pilot of another R44, registered F-GZBD, coming from Mazerin (see Figure 1) at an altitude of 4,500 ft³ and heading towards the Le Voile de la Mariée waterfalls, heard the pilot of F-HLOU on the radio announcing that he had arrived at Piton d'Enchaing via Col des Bœufs and was also heading towards Le Voile de la Mariée. He positioned himself behind F-HLOU at a distance of approximately 500 m. He saw F-HLOU, approximately 600 ft below him, flying along the western slope of the mountain, passing the waterfalls and heading towards Le Bois de Pomme.

Figure 1: flight paths followed by F-HLOU and F-GZBD (reconstructed from statements)
