Incident to the AIRBUS A350-900
registered **F-HTYO**
operated by Air France
on 28 May 2023
en route from Osaka airport (Japan)

SAFETY INVESTIGATIONS

Failure of weather radar in climb, turn-around, damage to radome, airspeed indicator probes affected and overweight landing

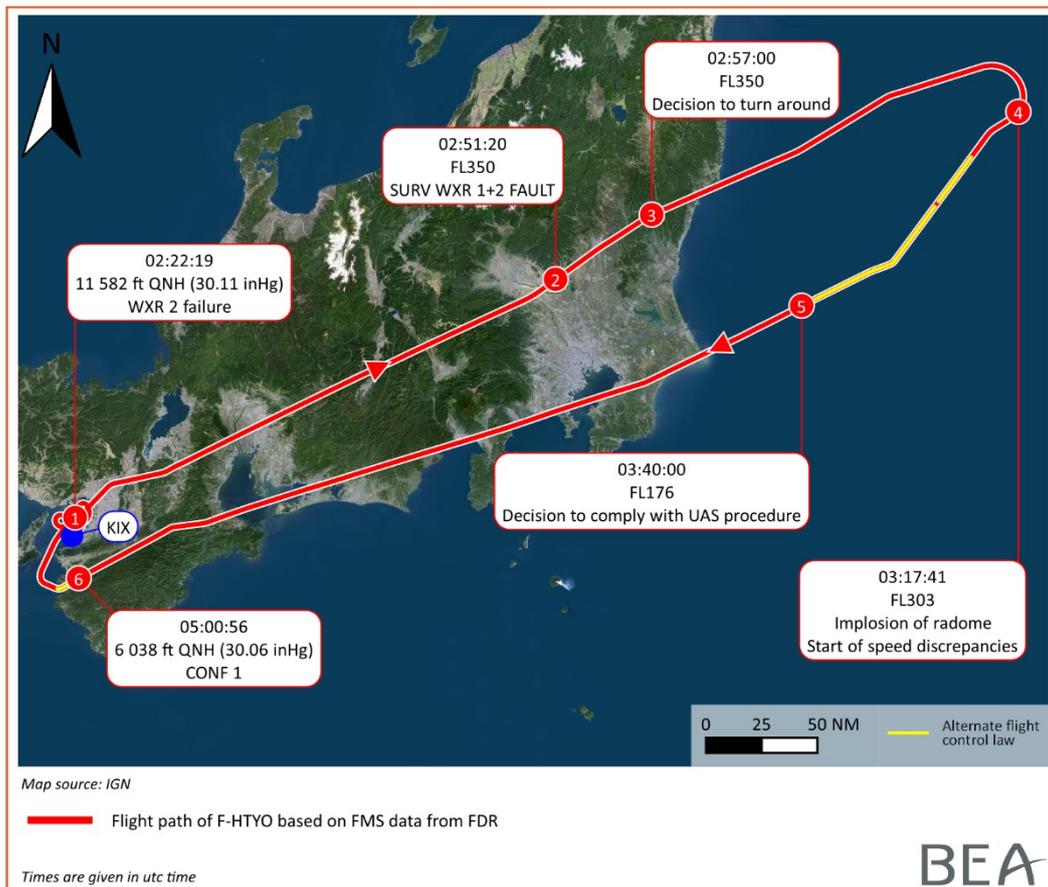
Figure 2: complete flight path

At 02:22, the aeroplane flew through 11,600 ft climbing towards FL 290 and a fault occurred on radar system 2 (see **Figure 2**, point **1**). The MASTER CAUTION⁴ alert was activated along with the message **SURV WXR 2 FAULT**⁵ displayed on the ECAM. In the minutes that followed, the crew alternately selected radar system 1 and radar system 2. They observed that neither system was operating nominally (intermittent operation). The crew changed the operating mode of the radar (OFF/Manual/Auto) but this did not correct the situation. The MASTER CAUTION alert was activated a number of times along with the fault messages **SURV WXR 1 FAULT** or **SURV WXR 2 FAULT** displayed on the ECAM.

At 02:51, the aeroplane was at FL 350 and the **SURV WXR 1+2 FAULT** message was displayed on the ECAM (see **Figure 1** and **Figure 2**, point **2**). The application of this procedure led the crew to perform the **SURV TOTAL LOSS OF WXR** procedure and to carry out a FORDEC. Informed by Air France operations of the presence of cumulonimbus along the route, and having more than six flight hours to Paris, the crew decided to turn back to Osaka (see **Figure 2**, point **3**). The captain became PM to focus on the radio exchanges with the controllers and Air France operations. Co-pilot B replaced co-pilot A⁶ and became PF up to landing.

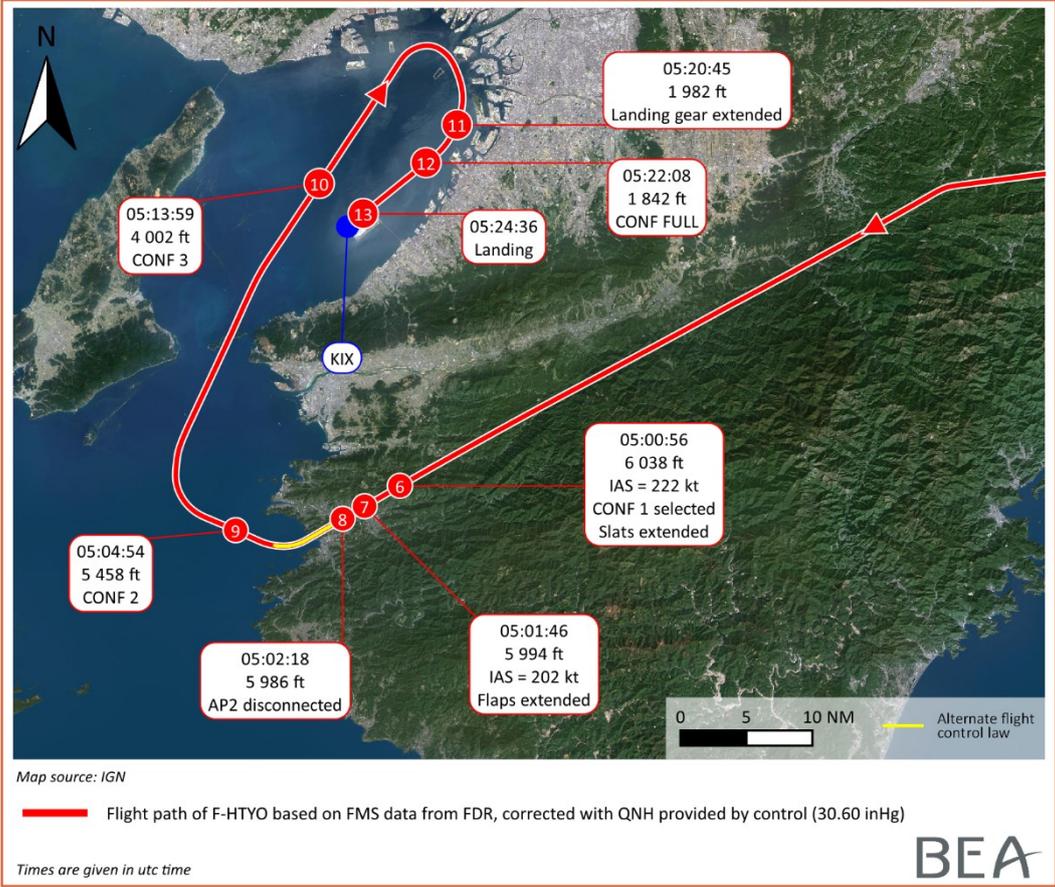
Figure 3: flight path - arrival

At 05:01, the aeroplane was stable at 6,000 ft at 224 kt. The crew selected CONF 1 (see **Figure 2** and **Figure 3**, point **6**), the leading edge slats were deployed. They reported that the situation had not changed and selected a speed of 200 kt.

When the aeroplane reached a speed of 203 kt, the flaps extended and the crew observed sudden drops and marked differences between the speeds displayed on the PFD (see **Figure 3**, point **7**). Surprised by this situation, they indicated that they had just lost the radome and that the suddenness of the variations was completely abnormal. The crew set the AIR DATA selector to "F/O on BKUP SPD", disconnected the A/THR, AP and FD, and decided to remain in manual mode until landing (point **8**).

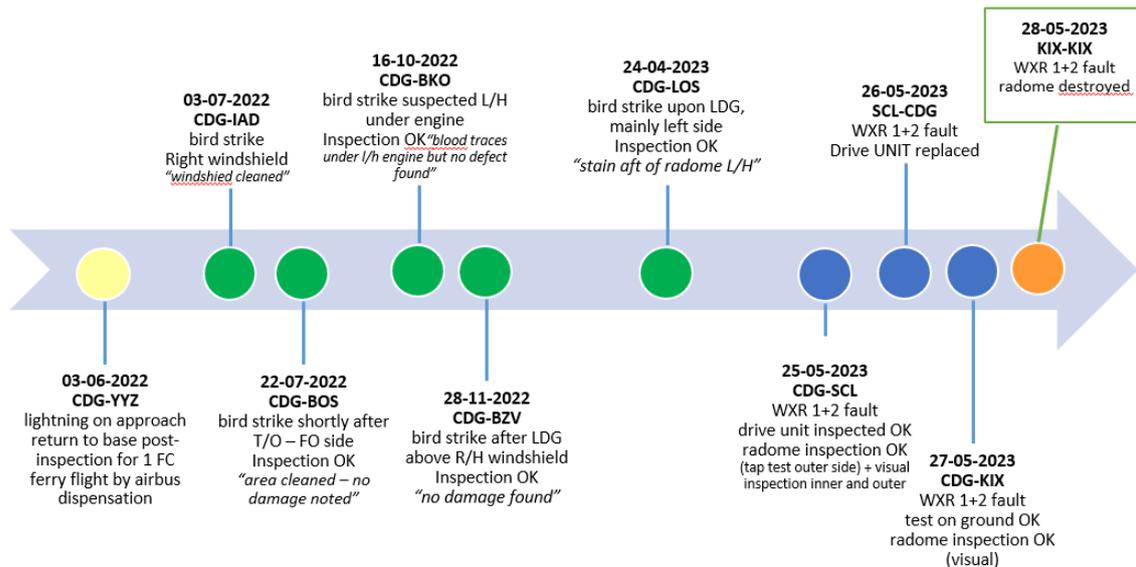
Figure 26: history of faults reported in the month preceding the incident

In the month preceding the incident flight, F-HTYO encountered a certain number of occurrences (mainly bird strikes) that may have damaged the radome. These occurrences were those reported in the ATL. Between 03 July 2022 and the incident, the aeroplane was subjected to at least five known bird strikes. In the month preceding the incident, the aeroplane experienced a bird strike and radar faults:

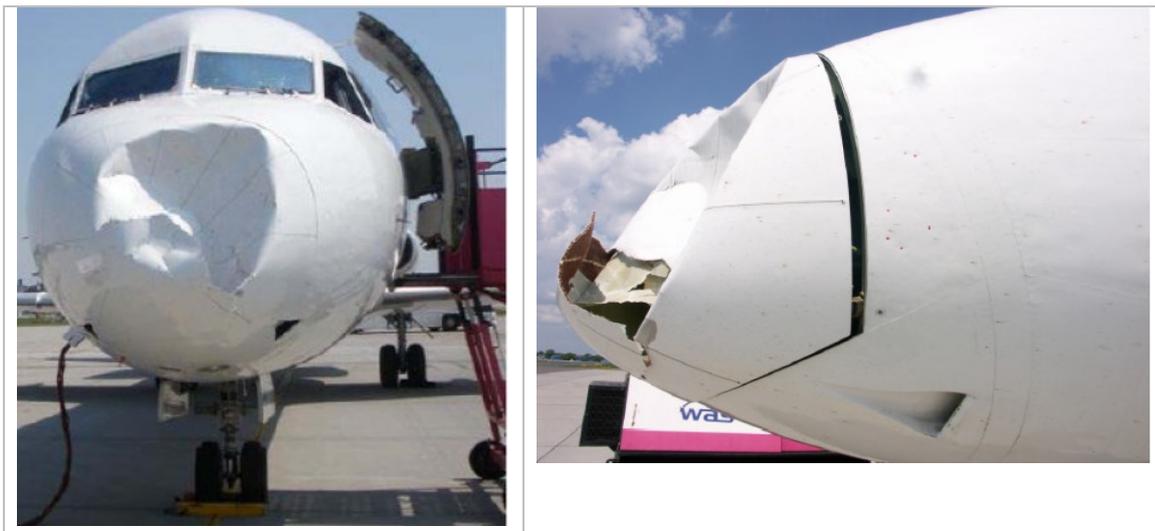
Figure 38: excerpt from the final report on the serious incident to D-AGPH

In its final report, the Polish Investigation Authority (SCAAI) stated that the gradual reduction in strength of the composite structure may have been the cause of the serious incident. Several bird strikes, which occurred prior to the occurrence flight, may have contributed to this gradual weakening that was not detected during maintenance inspections.
