Accident to the CESSNA 208 registered F-HVPC on Thursday 1 August 2024 at Vannes

Time	Around 14:05 ¹
Operator	École de Parachutisme Sportif de Vannes Bretagne (EPSVB)
Type of flight	Parachute drop
Persons on board	Pilot and 14 skydivers
Consequences and damage	Aeroplane slightly damaged, one skydiver injured
This is a courtesy translation by the BEA of the Final Report on the Safety Investigation. As accurate as the translation may be, the original text in French is the work of reference.

Untimely deployment of a parachute at aeroplane door, in climb, during a parachute drop flight

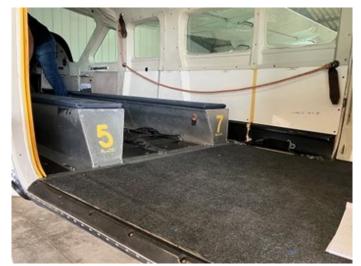
Figure 7: layout inside the airframe in skydiving activity configuration (source: BEA)

The aeroplane is configured for skydiving. It can carry up to 15 skydivers. Two benches can seat five and seven skydivers. The other skydivers sit on the floor of the aeroplane between the two benches and on the floor next to the aft door.
