**REPORT of the accident to the Falcon 20 E registered F-GHLN
operated by LEADAIR UNIJET on January 20th 1995 at Le Bourget airport**

F-LN950120EN

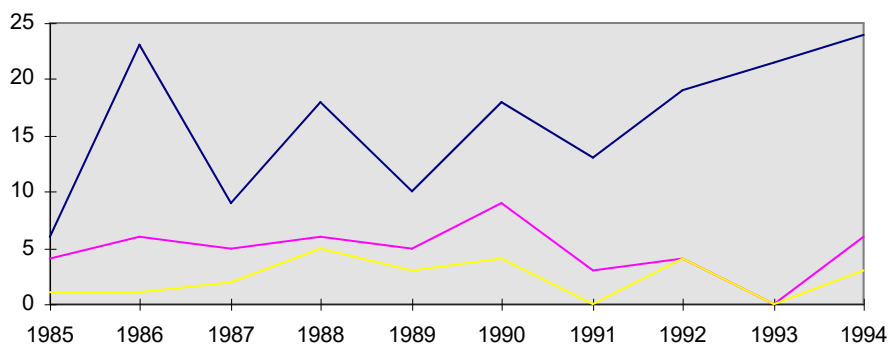
Annual incident rate at LE BOURGET

- the total number of collisions recorded after 1992 is mainly as a result of better collection of data,
- in 1993, no engines were damaged,
- in 1994, out of 24 incident reports³, 10 were submitted by the control tower, based on dead birds found on the runway.
