**Serious incident** to the De Havilland - DHC-6 Twin Otter  
Series - 300  
registered **F-OCQZ**  
operated by Aircalin  
on Tuesday 4 May 2021  
at Futuna Pointe Vélé (Wallis and Futuna islands)

## Loss of engine power during final approach

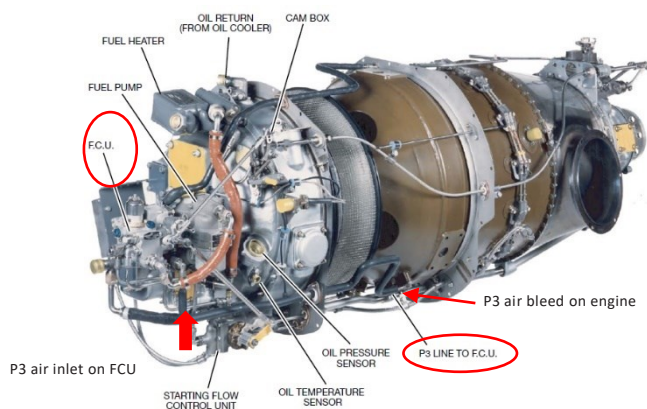
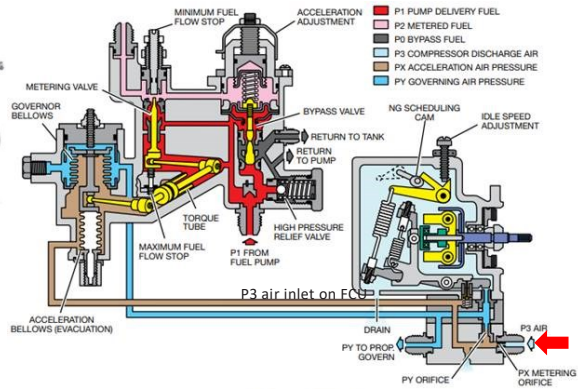
Figure 2: FCU and P3 supply line on PT6A27 (source: PRATT & WHITNEY)

During the physical inspection of the two FCUs, debris was found at the P3 and Py ports.

The borescope inspection carried out on the P3 and PY air inlets of LH FCU #1 revealed the presence of flaky debris, black granular deposits, fibres, yellowish particles and signs of corrosion.

The borescope inspection carried out on the P3 and PY air inlets of RH FCU #2 revealed the presence of black granular deposits, yellowish crystals and fibres.

Bench testing of the two FCUs did not reveal any operating anomalies that could explain the event.

At the request of the engine manufacturer (PRATT & WHITNEY), the FCUs and the fuel-oil heat exchangers of both engines were replaced and sent to its workshops for further examination.
