Accident to the PIPER - PA32 registered F-OJSN

on 28 November 2018
in the Baie des Saintes (Guadeloupe)

Vibrations in flight, diversion, engine failure on final, water landing

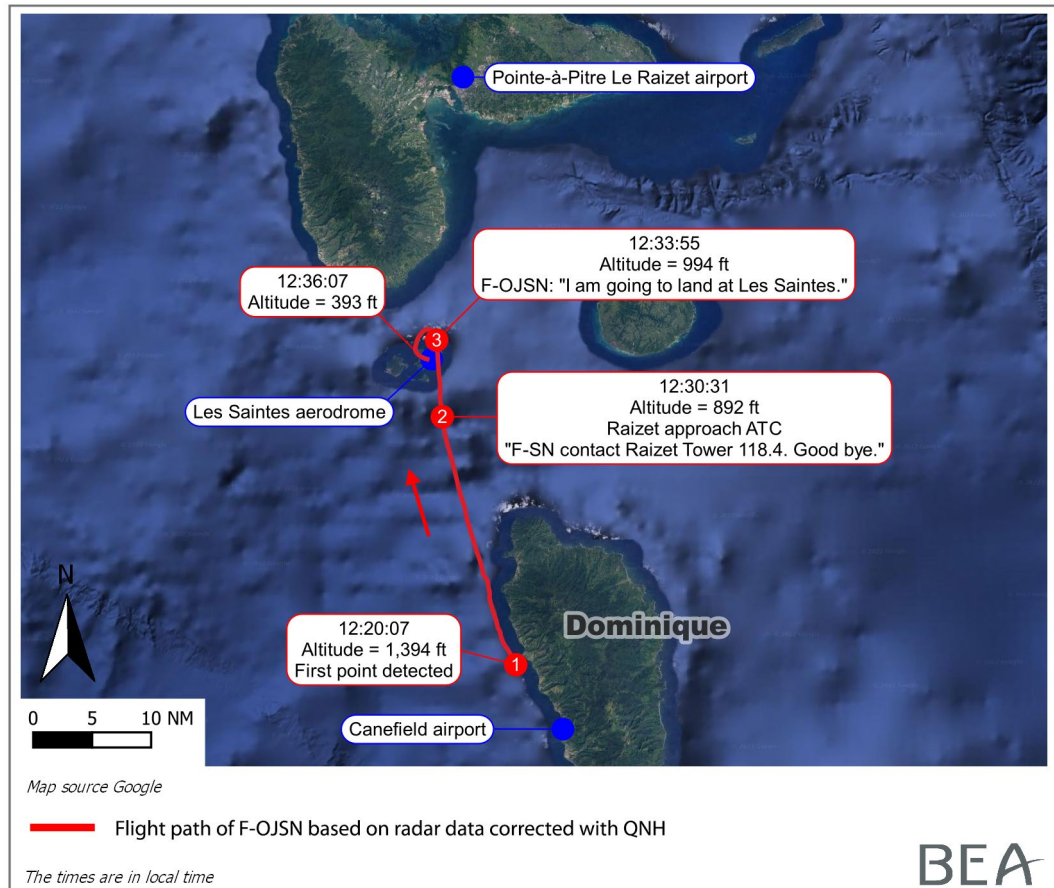
Figure 1: flight path

At 12:30, when the aeroplane was approaching the Les Saintes archipelago at an altitude of around 900 ft, the pilot was transferred by the Raizet Approach controller to the Raizet Tower controller, who asked him to call in before joining the Pointe-à-Pitre runway circuit (see [Figure 1](#), point ❷).

At 12:33, after flying past the Les Saintes archipelago at an altitude of around 1,000 ft, the pilot felt slight vibrations in the aeroplane's structure. He decided to divert to Les Saintes aerodrome and announced this to the Pointe-à-Pitre control tower, indicating that he wanted to check the doors (see [Figure 1](#), point ❸). The controller acknowledged receipt of the message and asked the pilot to switch to the A/A frequency.

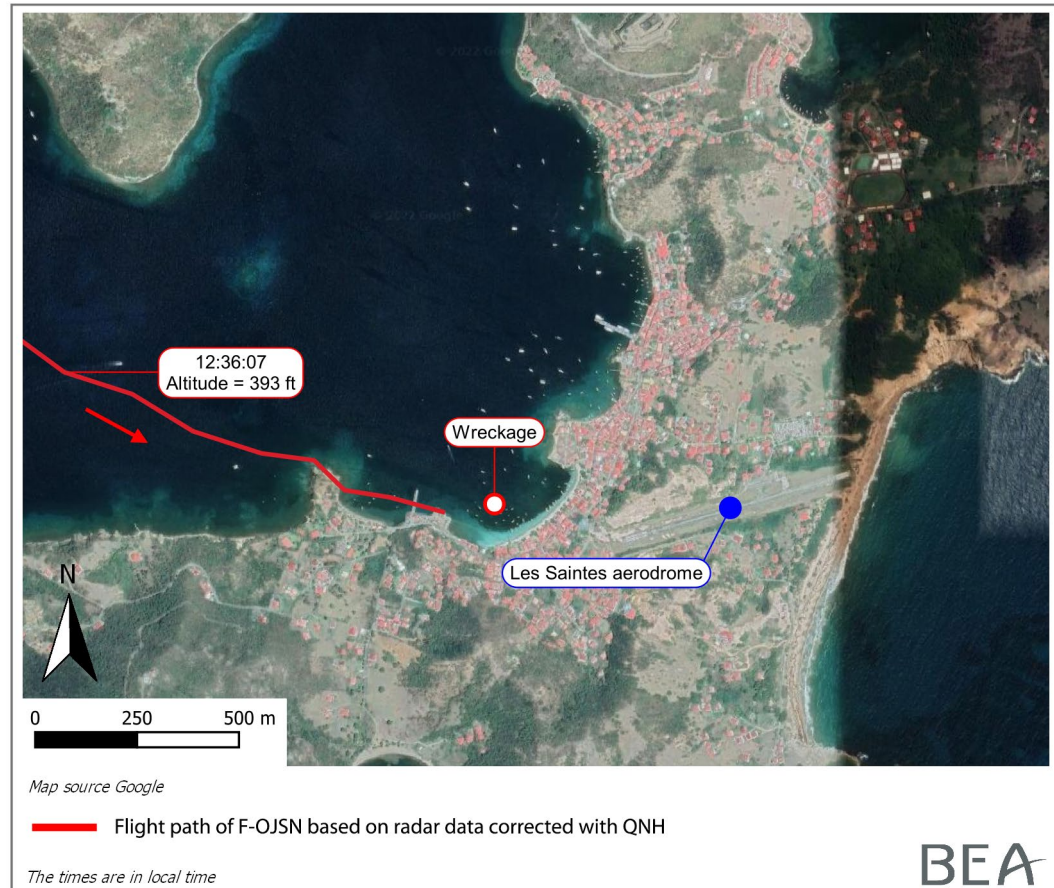
Figure 2: detail of end of path

At 12:36, on final over the Baies des Saintes, the pilot heard a noise from the engine and saw smoke in the cockpit. The vibrations continued to intensify, making the aeroplane difficult to control. The pilot then heard a loud noise that sounded like an explosion. He decided to make a water landing in the bay and turned left (see [Figure 2](#)).

He performed a precautionary approach without flaps and avoiding the boats. The engine stopped, the rear of the aeroplane's fuselage made contact with the surface of the water, the aeroplane glided across the surface of the water before coming to a stop. The occupants evacuated the aeroplane via the wings and were picked up by boats around one minute later. The aeroplane sank in the following minutes.

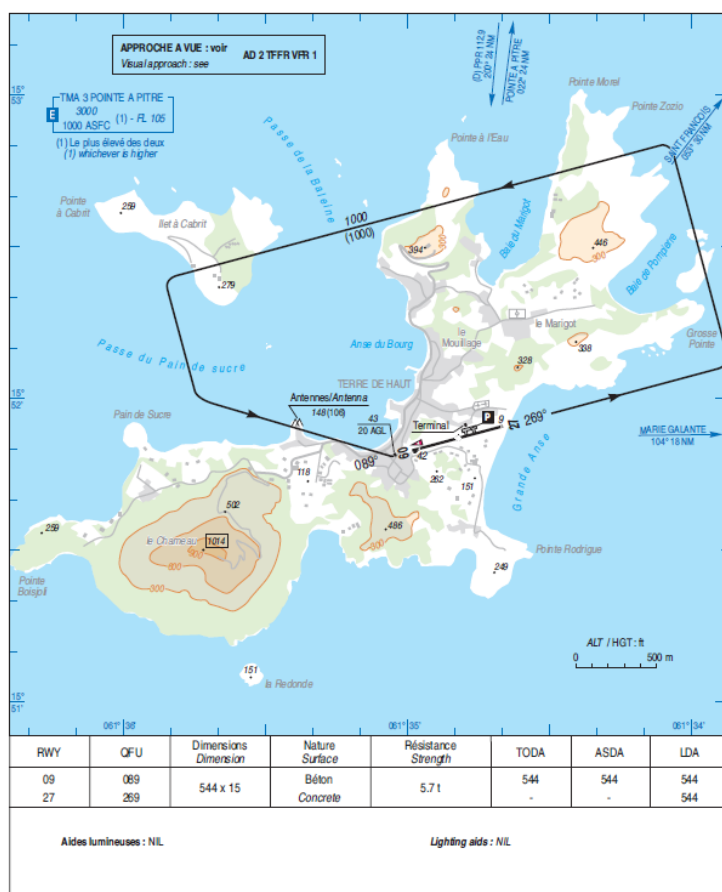
Figure 3: extract from the Les Saintes aerodrome VAC chart in force on the day of the accident (version 7 January 2016)

- The aerodrome is reserved for pilots who have good knowledge of the conditions of its use, as well as experience and specific training with an instructor.
- Due to the presence of obstacles and terrain around the runway axis, the final for runway 09 is displaced and is over the bay.
- Due to the short final on 09, pilots have to fly over the village of Terre-du-haut and dwellings at low height.
