**Accident** to the De Havilland DHC-6 400 “Twin Otter”  
registered **F-OMYS**  
operated by CAIRE  
on Thursday 24 August 2023  
at Saint-Barthélemy airport

This is a courtesy translation by the BEA of the Final Report on the Safety Investigation. As accurate as the translation may be, the original text in French is the work of reference.

**Runway veer-off on landing, collision with a parked helicopter**

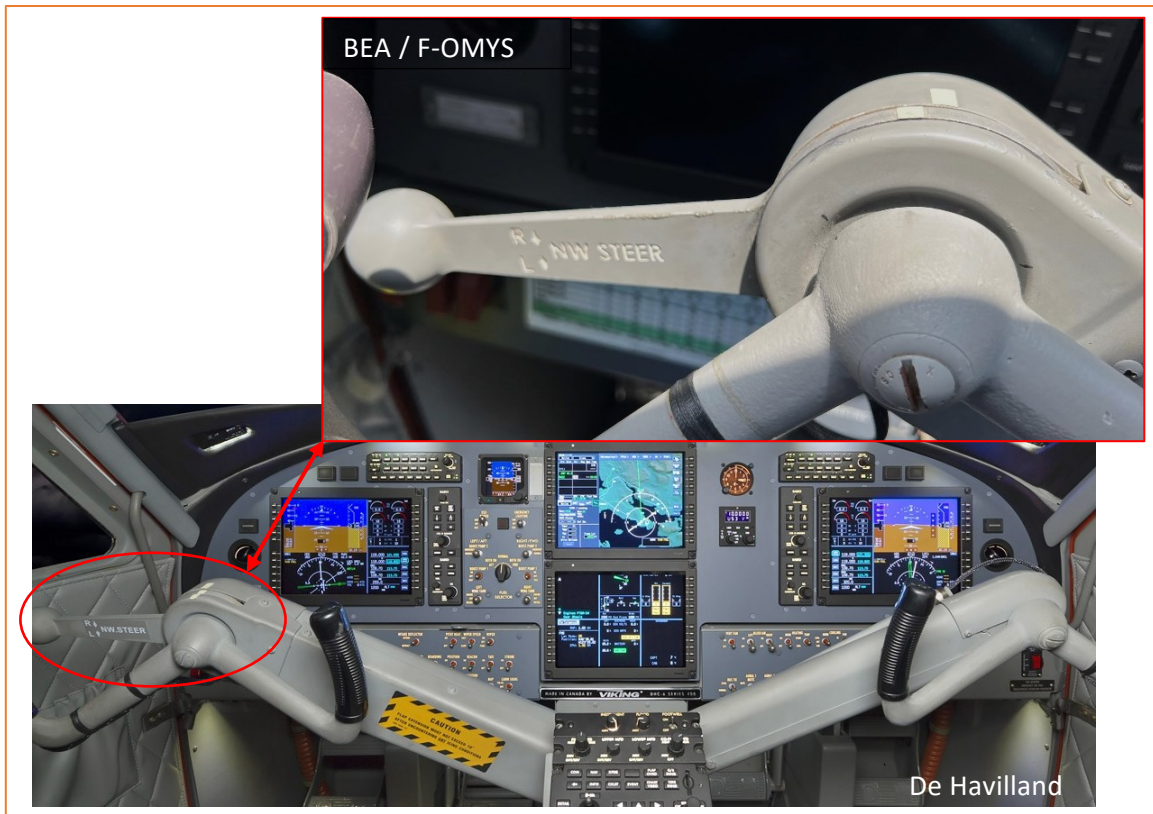
Figure 3: NWS lever (source: De Havilland / BEA)<sup>7</sup>

<sup>7</sup> The BEA photo in this figure shows the steering lever in F-OMYS. The De Havilland cockpit photo shows the overall view of the cockpit of another aeroplane.

During these tests, it was observed that the tension of the connecting cable between the NWS lever and the actuator was insufficient<sup>13</sup>. It was not possible to determine the cause of this insufficient tension level.

<sup>13</sup> The tension values measured were of the order of 10 lb for a nominal value of 40 lb in the conditions of the day.

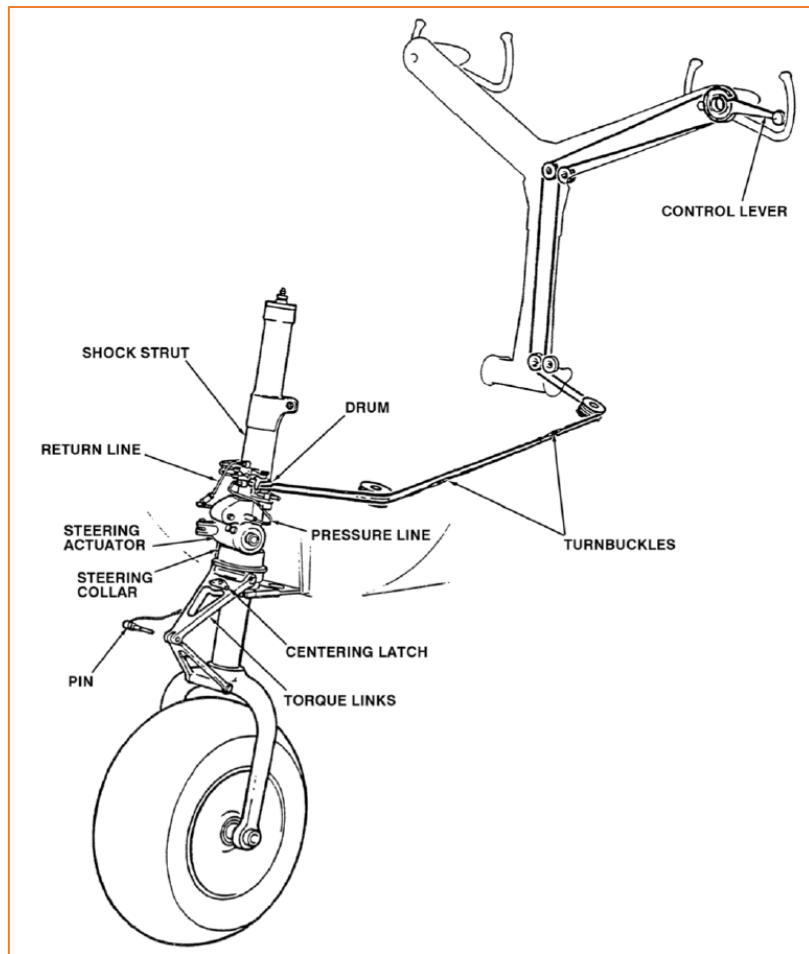
The steering control lever is connected via a system of cables and pulleys to a drum on the actuator steering valve which controls the direction and amplitude of the rotation in response to the steering lever being pivoted up or down.

Figure 4: diagram of NWS (source: De Havilland)

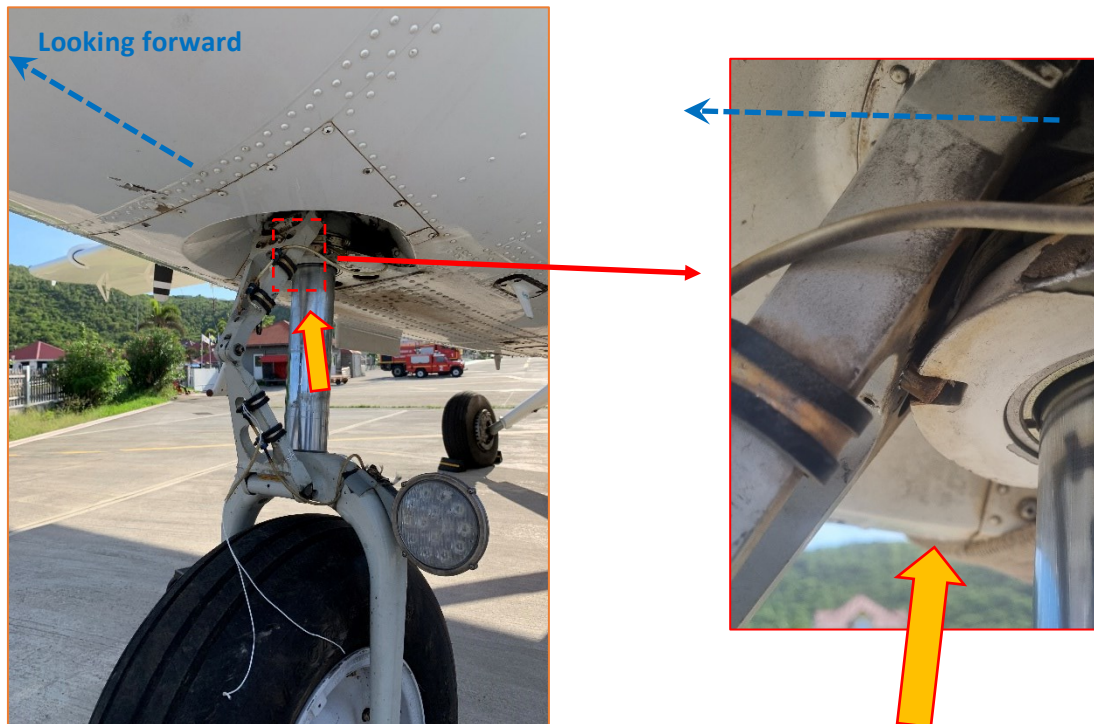
A spring latch locks the nose wheel in the centred position in flight when the shock absorber is decompressed provided that the wheel is aligned before the decompression of the shock absorber.

Figure 5: nose gear locking mechanism - spring latch in position, gear locked <sup>8</sup> (source: BEA)

The sector head added that he had occasionally noticed that the nose wheel was not centred in flight. He had associated this with improper locking of the NWS.

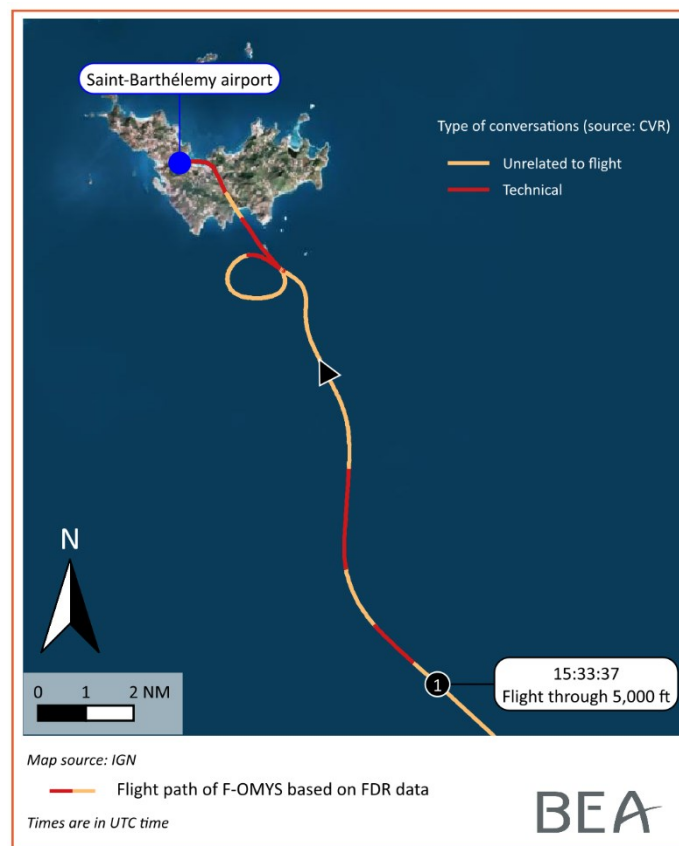
The examination of the conversations recorded on the CVR also revealed discussions unrelated to the flight during the sterile cockpit phase, below 5,000 ft (see paragraph 2.7.5), as illustrated in Figure 15. Out of the 8 min 46 s spent below this altitude, less than 42% of the time was used for technical discussions/call outs in relation with the flight or was marked by no conversation, and 58% of the time was devoted to conversation unrelated to the flight. Moments of silence were nearly non-existent.

Figure 15: flight path of F-OMYS, type of conversations during the flight
