**Serious incident** to the ATR72-212A  
registered **F-ORVO**  
on Monday 29 September 2025  
at Nuku Hiva airport (French Polynesia)

**Restriction in nose-down deflection then uncoupling of  
elevator controls during final approach**

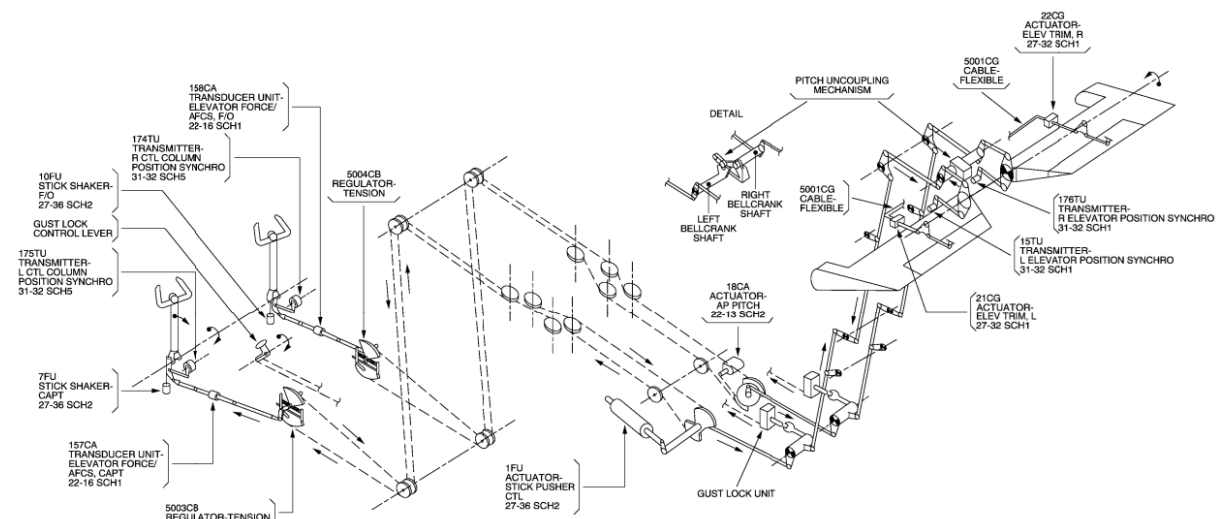
Figure 1: diagram of elevator flight controls (source: ATR)

Given that the inputs applied to the controls are measured by a dynamometric rod situated under the cockpit floor, before the departure of the control cables, the hypothesis of an object in the cockpit having jammed the control channel was excluded.

Likewise, the various elevator positions during the restriction meant that it was possible to exclude jamming due to the Gust Lock and Stick Pusher.

Between 30 September and 21 October, all of the elevator control channel was inspected by Air Tahiti in coordination with the BEA and ATR. Apart from some bird nests found at the top of the vertical stabilizer, no anomaly was reported.
