**Serious incident** to the ATR72-212A  
registered **F-ORVS**  
on Monday 4 April 2022  
at Hiva-Oa-Atuona (French Polynesia - Marquesas Islands)

**Non-stabilised approach, windshear, opposite dual inputs,  
hard landing, balked landing**

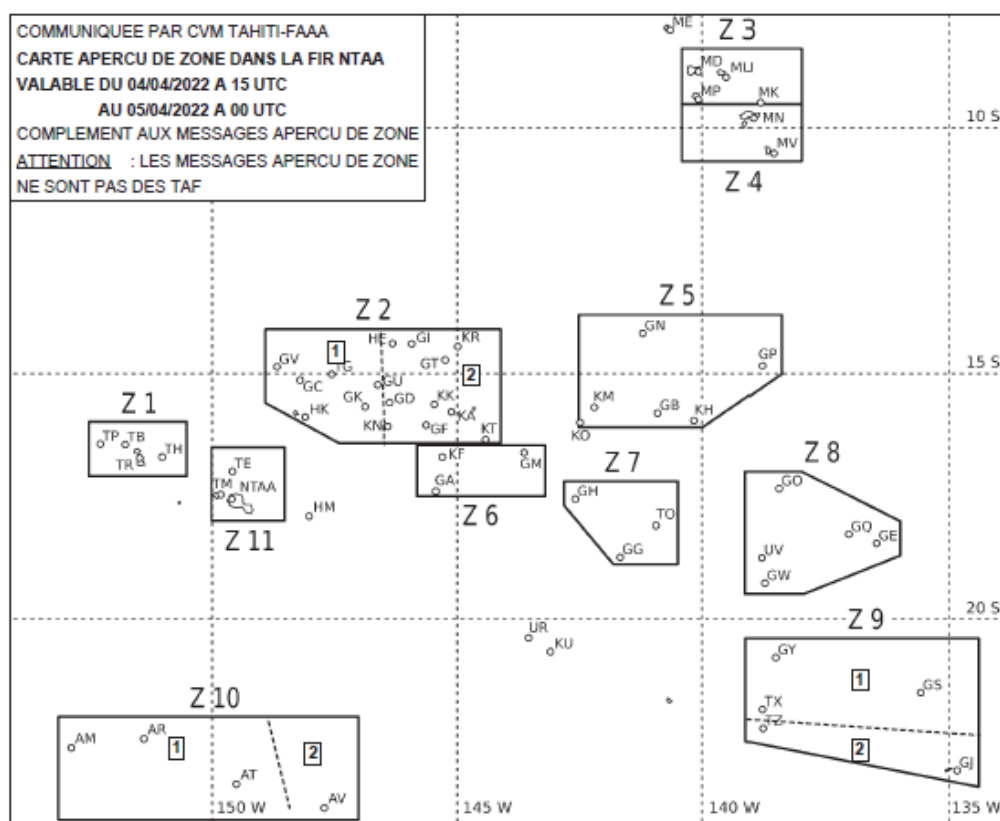
Figure 2: map of APZ zones (source: Météo-France)

The BEA contacted the DSAC's flight crew expertise centre (PN/EPN). The joint analysis found that the APZ bulletin is by nature imprecise given the local conditions within its perimeter, and the frequency at which it is updated. During flight preparation, it is not possible to use the information provided by the APZ to determine access conditions linked to visibility or RVR, at the destination or alternate aerodrome, from one hour before to one hour after the estimated time of arrival.

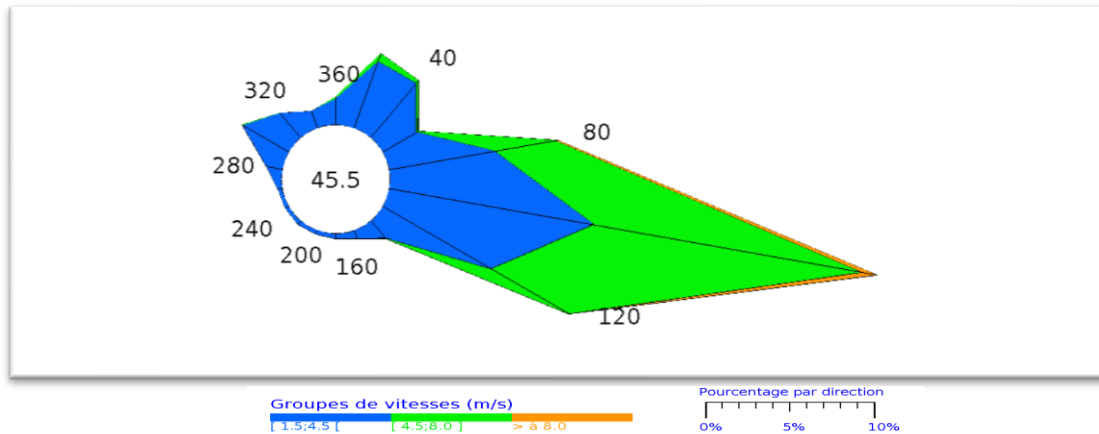
Figure 3: rose of prevailing winds at Atuona (source: Météo-France)

The hourly wind measured at a height of ten meters and averaged over ten minutes in April, over the period 1991-2020 is predominantly from the east-south-east (trade winds). The main direction is 100-120° and of around 10 kt.

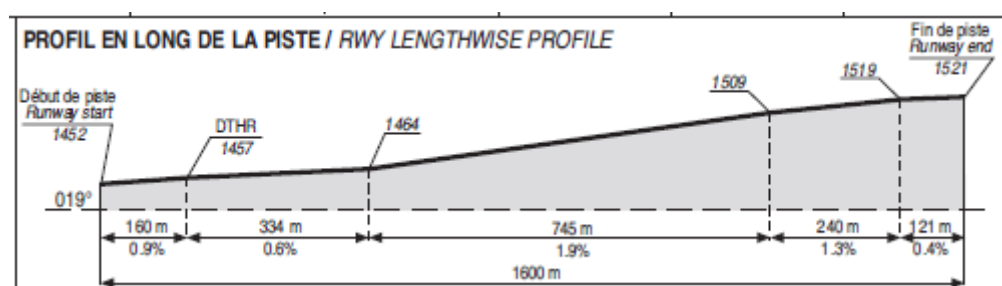
Figure 6: declared distances and runway lengthwise profile (source: SIA)

Hiva-Oa-Atuona airport is a category C, restricted-use airport. It is located on a ridge at an altitude of around 1,500 ft. It is bordered to the east and west by terrain rising to 2,825 ft and 2,838 ft respectively. The summit of the island lies to the south-west of the airport, at an altitude of 4,151 ft. It has a paved runway 02-20 measuring 1,600 x 30 m with a mean downward slope of 1.3% facing south-west (1% recommended in section 3.1.13 of ICAO Annex 14). The maximum slope is 1.9% in the middle part and wheel touchdown on runway 20 (1.5% maximum recommended in section 3.1.14 of Annex 14). It is open to VFR or IFR operations in the presence of the AFIS officer.

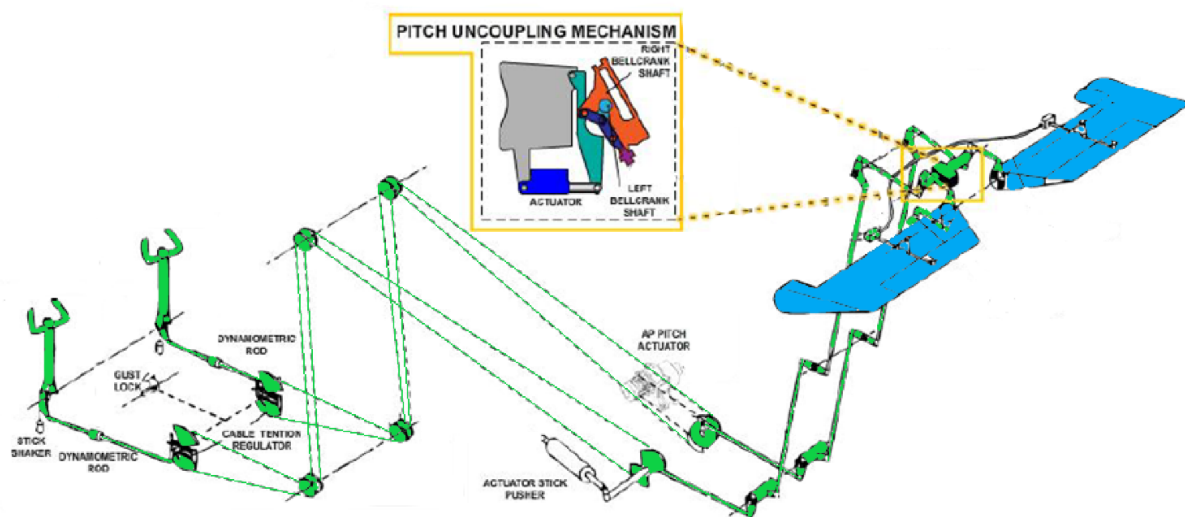
Figure 11: diagram of elevator control (source: ATR, modified by BEA)

The role of the PUM is to uncouple the two elevators and make them independent if one of them should be jammed by an outside phenomenon. This architecture was designed to minimise the crew reaction time and automatically uncouple the two elevators in certain critical flight phases, and allow the pitch axis to be controlled by the other elevator. The PUM acts when the differential load on the two elevators exceeds a fixed value. The uncoupling also occurs when opposite dual inputs are made on the control columns (between 50 and 55 daN applied to each control column on ground).

The uncoupling by the PUM is irreversible in flight. A maintenance action carried out on the ground by qualified personnel is required to recouple the system.
