**Accident to the NICOLIER HN700  
registered F-PADB  
on Monday 2 May 2022  
at Blois-Le Breuil aerodrome**

**Incorrect installation of roll control cables, loss of control  
on take-off, tipping over, collision with the ground**

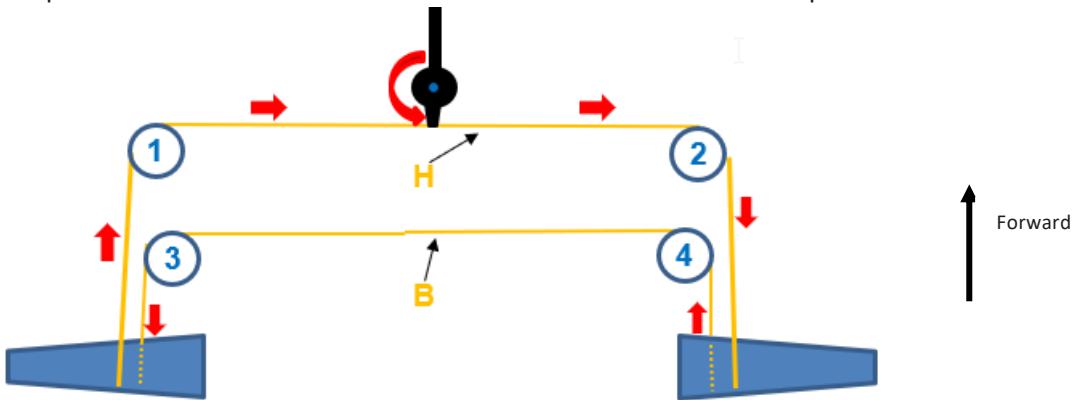
Figure 3: conceptual diagram of the aileron control.

**Figure 3<sup>3</sup>** below shows the entire roll control linkage as nominally assembled in an HN700. The idler pulleys installed in the wings are numbered 1 to 4, and the ailerons are shown in blue. The top cable is called "H" (actually, there are two cables connected together at the bottom of the stick) and the bottom cable is called "B". This cable is commonly referred to as the "coordination cable" on aeroplanes with this architecture.

**Figure 3** represents the direction in which the cables move when a left input is made on the stick:

When a left roll input is made on the stick, the left aileron raises and the right aileron lowers.
