**Accident** to the CESSNA - T303 "Crusader"  
registered **HB-LUV**  
on 04 December 2020  
at Annecy-Meythet

**Runway overrun during landing  
on a wet runway**

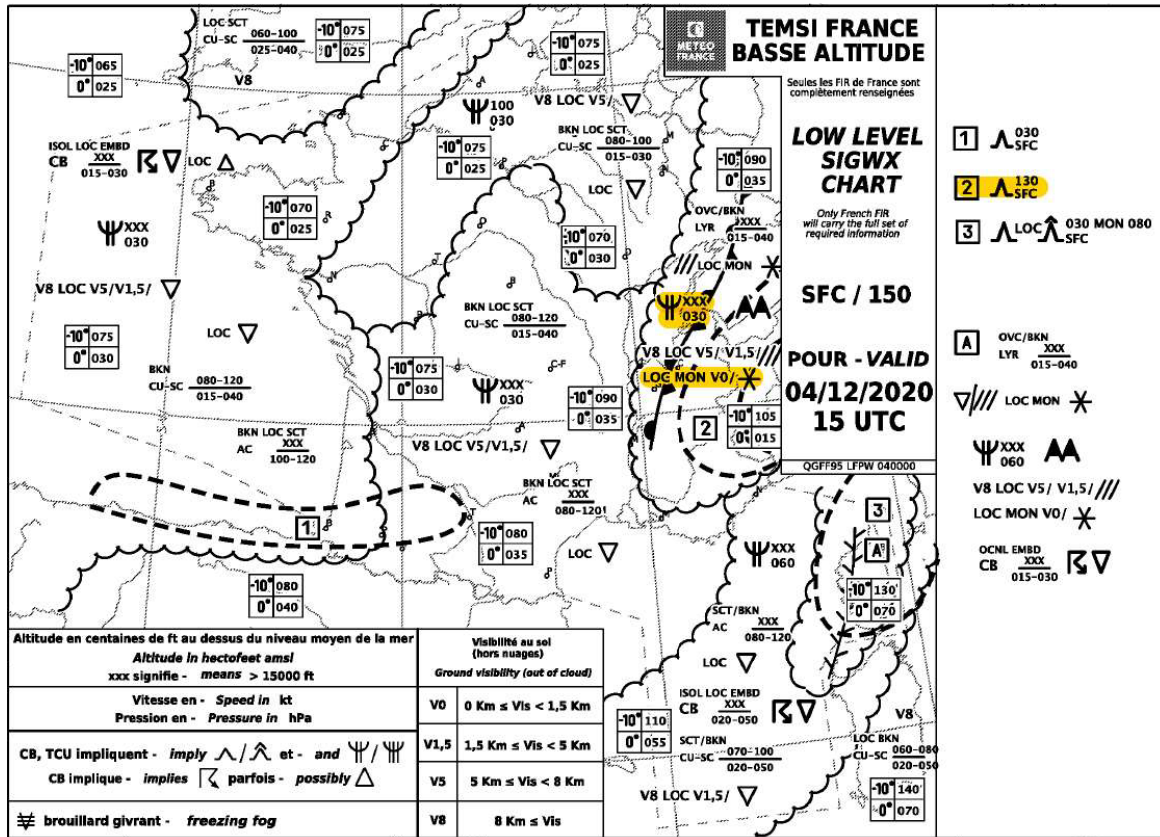
Figure 2: SIGWX chart (Source: Météo-France)

The SIGWX chart at 15:00 UTC for the Annecy region indicated visibility locally reduced to 1,500 m and snow precipitation in the mountains.

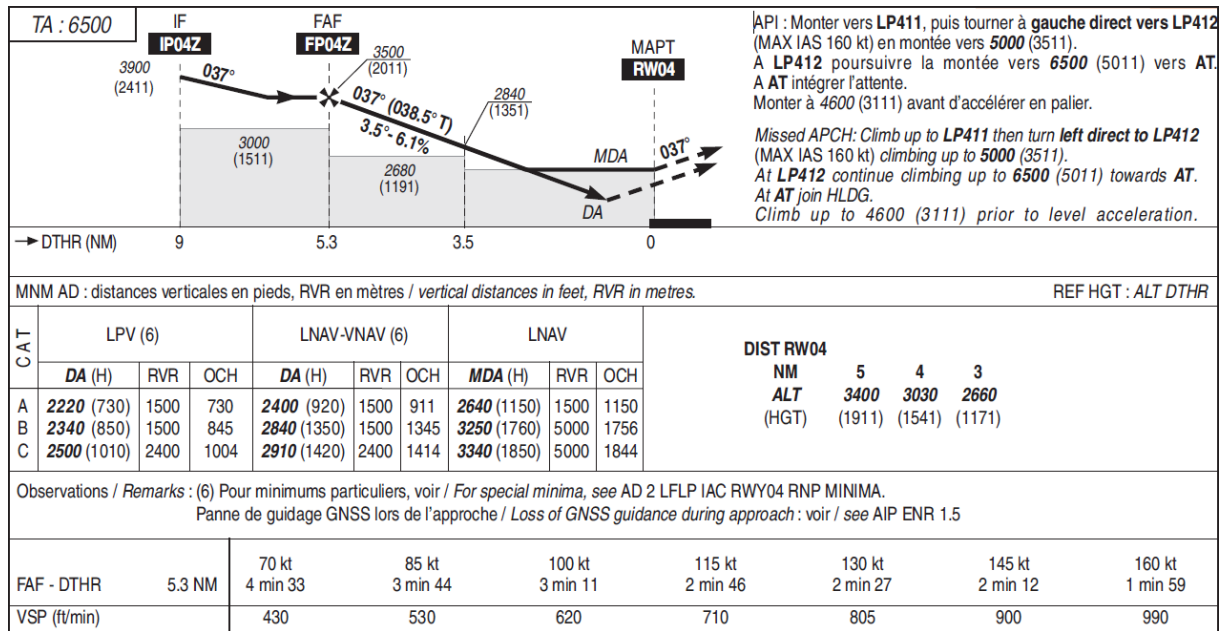
Figure 4: excerpt from RNP Z 04 procedure

For a Category A aeroplane<sup>6</sup>, the runway visual range required for landing is 1,500 m. For the LNAV procedure, the minimum descent altitude (MDA) is 2,640 ft (i.e. a height (MDH) of 1,150 ft). The approach slope is 3.5°.
