Accident to the PIPER PA-28RT - 201T
registered **HB-PNP**
on Thursday 23 July 2020
on Bâle-Mulhouse airport

In-flight fire, emergency landing

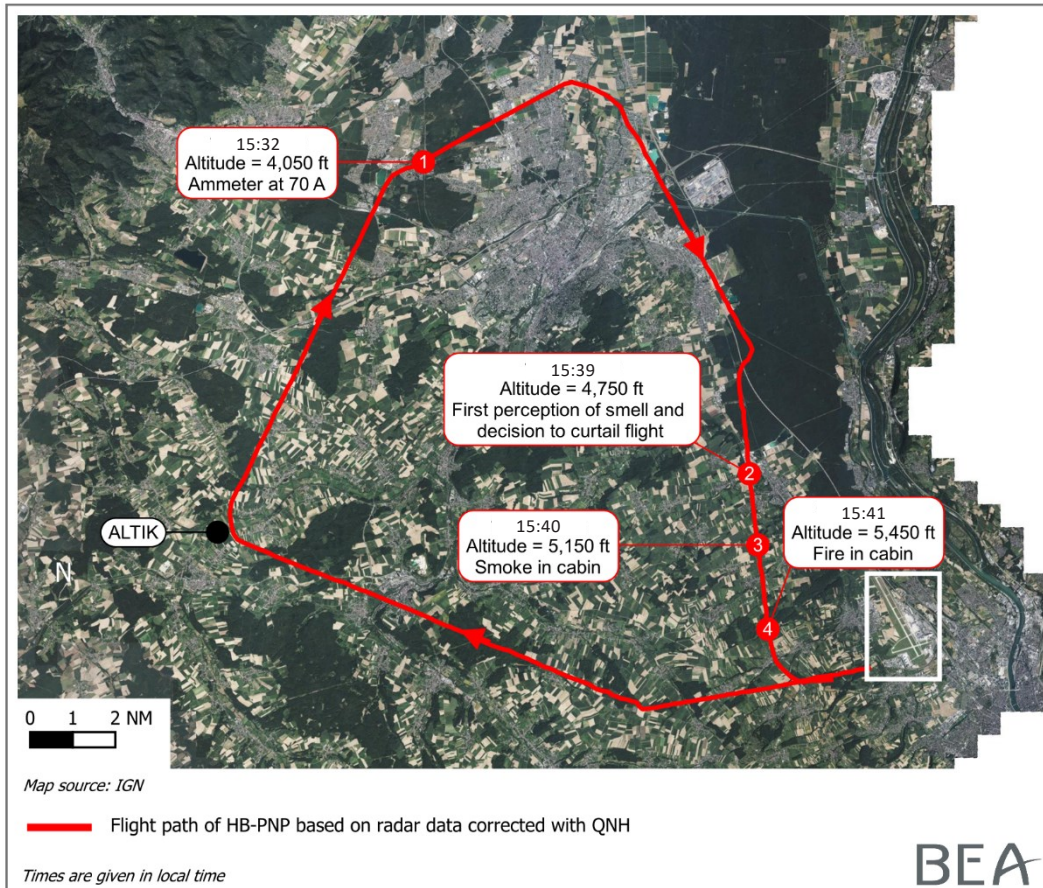
The pilot took off at 15:17 from runway 15. The first minutes into the flight were normal and the various tests of the autopilot and flight director were satisfactory. After a flight time of around 15 minutes, between waypoint ALTIK and the final for runway 15, the pilot observed an ammeter charge indication close to 70 A which corresponds to the needle being close to the indicator's limit. This charge value was a lot higher than the values expected for such a flight phase, which are normally between 10 and 30 A (see Figure 1, point ①).

Figure 1: flight path of HB-PNP based on radar data and the pilot's statement.
The positions of the red circles on the flight path are approximate as solely based on the pilot's statement.

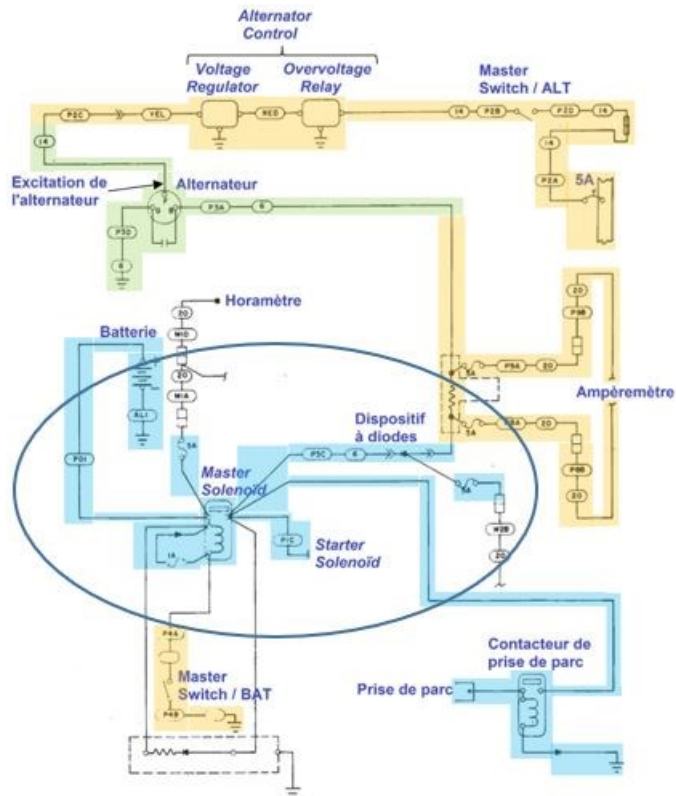
In the electrical power system of the PA-28, the diode device (Piper equipment P/N 79412-011) is located between the battery and the alternator. It participates in rectifying the voltage at the alternator output to recharge the battery. This device also prevents the current from the battery returning to the alternator (see Figure 4).

Figure 4: aircraft's electrical power system (source: Piper, annotations BEA)

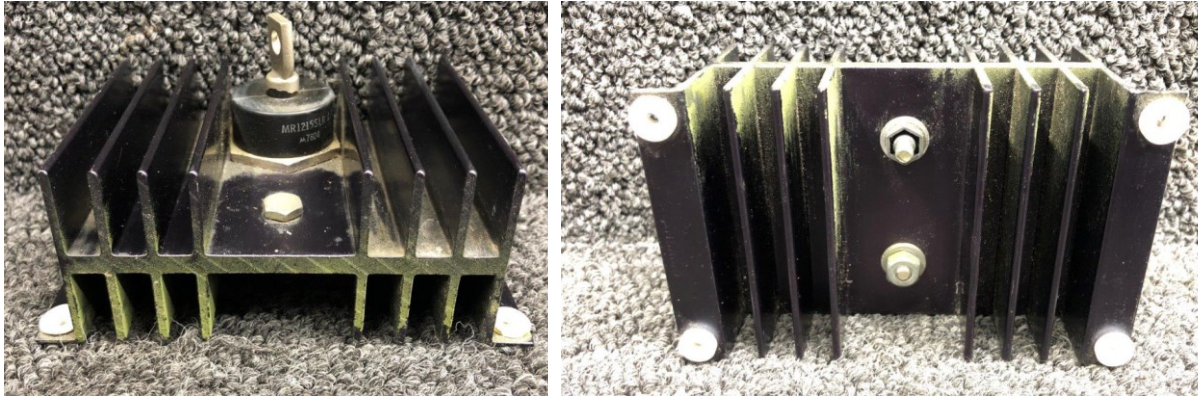
This equipment is composed of a four-diode device attached to a metal cooler (heat sink). This aluminium alloy cooler has an outer protective coating formed by electrolytic anodisation.

Figure 5: undamaged diode device (source: Piper spare parts on-line store)

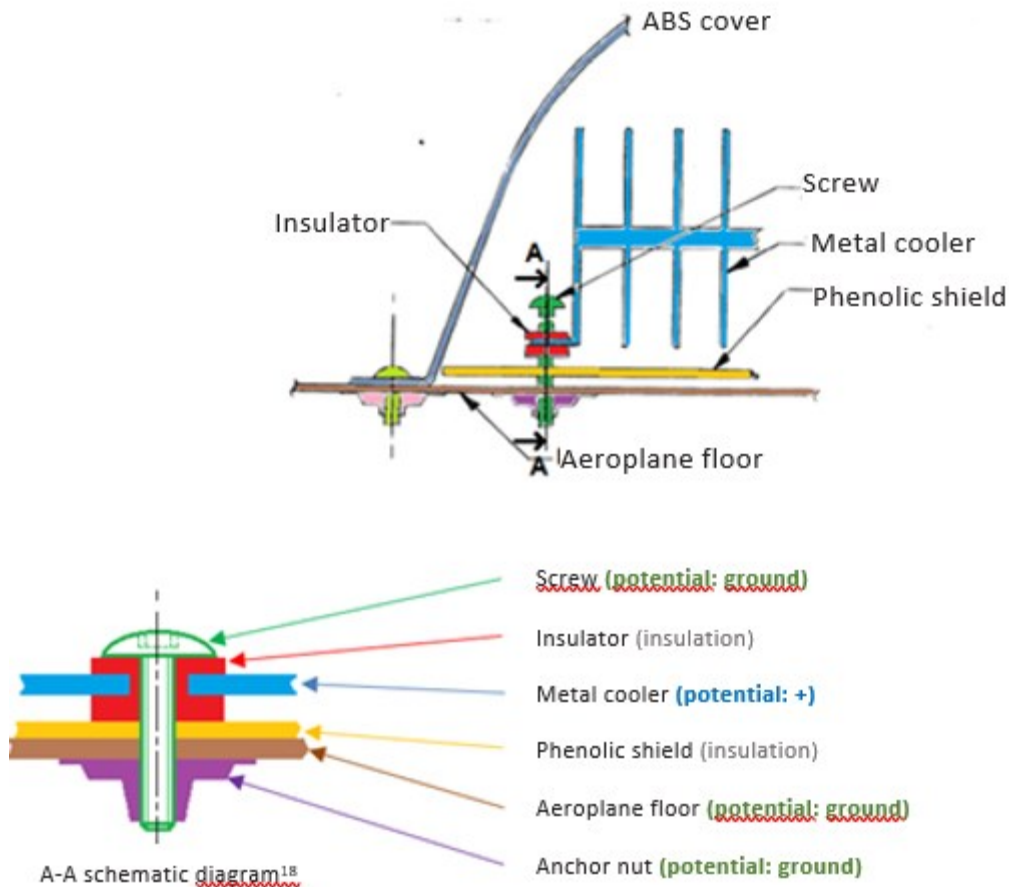
This device is located in the compartment situated behind the luggage hold, close to the battery. The metal cooler is attached to the aeroplane floor by means of four carbon steel screws. It is electrically insulated from the floor by a phenolic shield and electrically insulated from the attaching items by isolating washers. The cooler has an outer protection composed of a plastic (ABS⁷) cover.

Figure 6: diagram of diode device installation (source: Piper, annotations BEA)

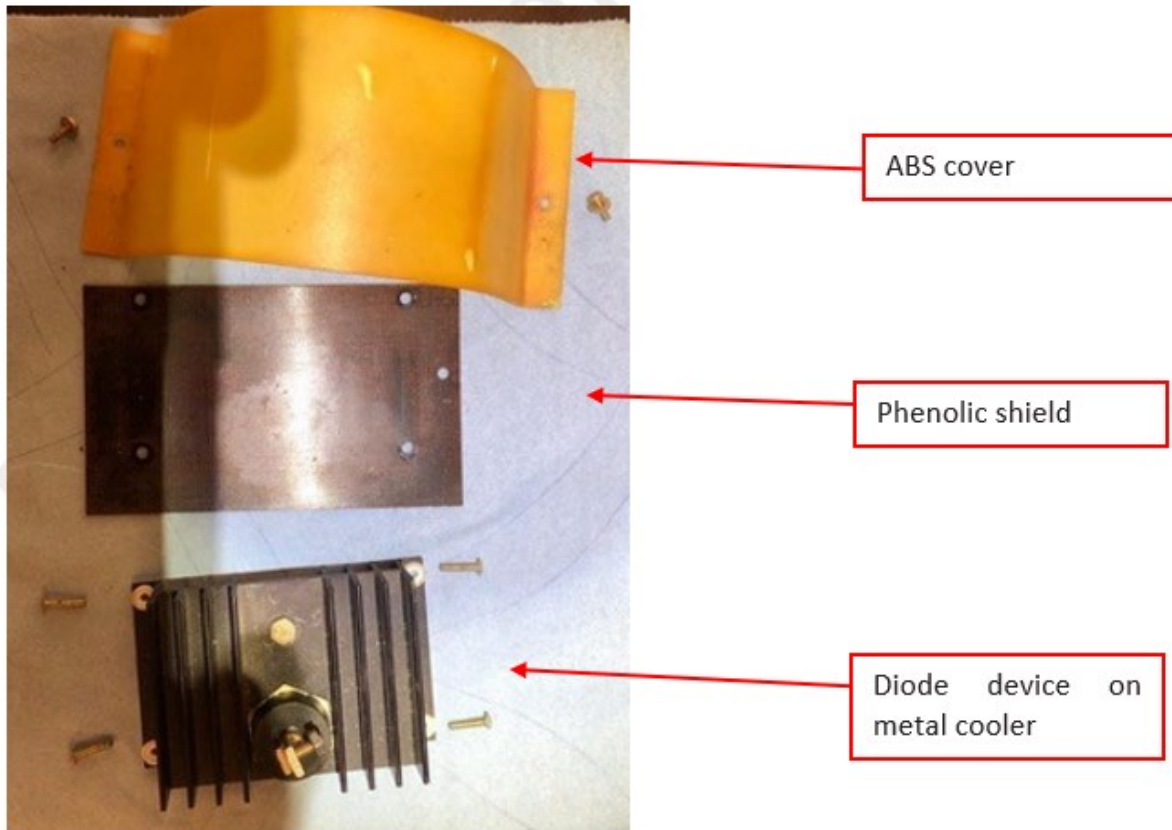
Figure 7: photo of device from a PA-28RT-201T
(source: FLUGSCHULE BASEL flying club)

The electrical terminal of the diode device, in contact with the cooler, is connected to the alternator. Consequently, if the insulation is incorrect between the cooler and the aeroplane floor, the alternator is directly connected to the structure of the aeroplane. This could create a short-circuit and the alternator would supply its maximum power.

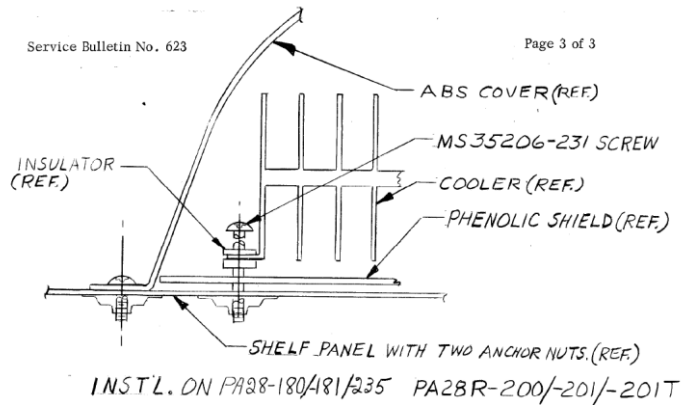
Piper published service bulletin [SB 623](#) on 1 November 1978 to warn maintenance workshops that the incorrect installation of the items attaching the cooler to the floor could cause a short-circuit and demand maximum output from the alternator.

Figure 8: excerpt from Piper service bulletin SB 623

This SB applies to the various Piper PA-28 models manufactured between 1975 and 1978 which includes the PA-28R-201T (model with a conventional tail unit). It was not referenced as being applicable to the PA-28RT-201Ts which were manufactured between 1979 and 1988, i.e. after the publication of the SB which has not been updated since.

This service bulletin provided a sketch indicating the correct installation of the equipment and included instructions to remove any insulating washer incorrectly installed to prevent a possible malfunction of the electrical system.

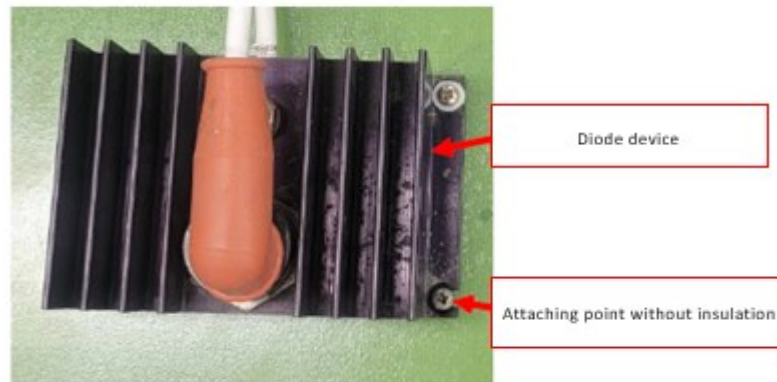
The insulating washer between the metal cooler and an attaching screw were removed and the washer was replaced by a slightly bent metal washer with the idea that it would penetrate the oxide coating which protects the outer surface of the metal cooler (see Figure 16). The test was repeated three times.

For the duration of two tests, the current was 77 A (nominal value of alternator with an overcurrent of 10%). For the duration of the last test, the current was 70 A.

Figure 16: installation for tests (source: CONCORDE BATTERY CORPORATION)

It was observed that the cooler attaching point without the insulating washer melted during the three tests. This melting occurred after different time periods of between 9 and 35 min. The results of these three tests show cooler damage similar to the damage observed on the HB-PNP cooler (see Figure 17)

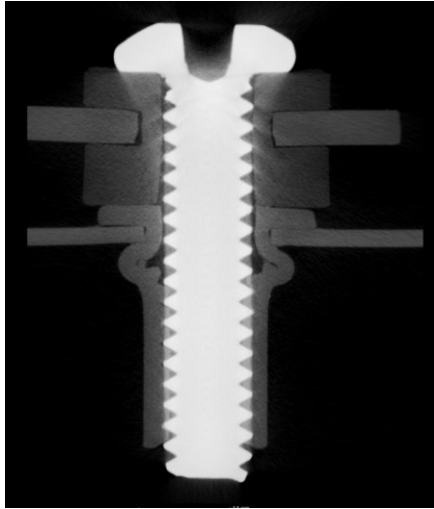
Figure 22: tomographic view of assembly with an insulating washer in good condition (source: BEA)

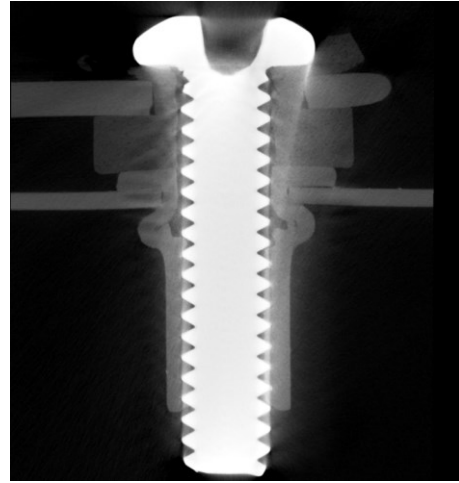
The examination of washers from another diode device equipping another PA28 found that the latter can be damaged and allow the screw head to come into direct contact with the cooler or lead to a reduction in the distance between these two components and the appearance of electric arcs.

Figure 23: tomographic view of an assembly with one of the washers cracked equipping an identical aeroplane (source: BEA)
