Accident to the Airbus AS350 - B3
registered **HB-ZES**
on Wednesday 14 February 2024
at Niouc (Switzerland)

Collision with a high-voltage power line during an external sling load operation

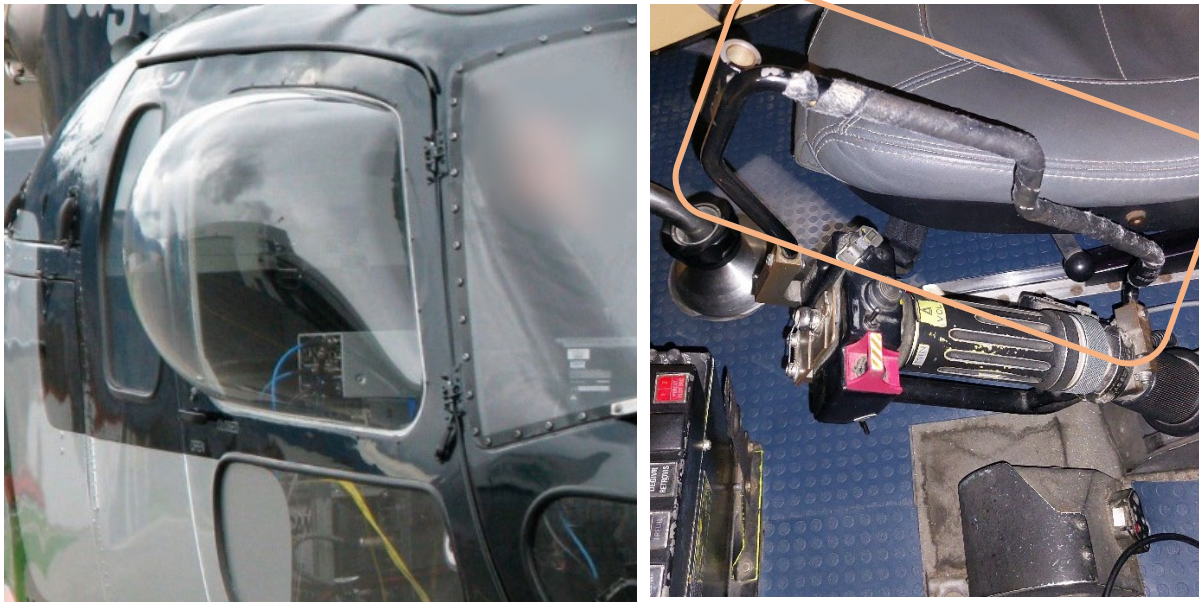
The helicopter was equipped with a bubble door covered by an STC which allows the pilot to see his load and identify external visual references more easily during the aerial work. During this type of manoeuvre, the pilot leans over with his head in the bubble of the right-hand window to watch his load and uses the collective pitch lever by means of an extension (see **Figure 6**).

Figure 6: illustration of a bubble door and an extended collective pitch lever (source: Eagle Valais)

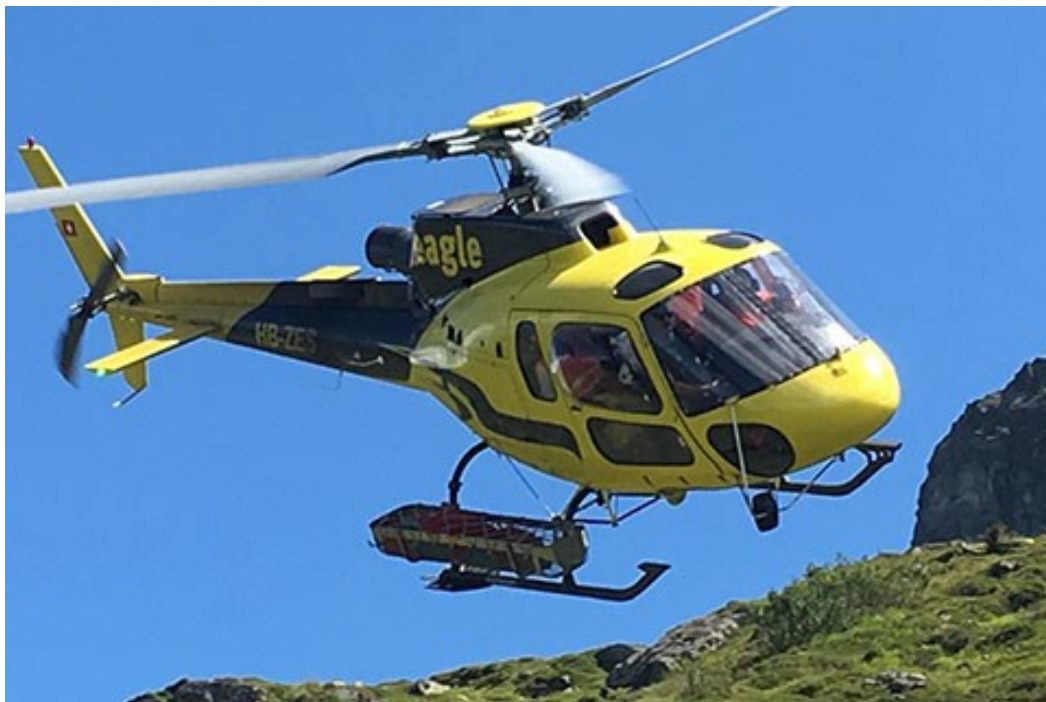
The helicopter was also equipped with two roof windows to ensure safety overhead the helicopter (see Figure 7).

Figure 7: detail of glass panels of HB-ZES (source: Eagle Valais)
