Accident to the CESSNA 340
registered **N340GJ**
on Monday 2 December 2024
at Pernand-Vergelesses

**Loss of external visual references, collision with tree tops,
fire, during a practical exam**

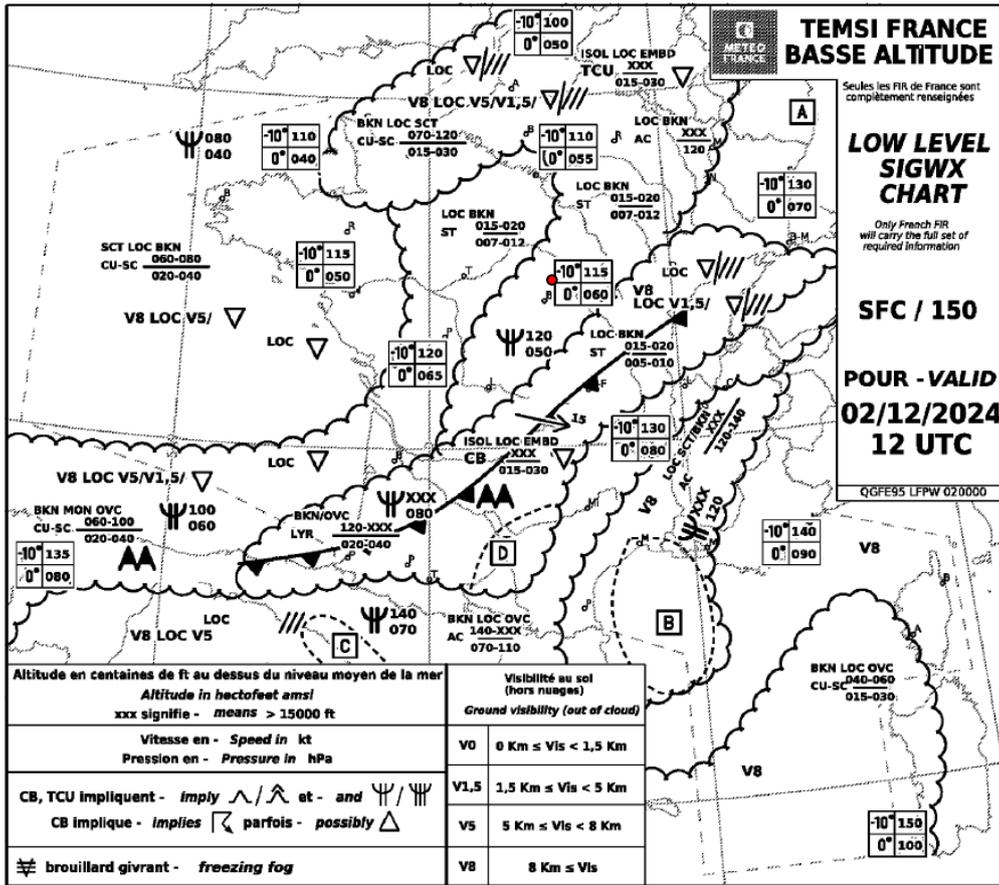
Figure 4: 13:00 SIGWX chart France

The sky was overcast with several cloud layers. The air mass was humid in the lower levels with stratus clouds close to the ground locally, along with cumulonimbus and towering cumulus (TCU) embedded in the cloud mass.

The 13:00 Dijon - Longvic METAR indicated visibility 3,400 m, mist, FEW at 600 ft and OVC at 7,600 ft. At 13:30, visibility was 4,200 m and the cloud cover was BKN at 400 ft and 1,600 ft and OVC at 2,100 ft.

The 13:00 Chalon - Champforgeuil METAR indicated visibility 9,000 m, drizzle and the presence of CB. At 13:30, visibility was 5,000 m with rain and mist, and cloud cover was BKN at 1,500 ft, 3,100 ft and 5,200 ft with the presence of CB.

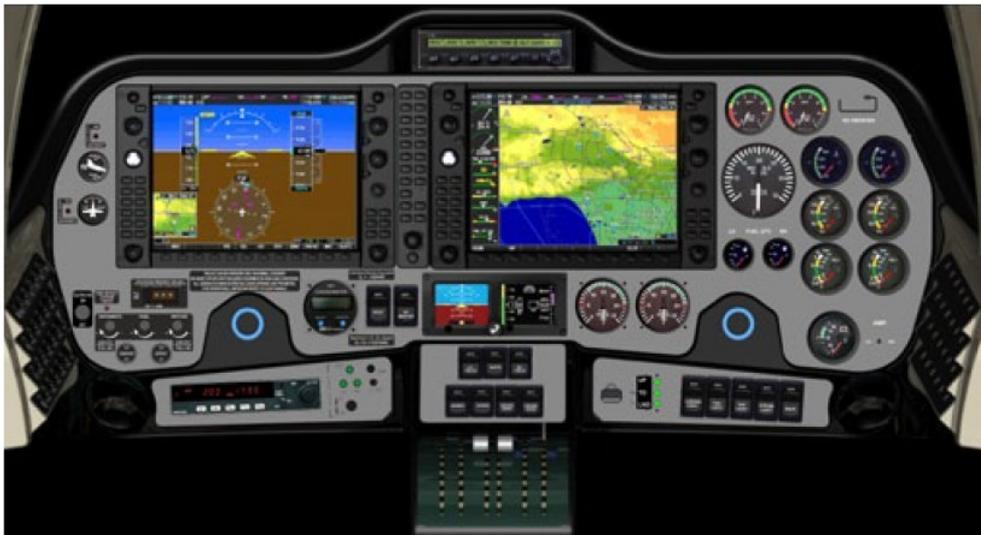
Figure 6: Tecnam P2006 instrument panel (source: EAS Barcelona)

Based on statements from several experienced instructors gathered by the BEA during its investigation, the Cessna 340 is very different from the TECNAM P2006, particularly with regard to manoeuvring speeds, flight performance, cockpit instruments and procedures. These instructors thought that it would be difficult for a pilot trained on the P2006 to have a satisfactory level for a practical exam flight without prior training on the Cessna 340.
