Accident to the CESSNA – 401 B
registered **N517HC**
on 30 October 2020
close to Toussus-le-Noble aerodrome

Fire in left engine during approach, forced landing in a field

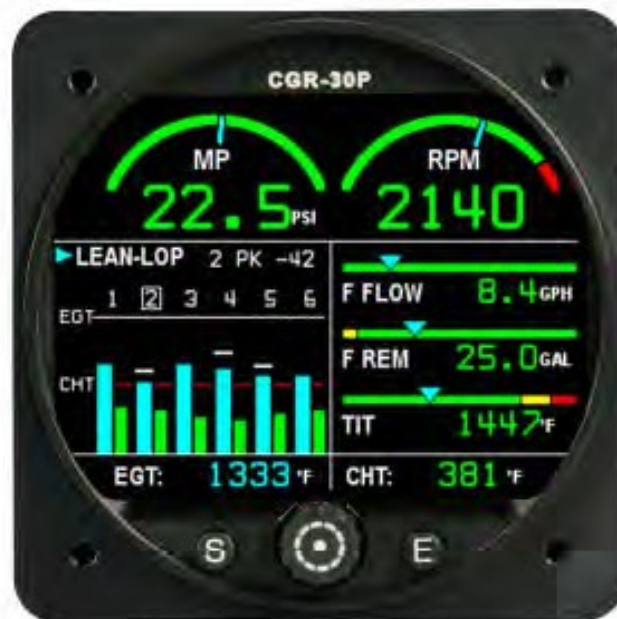
Figure 3: CGR-30 display
(source: CGR-30P Instructions Manual, page 1)

On analysing the recorded data, it was observed that certain ground tests showed that the temperature of the cylinder No. 2 and 4 heads of the left engine tended to significantly exceed that of the other cylinders of the left and right engines without, however, reaching the limit defined by the manufacturer (460°F)¹³. However, given the uncertainty about the conditions in which these tests were carried out, it was not possible to reach a definite conclusion about the existence of an engine malfunction prior to the accident flight. The other recorded parameters did not show a significant deviation from the norm.
