Accident to the CESSNA 210K
registered **N5767J**
on Thursday 25 July 2024
at Beblenheim

Time	Around 17:45 ¹
Operator	Private
Type of flight	Cross country
Persons on board	Pilot, passenger
Consequences and damage	Aeroplane destroyed, persons on board seriously injured
This is a courtesy translation by the BEA of the Final Report on the Safety Investigation. As accurate as the translation may be, the original text in French is the work of reference.

Fuel exhaustion, forced landing in a field, overturn

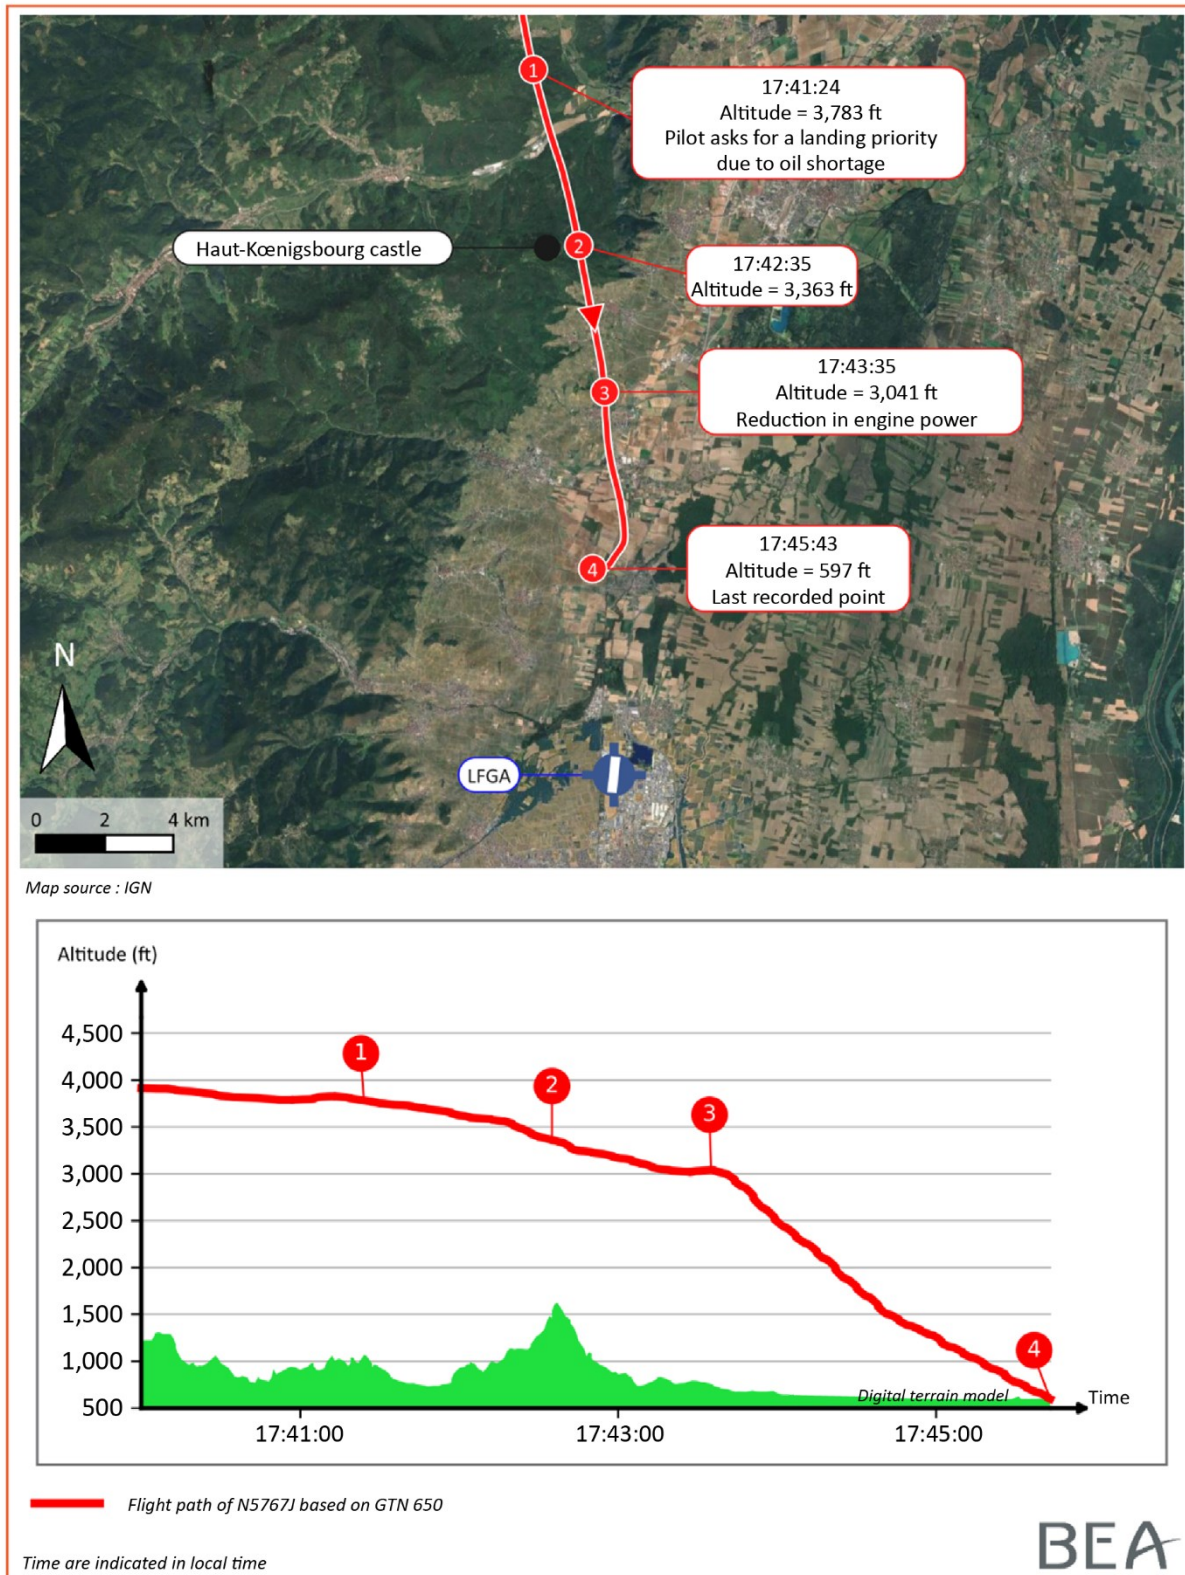
Figure 1: end of flight path of N5767J

The last point recorded by the on-board GPS was at 17:45:35, when the aeroplane was on final at a low height. The landing gear came into contact with the vegetation of a field and then a road (D3) situated before the field chosen for the landing (see **Figure 2**). The aeroplane bounced, turned over onto its back and came to rest in this field.

The accident site was situated approximately 6 km north of Colmar aerodrome (marked LFGA in **Figure 1**), at an altitude of approximately 600 ft.
