Accident to the BRM AERO Bristell B23
registered **OE-AMK**
on Thursday 9 May 2024
at Chambéry - Challes-les-Eaux

Winch cable strike in initial climb, loss of control, collision with ground, fire

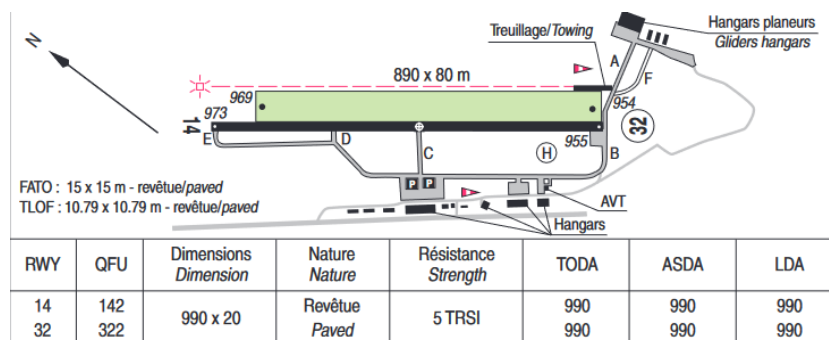
Figure 2: excerpt from Chambéry - Challes-les-Eaux aerodrome VAC chart (source: SIA)

Winch launching takes place on the north edge of grass runway 32 (winch launch axis shown by a line of red dashes on the VAC, see **Figure 2**). The lateral distance between the centreline of the paved runway and the winch cable is therefore around 85 m. The winch and the winch operator are positioned behind the threshold of runway 14 (see **Figure 3**).

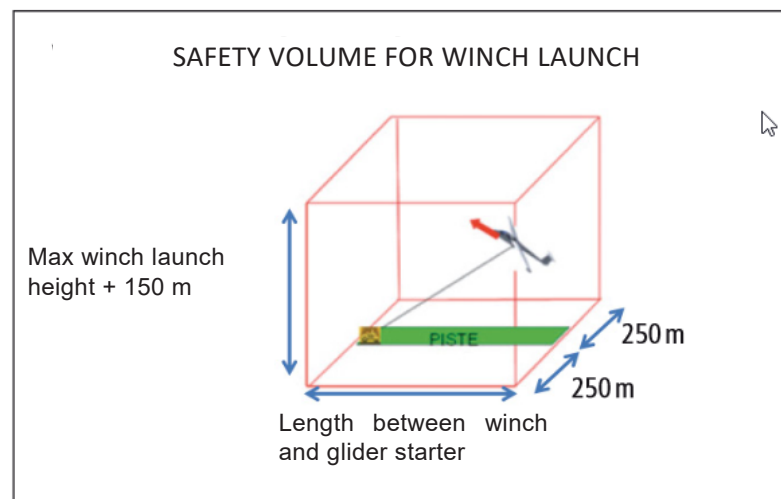
Figure 4: winch launch safety volume described in the glider winch-launch manual (source: CNVV, translated by BEA)

The CNVV defines a winch launch safety volume. Before starting the winch launch, the winch operator must check that there are no vehicles, aircraft or people on the runway in the take-off zone, and that there are no aircraft (in motion) in or near the winch launch volume.
