Accident to the PILATUS PC-12
registered **OO-PCN**
on Saturday 17 February 2024
at Courchevel (Savoie)

Time	10:25 ¹
Operator	European Aircraft Private Club
Type of flight	Cross-country
Persons on board	Pilot-in-command and co-pilot
Consequences and damage	Aeroplane substantially damaged
This is a courtesy translation by the BEA of the Final Report on the Safety Investigation. As accurate as the translation may be, the original text in French is the work of reference.

**Bank strike before runway during landing, runway veer-off,
in mountain flight**

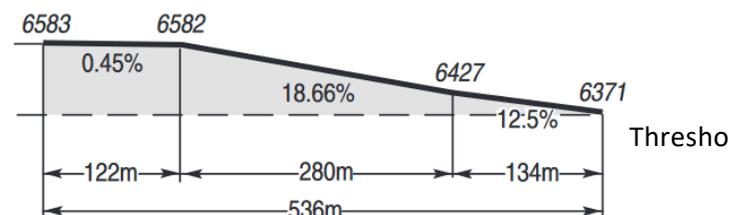
Courchevel mountain airfield is a restricted-use aerodrome. It has one runway oriented 22/04 measuring 536 m long; the threshold of runway 22 is situated at 6,371 ft. The profile of the runway is shown below:

Figure 5: lengthwise profile of runway 04/22 at Courchevel, taken from VAC chart (Source: AIS)

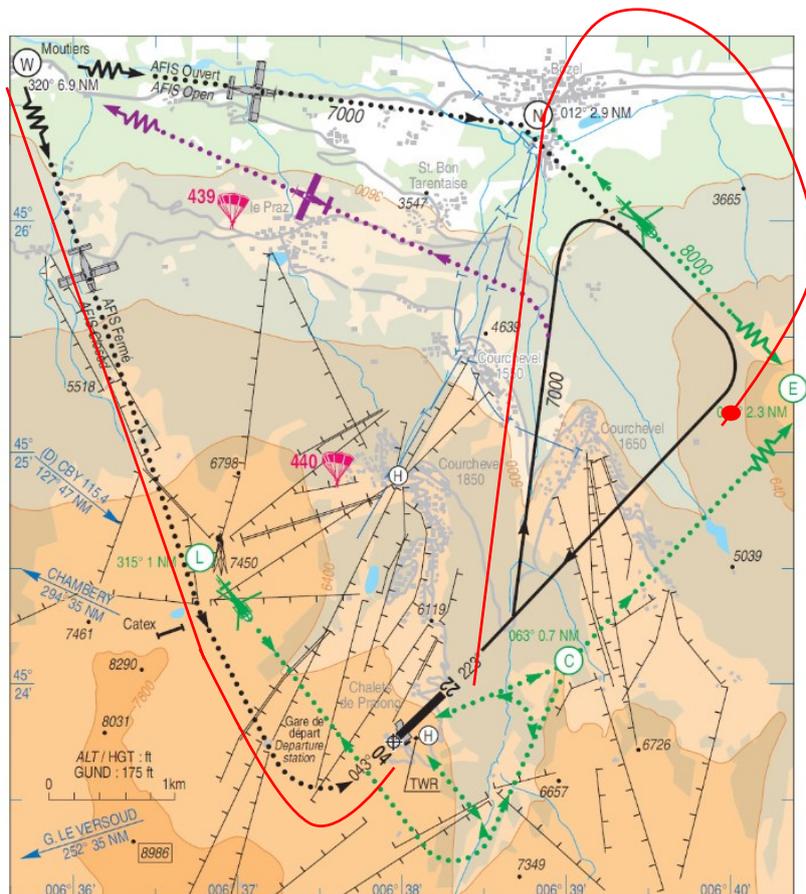
According to the VAC chart, when the AFIS is open, the QNH is provided by the AFIS officer to set the altimeter reference. It is then possible to arrive via point N, or via the same route as when the AFIS is closed, i.e. by passing north abeam point L and then flying overhead the mountain airfield at 7,100 ft before joining the base leg.³

The BEA contacted two instructors who train pilots for obtaining access authorisation on PC-12s at Courchevel, including the instructor who trained the accident pilot. They explained that they teach a systematic pass overhead the mountain airfield to assess the condition of the runway, the availability of the parking area and the strength and direction of the wind. The approach continues with an outbound leg beyond the area indicated by the VAC chart, with a widened turn for joining the circuit in distant final (see **Figure 6**). This method gives the pilot more time to stabilise the aeroplane before starting the descent. In calm wind conditions, the pilot follows a 5% glide slope, with an aiming point at the middle of the bank, allowing touchdown at the runway designation markings (see **Figure 7**). These references are indicated in the instructor's theoretical briefing and in the operator's OM ("Airport Briefing Courchevel LFLJ", version dated 1 December 2021).

Figure 6: excerpt from Courchevel mountain airfield VAC chart and path taught during the training for obtaining access authorisation (in red) (Source: AIS)
