Serious incident between
the Embraer ERJ-175 registered **PH-EXH**
and the Boeing 737-800 registered **7T-VKR**
on 5 September 2022
at Lyon-Saint-Exupéry (Rhône)

Landing on a runway occupied by an aeroplane taking off

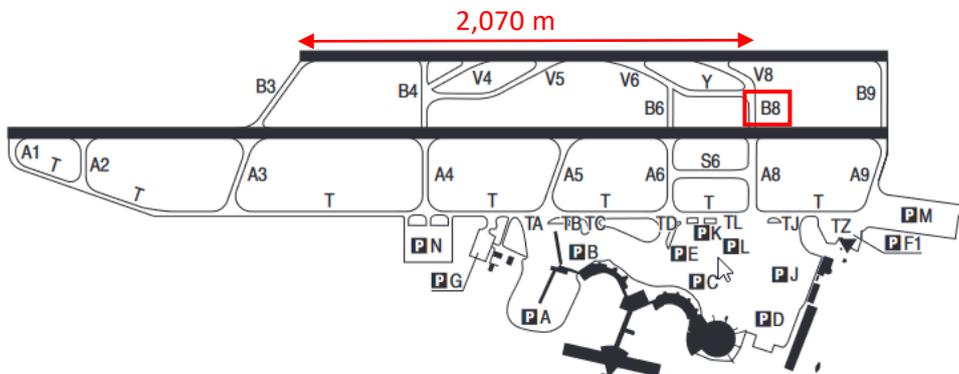
Figure 7: runway separation minimum at Lyon-Saint-Exupéry prior to August 2022 (source: TWR/APP OM)

Piste	35R	35L	17L	17R		
Si ACFT n°1	Au décollage a passé travers B4 et a décollé	Au décollage ou à l'atterrissage a passé travers seuil 17L	Au décollage a passé travers seuil 17L et a décollé	Au décollage a passé travers B8 et a décollé	Au décollage ou à l'atterrissage a passé A5	Au décollage a passé A8 et a décollé
Alors ACFT n°2 peut être autorisé à	Atterrir	Atterrir	Décoller depuis A8 ou A9	Atterrir	Atterrir	Décoller depuis A1, A2 ou A3

Regulatory changes led the SNA-CE to modify the reduced separation minima at Lyon-Saint-Exupéry. In particular, as the distance of 2,400 m did not correspond to any visual references on runway 17L, the SNA-CE considered it preferable to abolish the reduced separation for this runway.

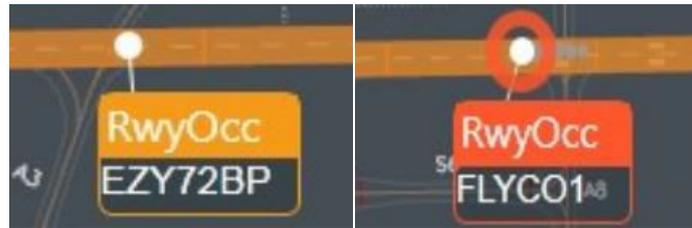
Figure 10: overview of A-SMGCS notifications (source: Directive No 2022-032/SNA-CE/SE/C)

- the second type is an alert, with a red label and an aural signal being triggered to warn of an imminent or ongoing conflict requiring immediate action.

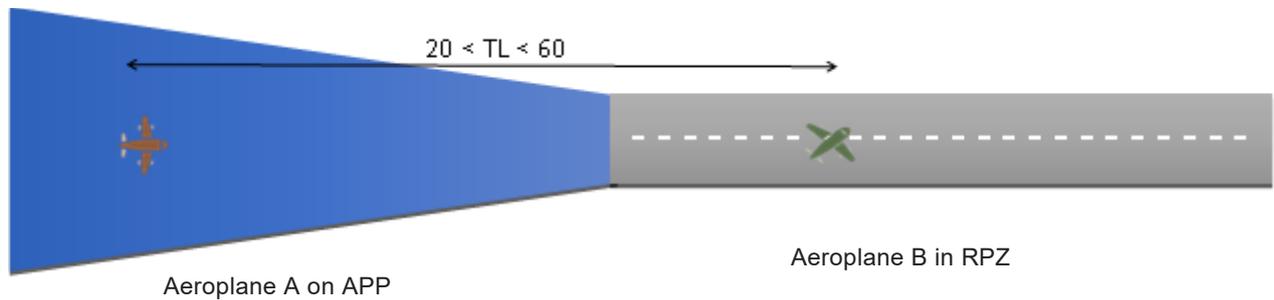
At the time of the event, and since its commissioning, the system’s settings for VMC conditions were based on the former reduced runway separation minima (see para. 2.4.2). The SNA-CE was not aware of this. After the event, on 07 September 2022, the SNA-CE transmitted the information in a memo to all controllers.

When the aircraft on final is not in the RPZ:

- no notification when TL is greater than 60 s;
- informational notification triggered when TL is between 20 and 60 s;

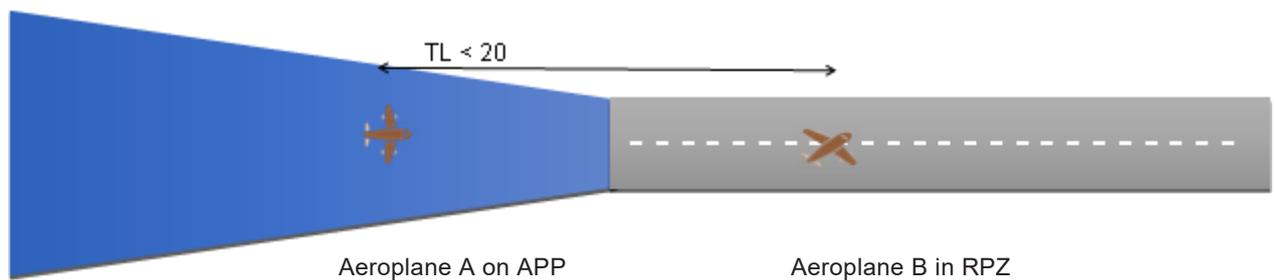
- alert notification triggered when TL is less than 20 s.

When the aircraft on final is in the RPZ: alert notification triggered if the distance between both aircraft is less than 2,000 m.

The time values (20 s, 60 s) were determined during the A-SMGCS design phase and were supposed to ensure compliance with the reduced separation distance (2,070 m) when the aircraft on final crosses the runway threshold.
