## Serious incident

between the De Havilland DHC-6 registered **PJ-WIX** operated by Winair and the Pilatus PC12 registered **N590TW** operated by Tradewind Aviation on Wednesday 29 January 2025 on Saint-Barthélemy airport

## Landing on an engaged runway

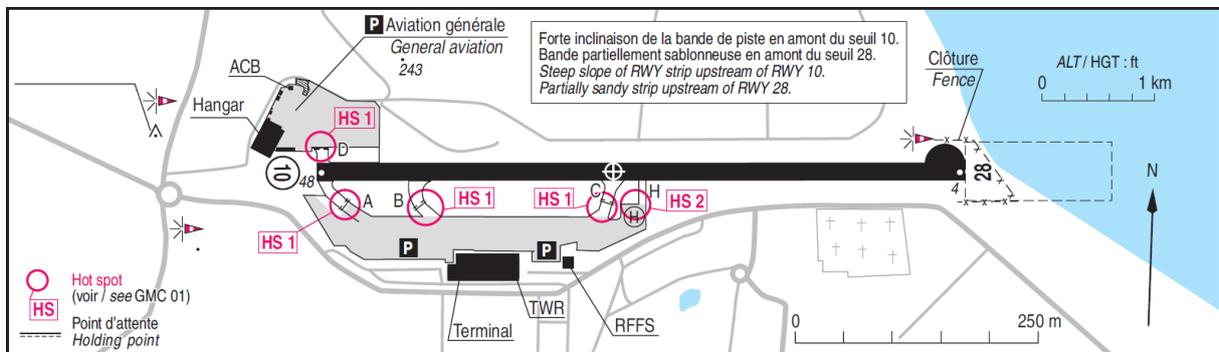
Figure 4: excerpt from AIP France (source: SIA)

Runway 28 has a landing distance of 646 m. It is connected to the "main" parking to the south by taxiways "C", "B" and "A", located respectively 350 m, 545 m and 640 m from the threshold, and to the "general aviation" parking to the north via taxiway "D", located opposite taxiway "A" at the end of the runway. There is a paved strip approximately 50 m long and 20 m wide within the runway safety area between the runway and the "general aviation" parking and is directly adjacent to taxiway "D".

The approach to runway 28 can be made by joining the RH or LH base leg, respectively from the reporting points FREGATE (north) or COCO (south). Due to environmental constraints, a missed approach to runway 28 can only be carried out by making a RH turn no later than

approximately 0.25 NM from the threshold (EDEN ROCK decision point, corresponding to a southern tip of land extending into the bay). The AIP does not define criteria for carrying out a missed approach abeam this point, for example, should the runway be engaged. The AIP warns of the risk of dazzling on final approach to runway 28 at the end of the day.

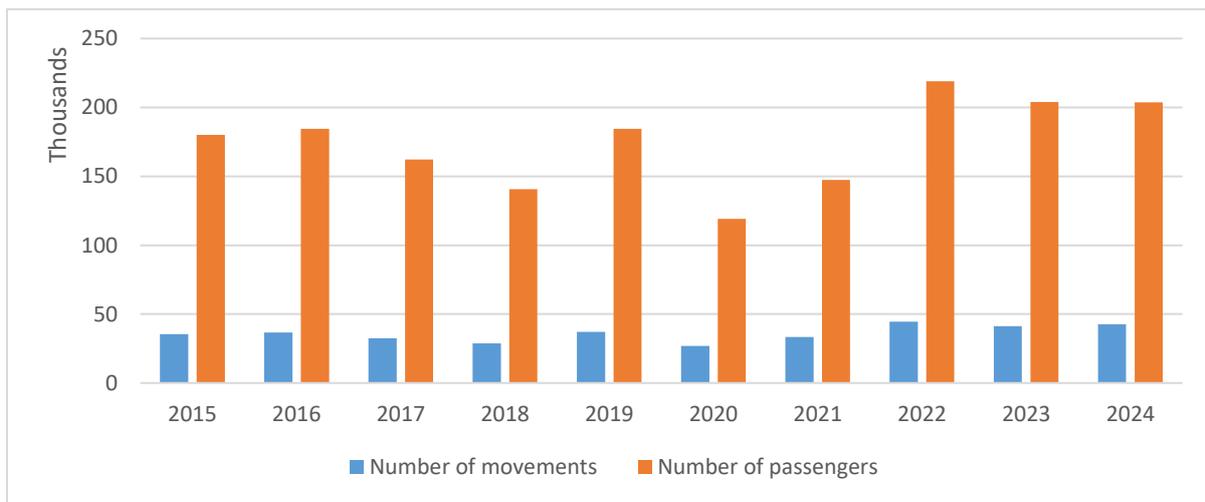
Figure 5: statistics for Saint-Barthélemy airport (source: Union des Aéroports Français)

Over the past ten years, the number of movements recorded at Saint-Barthélemy airport has globally followed a slight upward trend, even though it experienced drops in traffic in 2017-2018 (due to hurricane Irma) and then in 2020-2021 (due to the COVID-19 pandemic). In 2023 and 2024, the total number of movements was around 42,000, compared to approximately 36,000 in 2015 and 2016.

In 2023 and 2024, more than 90% of the movements involved commercial air transport. Over 200,000 passengers were transported during each of these two years. The commercial activity at Saint Barthélemy airport is seasonal, with a peak between November and March. On one day, 323 aircraft movements were recorded during this period.
