## Final Report

**EgyptAir A320 Aircraft crash in the Mediterranean, registered SU-GCC,  
flight number MSR804, from Charles De-Gaulle Airport, Paris to Cairo  
International Airport, on 19/05/2016**

EGAI2016-01

October 2024

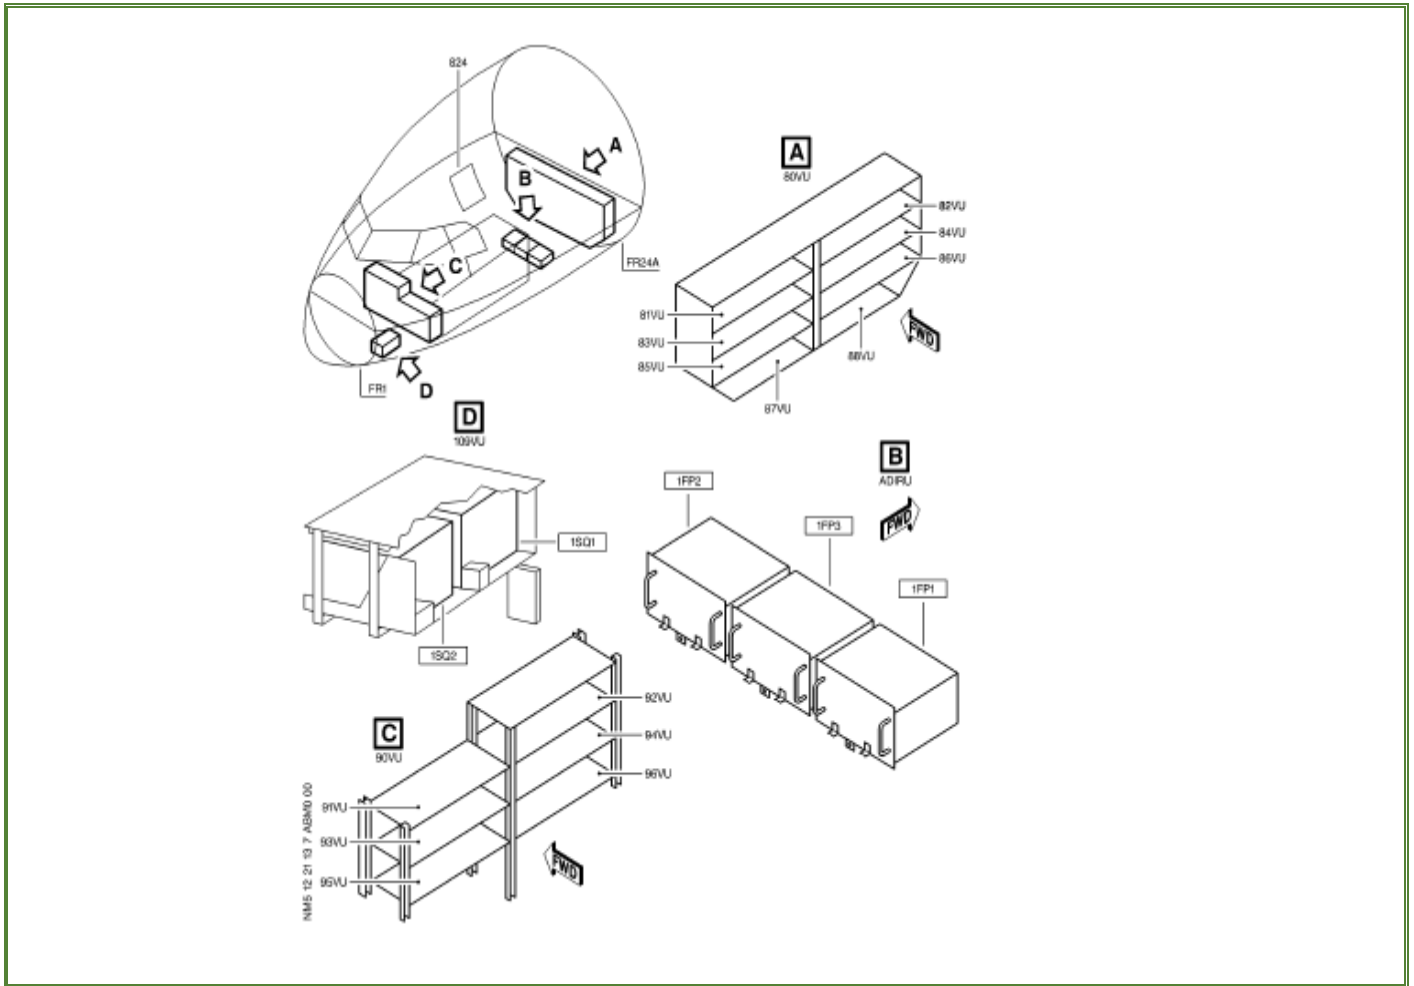
Figure 1.6/12: Computers Locations

No.	Computer	Computer	Location	Time of Loss
1	SEC3	Spoiler and Elevator Computer No.3	93VU	00:29:26
2	TCAS	Traffic Collision Avoidance System Computer	82VU	00:29:28
3	RUDER PEDAL FORCE SNSR	Ruder Pedal Force Sensor	Cockpit	00:29:28
4	SEC2	Spoiler and Elevator Computer No.2	84VU	00:29:34
5	SDCU CHANNEL B	Smoke Detector Control Unit	94VU	00:29:35
6	FAC2	Flight Augmentation Computer	84VU	00:29:36
7	WR 1 & 2	Weather Radar	109VU	
8	FMGC2	Flight Management and Guidance Computer	84VU	Between 00:29:37 and 00:29:42
9	EEC2 CHANNEL B	Engine Electronic Control	ENG 2	
10	DMC3	Display Management Computer No.3	80VU	
11	FCDC2	Electrical Flight Control System No.2	84VU	
12	EVMU	Engine Vibration Monitoring Unit	86VU	00:29:45

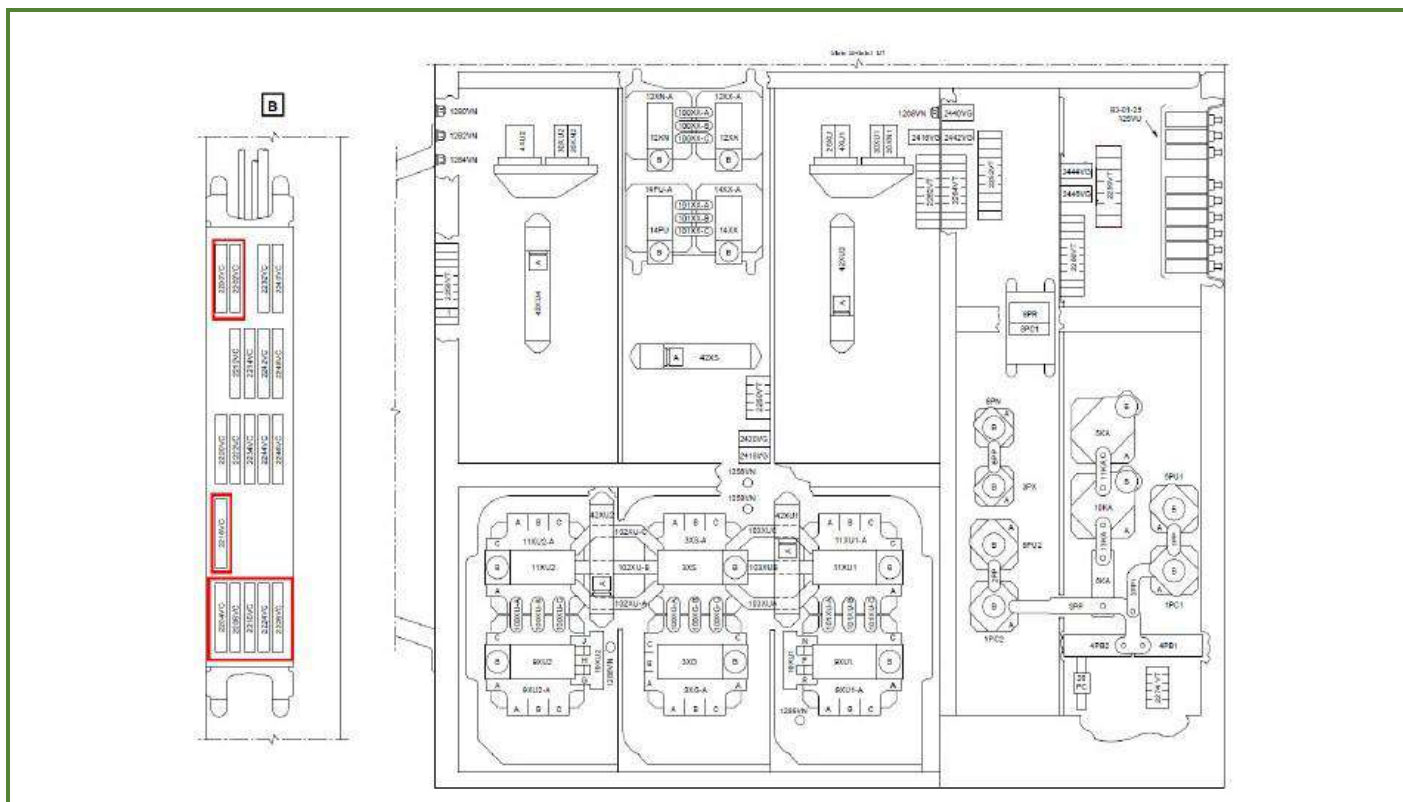
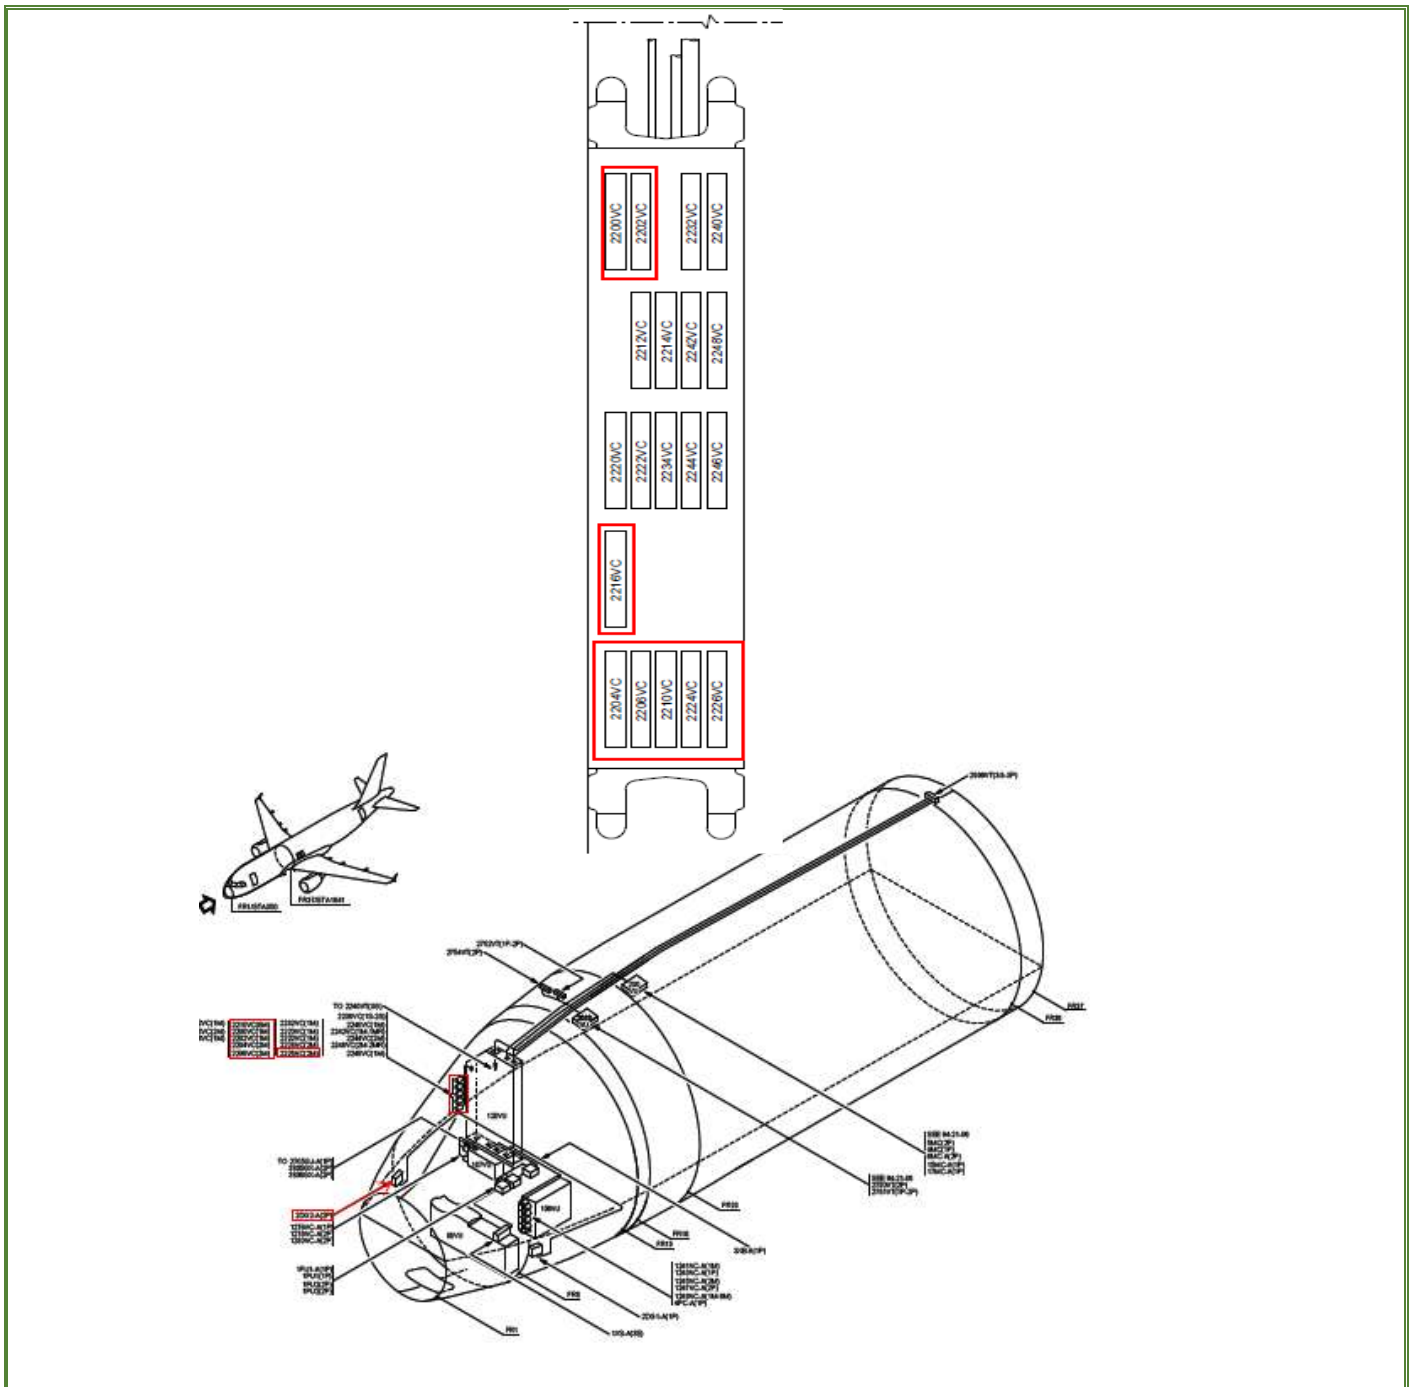
Figure 1.6/14: Affected Computer By Connectors

No.	Connector	Location	Computer
1	2200VC	120VU	EVMU
2			BSCU
3	2250VC	120VU	TCAS
4	2204VC	120VU	FAC2
5			FAC2
6			WR2
7	2206VC	120VU	FMGC2
8			DFDR
9	2210VC	120VU	SEC3
10			SEC2
11			FCDC2
12	2226VC	120VU	SDCU
13	2202VC	120VU	WR1
14			DMC3
15	2216VC	120VU	EEC2

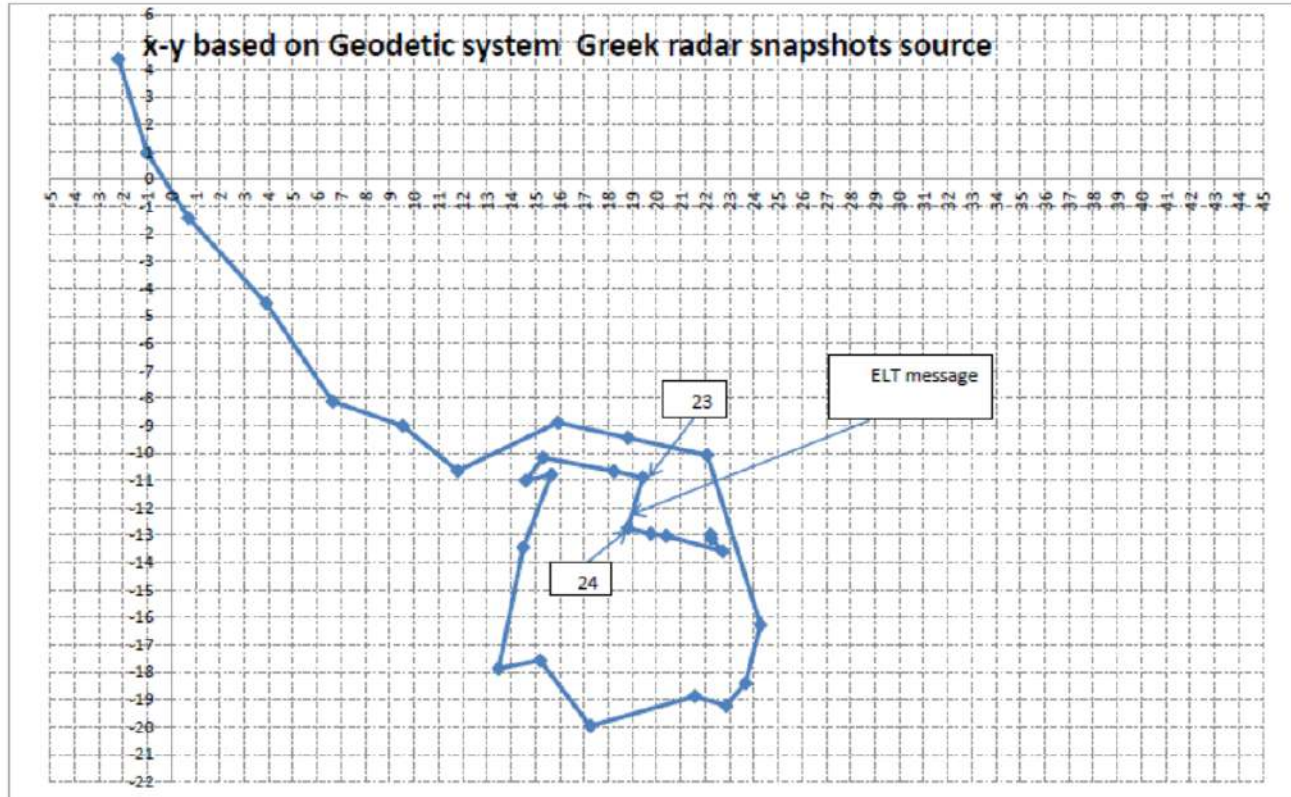
Last 7 snapshots Greek radar returns

- There were at least 6 radar return points from snapshots Greek radar data after the ELT message (covering 1 minutes, 51seconds after ELT message).
- It can be concluded that the aircraft was still in the air when the ELT message was originated, excluding the probability that the ELT message was originated because of hitting the water.

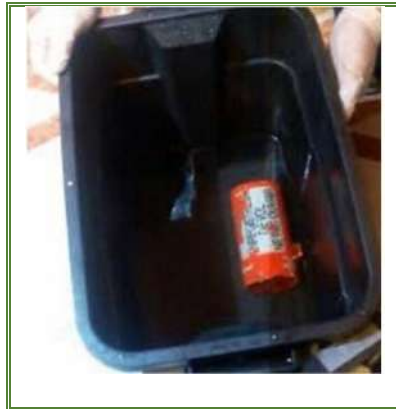
Figure 1.11/2: CSMU received in water

The CSMU was removed from the container of fresh water and examined. There were no visible markings on the CSMU indicating the part or serial number. The CSMU had damage indicative of significant impact forces including:

- Chips in the paint;
- Significant gouges in the external surface of the CSMU case;
- 3 of the 4 mounting brackets that secure the CSMU to the chassis broken off;
- Shearing of the flex cable between the CSMU and the chassis;
- Absence of the one of two Underwater Locator Beacon (ULB) mounting brackets and the ULB;
- Structural failure of the second ULB bracket.

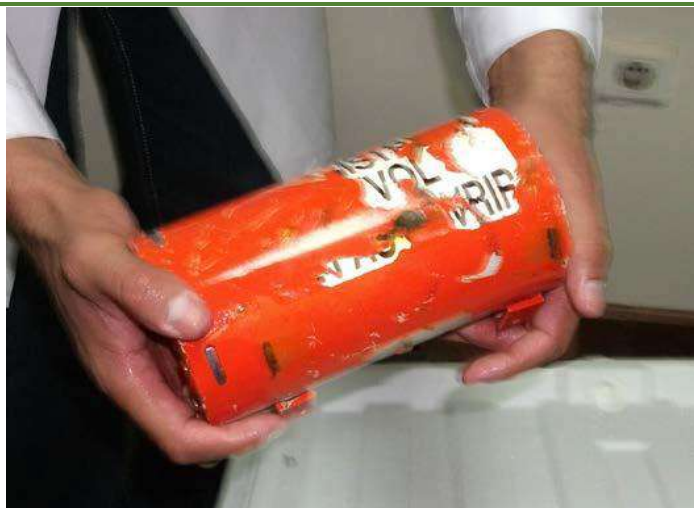
- Chips in the paint;
- Significant gouges in the external surface of the CSMU case;
- 2 of the 4 mounting brackets that secure the CSMU to the chassis broken off;
- Shearing of the flex cable between the CSMU and the chassis;
- Absence of the one of two Underwater Locator Beacon (ULB)
- Mounting brackets and the ULB;
- Structural failure of the second ULB bracket

Figure 1.11/4 : Missing decals, paint chips and gouges in the CSMU

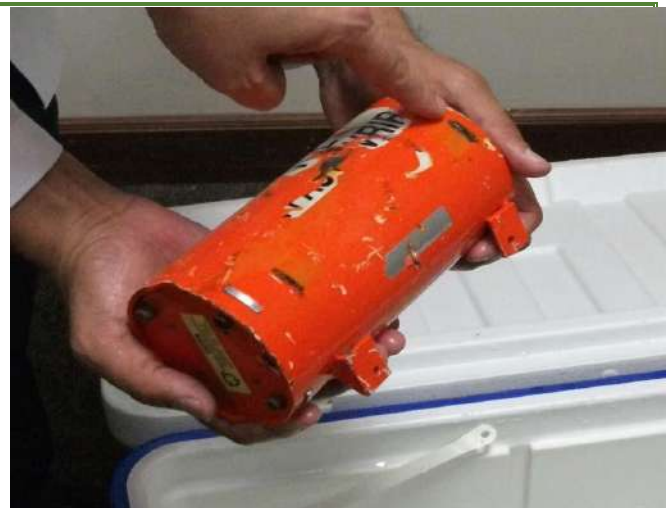
Figure 1.11/5: Two of four mounting brackets missing

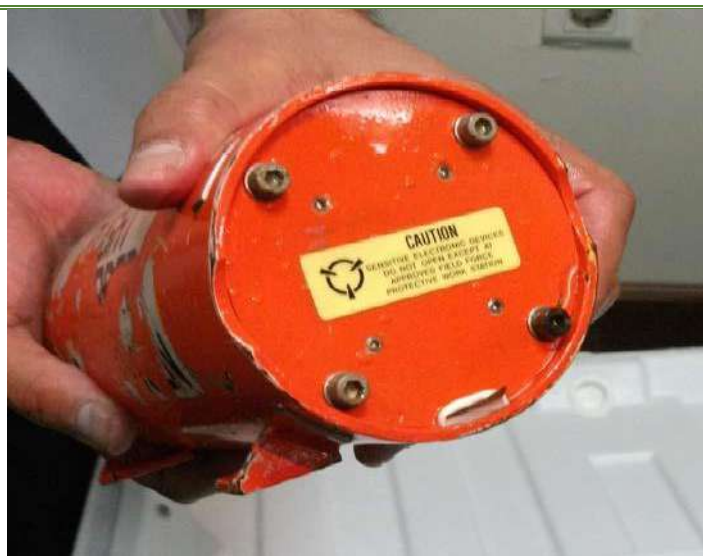
The flex cable between the CSMU and the chassis is an intentional structural and thermal weakness designed into the SSFDR to help protect the memory of the CSMU from inertial and thermal damage. It is designed to be broken outside the CSMU in the event that the CSMU breaks free of the chassis during the accident sequence or burned away in the event that the recorder is subjected to a post-crash fire. As noted above, the CSMU separated from the chassis during this accident and severed the flex cable. When the flex cable is damaged in this way, there is a possibility that the copper traces in the damaged end of the flex cable could come in contact with each other creating short circuits and prevent the recorder from downloading properly and/or damage the stored data. There are two processes to prevent and test for this problem.

Figure 1.11/6 : Sheared flex cable

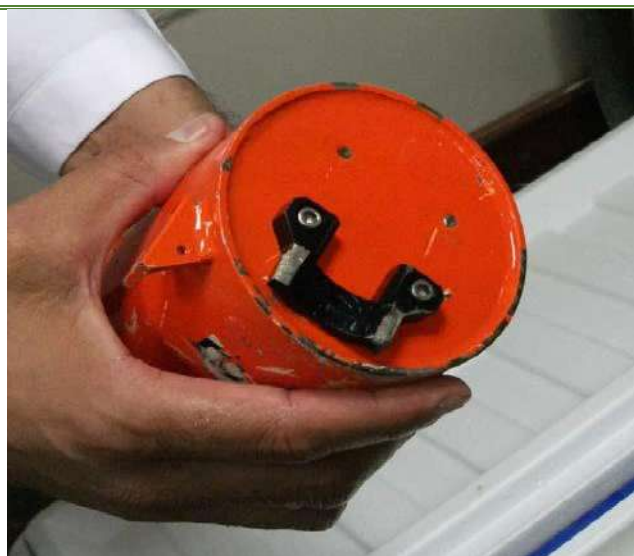
Figure 1.11/7:ULB bracket failure and the second bracket missing

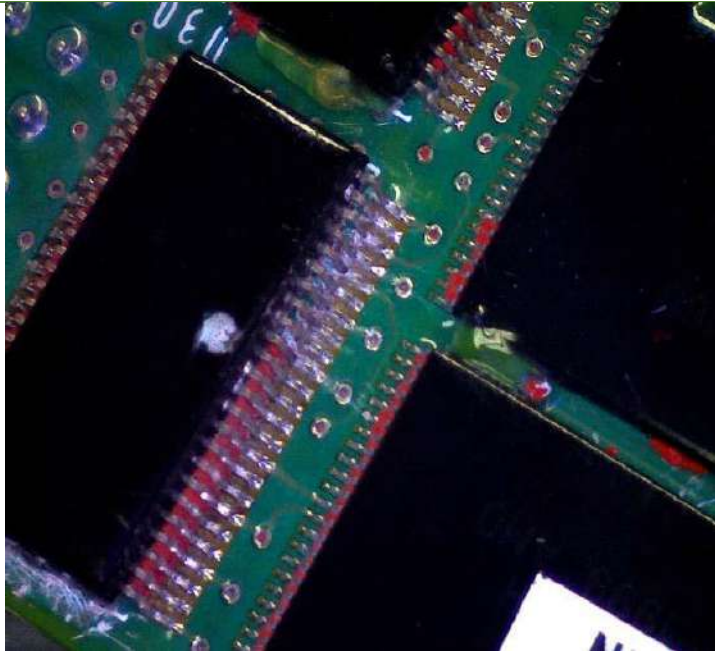
Figure 1.11/9: Chip U29 pins 39 to 48 before bath

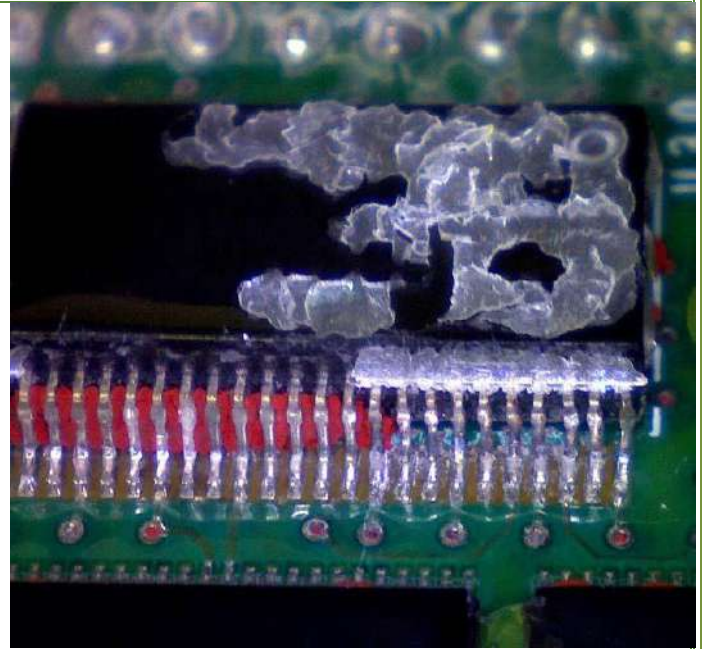
The board was then examined with the electronic microscope. The effects of the bath were clearly visible on the pins of the chipset U29. A new electrical check was then performed:

- Pins 12 and 13 were still shorted.
- The impedance between ground and Vcc reached 3 k  $\Omega$ , a value more consistent with the expected test results.

Figure 1.11/10: Chip U29 pins 39 to 48 after bath

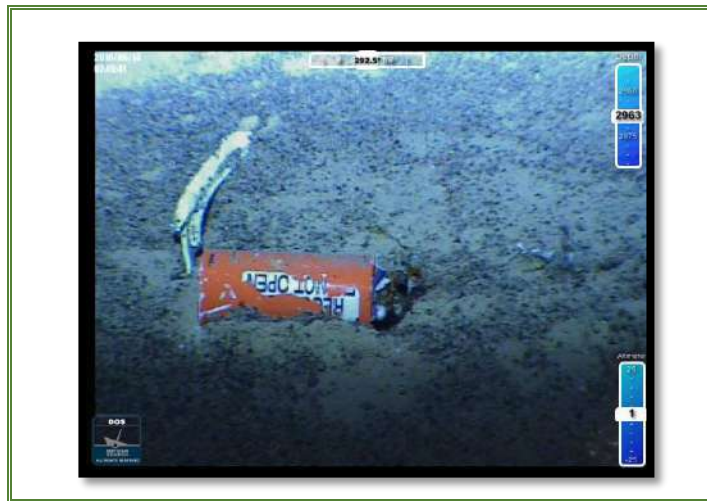
Figure 1.12/3: The memory unit belonging to one of the aircraft flight recorders at the depth of 3020 meter from the sea surface

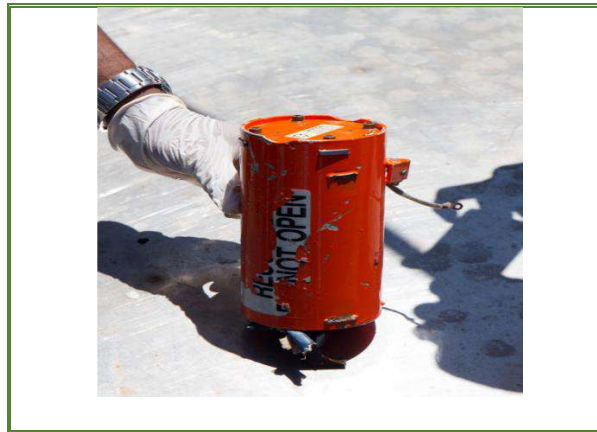
Figure 1.12/4: The CSMU memory unit belonging to one of flight recorders after being recovered.

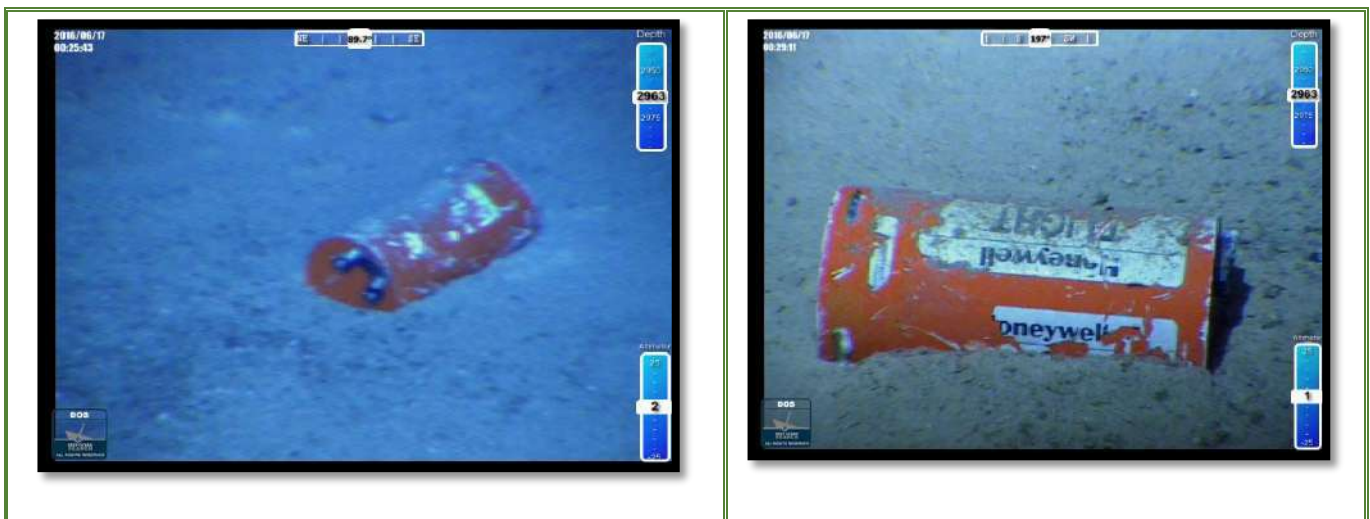
Figure 1.12/5: The memory unit belonging to one of the aircraft recorders at the depth of 2960 meter from the sea surface

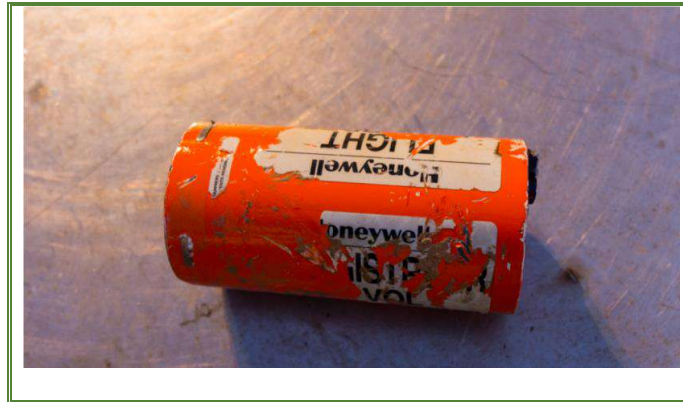
Figure 1.12/6: The CSMU memory unit belonging to one of the aircraft recorders after being recovered

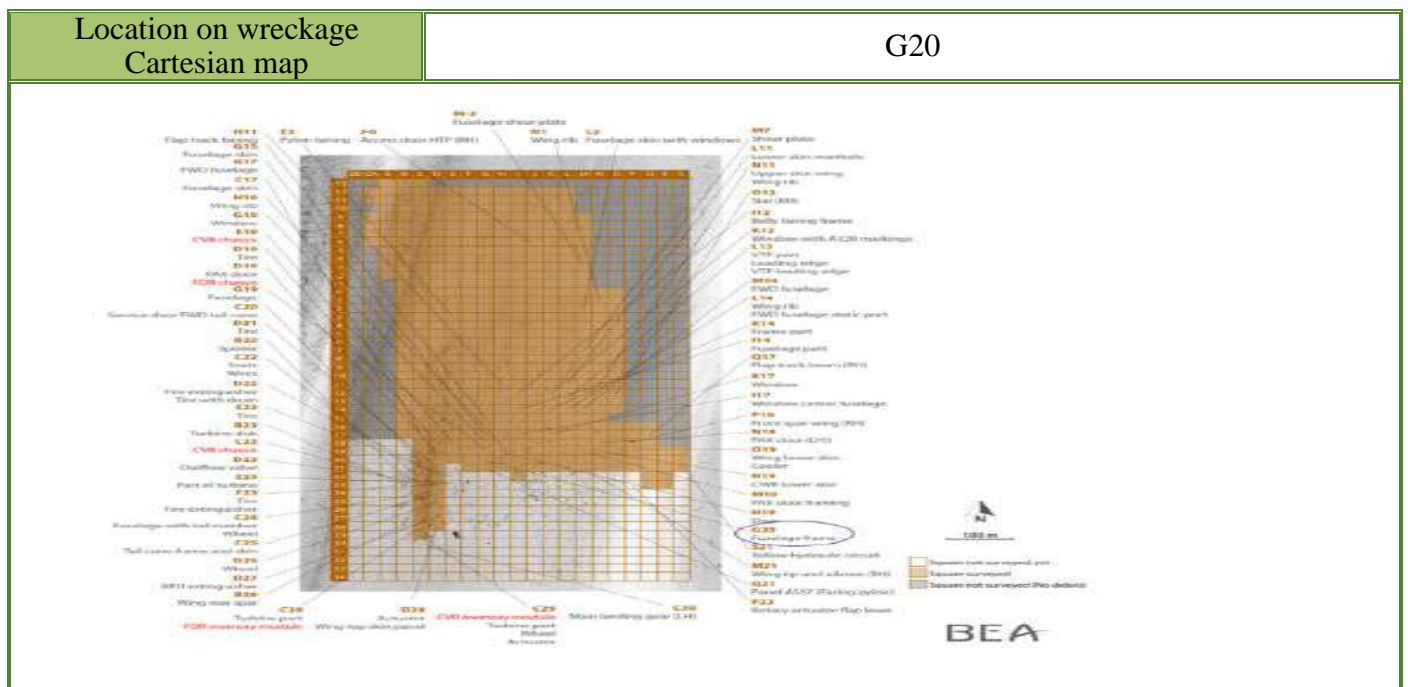
Figure 1.12/10: Upper Central Segment of frame 20

Part/ piece position on the aircraft	- Upper central part connecting the two aft edges of left and right passenger door.
description	A part of aircraft frame with the dimensions of 190 cm ×15 cm consisting of flange-web-flange
Remarks on piece/ Part	<ul style="list-style-type: none"><li>- The original crescent shape has deflected backward out of its original vertical plane.</li><li>- A bend was found in the center and edge.</li><li>- a change in the original metal color was identified on both edges</li></ul>

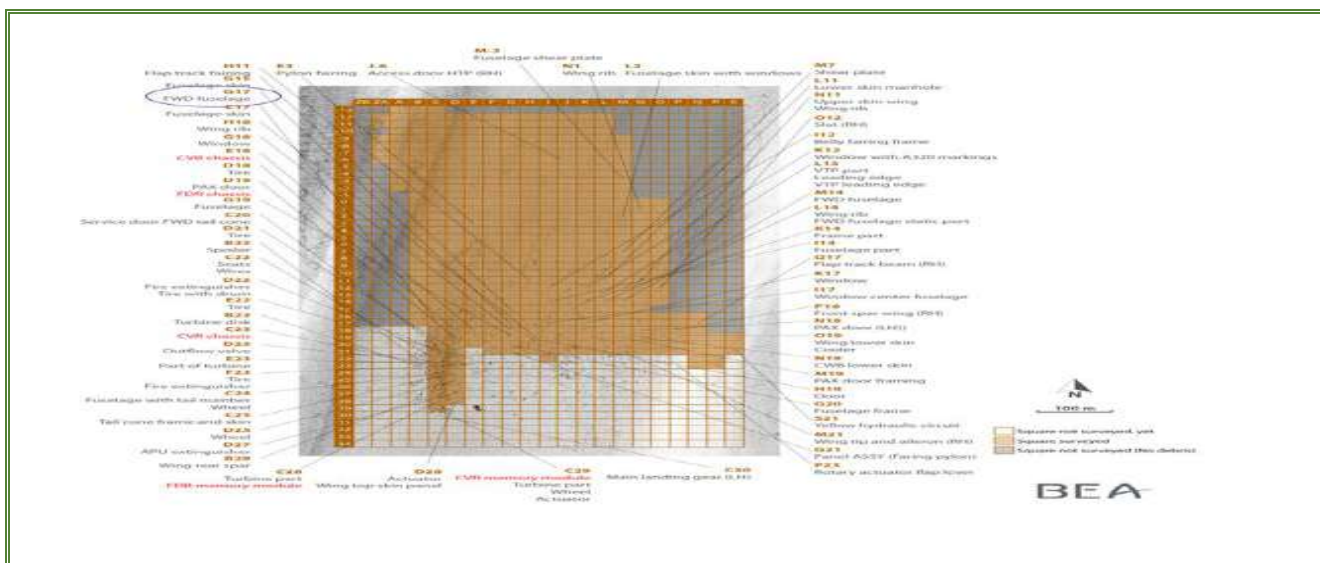
Figure 1.12/12: Forward fuselage with static port

Description	Forward fuselage with static port
No.	37
Diving no.	D2
Location on wreckage Cartesian map	G17

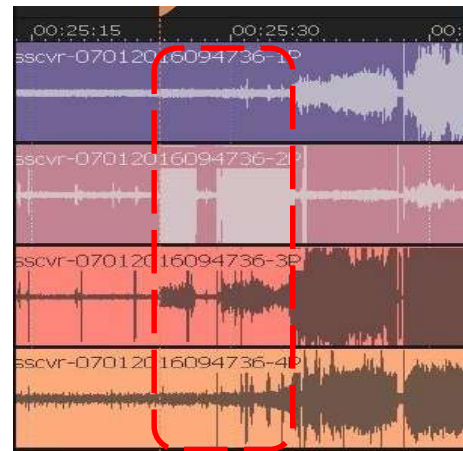
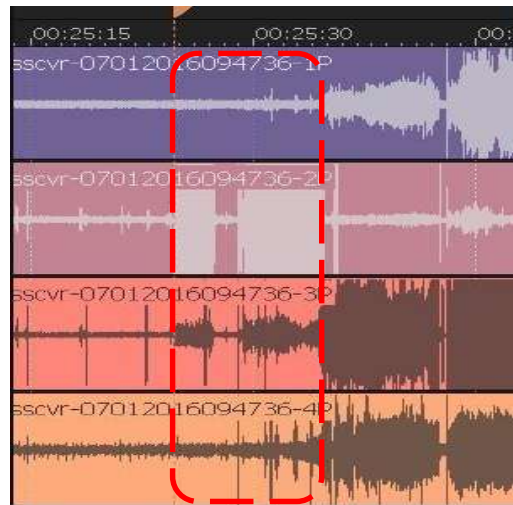
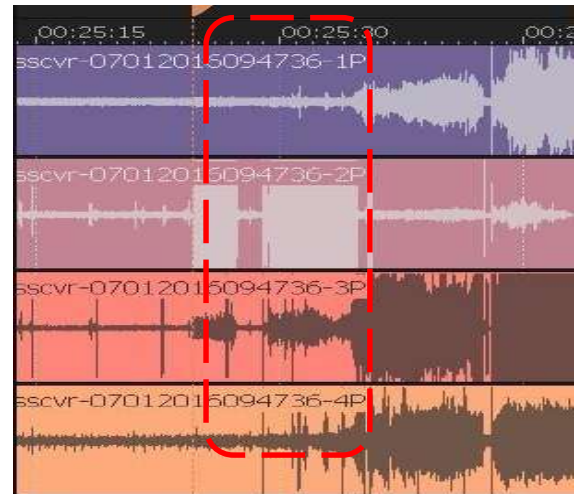
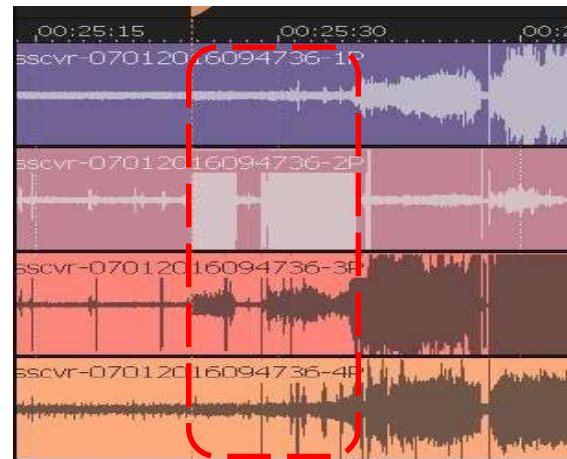
Figure 1.16/3: Wave forms from MSR804 CVR recording

1. The sound of oxygen flow heard on the inflight test (three cases 2, 3, 4) is similar to the hissing sound of MSR804 CVR recording in which the knob was set to emergency position.
2. By comparing all the four channels for case no.3 with the hissing sound for the four channels in the MSR804 CVR recording found similarities in wave form and sound intensity.
3. Sound of MSR804 is similar to the sound of case no.3 (Open oxygen box door, the knob on Emergency position) in all its four channels.
4. Ambient noise recorded clearly in the CVR but was not heard on cockpit speakers.

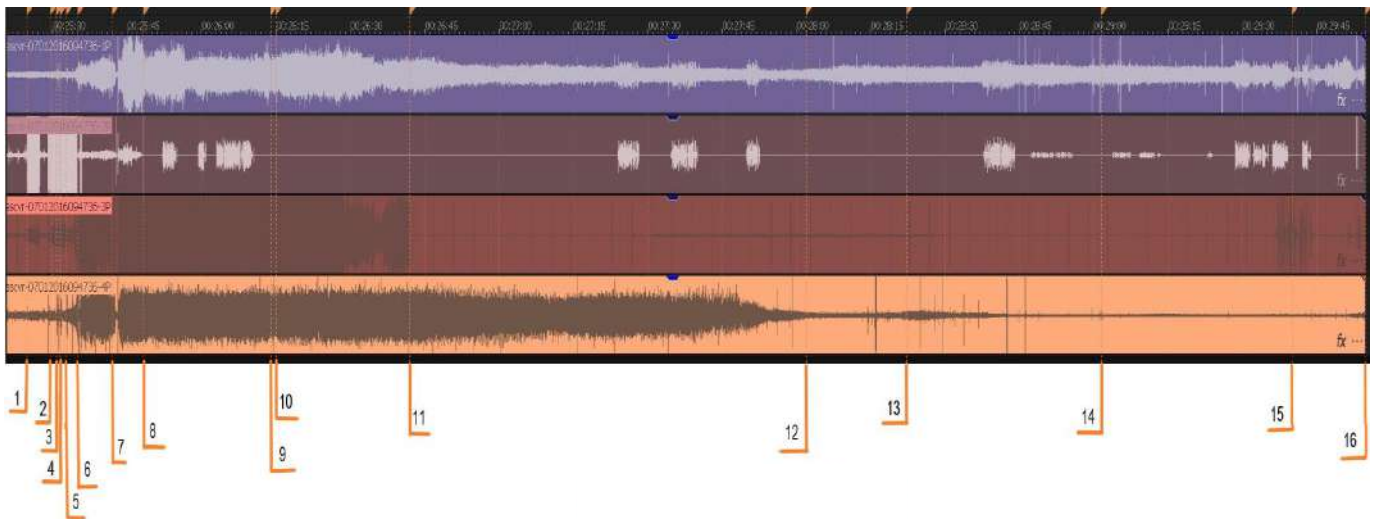
Figure 2.10/1: CVR Sequence of events

NO.	UTC Time	Event
1	00:25:24	1 <sup>st</sup> Hissing Sound
2	00:25:27	Unidentified word
3	00:25:29	2 <sup>nd</sup> Hissing Sound
4	00:25:30	F/O calling: "Fire Fire"
5	00:25:31	Female flight attendant calling: " Fire"
6	00:25:32	PIC calling: "Fire"
7	00:25:35	PIC calling: "Extinguisher, Extinguisher quickly bring extinguisher quickly"
8	00:25:42	PIC calling: "close the door"
9	00:25:48	Ch.2 mic. disconnected

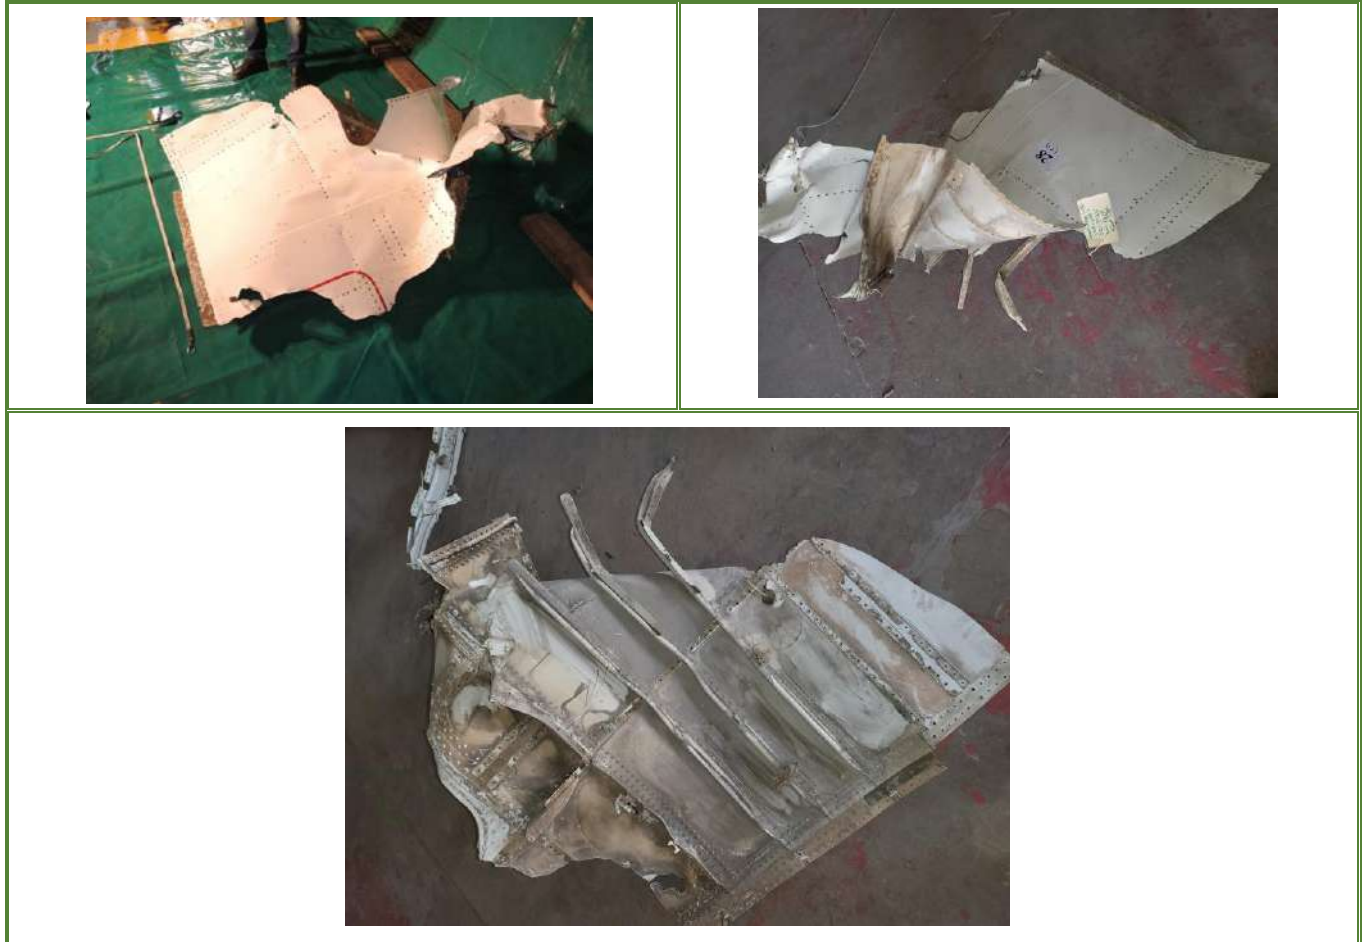
Figure 2.11/4 : Forward fuselage with static port (part No. 37)

4. Forward fuselage with static port (part No. 37)

- Outward deformation of the forward edge skin.
- Front lower corner of part rolled outward with dark color on the internal side.
- All edges are torn off except the back edge.

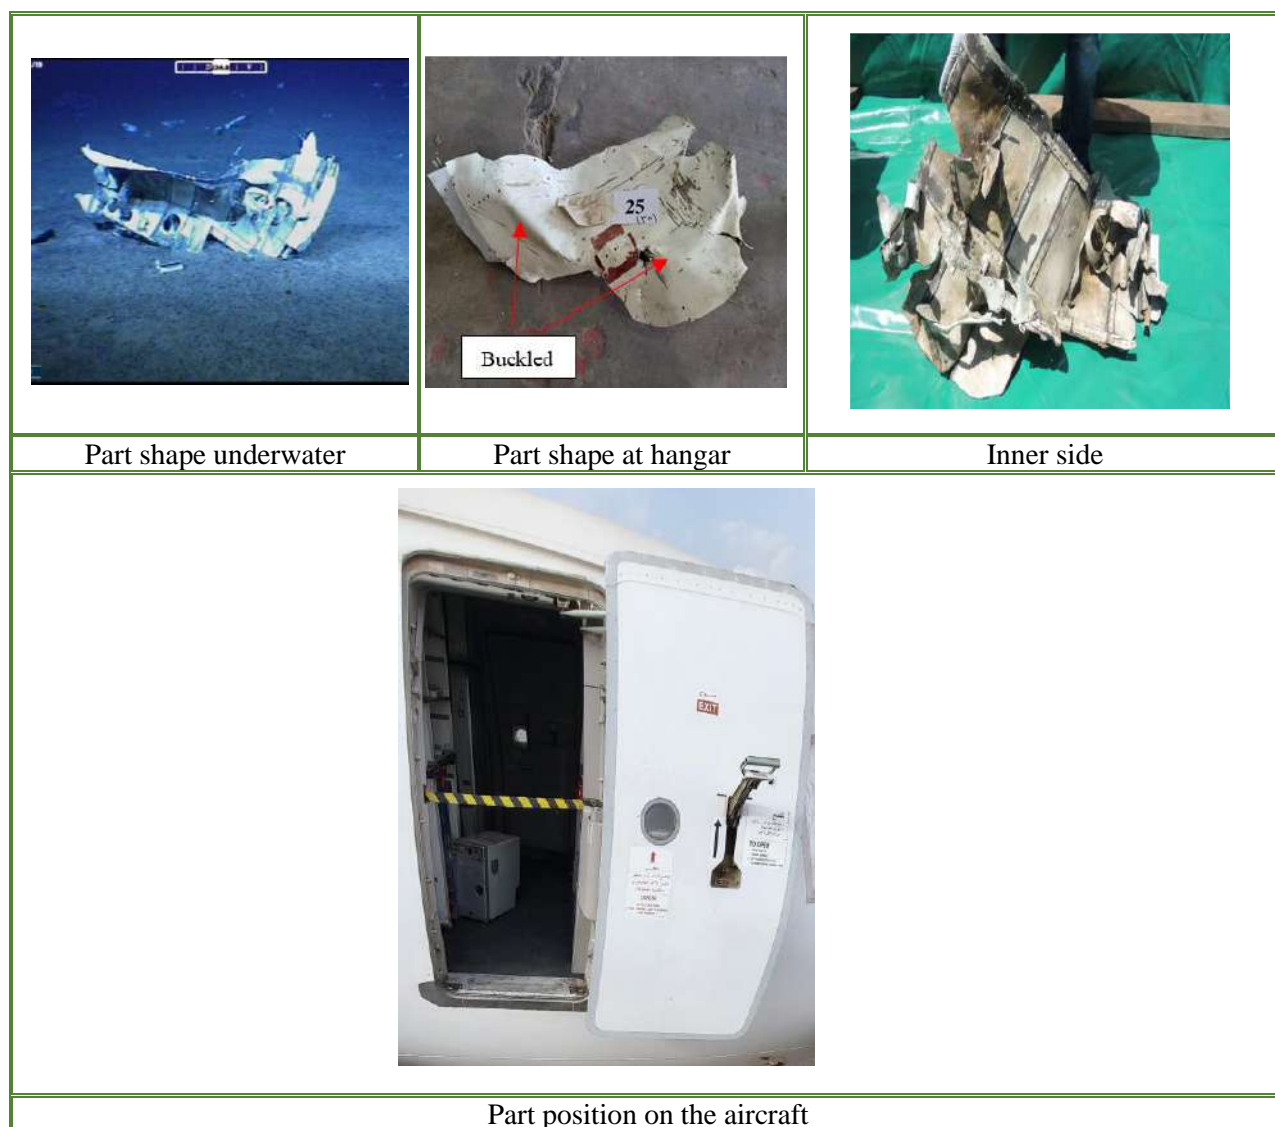
Figure 2.11/5 : FWD PAX RHS DOOR

## 5. FWD PAX RHS DOOR

- Upper third part of the FWD RHS PAX door.
- Almost two thirds of the FWD RHS PAX door lower part was torn away and completely detached. The piece shows buckling outwards in 2 locations. Inner side of the remaining part shows dark spots.

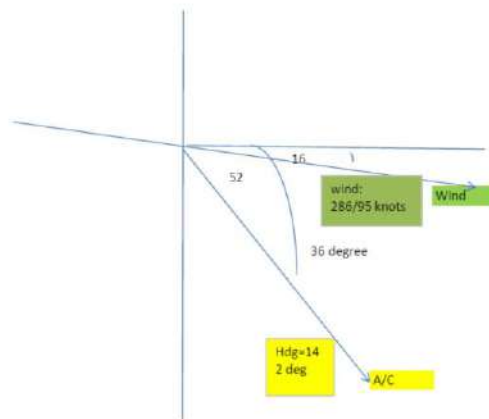
Figure 2.13/1 : wind direction analysis illustration

- (Aircraft heading was about 142 degree)
- Relative angle= 36 degree.
- Tail Wind =  $V_{wind} * \cos(36) = 95 \text{ knots} * \cos(36) = 76.87 \text{ kts TW}$

- Cross wind (right to left) =  $V_{wind} * \sin(36) = 95 \text{ kts} * \sin(36) = 55.84 \text{ kts}$  from right to left.
- Drift angle varied between 6, 7 degrees (right) throughout the end portion of the recording.

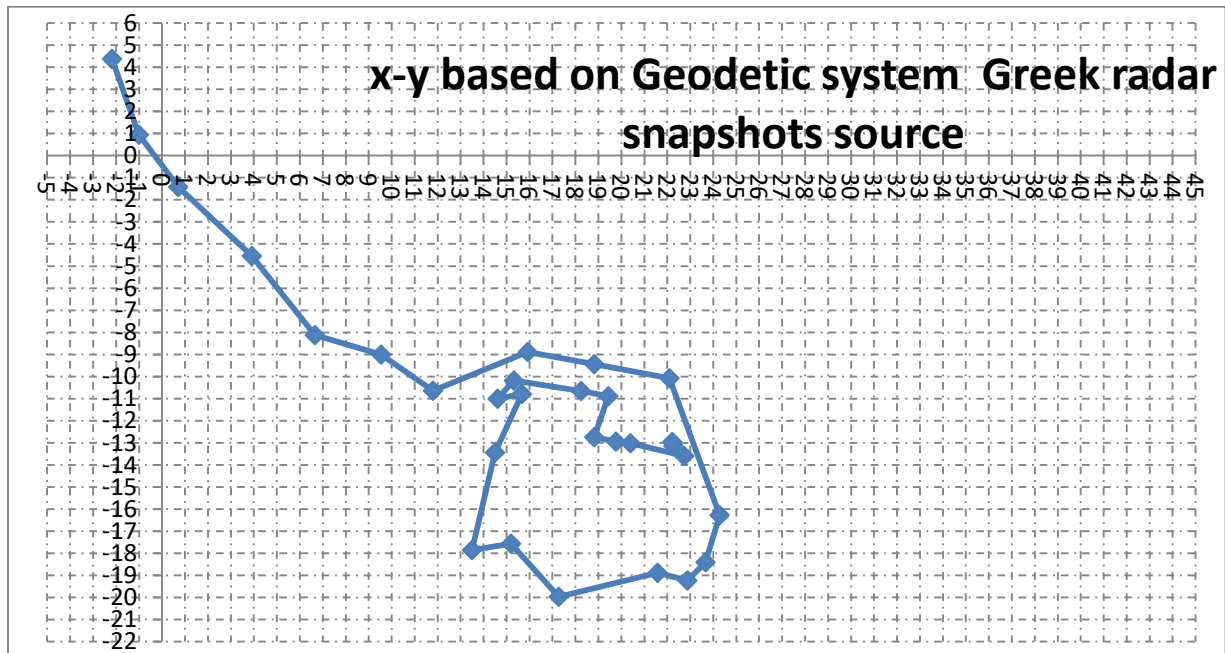
The aircraft changed its direction several times. The aircraft has entered in a complete circle.

A/P was disengaged with no manual control inputs

Aircraft flight path based on Greek radar snapshots source

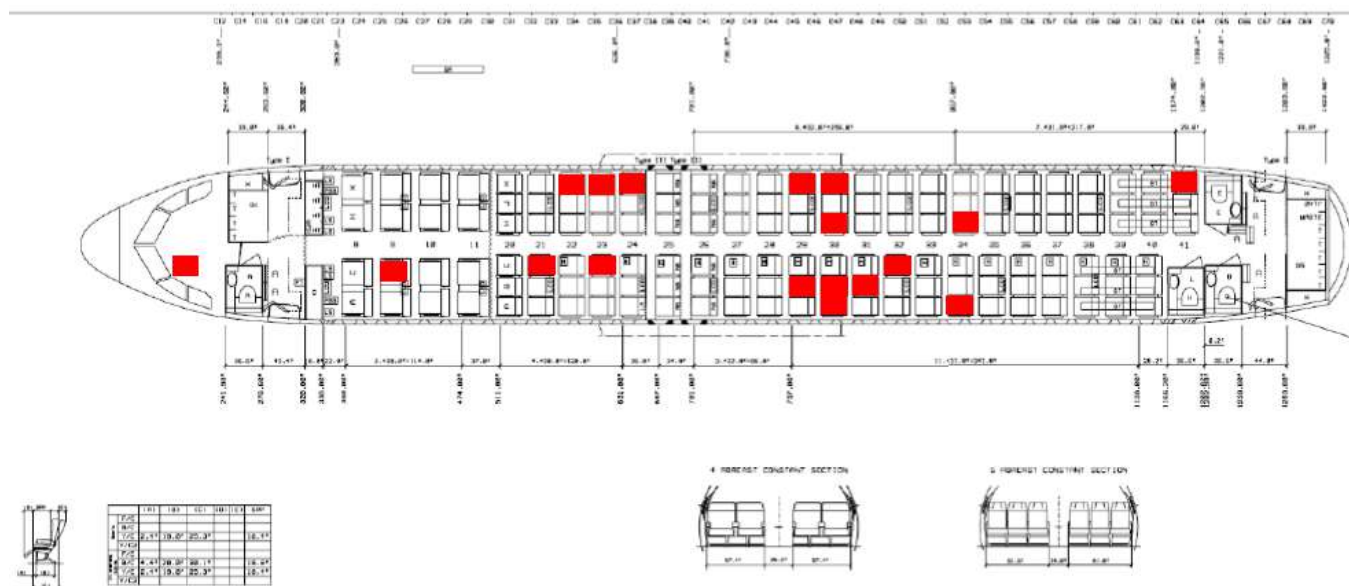
Figure 2.19/1: Distribution of positive samples on aircraft seats

Serial No.	Number of positive samples
1	1
2	1
3	1
4	1
5	1
6	3
7	2
8	2
9	1
10	1
11	1
12	2
13	1
14	1
15	1
16	1
17	1
18	1

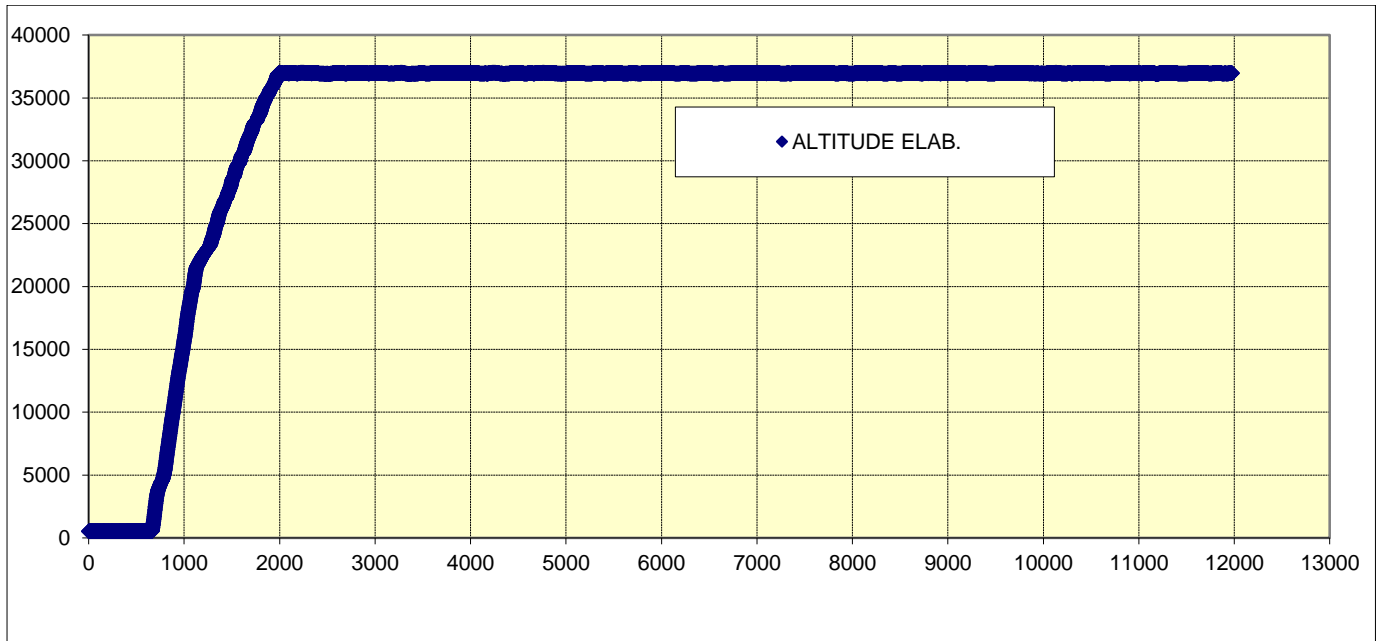
Aircraft reached top of climb (37000 ft) at almost 21:43:38 UTC (2009 seconds on the plot)

Cruise altitude was 37000 ft to the end of recording

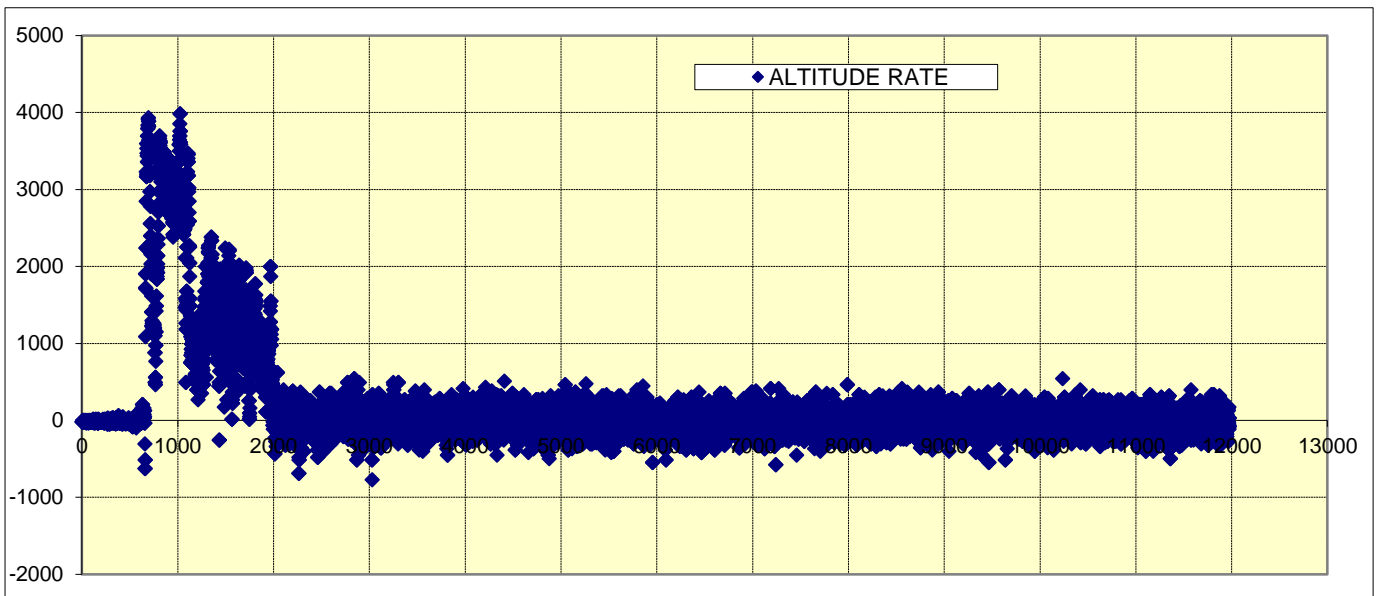
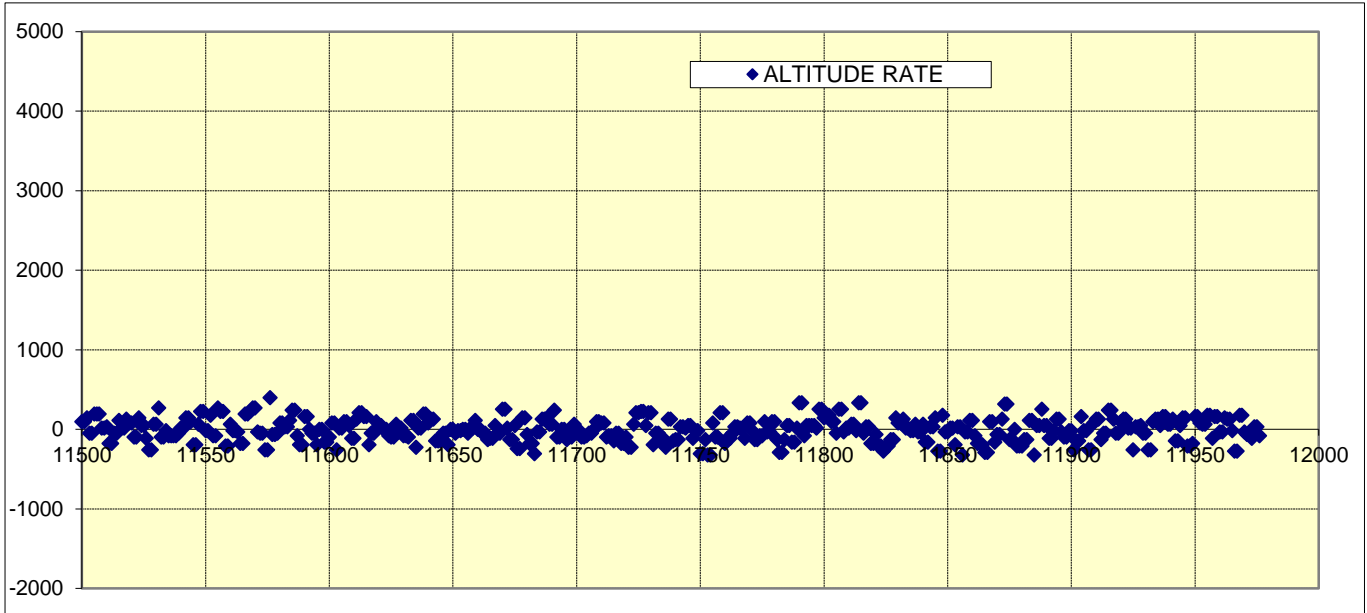
- Altitude Rate

Altitude Rate shown at the end portion of the recording
