## Final Report

**EgyptAir A320 Aircraft crash in the Mediterranean, registered SU-GCC,  
flight number MSR804, from Charles De-Gaulle Airport, Paris to Cairo  
International Airport, on 19/05/2016**

EGAI2016-01

October 2024

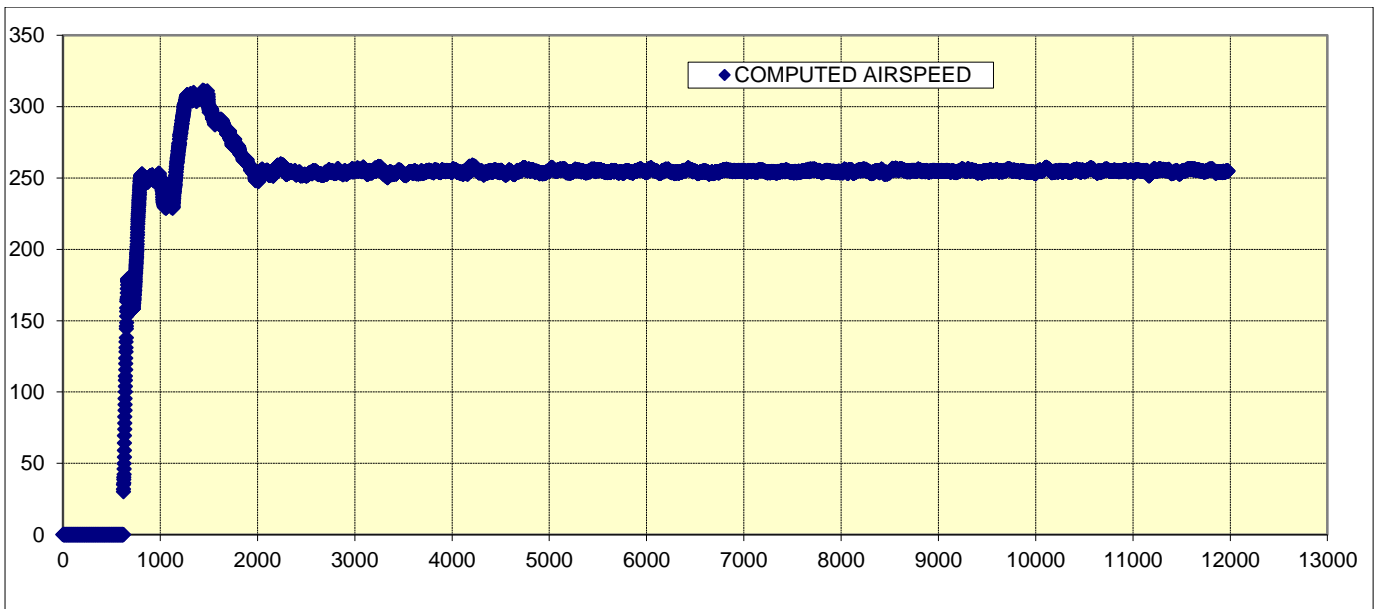
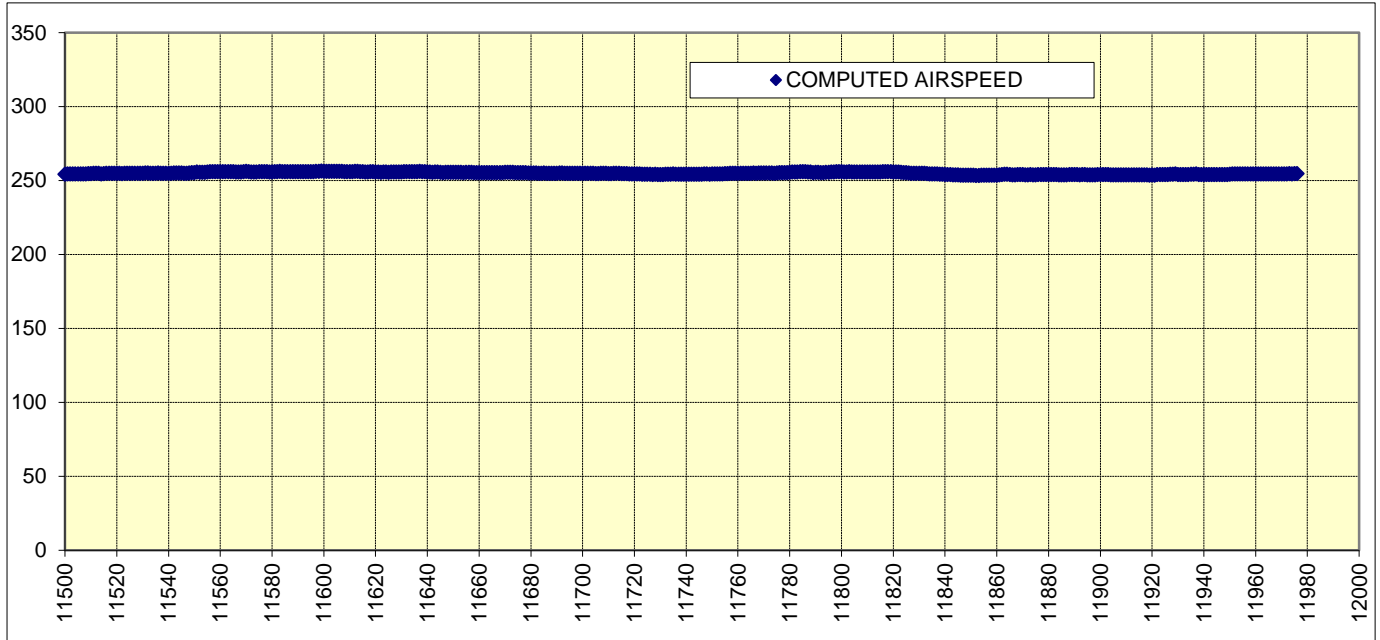
– COMPUTED AIRSPEED

Computed Airspeed at the last portion of the recording

Airspeed was almost 254 knot

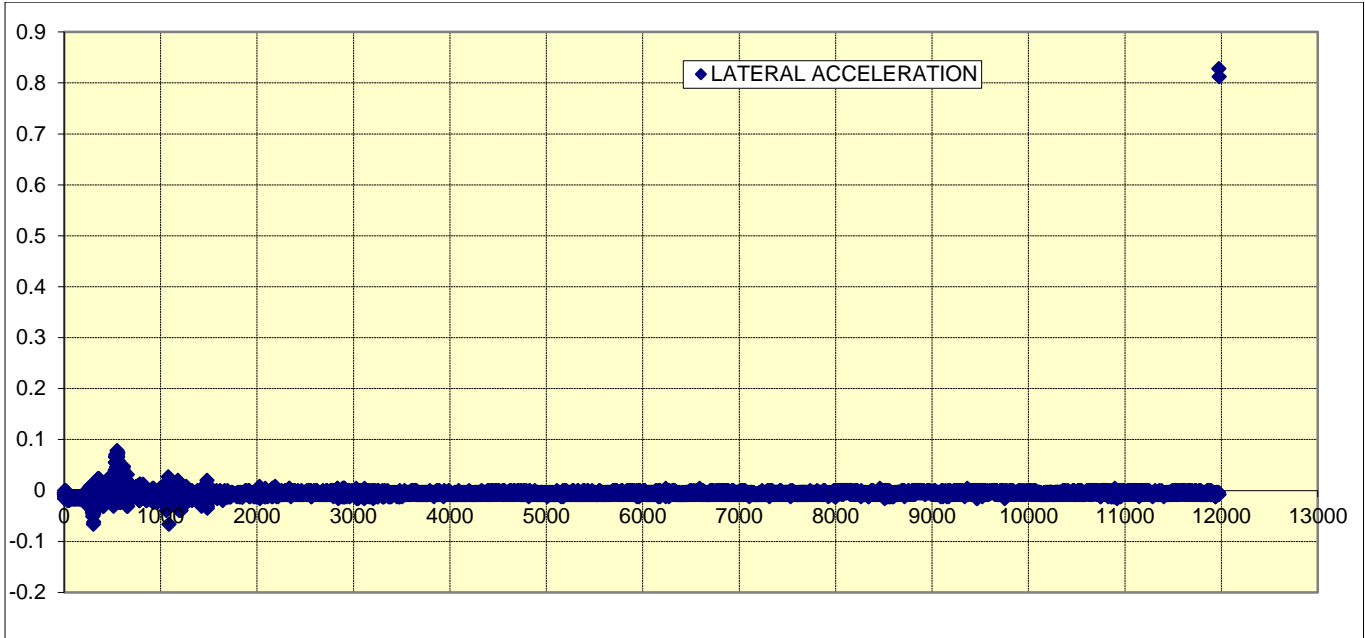
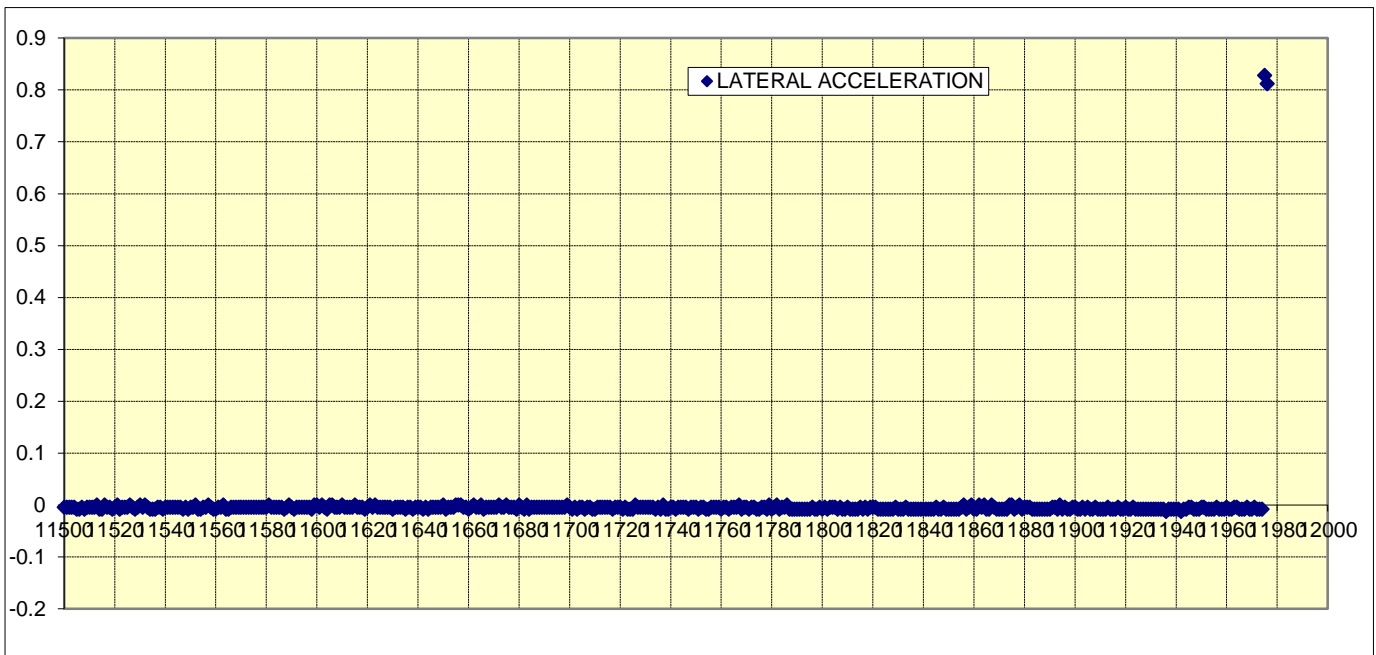
- LATERAL ACCELERATION

- Lateral Acceleration, closer view at the end of the recording

UTC	Lateral acceleration	Plot time
24:29:42	-0.008	11973
24:29:43	-0.008	11974
24:29:44	0.828	11975
24:29:45	0.812	11976

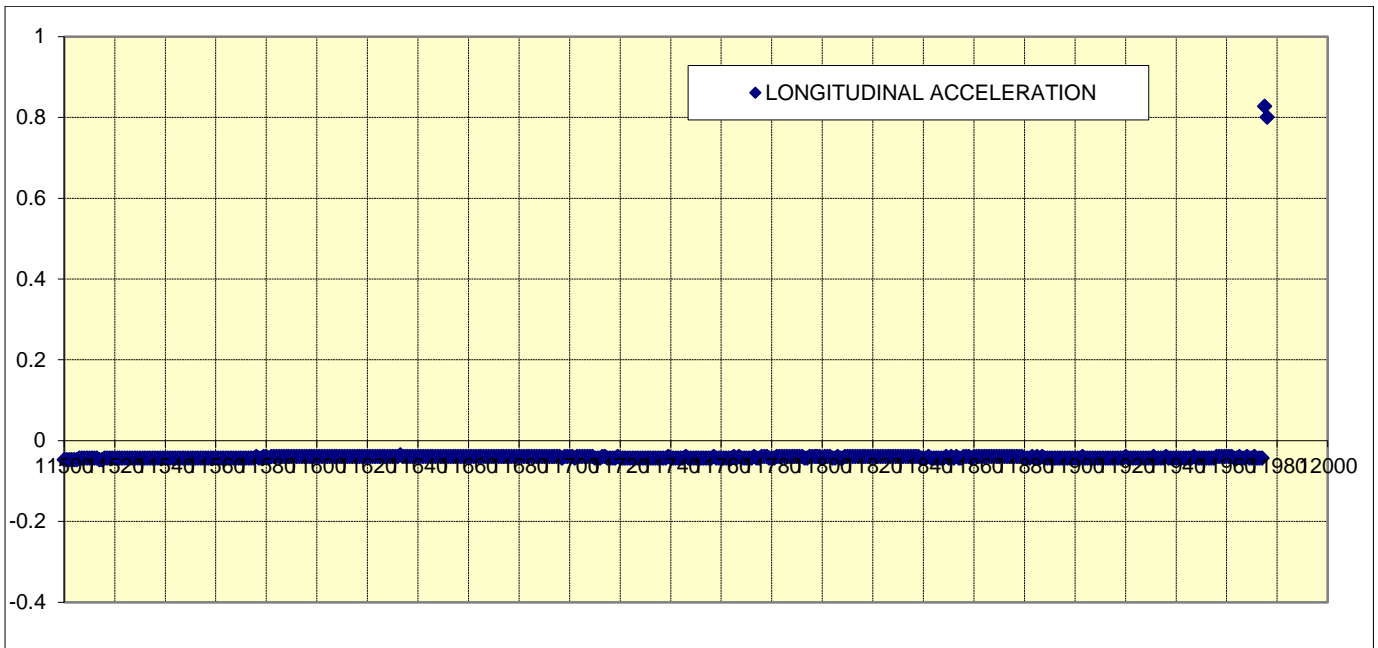
(last portion of the flight)

UTC	Longitudinal acceleration	Plot time
24:29:42	-0.043	11973
24:29:43	-0.043	11974
24:29:44	0.828	11975
24:29:45	0.801	11976

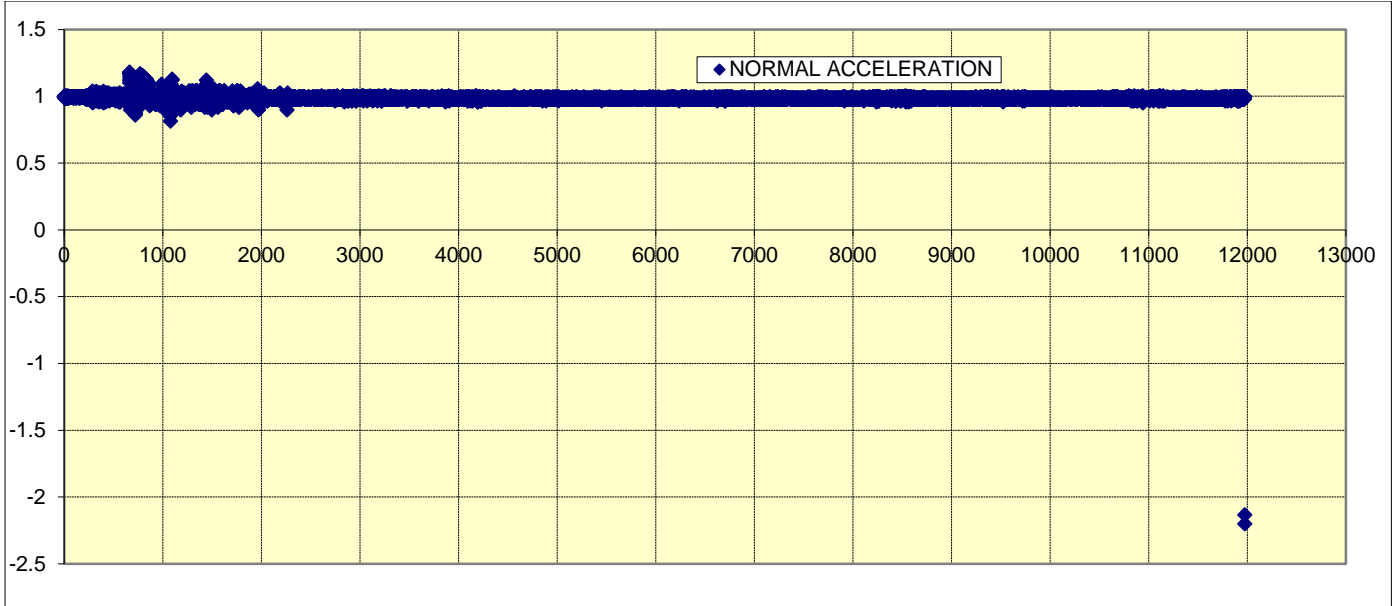
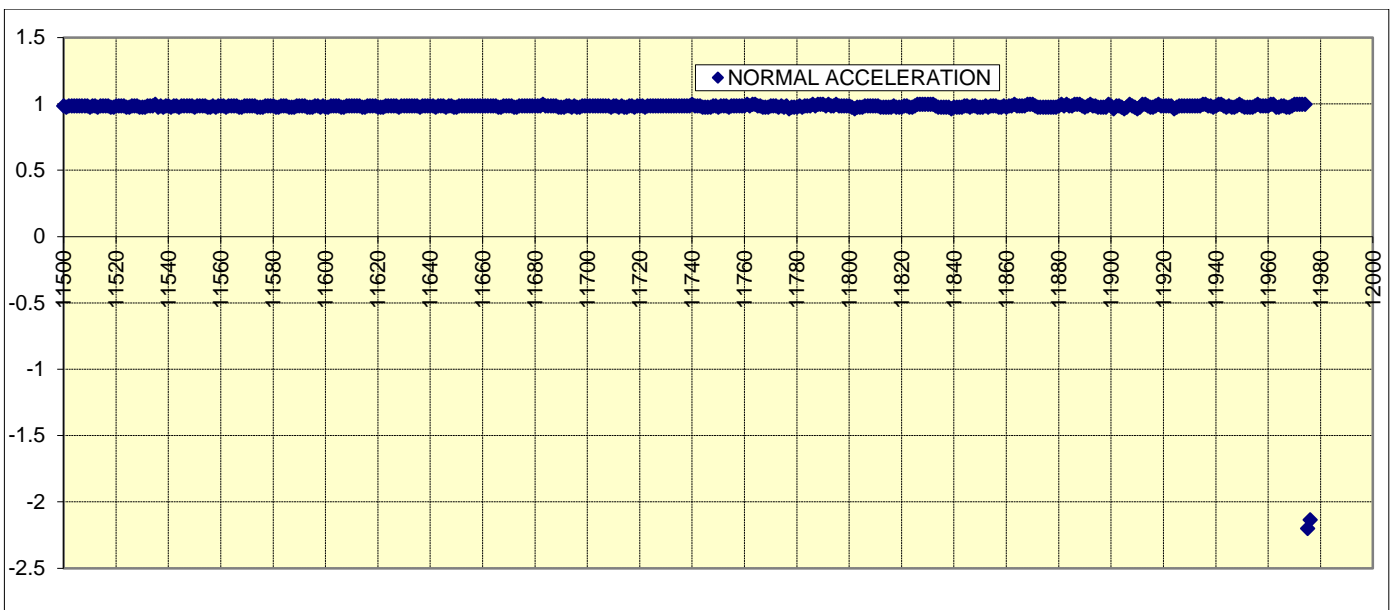
– NORMAL ACCELERATION

Normal Acceleration, closer view at the end of the flight

UTC	normal acceleration	Plot time
24:29:42	0.977	11973
24:29:43	0.997	11974
24:29:44	-2.134	11975
24:29:45	-2.2	11976

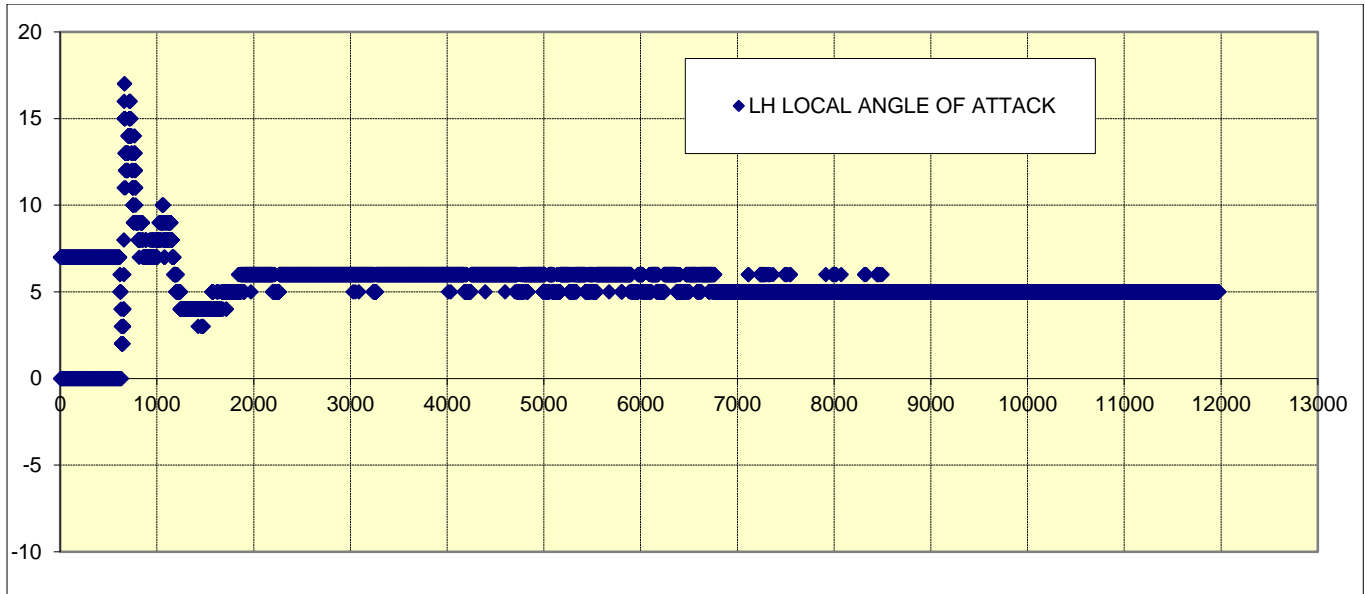
– LH LOCAL ANGLE OF ATTACK

LH local Angle of Attack was varying between 6 degrees and 5 degrees

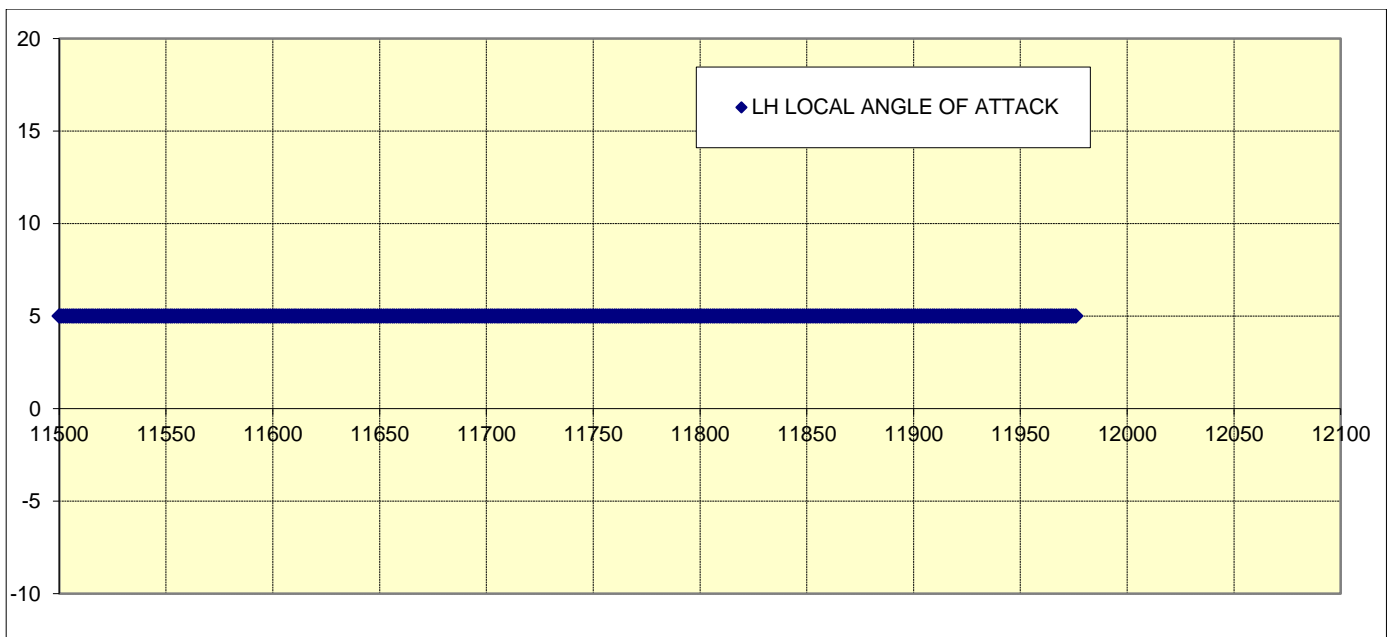
– LH local Angle of Attack, closer view at the end of the flight

LH local Angle of Attack showed a fixed value of 5 degrees for almost the last 3500 seconds of the recording

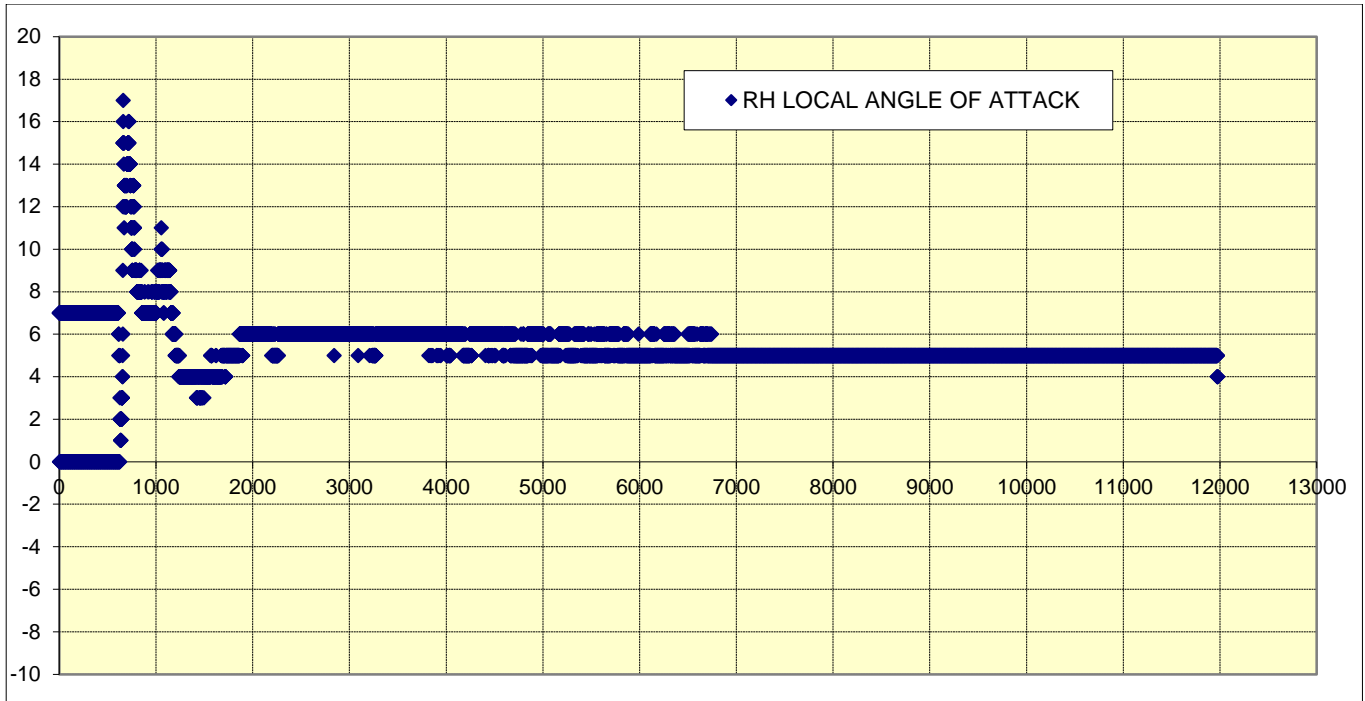
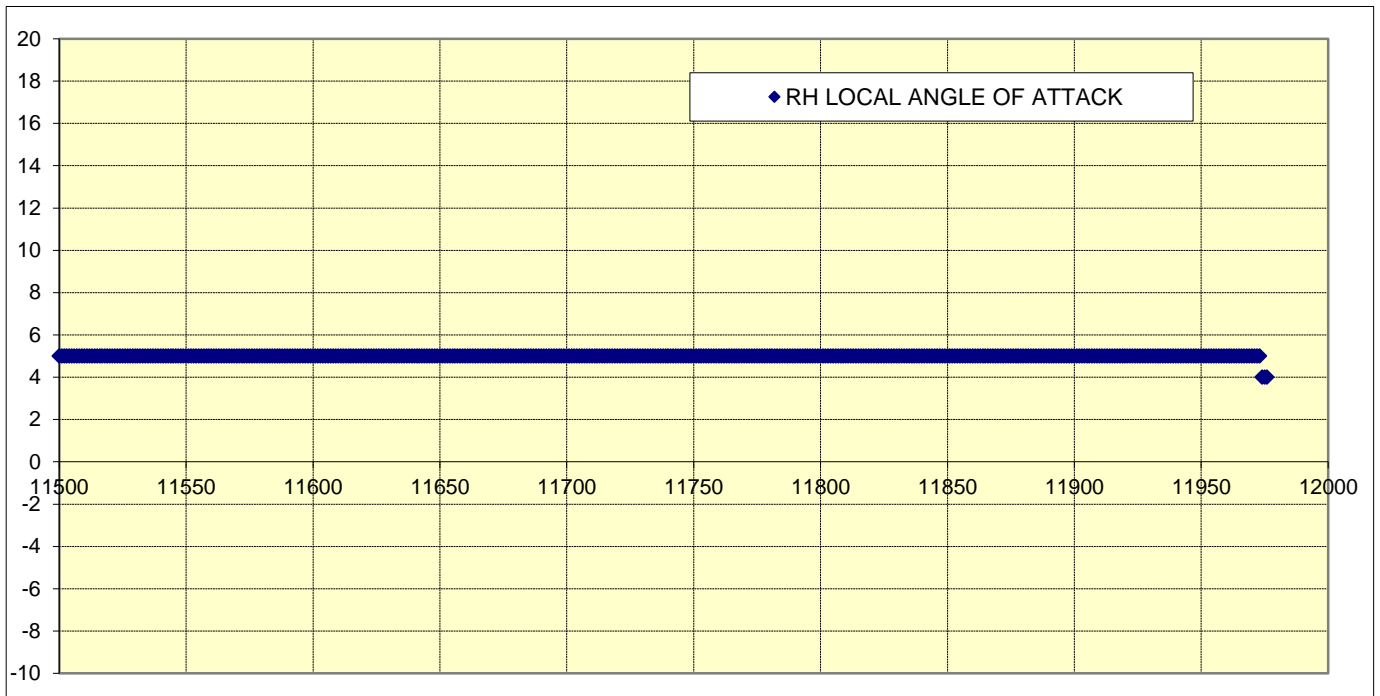
– RH LOCAL ANGLE OF ATTACK

RH local angle of attack shown at the end portion of the recording

At almost 00:29:42 UTC (11973 seconds on the plot) RH angle of attack changed from a constant value of 5 degrees to -4 degrees till the end of the recording 00:29:45 UTC (11976 seconds on the plot)

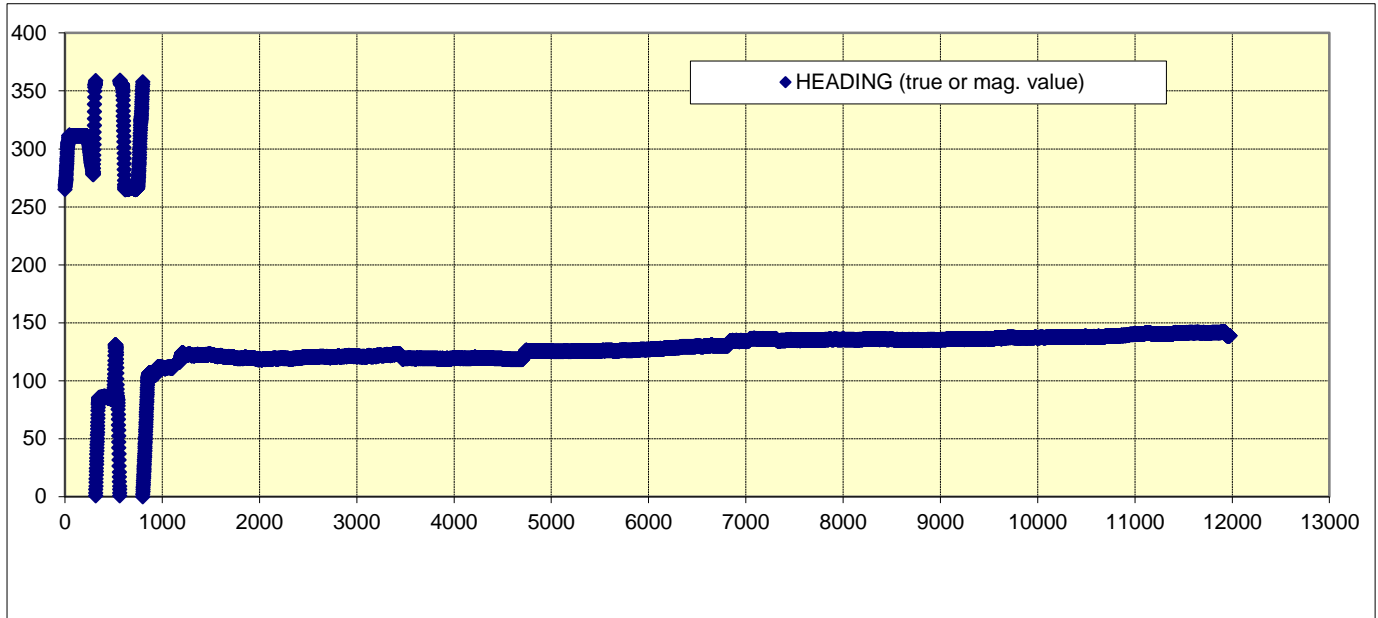
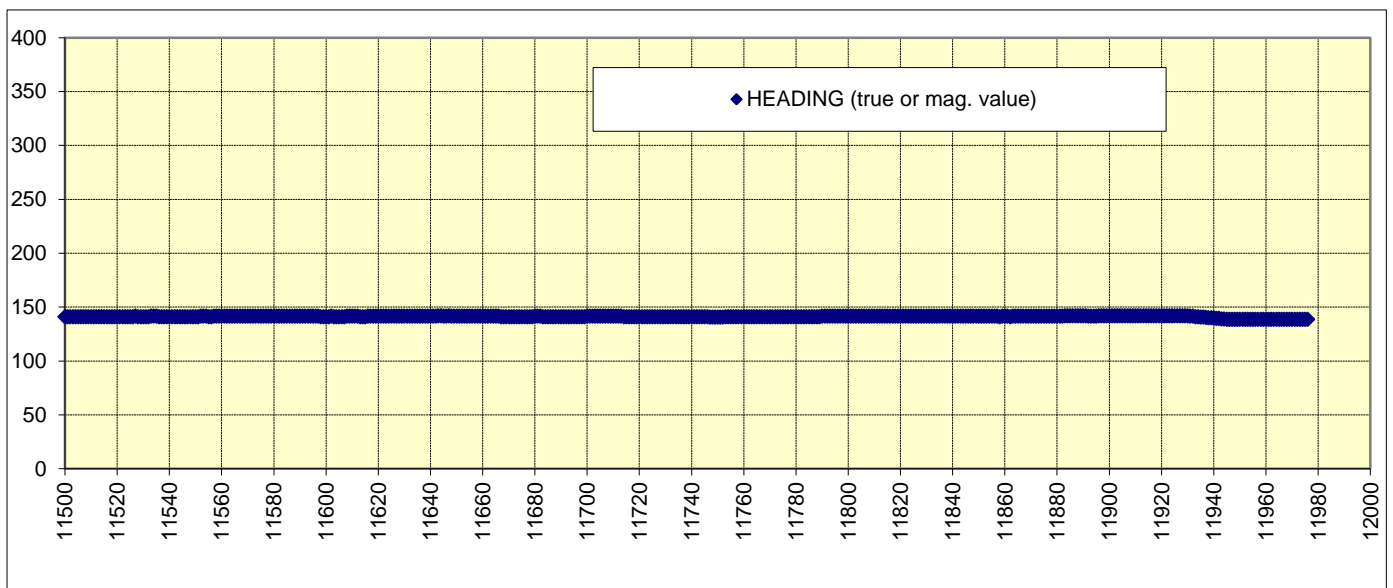
- HEADING (true or mag. value)

Heading shown at the last portion of the recording

Heading was almost constant at 142 degree at the last portion of the recording, changed slightly to 139 degree 40 seconds before the end of the recording

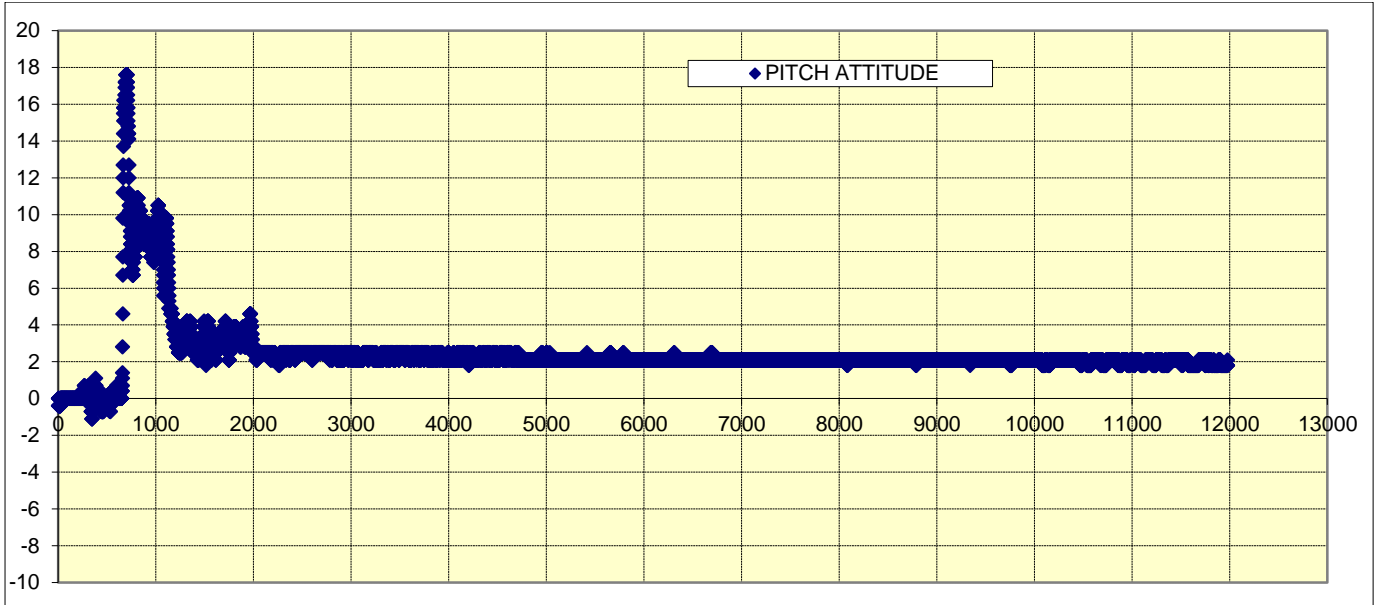
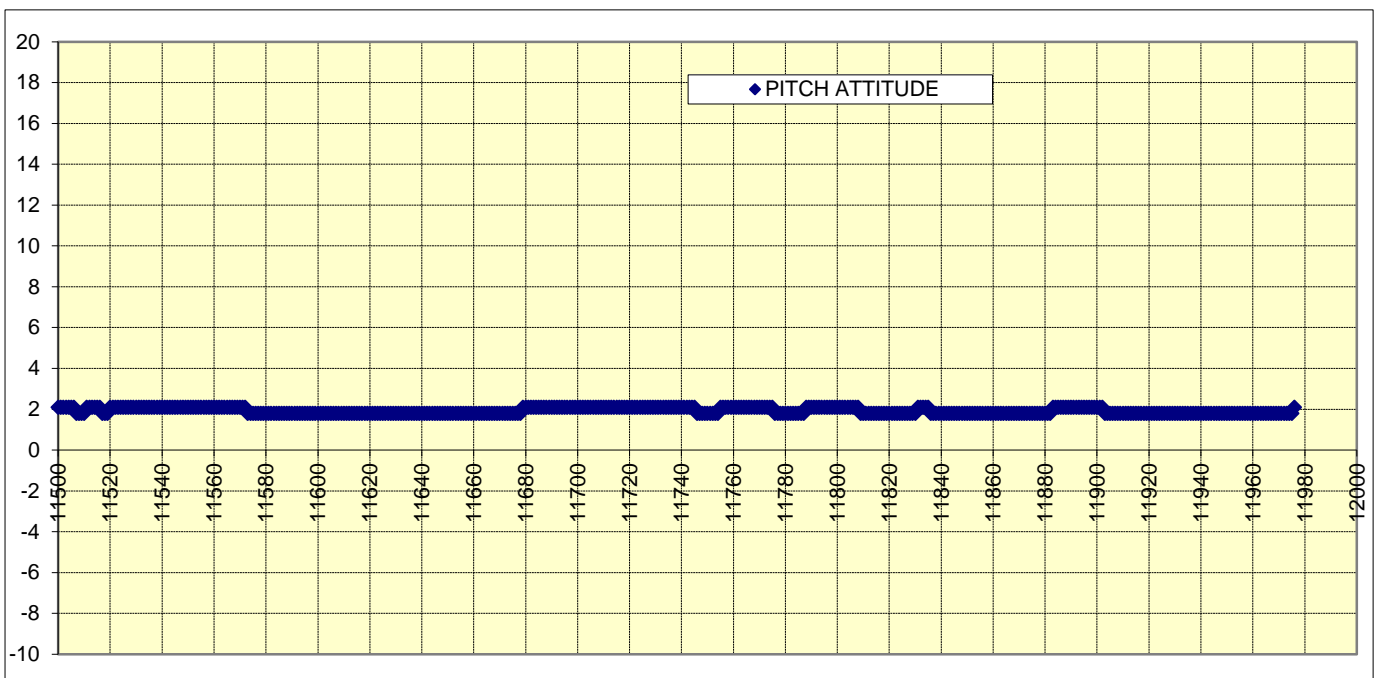
- PITCH ATTITUDE

Pitch shown at the end portion of the recording

The Pitch was almost 1.8 degrees at the end portion of the recording with exception of the last second it changed slightly to 2.1 degree (at 00:29:45 UTC)

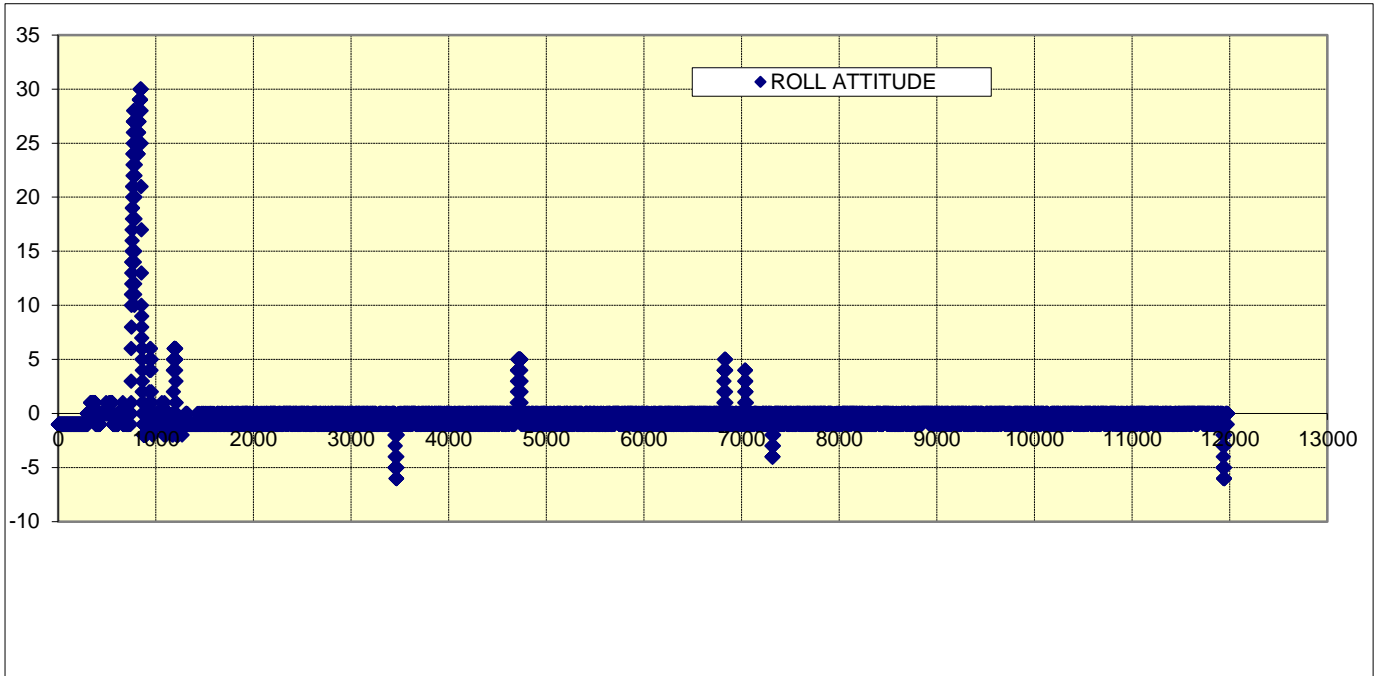
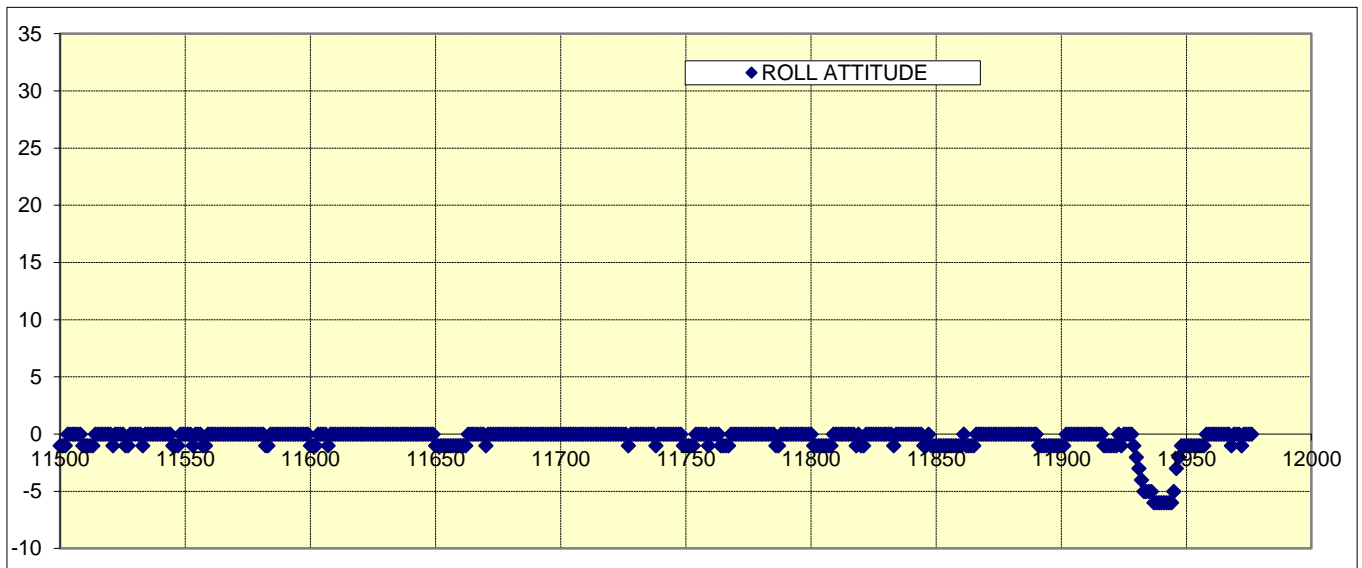
- ROLL ATTITUDE

Roll was showing values between -0.4 to -0.7 degrees, then starting from 00:28:59 UTC changing reaching a max value of -6 degrees at 00:29:10 UTC then dropped to its initial value of -0.7 at 00:29:22 UTC

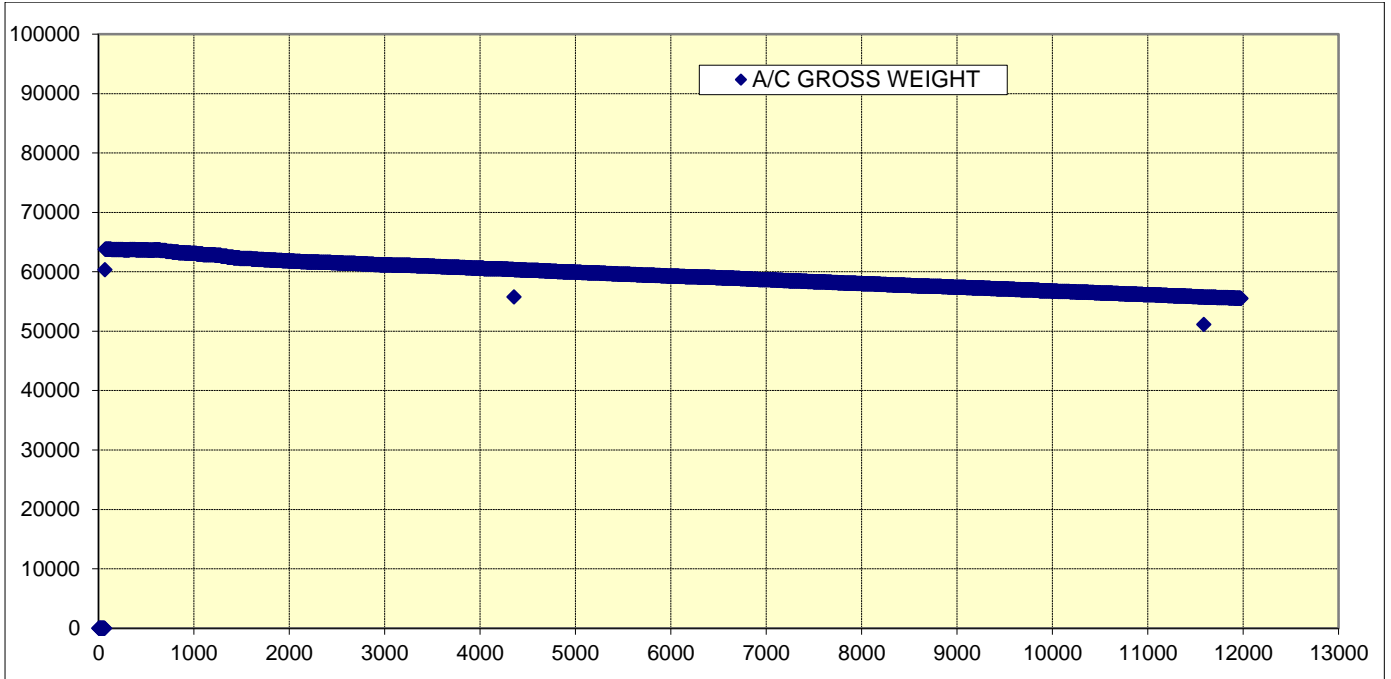
- A/C GROSS WEIGHT

Recorded weight at the end of the recording was 55490 kg

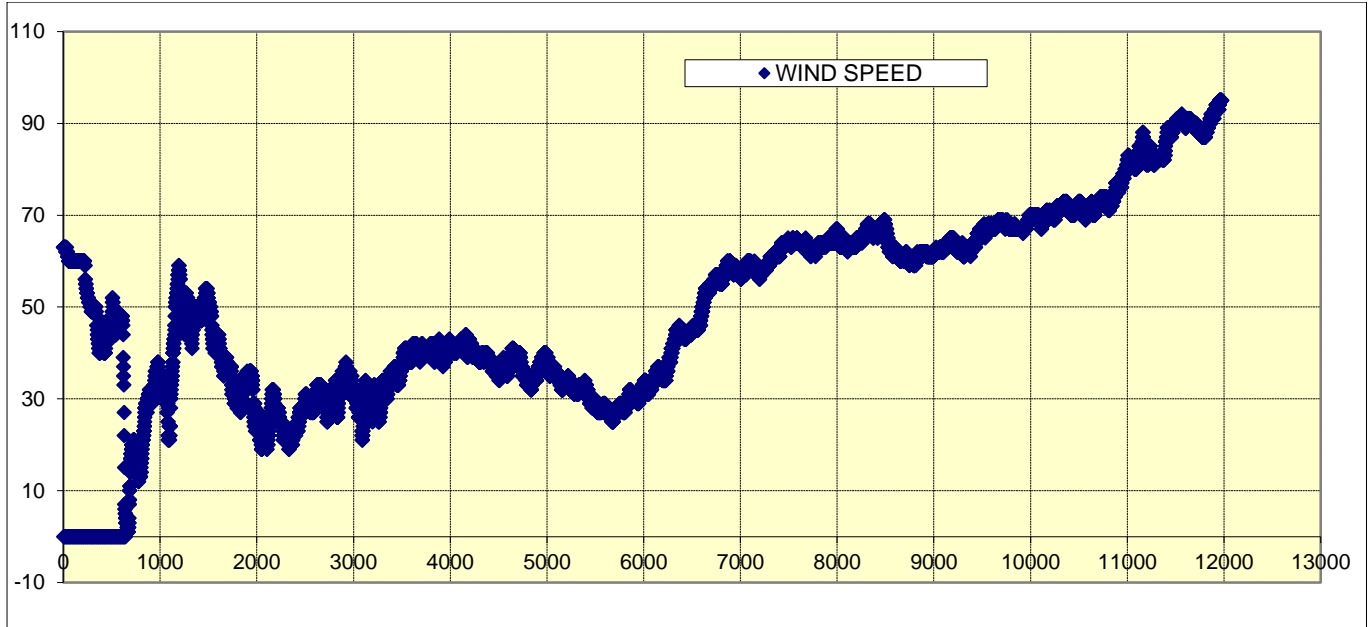
- WIND SPEED

The wind speed was shown to be 95 knots at the end recording

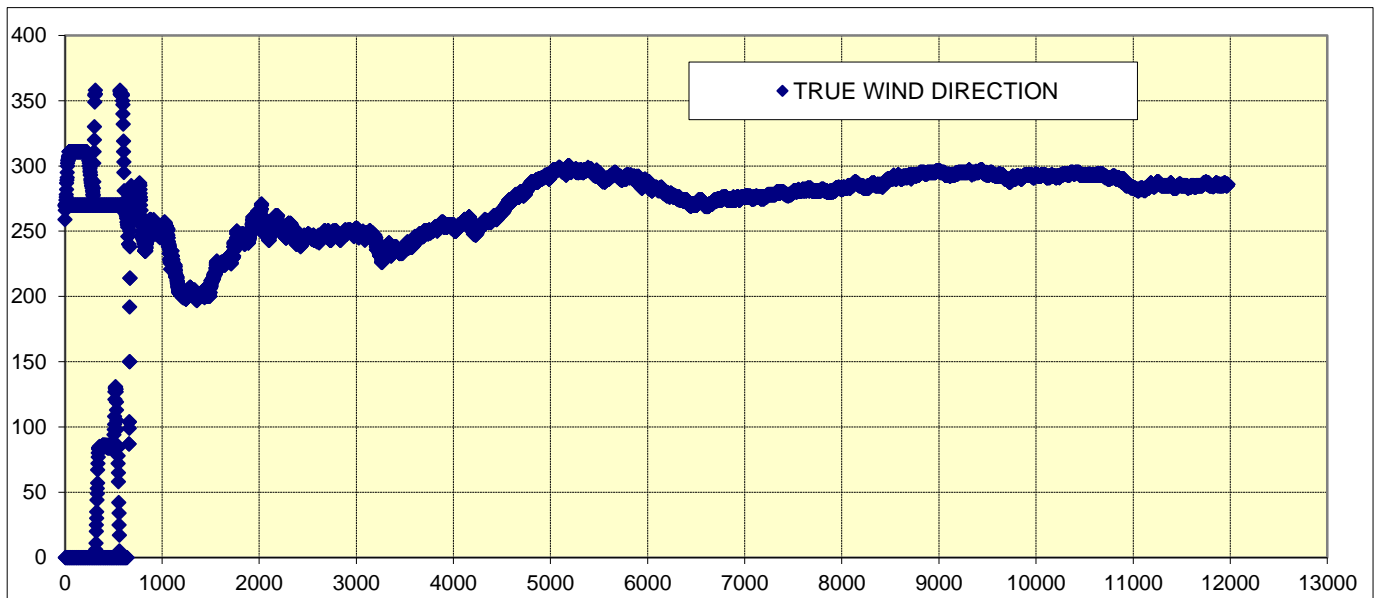
- TRUE WIND DIRECTION

Last True wind direction recorded is 286 degrees

(A/C heading was about 142 degree)

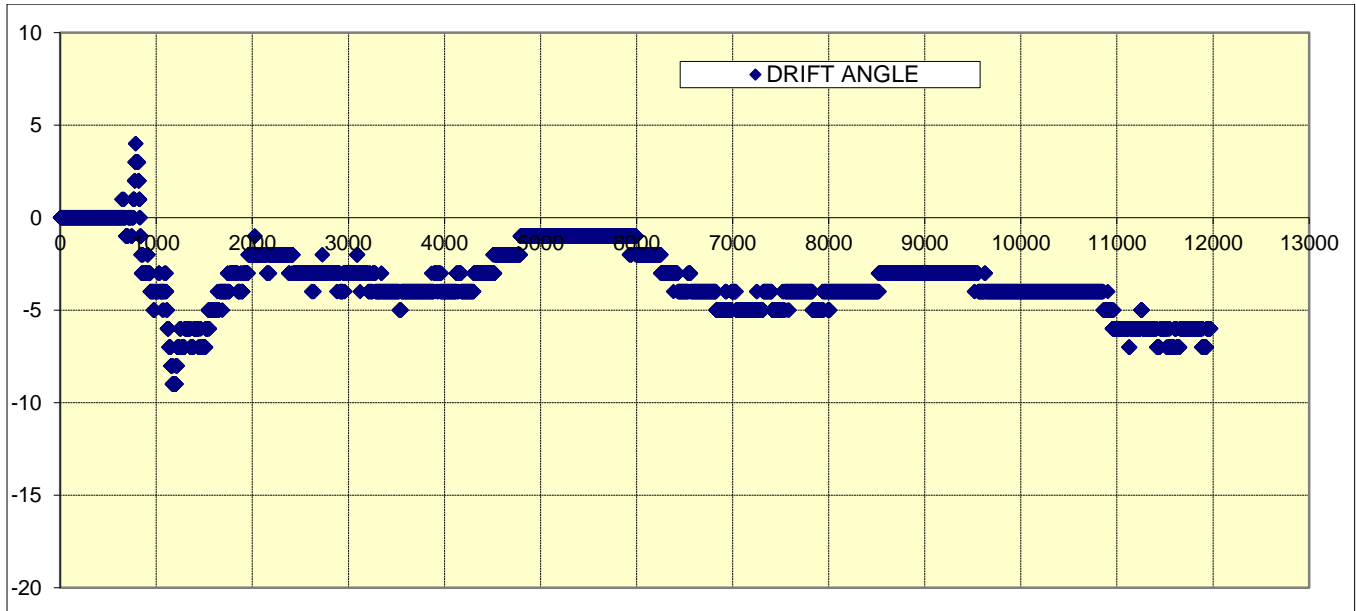
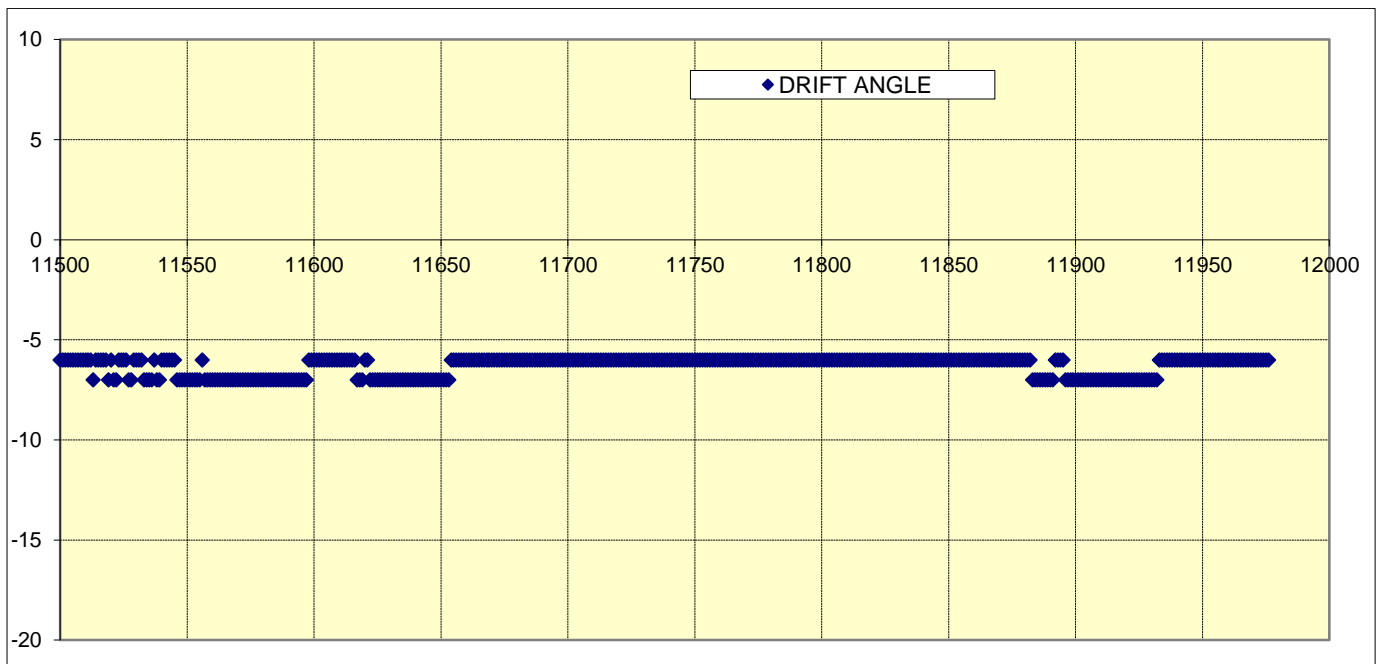
- DRIFT ANGLE

Drift angle shown at the end portion of the recording

Drift angle varied between -6, -7 degrees throughout the end portion of the recording

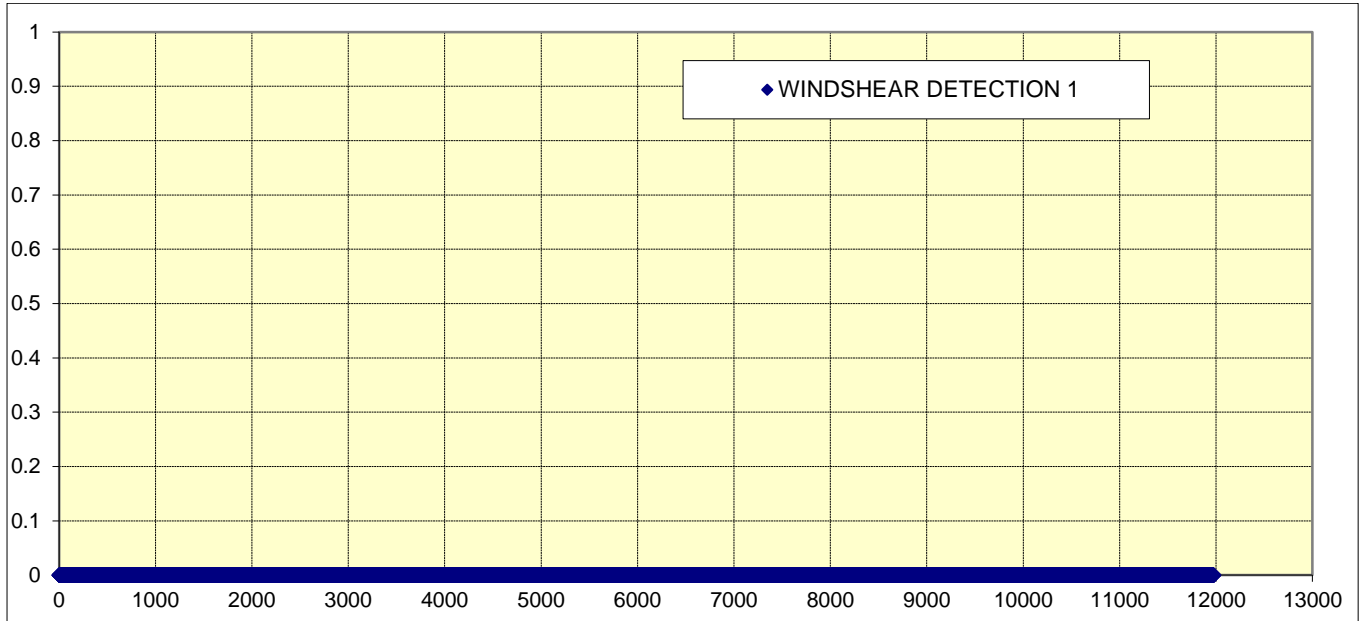
- WINDSHEAR DETECTION 1  
(0 no windshear)

No windshear detected (Windshear detection 1)

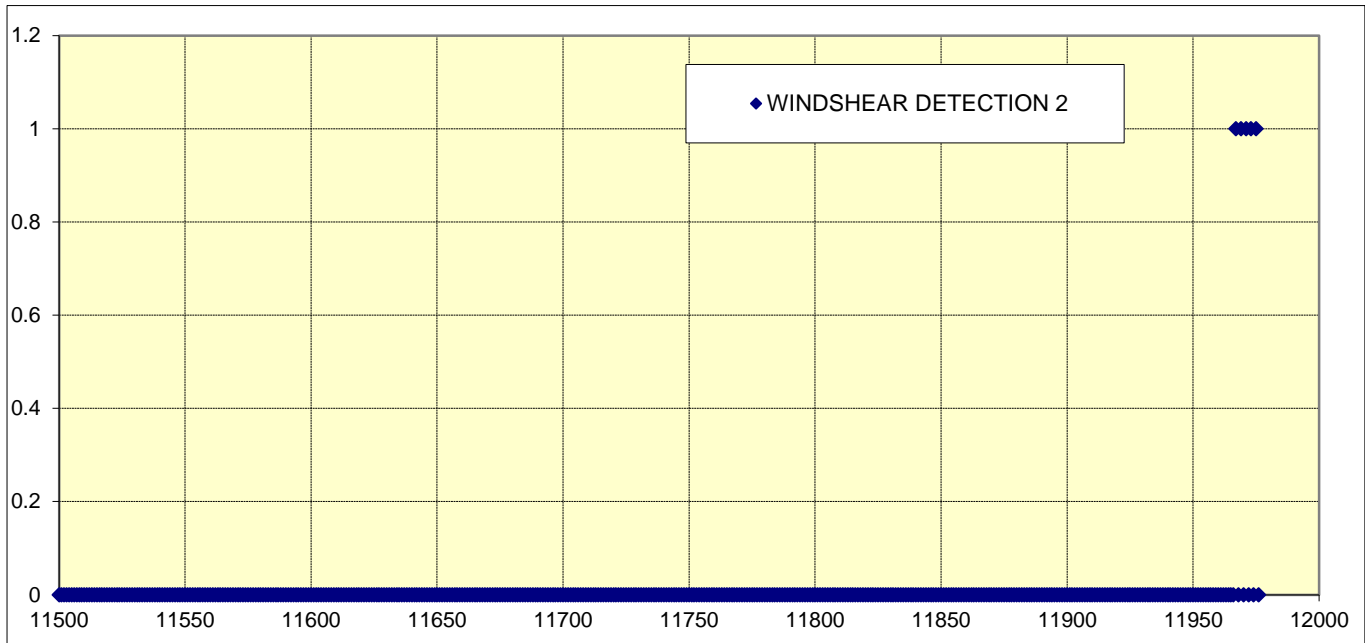
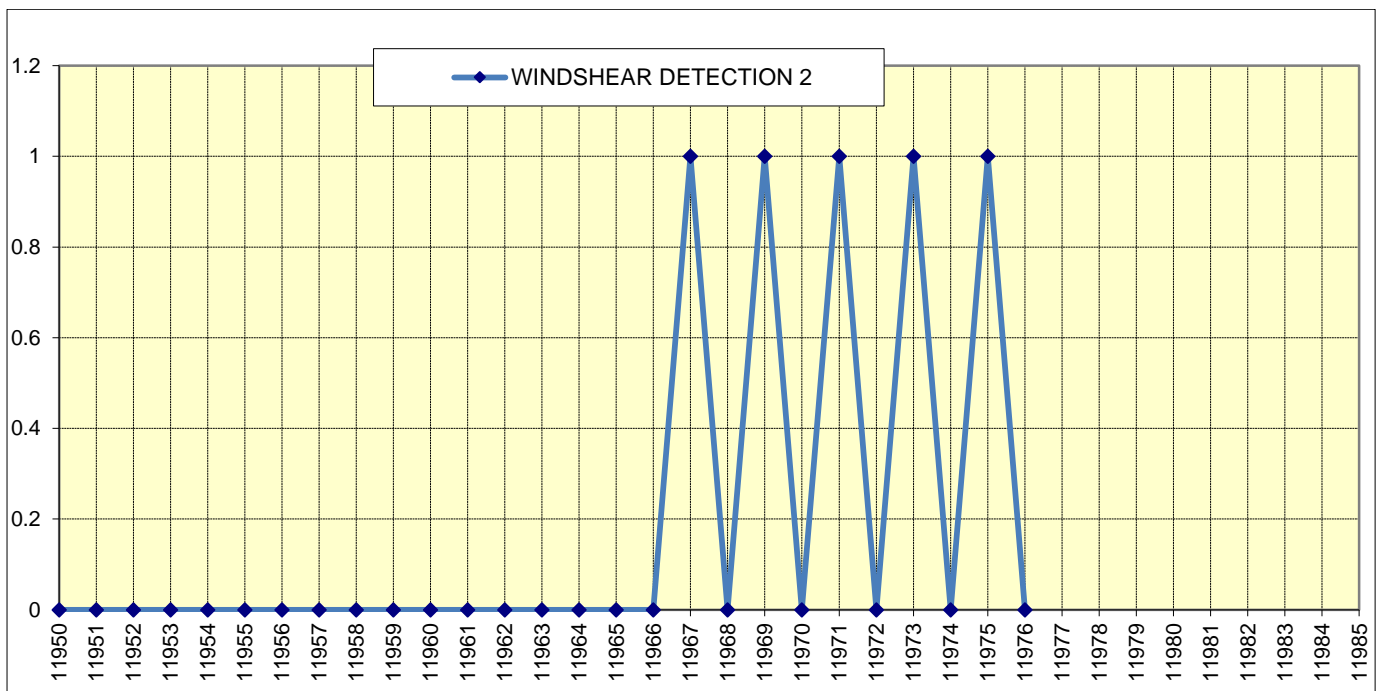
Windshear Detection 2 shown at the end portion of the recording

Windshear detection 2 shown at the end of the recording

No windshear detected until 00:29:35 UTC (11966 seconds on the plot) then started reciprocating between ON and OFF until the end of the recording at 00:29:45 UTC (11976 seconds on the plot) (about 10 seconds)
