## Final Report

**EgyptAir A320 Aircraft crash in the Mediterranean, registered SU-GCC,  
flight number MSR804, from Charles De-Gaulle Airport, Paris to Cairo  
International Airport, on 19/05/2016**

EGAI2016-01

October 2024

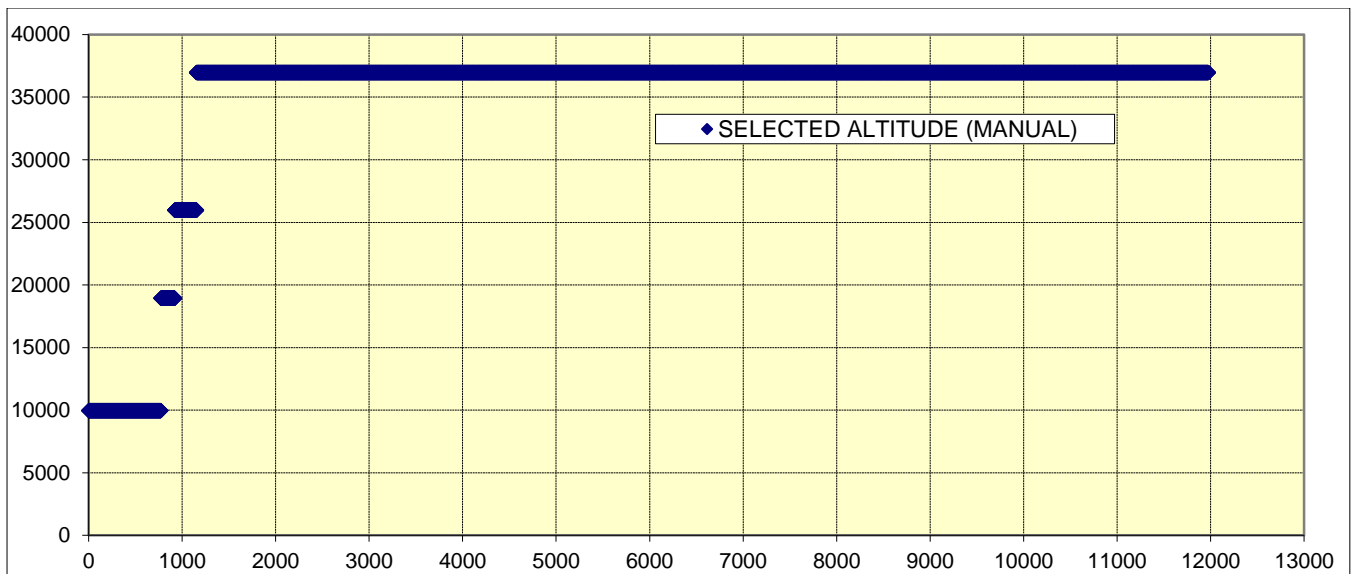
- SELECTED ALTITUDE (MANUAL)

Selected altitude was 37000 ft

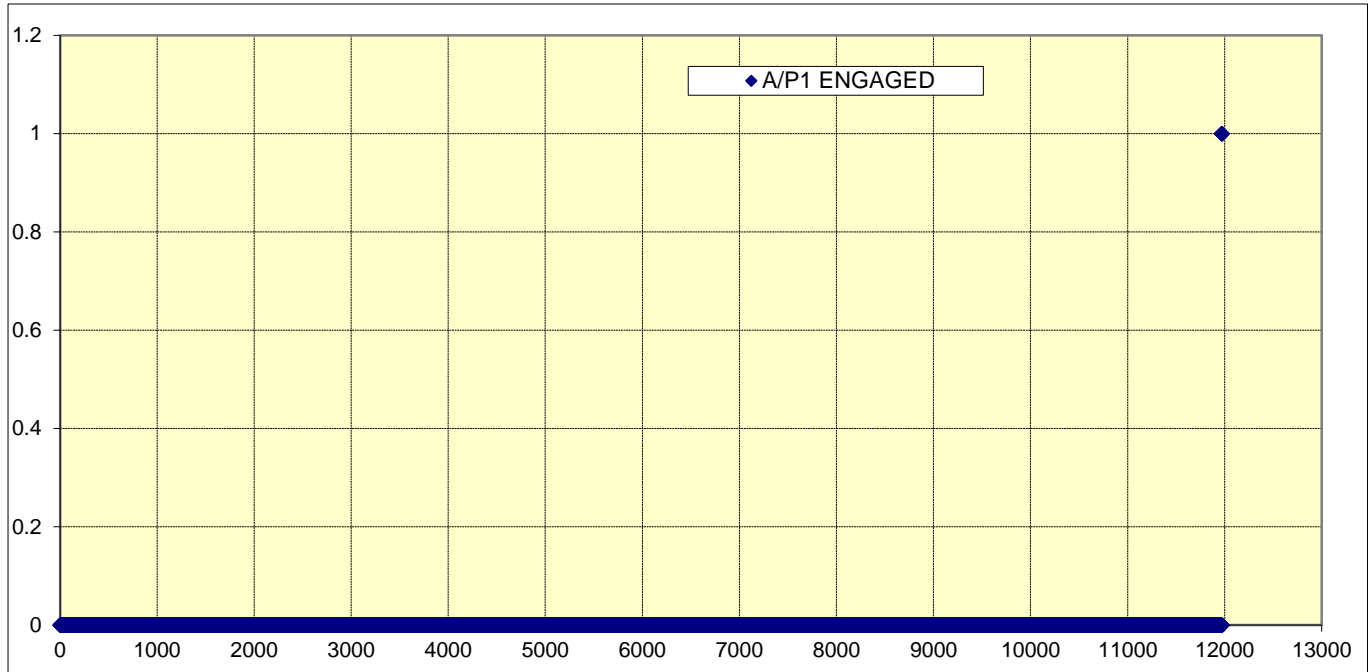
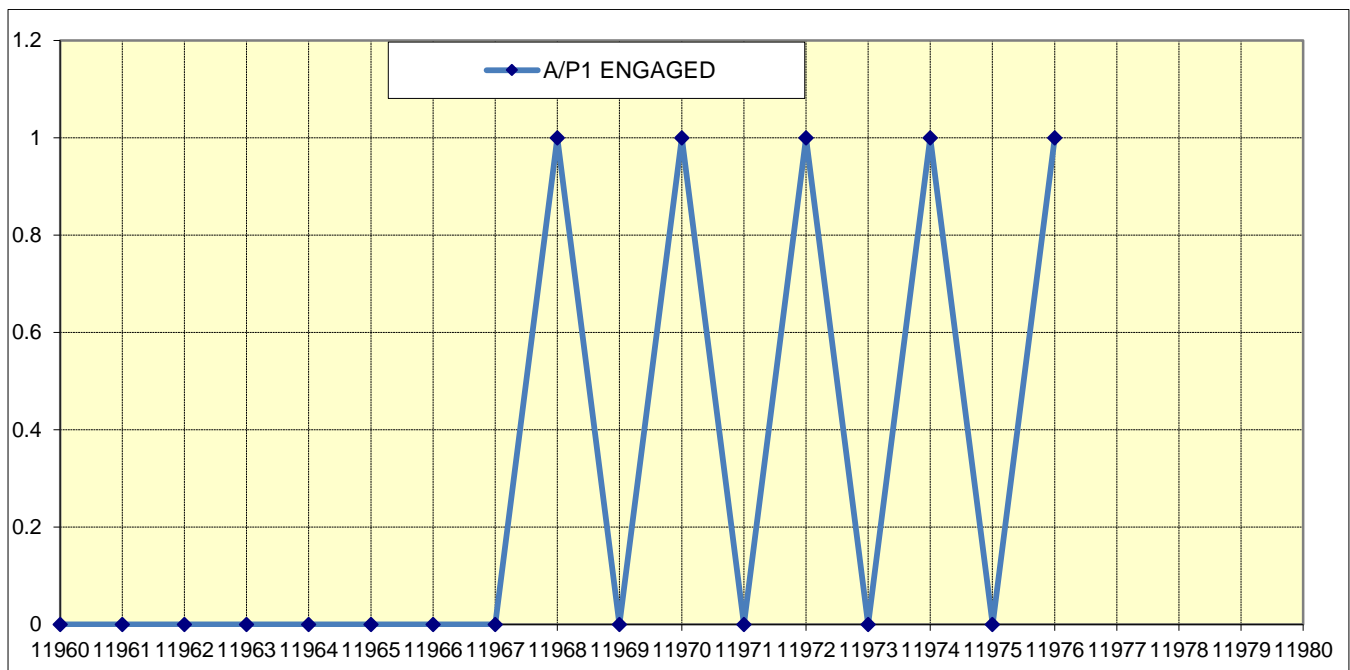
– A/P1 ENGAGED

A/P 1 engaged shown near the end of recording

A/P 1 was not engaged throughout the whole recording time until 00:29:36 UTC (11967 seconds on the plot), then it started reciprocating between ON and OFF until the end of the recording at 00:29:45 (11976 seconds on the plot) (about 9 seconds)

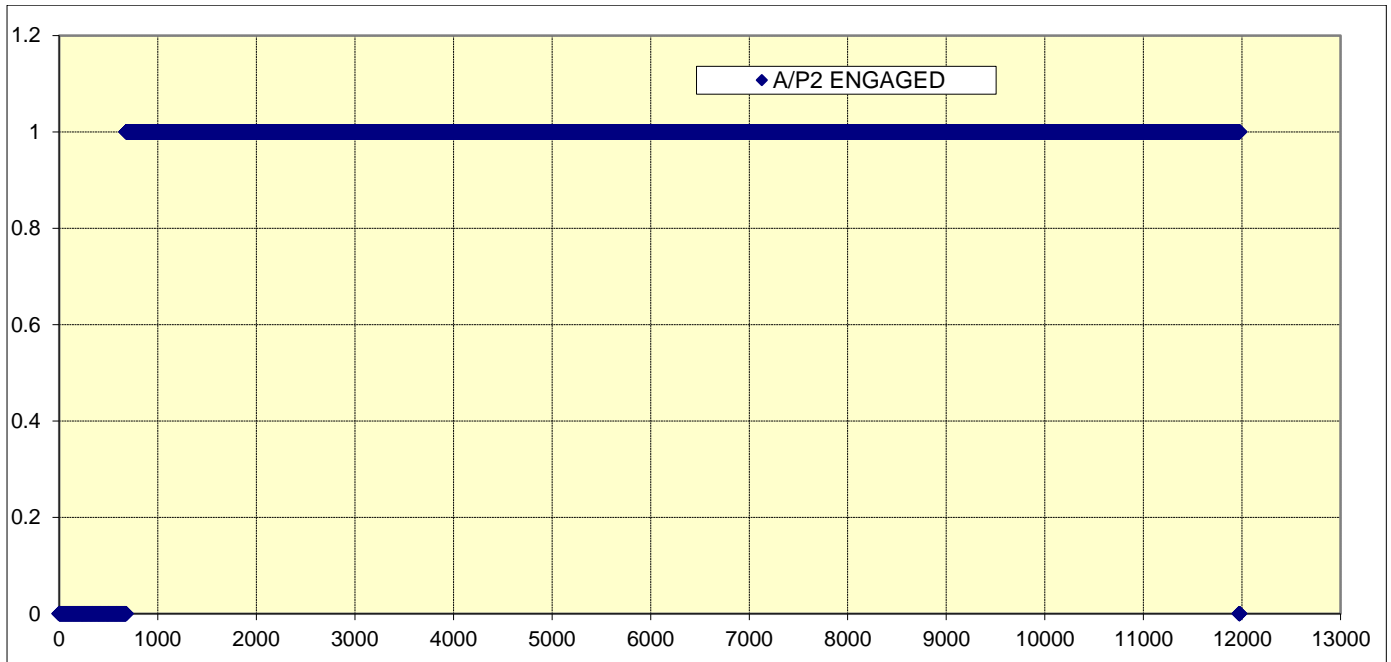
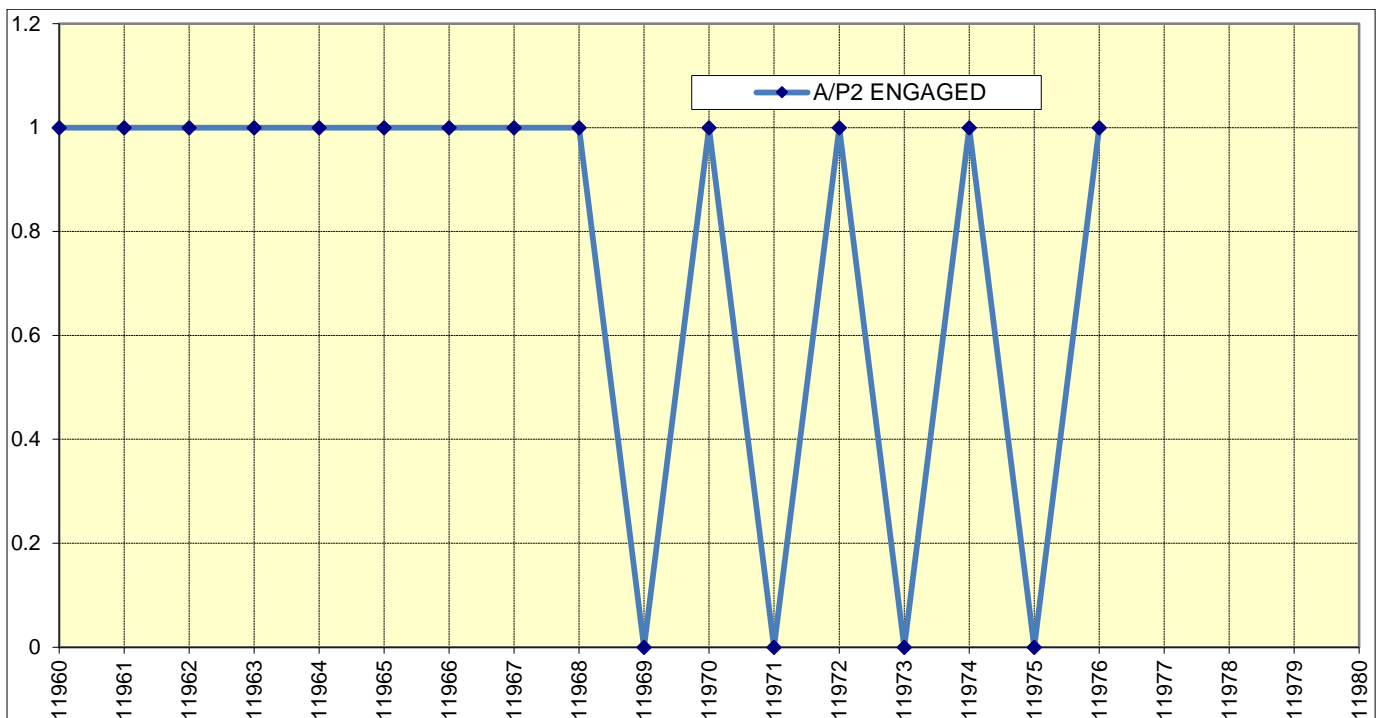
- A/P2 ENGAGED

A/P 2 engaged shown near the end of recording

A/P 2 was engaged almost throughout the whole recording time until 00:29: 37 UTC (11968 seconds on the plot), then it started reciprocating between ON and OFF until the end of the recording at 00:29:45 (11976 seconds on the plot) (about 8 seconds)

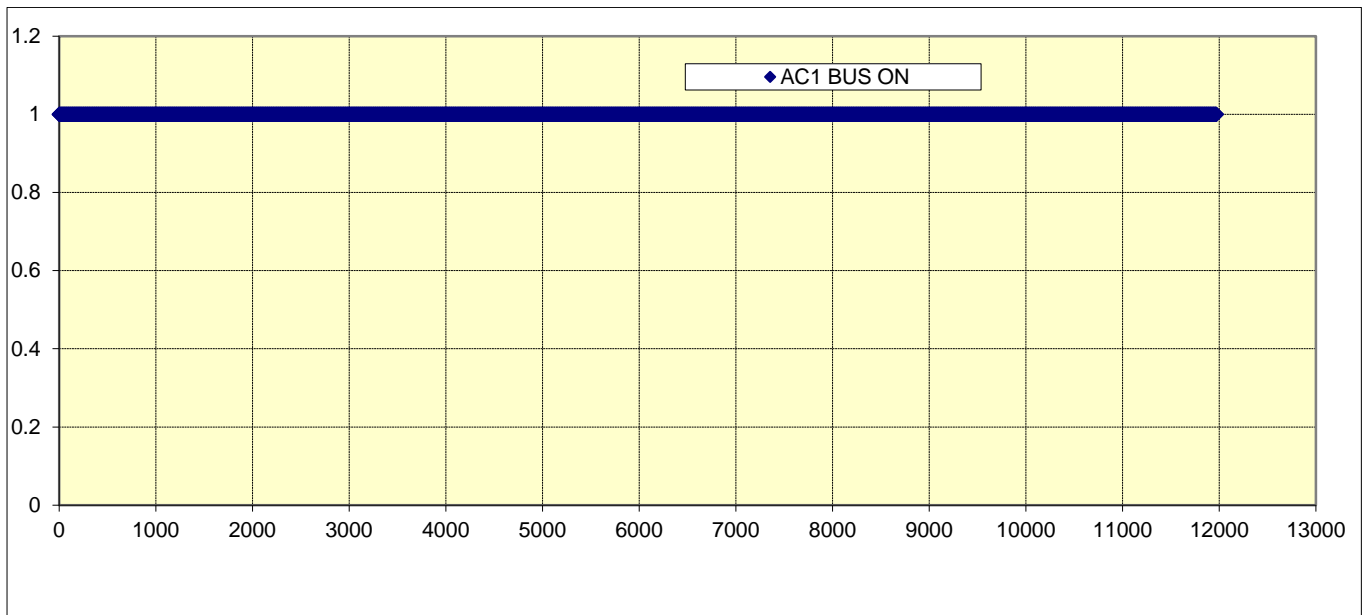
- AC1 BUS ON  
(1 powered)

AC1 BUS was powered throughout the whole recording

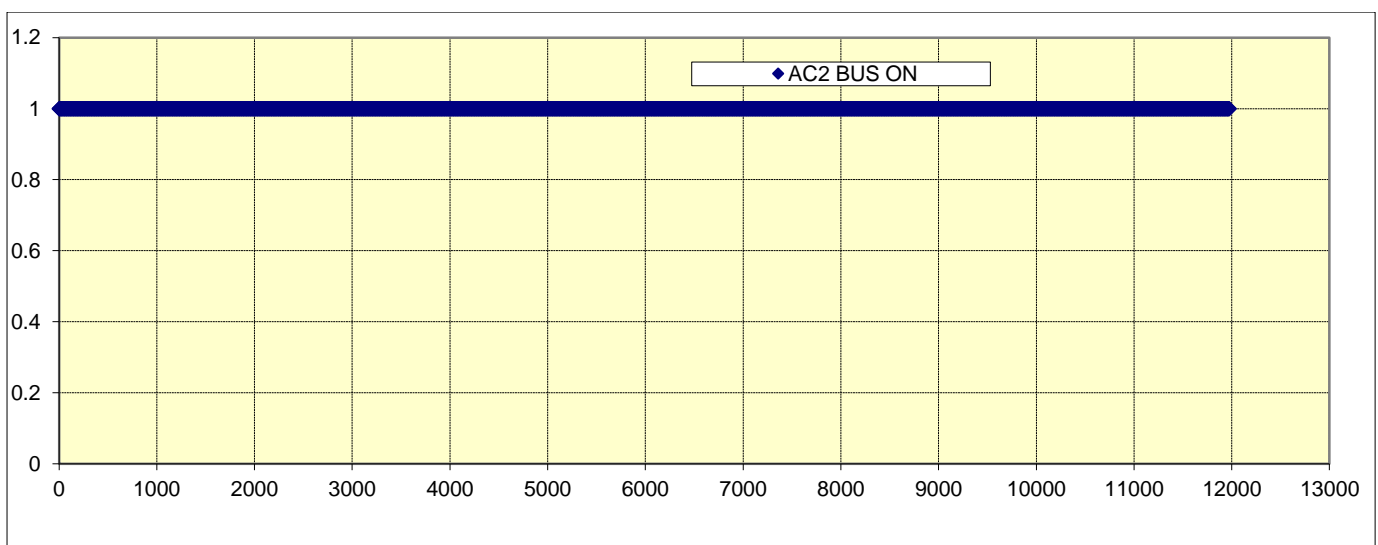
- AC2 BUS ON  
(1 powered)

AC2 BUS was powered throughout the whole recording

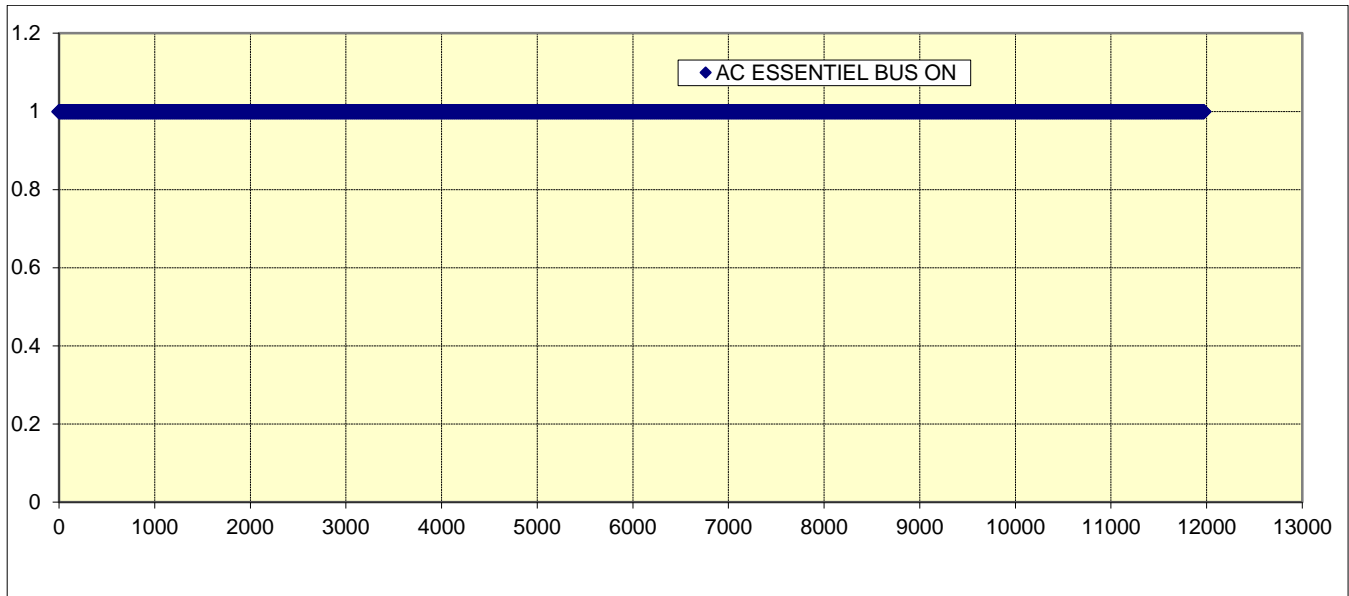
- AC ESSENTIEL BUS ON  
(1 powered)

AC essential BUS was powered throughout the whole recording

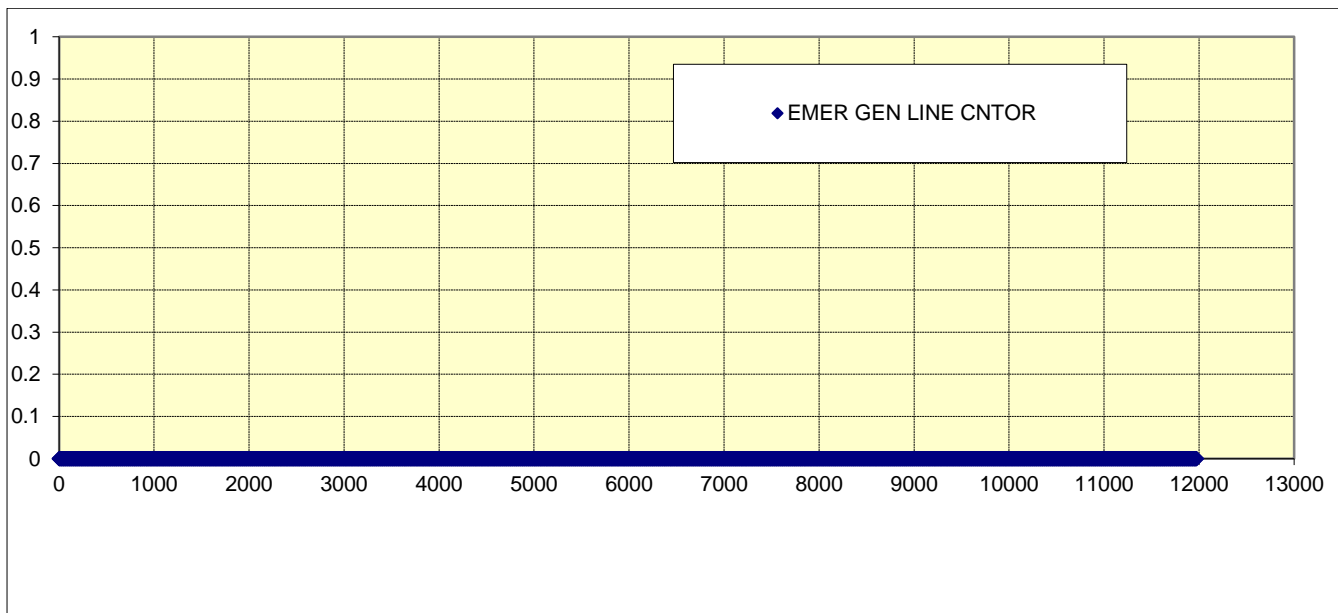
- EMER GEN LINE CONTACTOR

Emer Gen Line Contactor was off throughout the whole recording

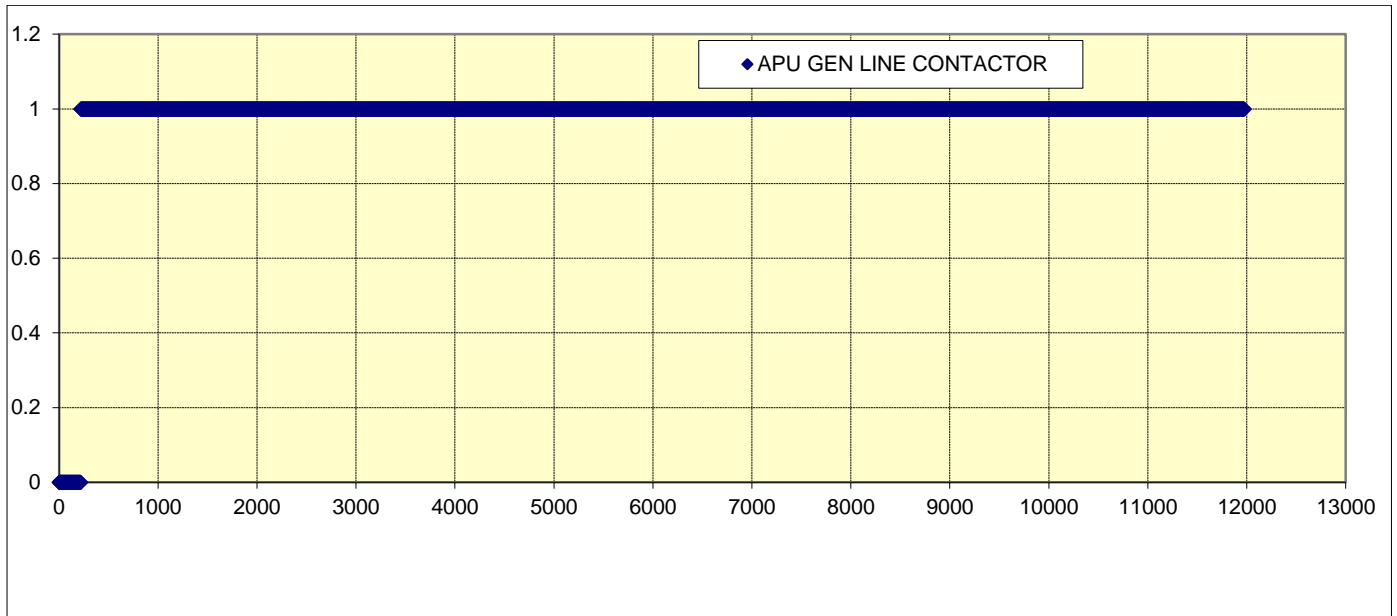
- APU GEN LINE CONTACTOR  
(0 closed)

APU Gen line contactor was off throughout the whole recording

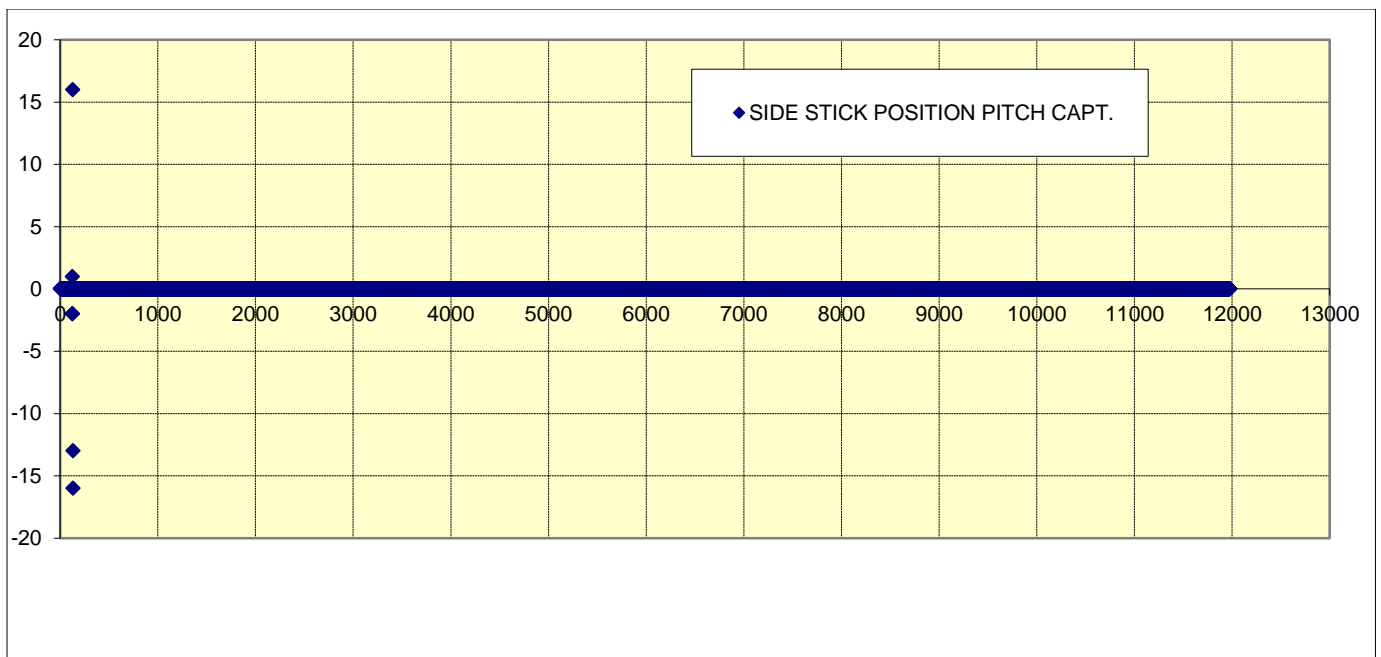
- SIDESTICK position pitch Capt

No pitch movement on the captain side stick during cruise throughout the recording

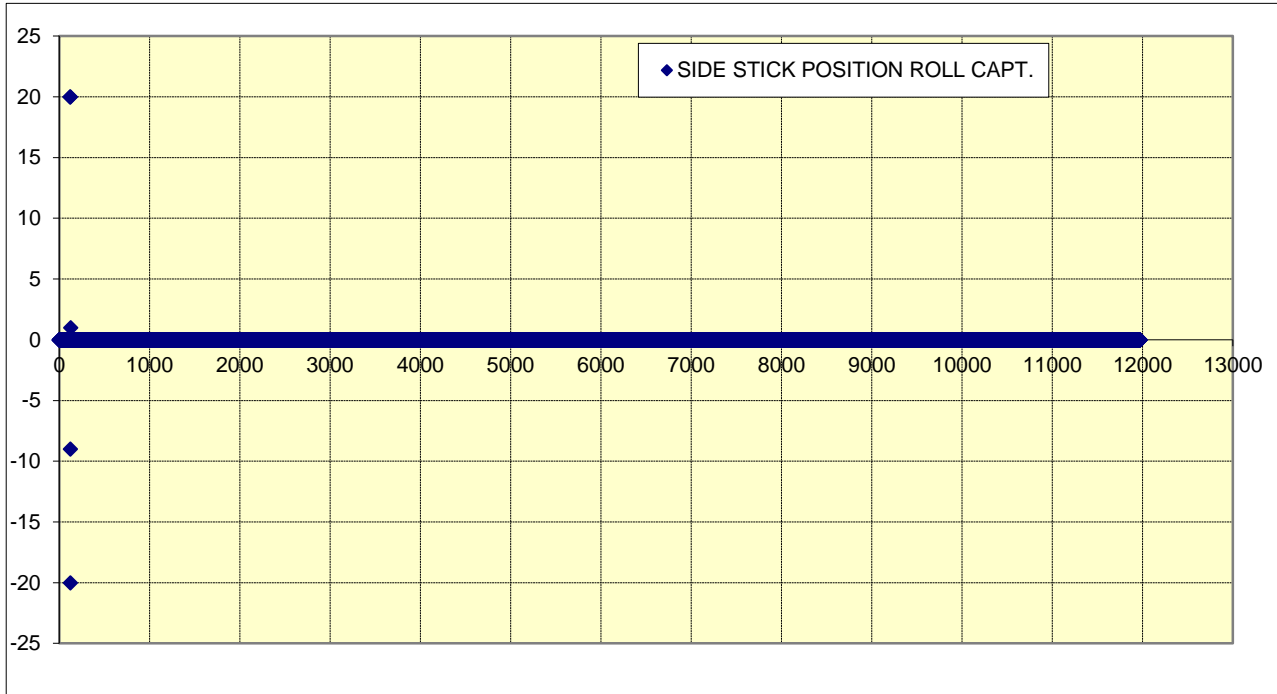
- SIDESTICK position roll Capt

No roll movement on the captain side stick during cruise throughout the recording

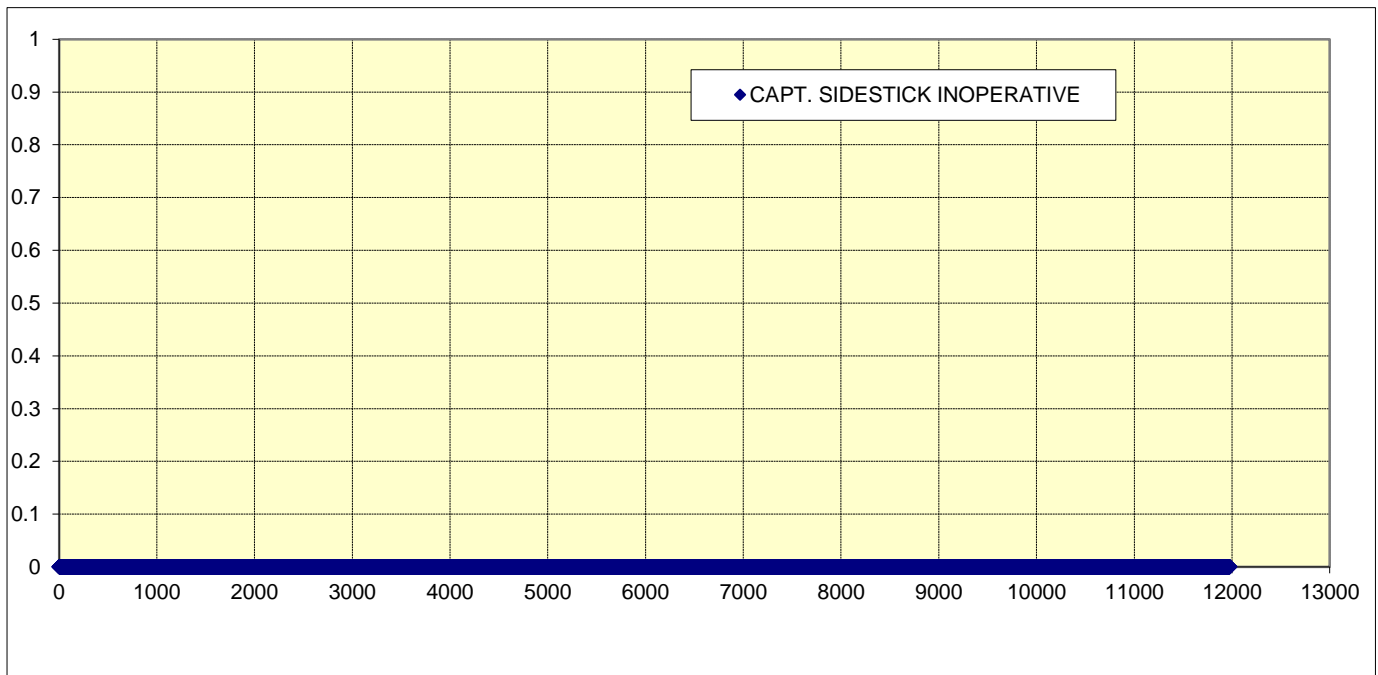
- CAPT. SIDESTICK INOPERATIVE

No evidence of CAPT. SIDESTICK INOPERATIVE condition

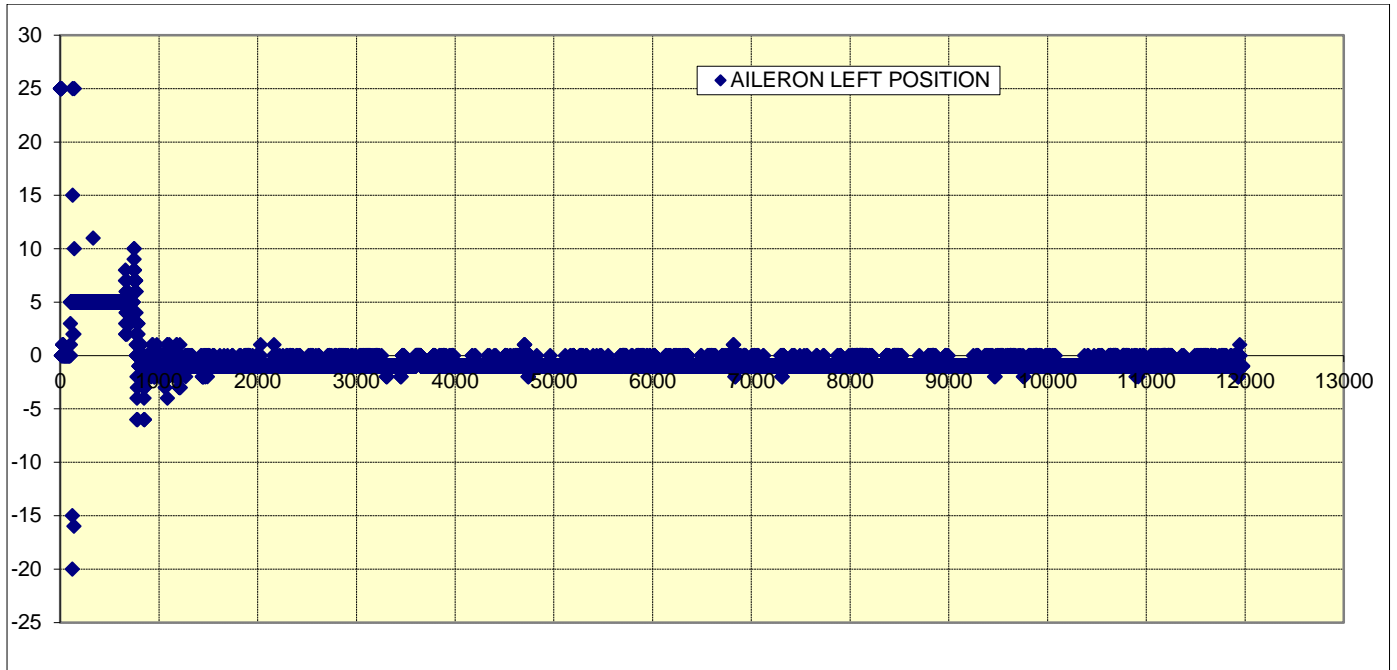
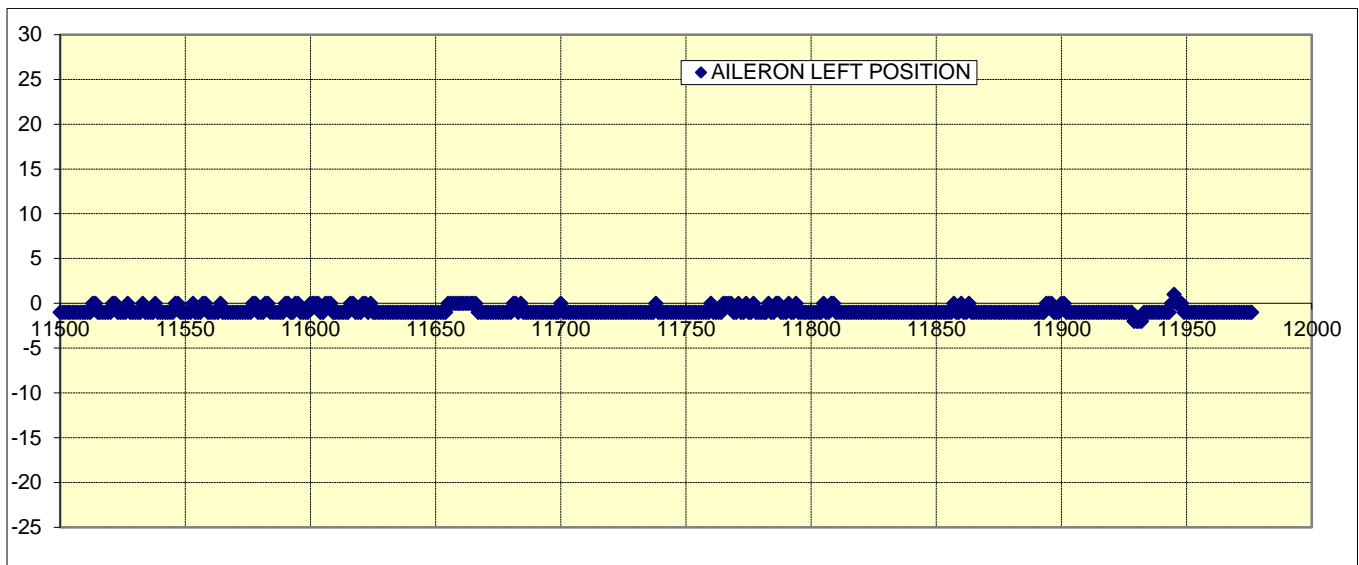
- AILERON LEFT POSITION

Position shown at the last portion of the recording

Left aileron position was -1 degree almost throughout the whole flight, varying between 0 and -1 degrees (except for very few points it reached -2 degree and +1 degree)

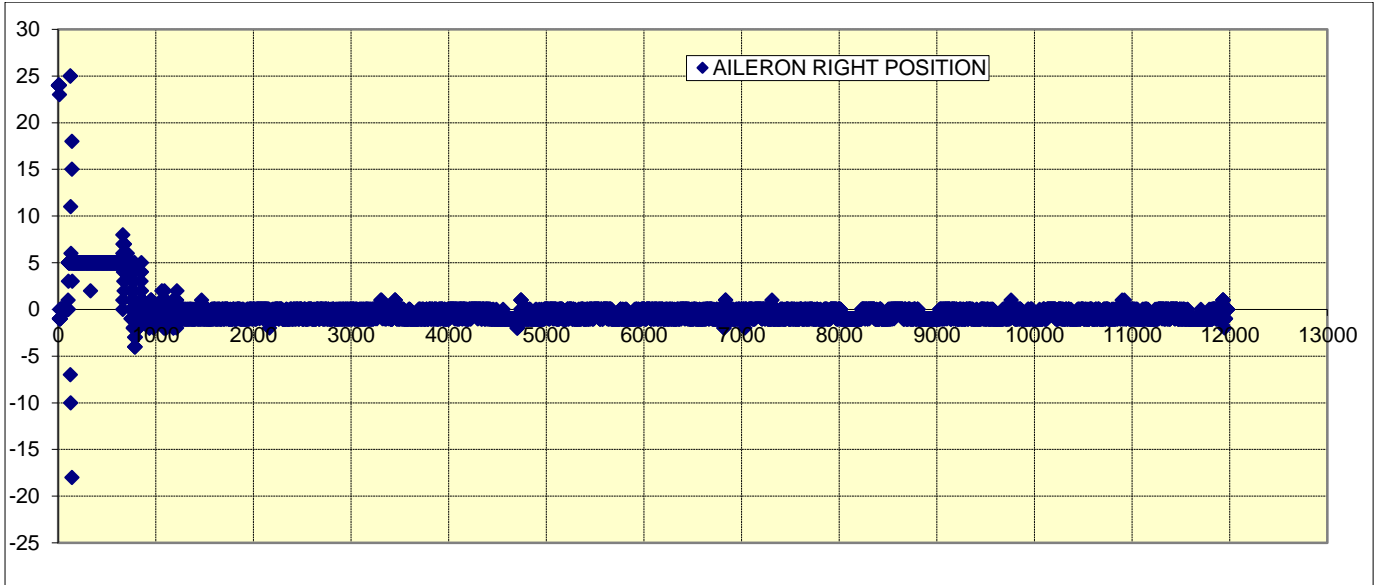
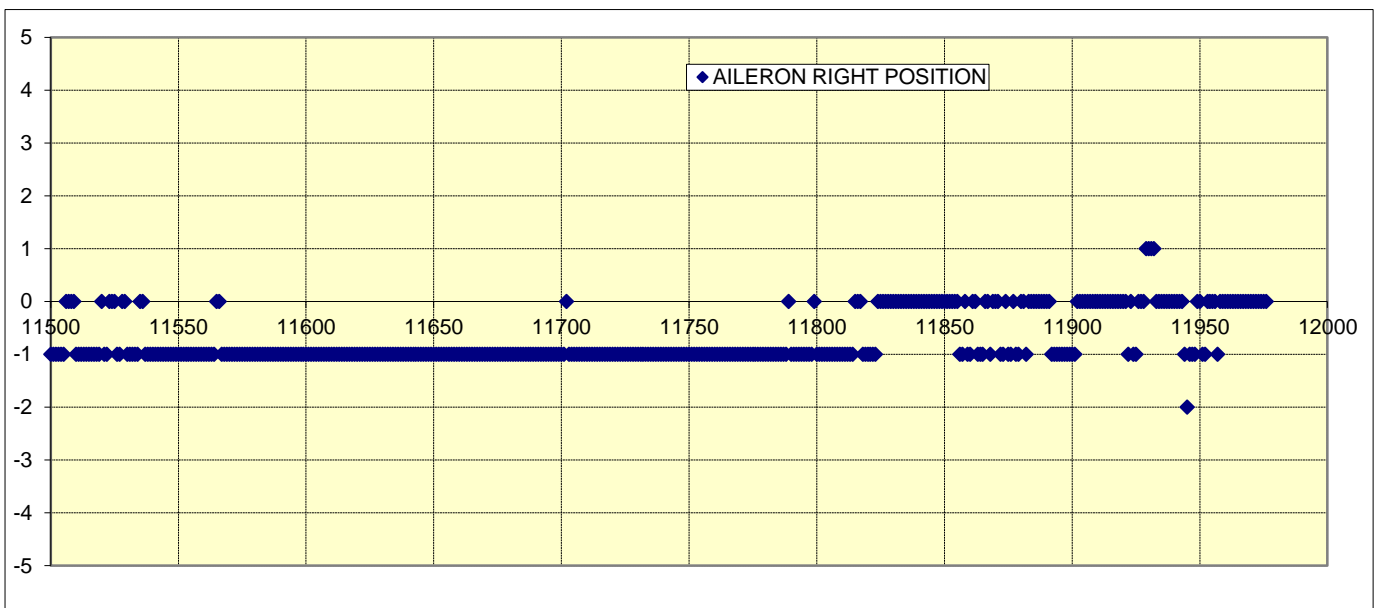
- AILERON RIGHT POSITION

Aileron Right position viewed at the end portion of the recording

Right Aileron movements were almost between 0, -1 degrees (0 at the end of recording)

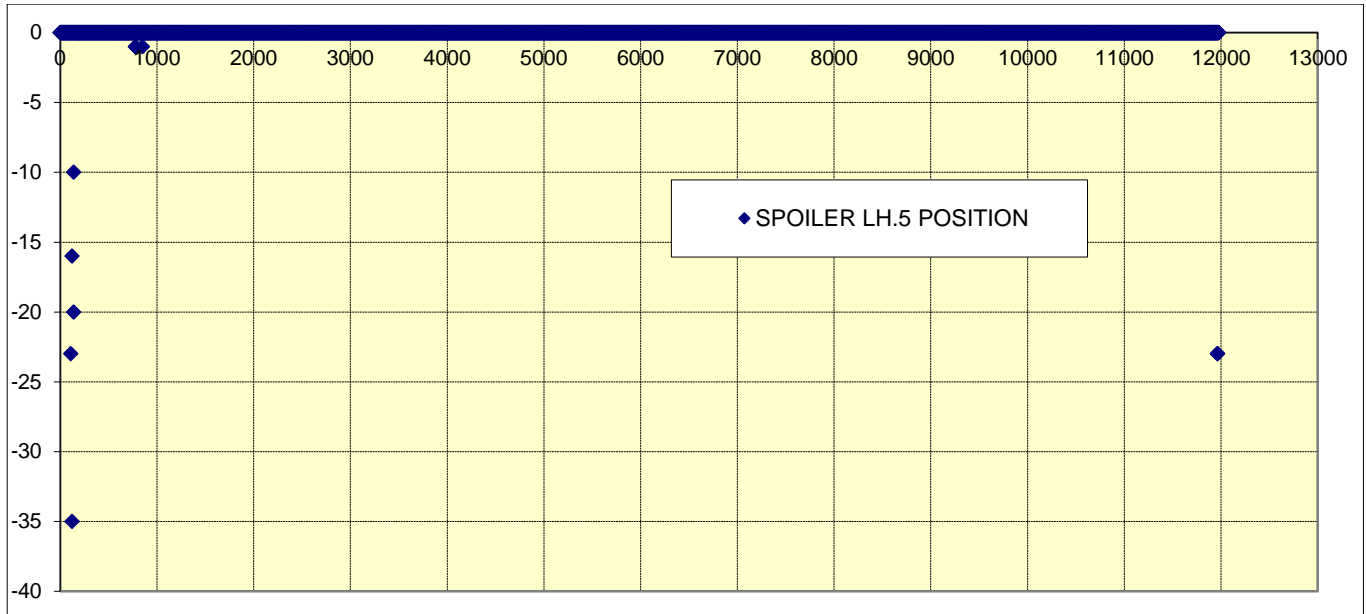
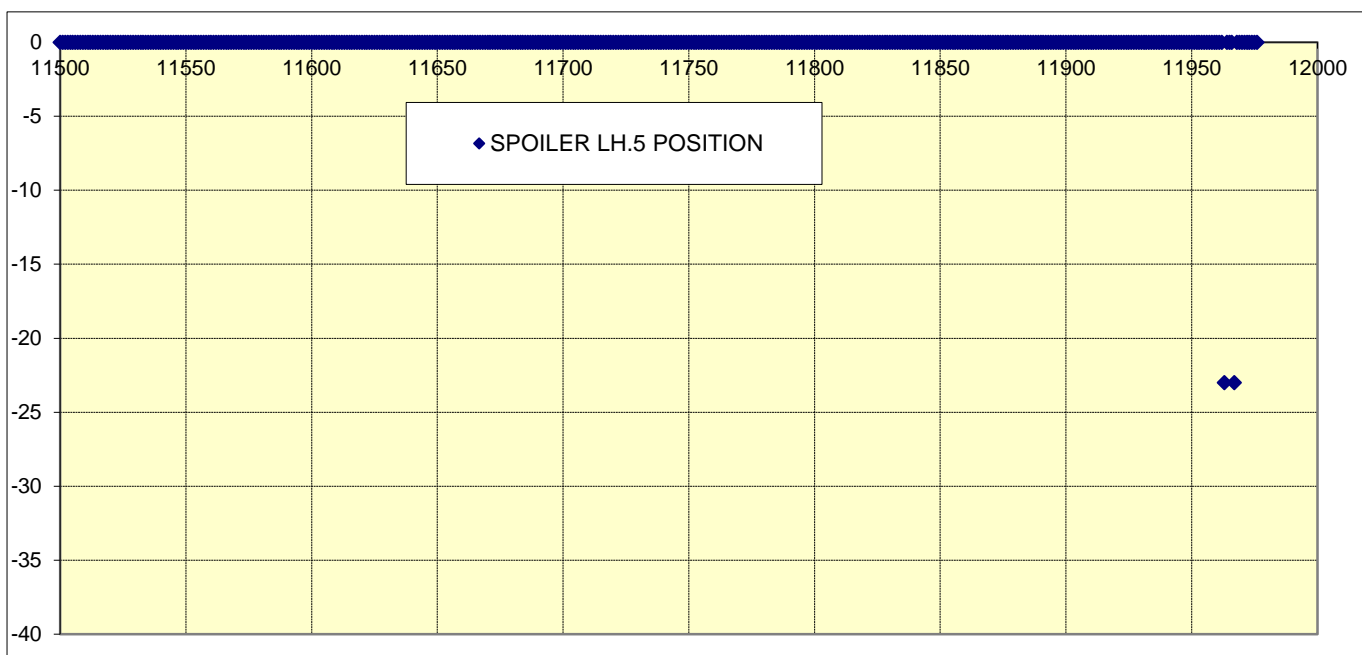
- SPOILER LH.5 POSITION

LH spoiler #5 shown at the end portion of the recording

LH spoiler #5 showed up position throughout the flight

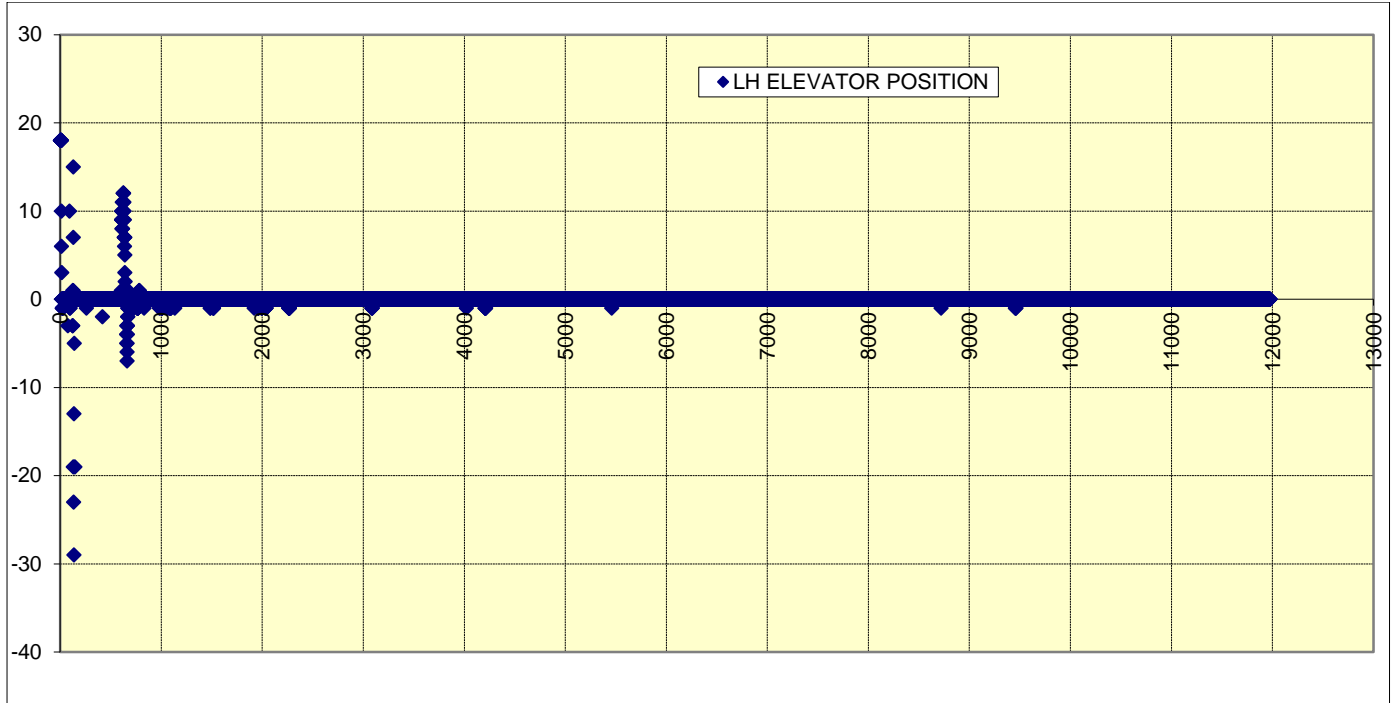
### -LH ELEVATOR POSITION

Left elevator showed a value of 0 degree throughout the cruise [hase up to the end of recordingRH

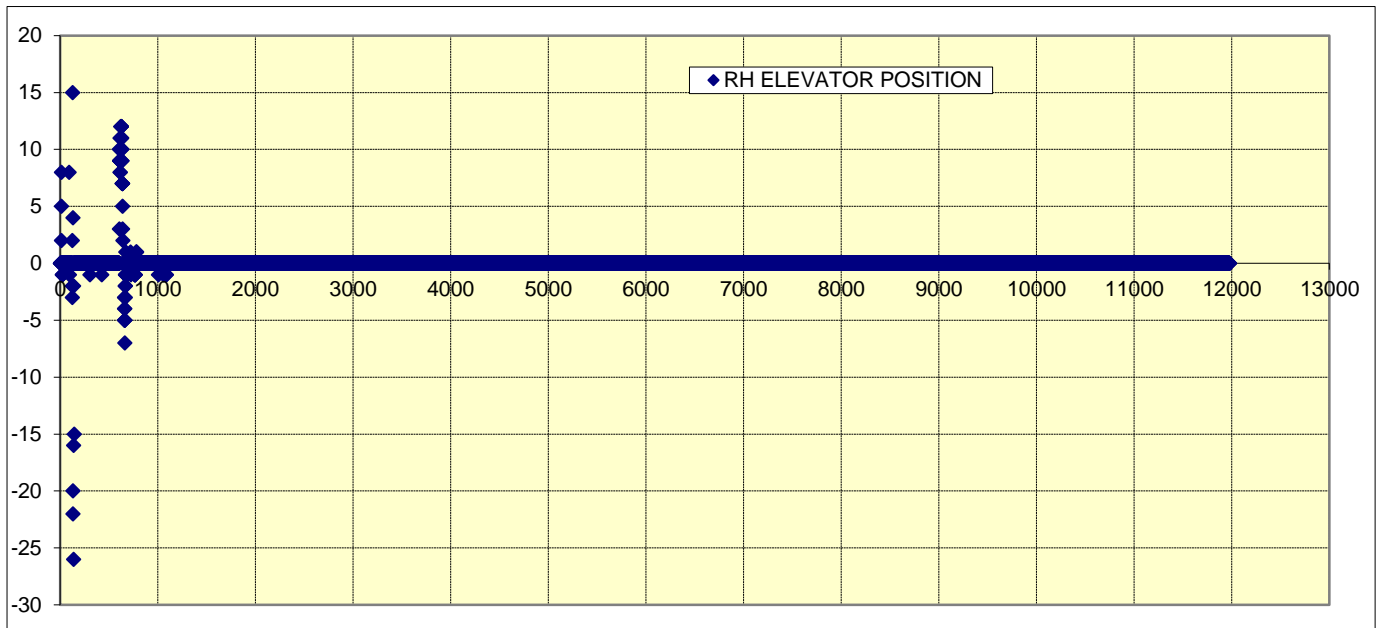
### - ELEVATOR POSITION

Right elevator showed a value of 0 degree throughout the cruise [hase up to the end of recording

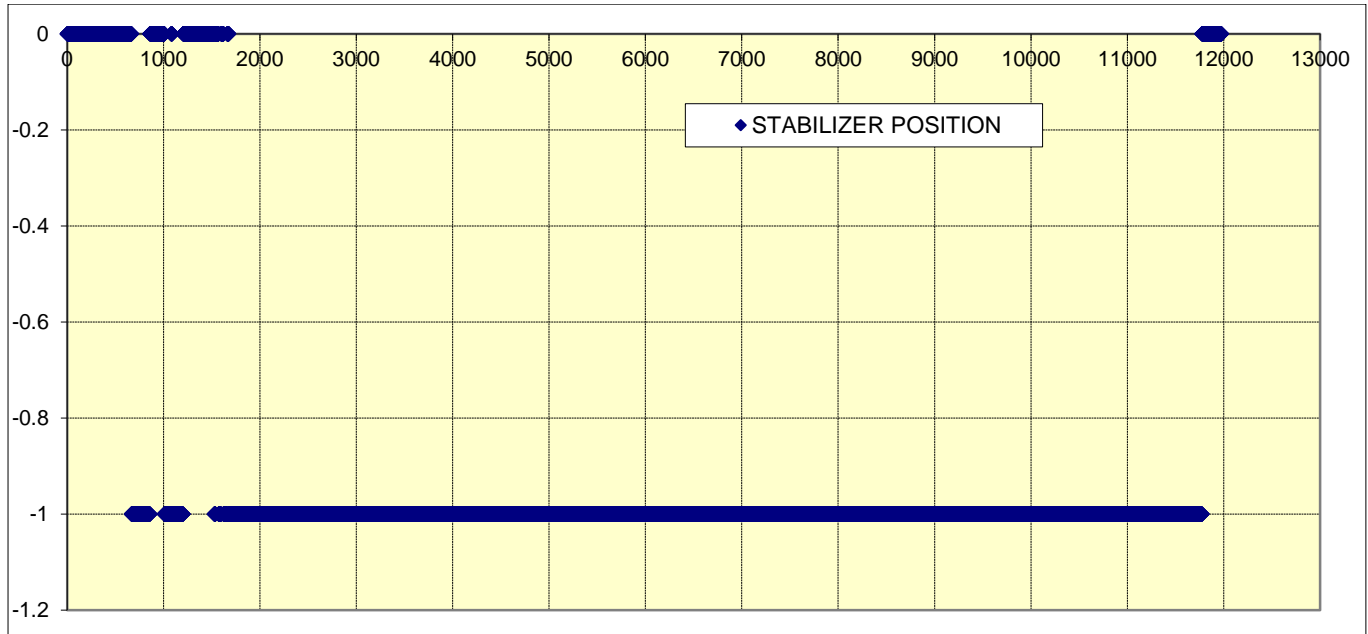
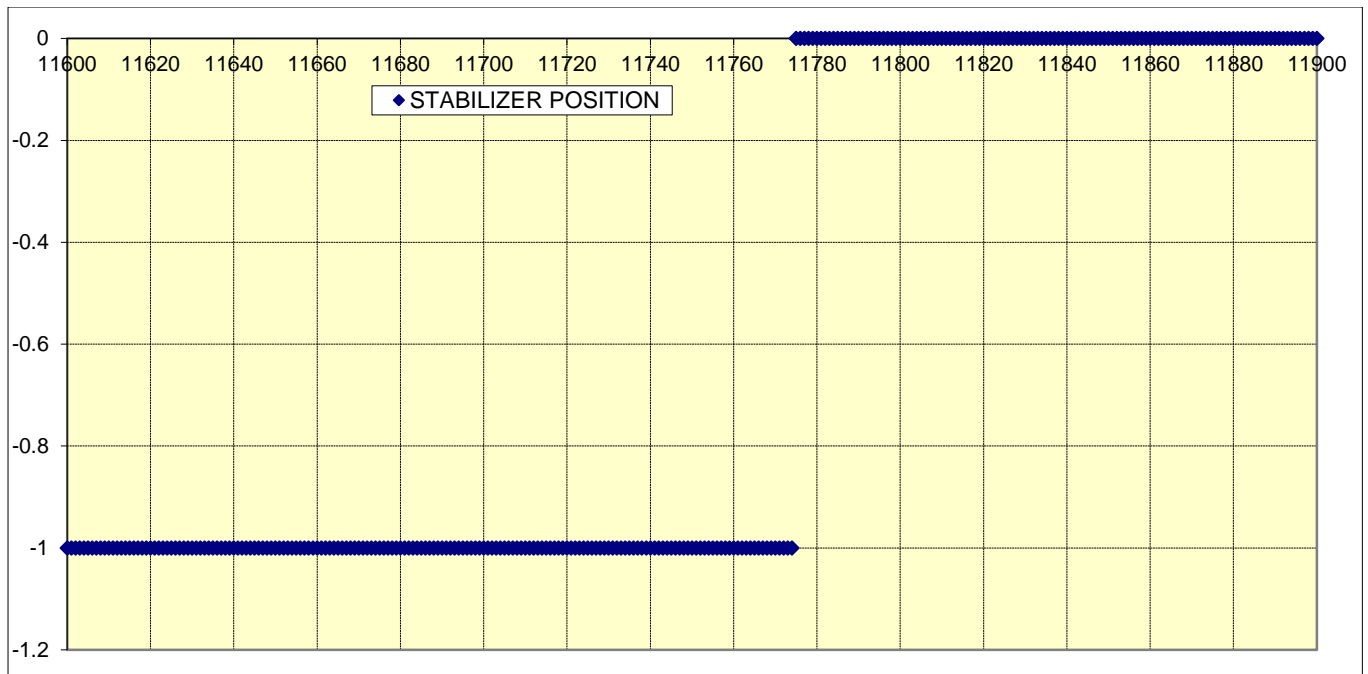
- STABILIZER POSITION

Stabilizer position showed a position of -1 throughout most of the recording time up to 00:26:23 UTC (11774 Seconds on the plot) then it moved to 0 and remained at 0 up to the end of recording at 00:29:45 UTC

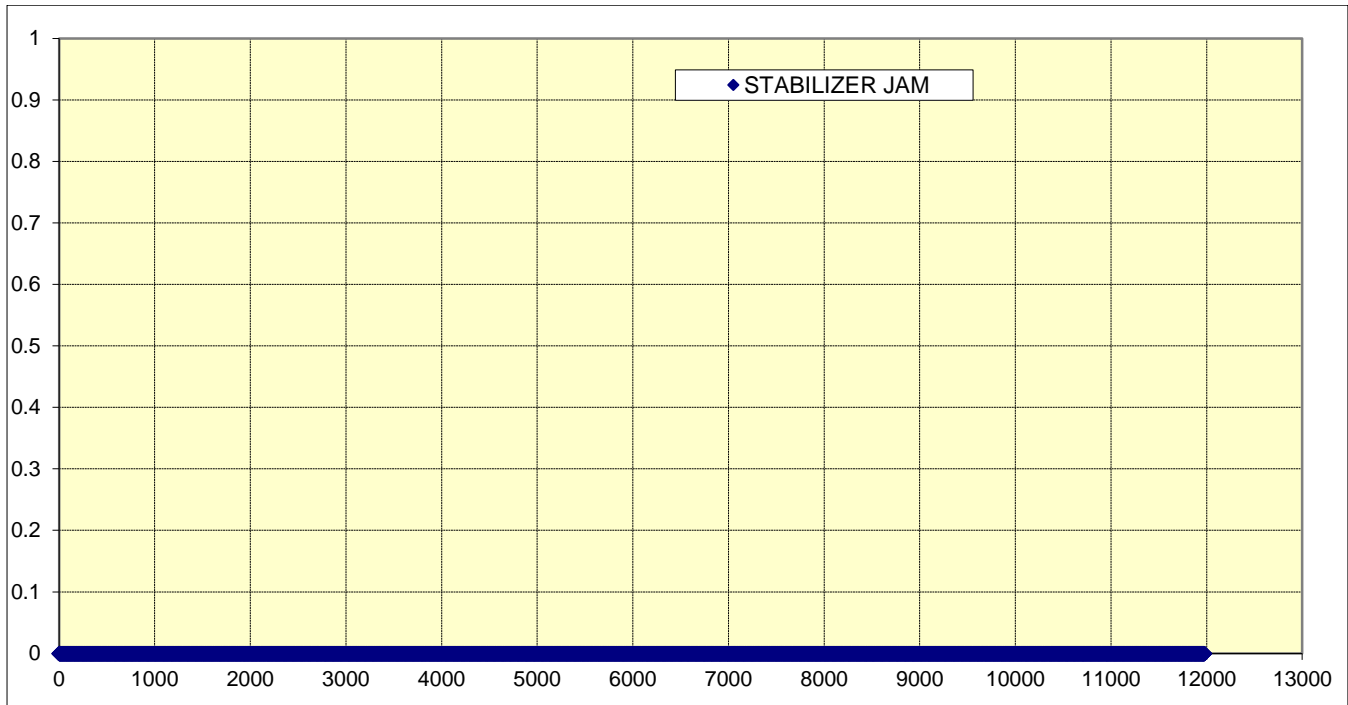
– STABILIZER JAM  
(1 jammed)

No stabilizer jam
