## Final Report

**EgyptAir A320 Aircraft crash in the Mediterranean, registered SU-GCC,  
flight number MSR804, from Charles De-Gaulle Airport, Paris to Cairo  
International Airport, on 19/05/2016**

EGAI2016-01

October 2024

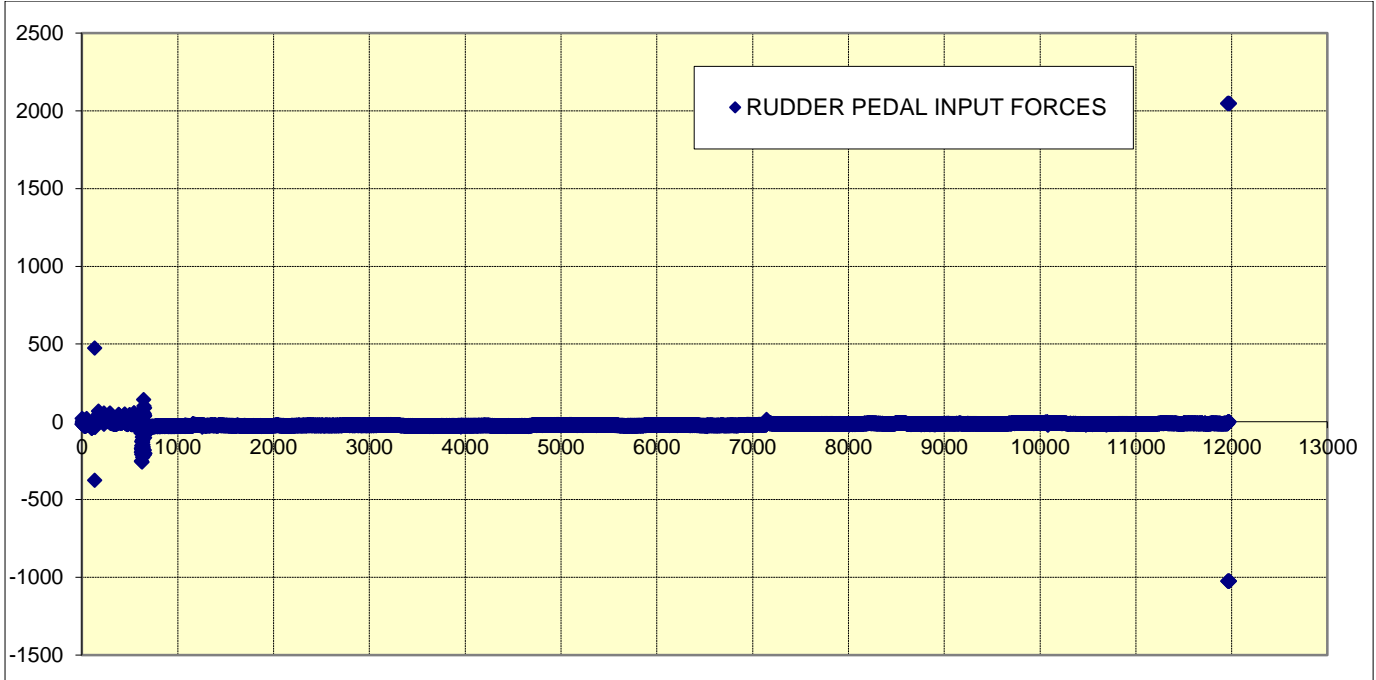
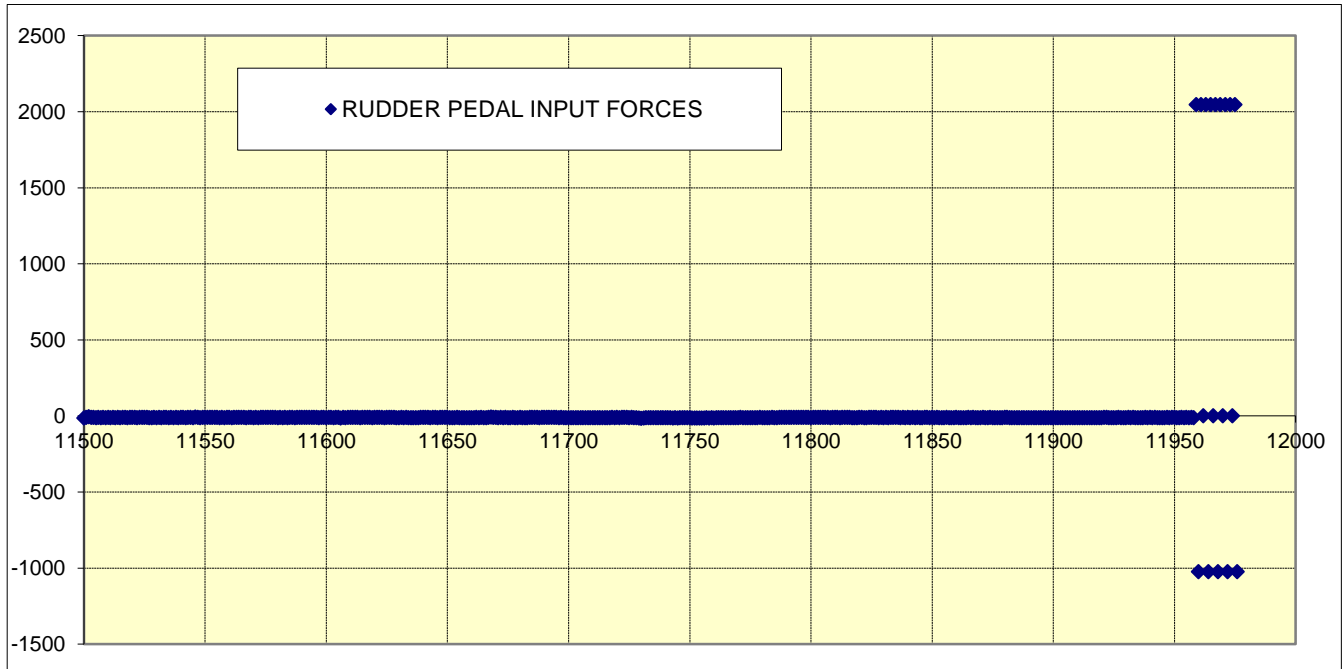
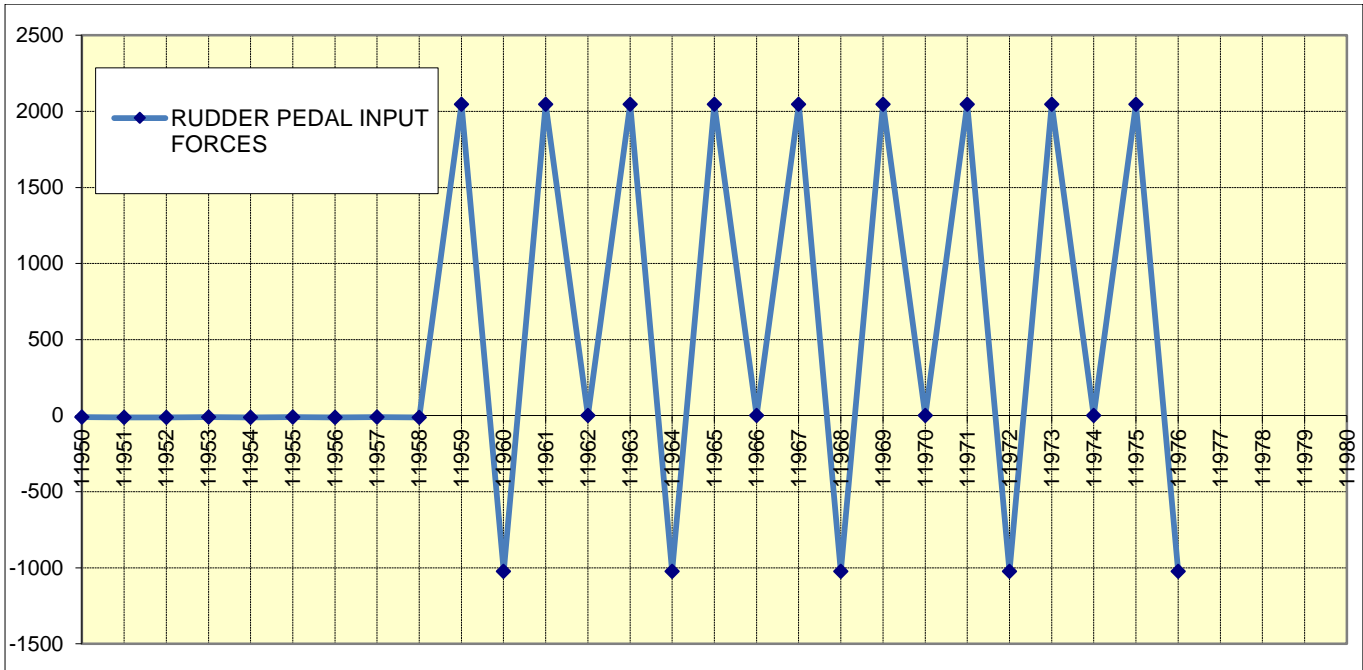
– RUDDER PEDAL INPUT FORCES

Rudder pedal input forces, closer view at the end of the recording

Rudder Pedal Input forces shown at the end of recording

Rudder Pedal Input forces showed a constant value of 0 up to 00:29:27 (11958 seconds on the plot) then it started varying between 2047 and -1024 up to the end of recording 00:29:45 (11976 seconds on the plot)

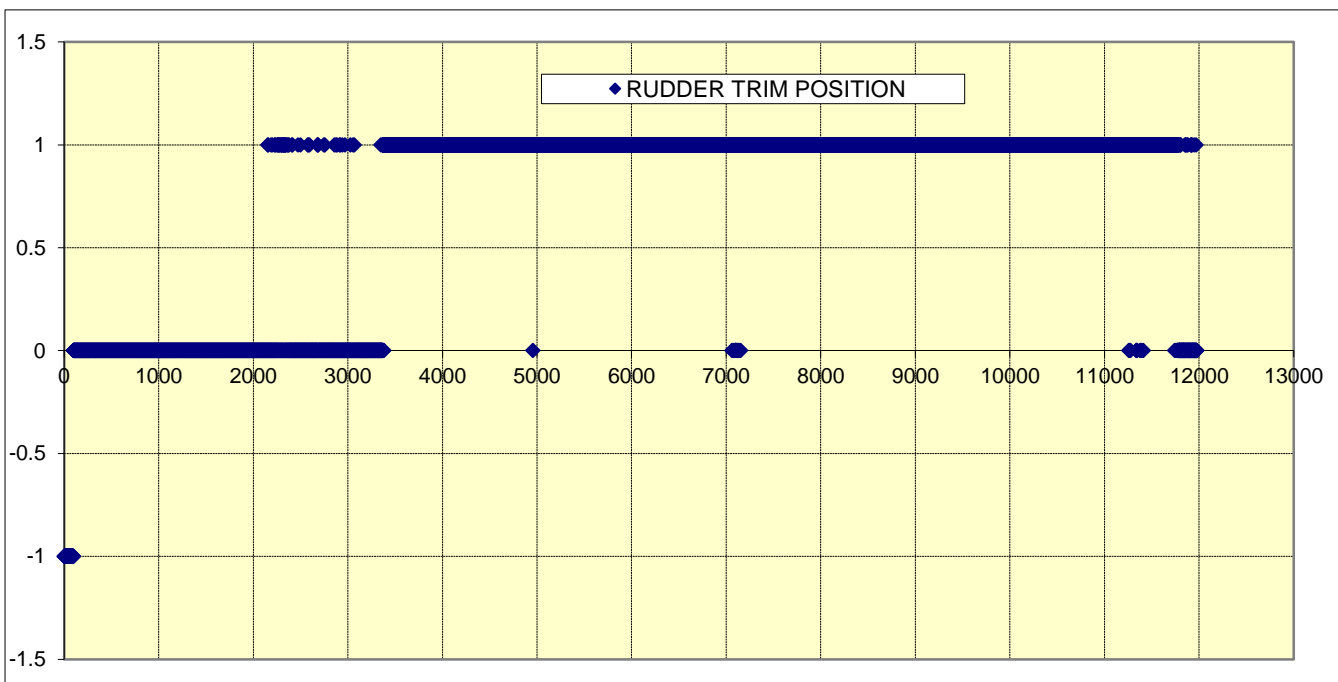
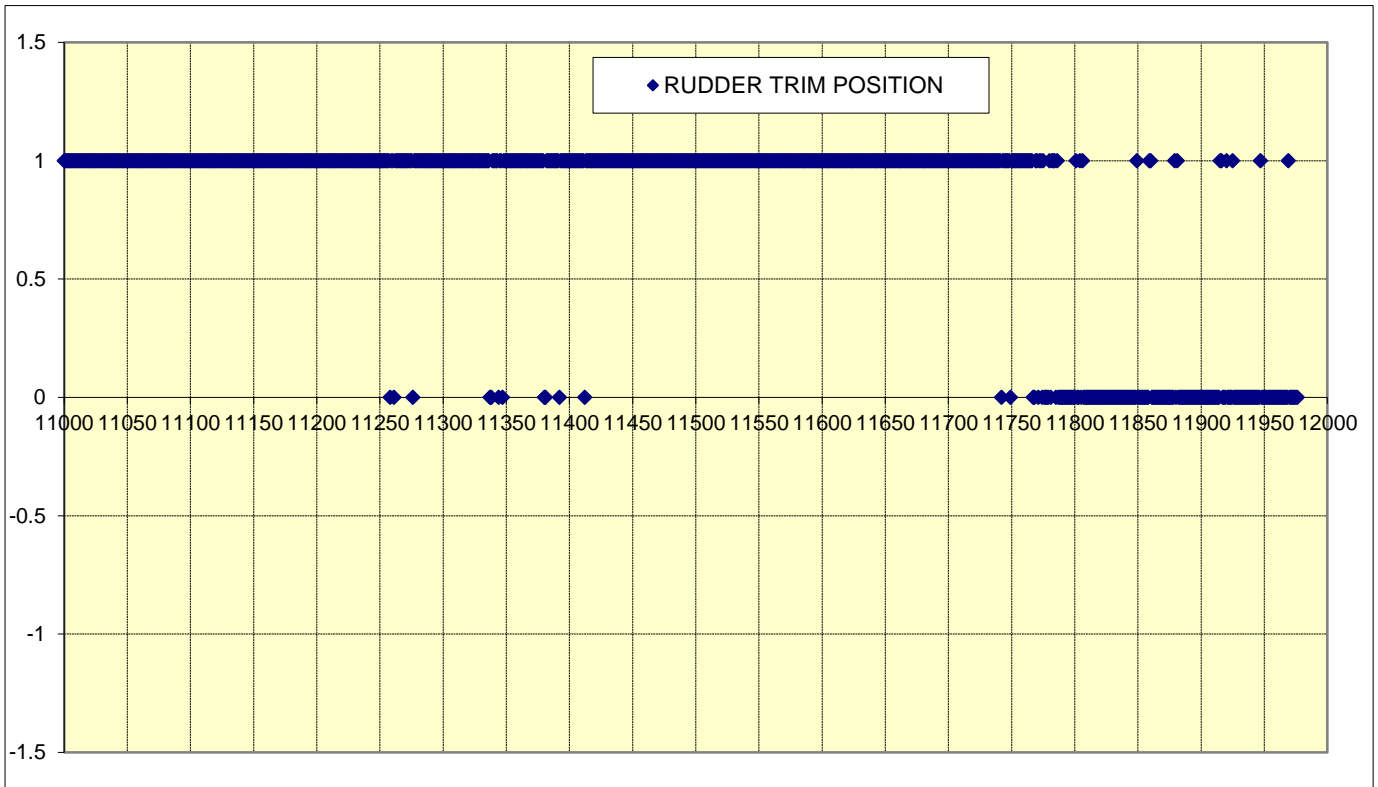
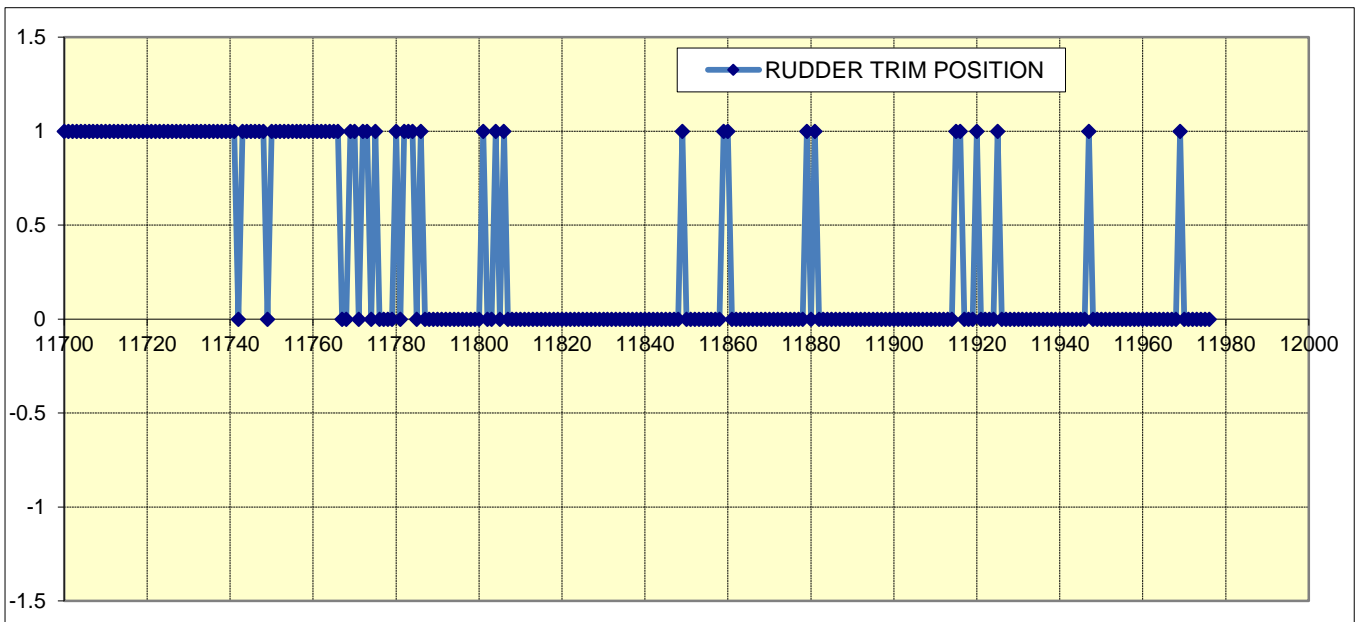
- RUDDER TRIM POSITION

Rudder trim position, closer view at the end of the recording

Rudder trim position showed a value of 1 most of the cruise flight. At 00:25:58 (11749 seconds on the plot) the rudder trim position started variation between 1 and 0 until the end of the recording at 00:29:45

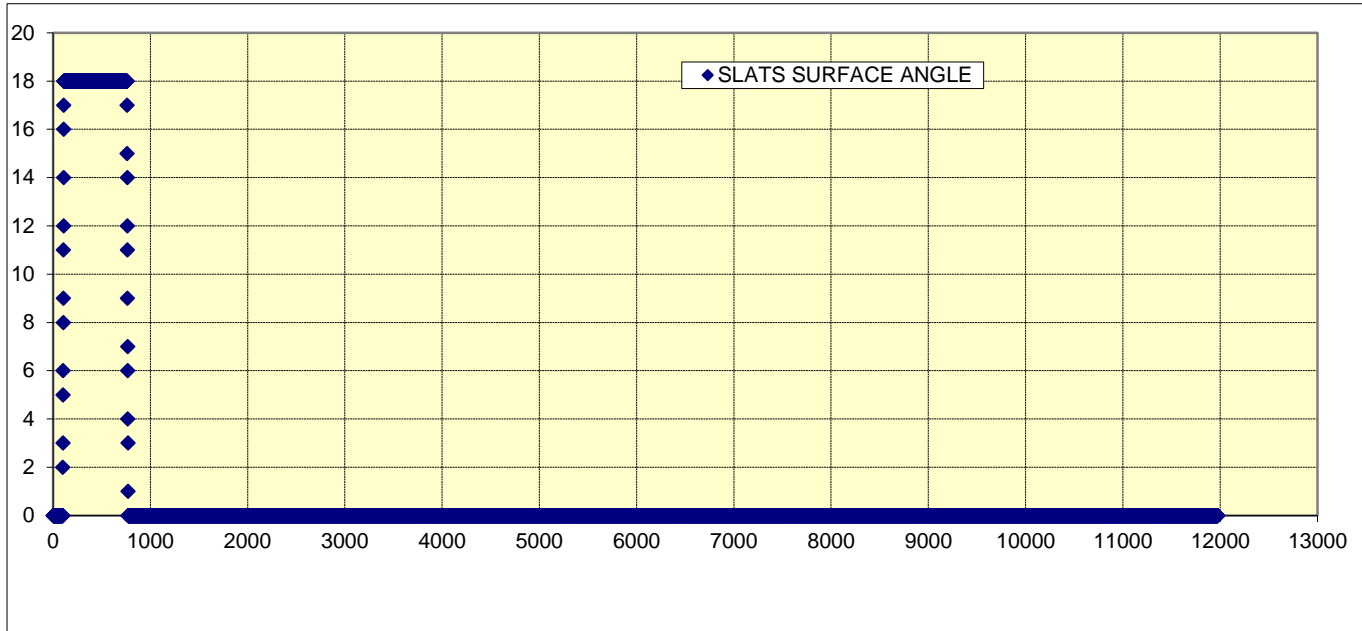
- SLATS surface angle

Slats remained retracted up to the end of the recording

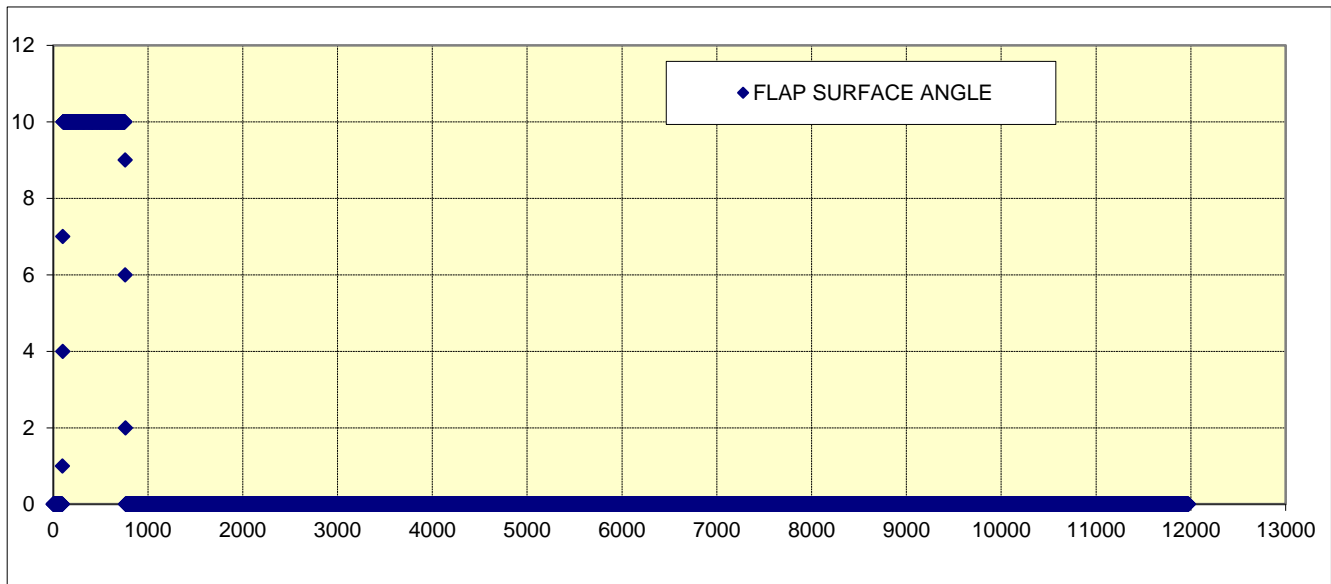
- FLAP SURFACE ANGLE

Flaps remained retracted up to the end of the recording

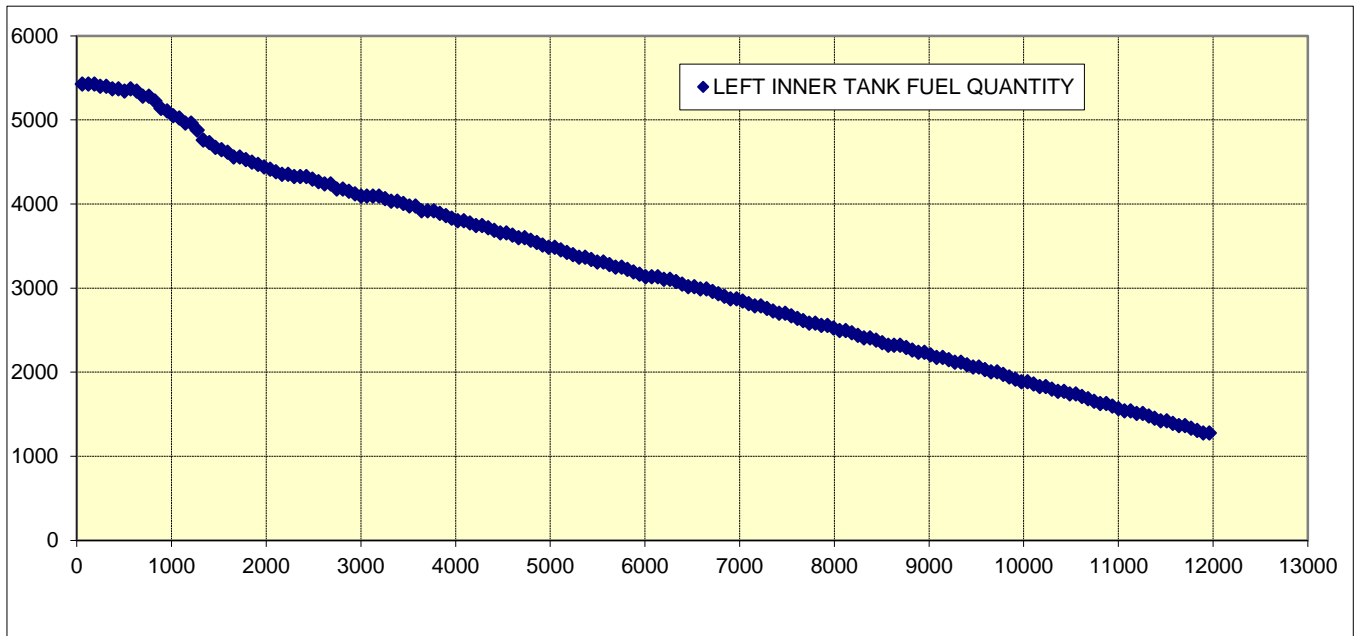
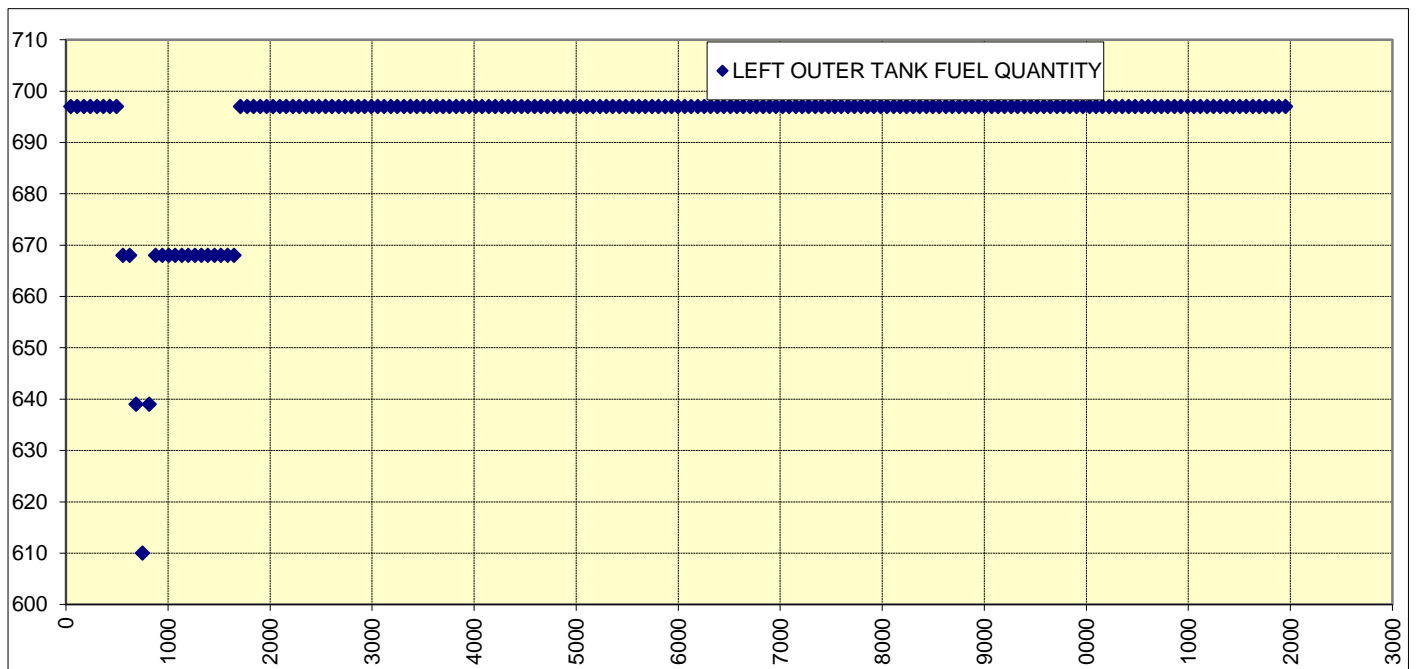
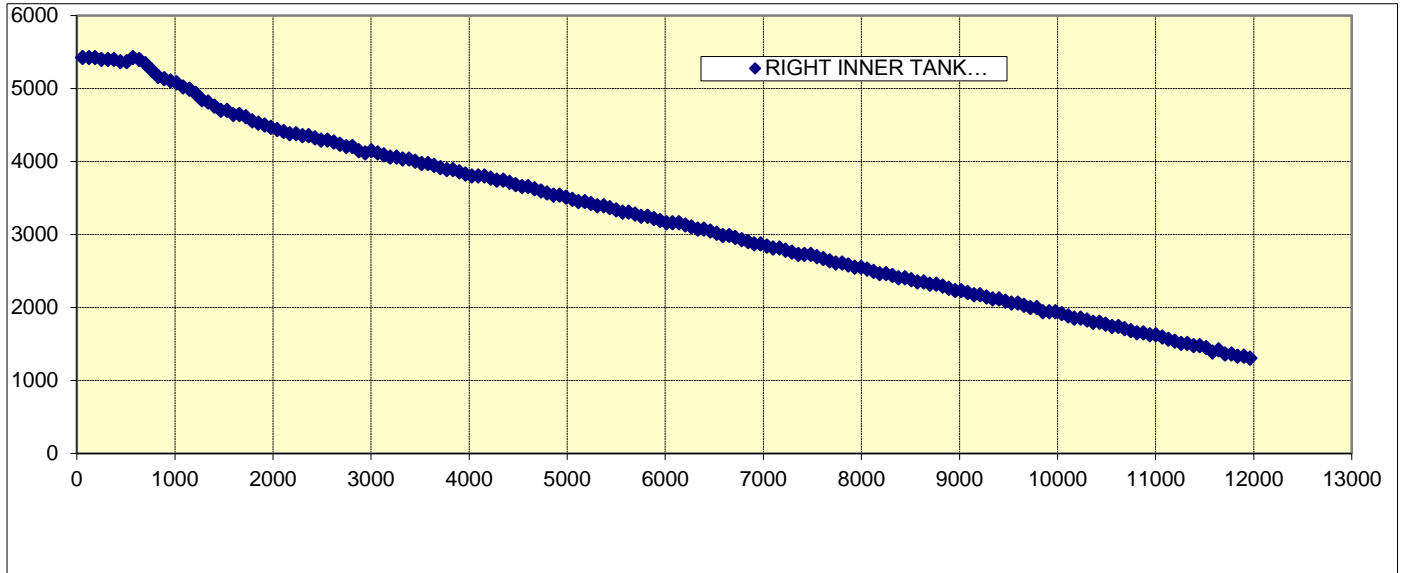
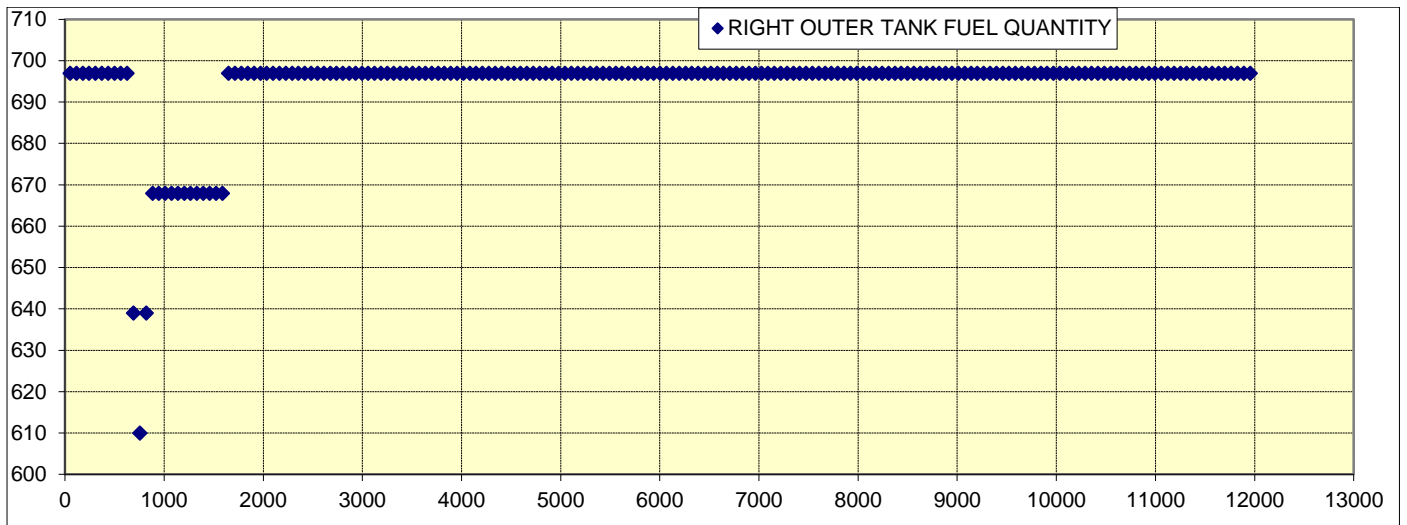
No evidences of anomalies with fuel tanks quantities

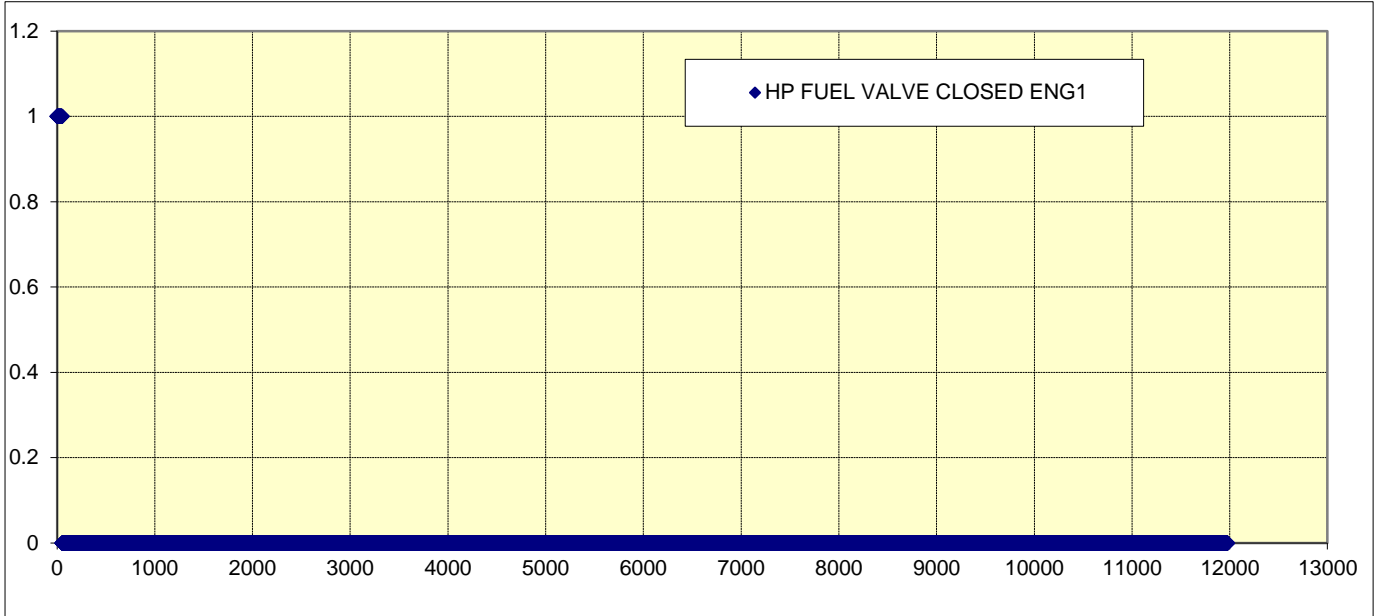
- HP FUEL VALVE CLOSED ENG1

HP FUEL VALVE CLOSED ENG1 was not closed throughout the whole recording

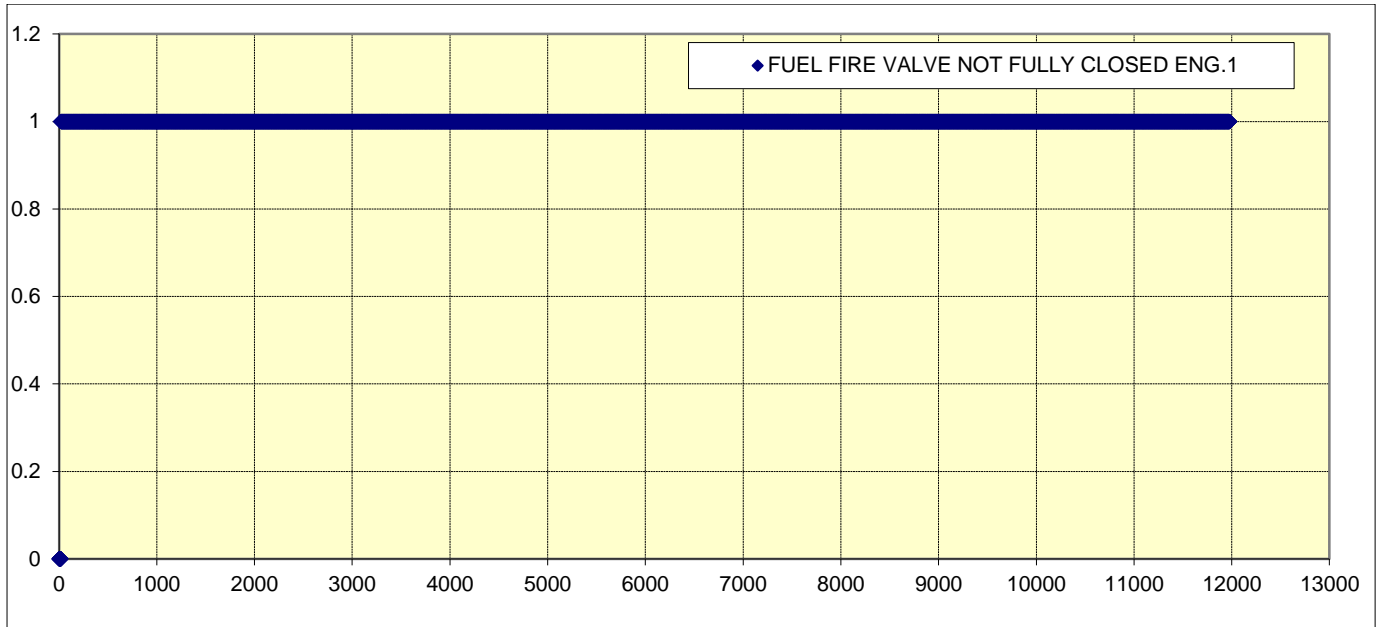
- FUEL FIRE VALVE NOT FULLY CLOSED ENG.1

FUEL FIRE VALVE was NOT FULLY CLOSED ENG.1 throughout the whole recording time

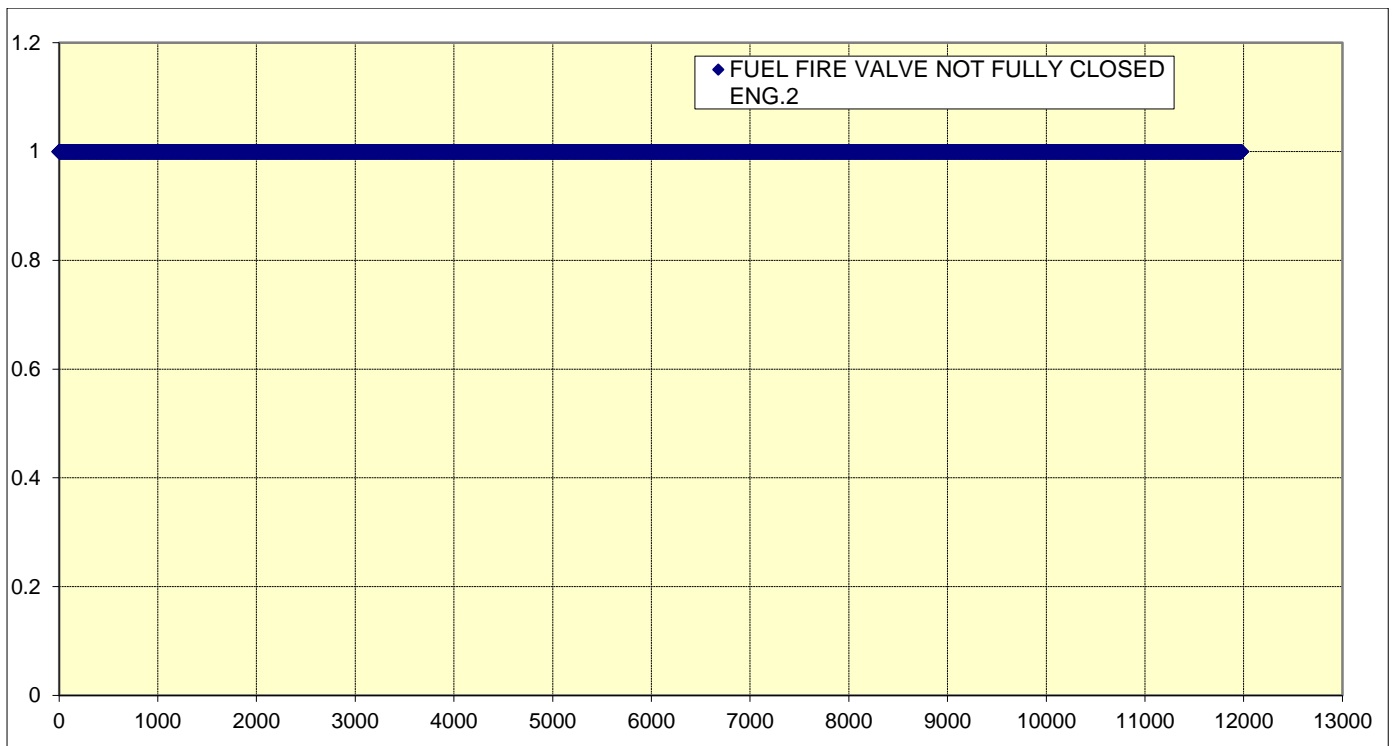
- FUEL FIRE VALVE NOT FULLY CLOSED ENG.2

FUEL FIRE VALVE was NOT FULLY CLOSED ENG.2 throughout the whole recording time

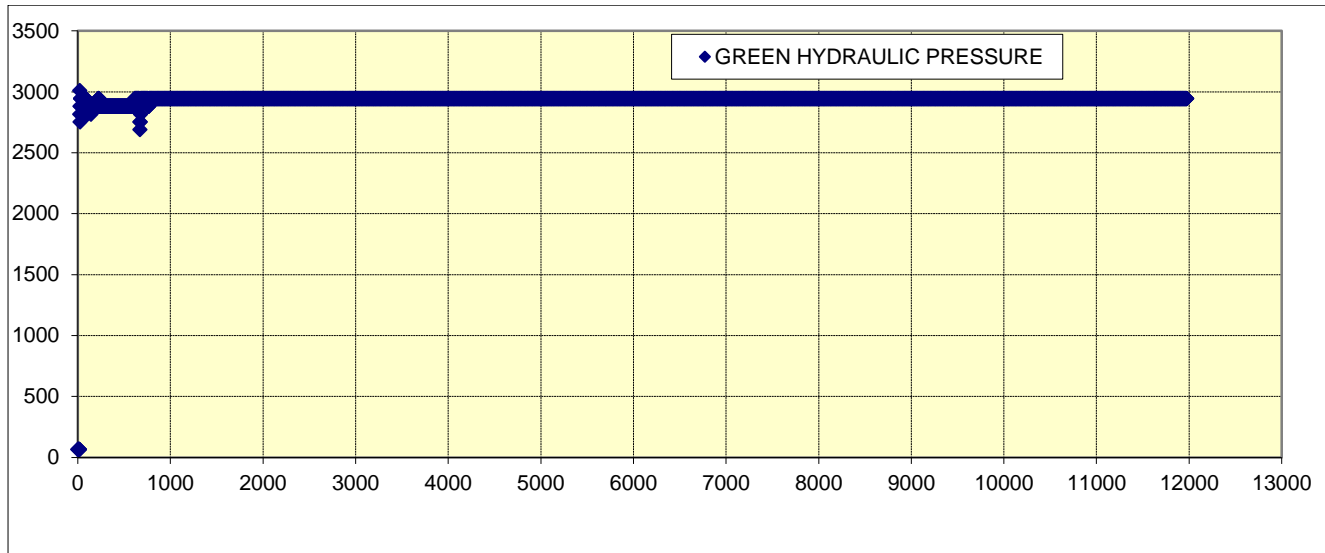
### - GREEN HYDRAULIC PRESSURE

Green hydraulic pressure was almost 2944 psi throughout the whole recording

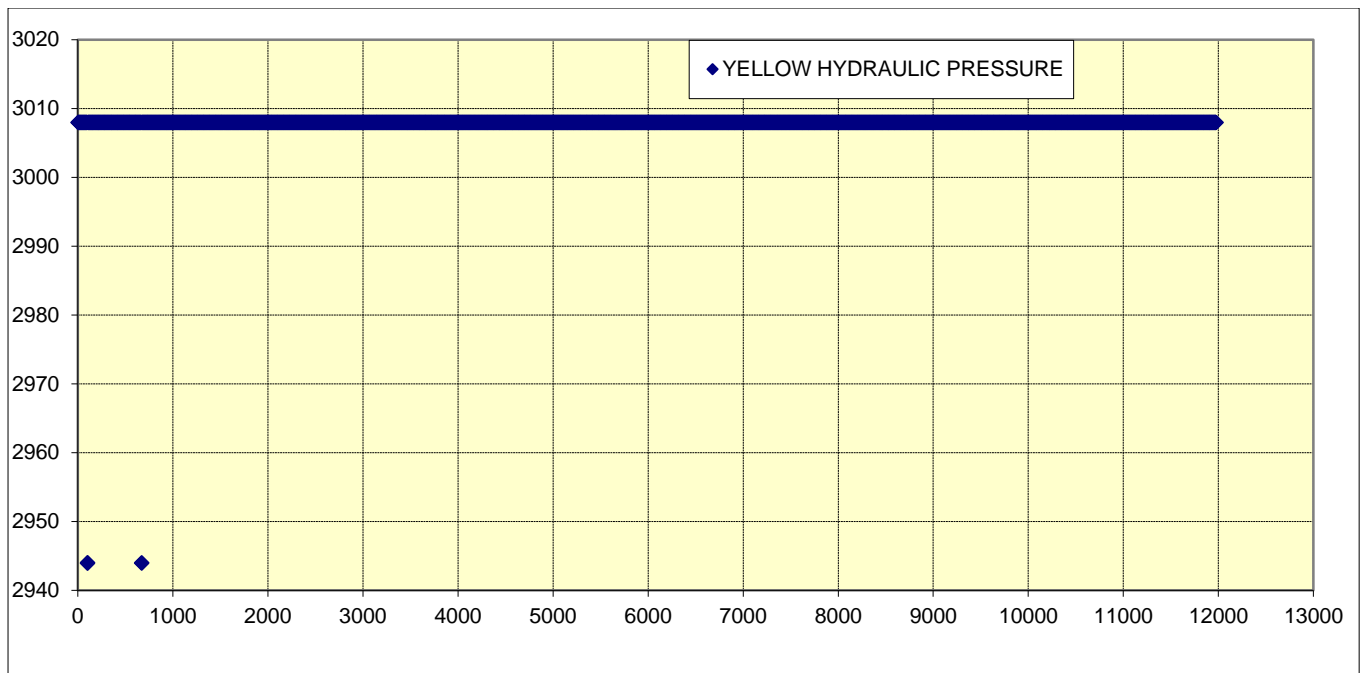
### - YELLOW HYDRAULIC PRESSURE

Yellow hydraulic pressure was almost 3008 psi throughout the whole recording

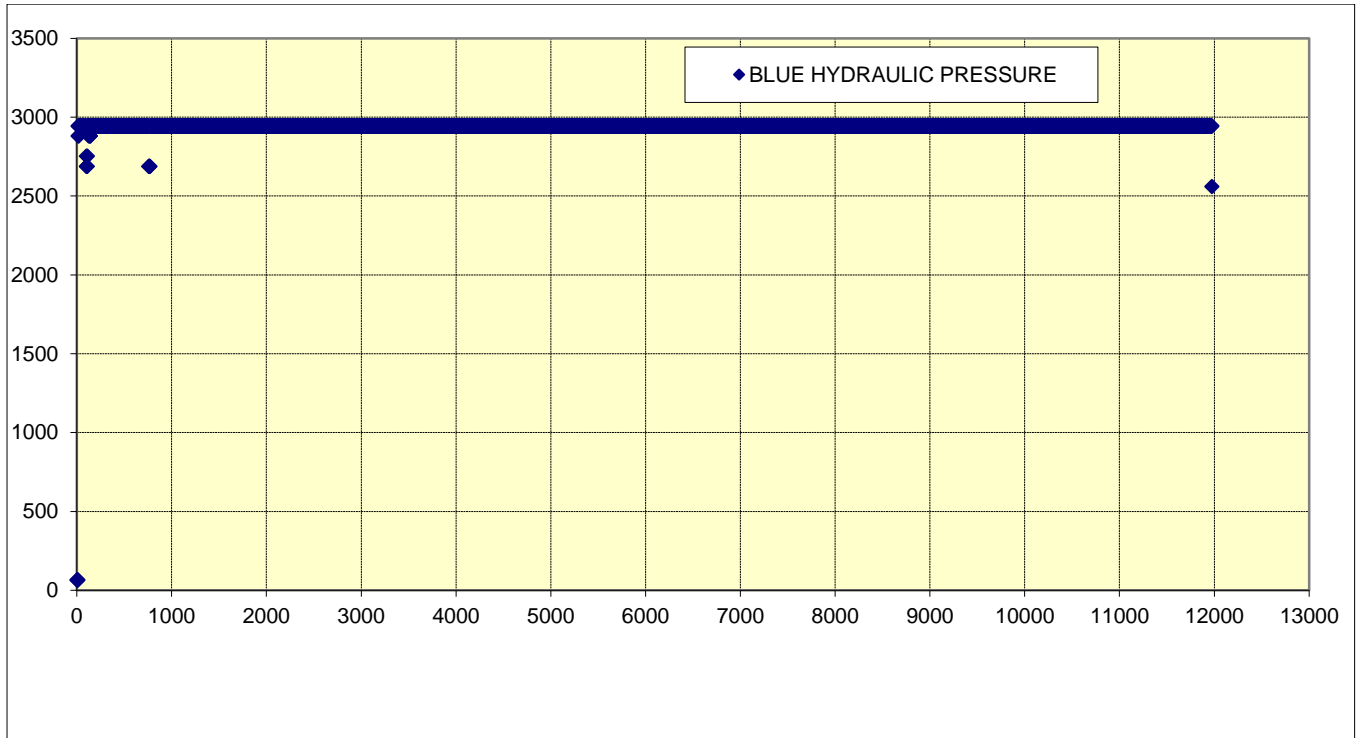
- BLUE HYDRAULIC PRESSURE

Blue hydraulic pressure was almost 2994 psi throughout the whole recording

Note: only at the last recorded point (11976 seconds on the plot) the Blue hydraulic pressure dropped to 2560 psi

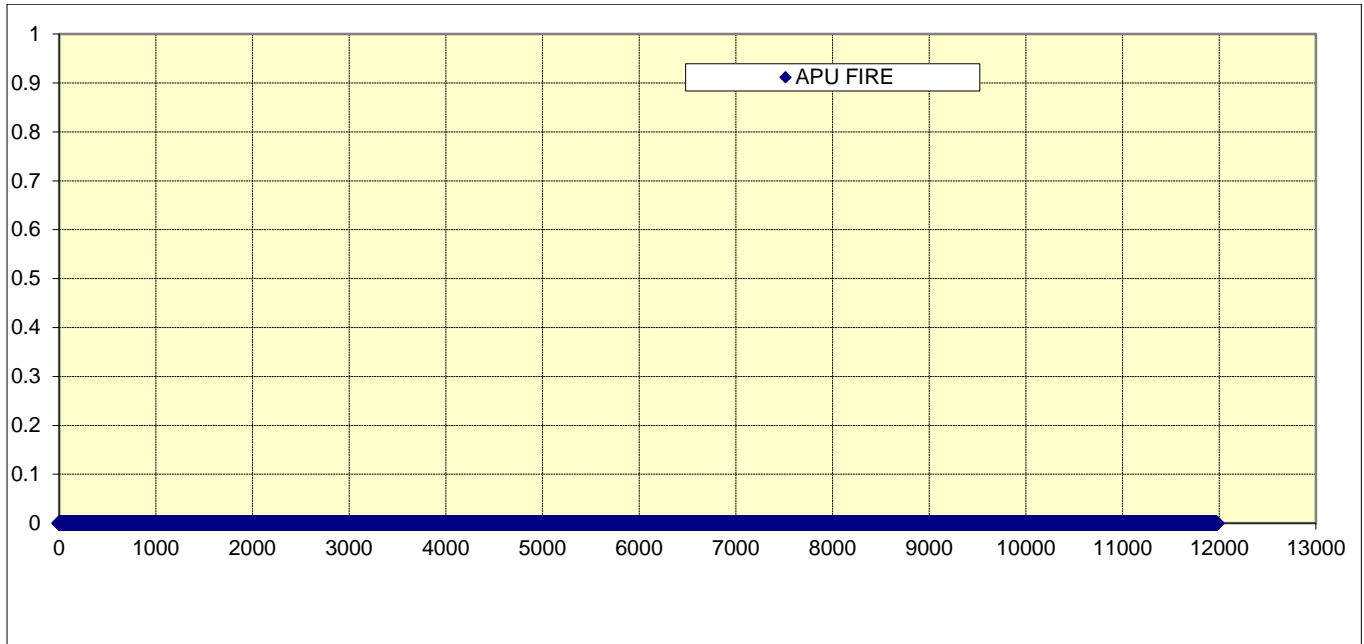
- APU FIRE  
(1 fire)

No APU fire detected

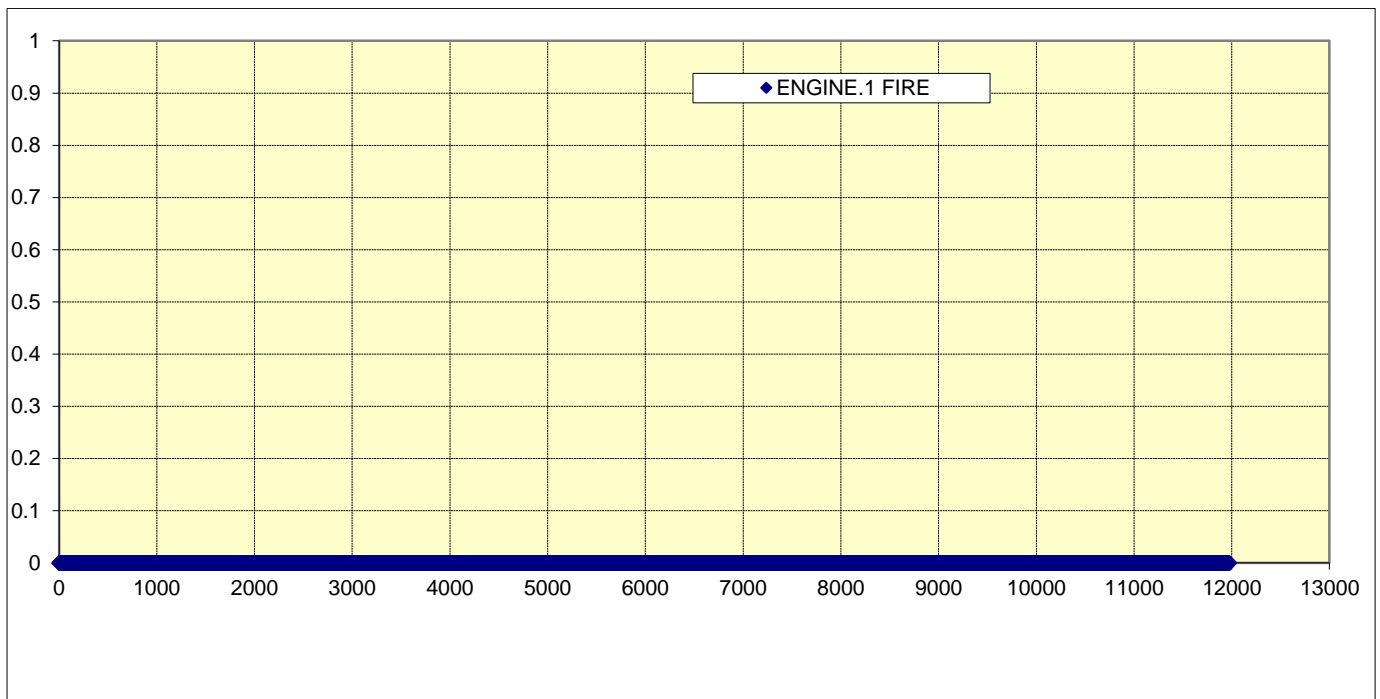
- ENGINE.1 FIRE  
(1 fire)

No fire detected in engine 1

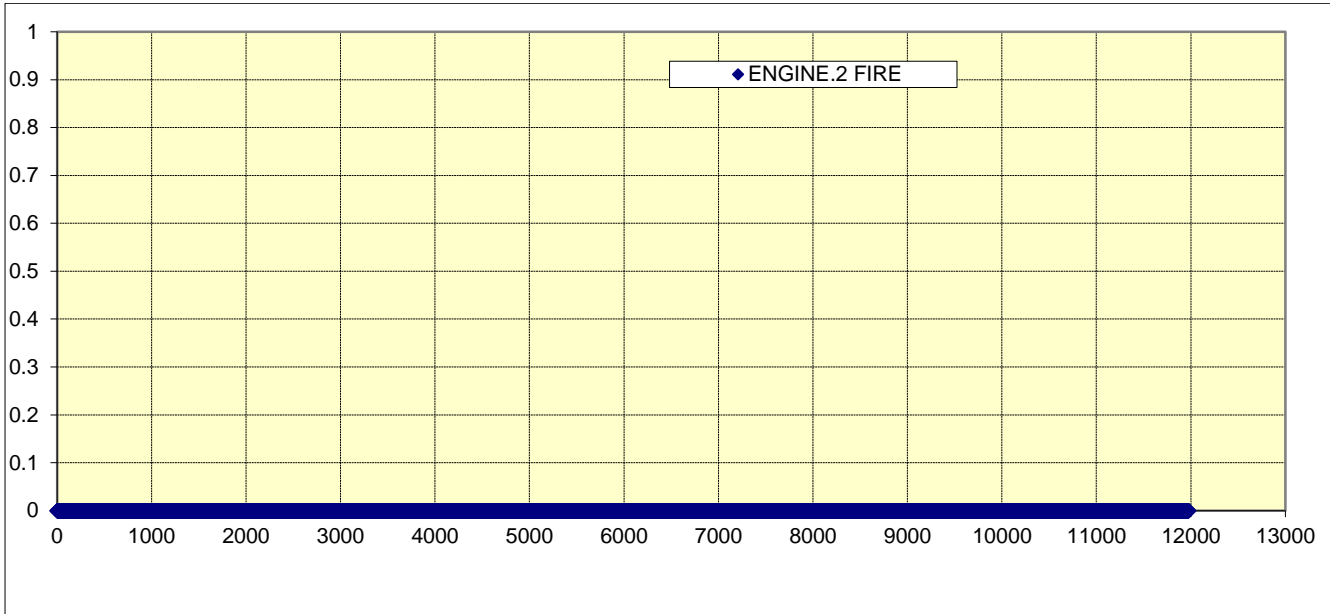
- ENGINE.2 FIRE  
(1 fire)

No fire detected in engine 2

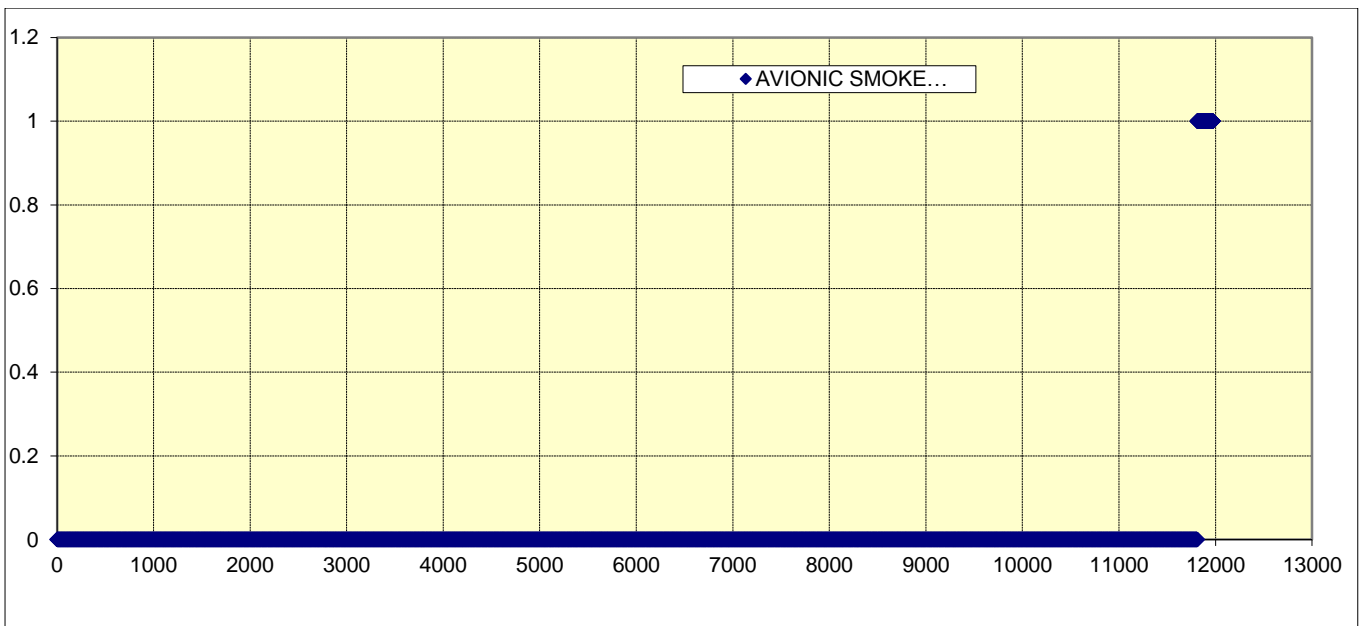
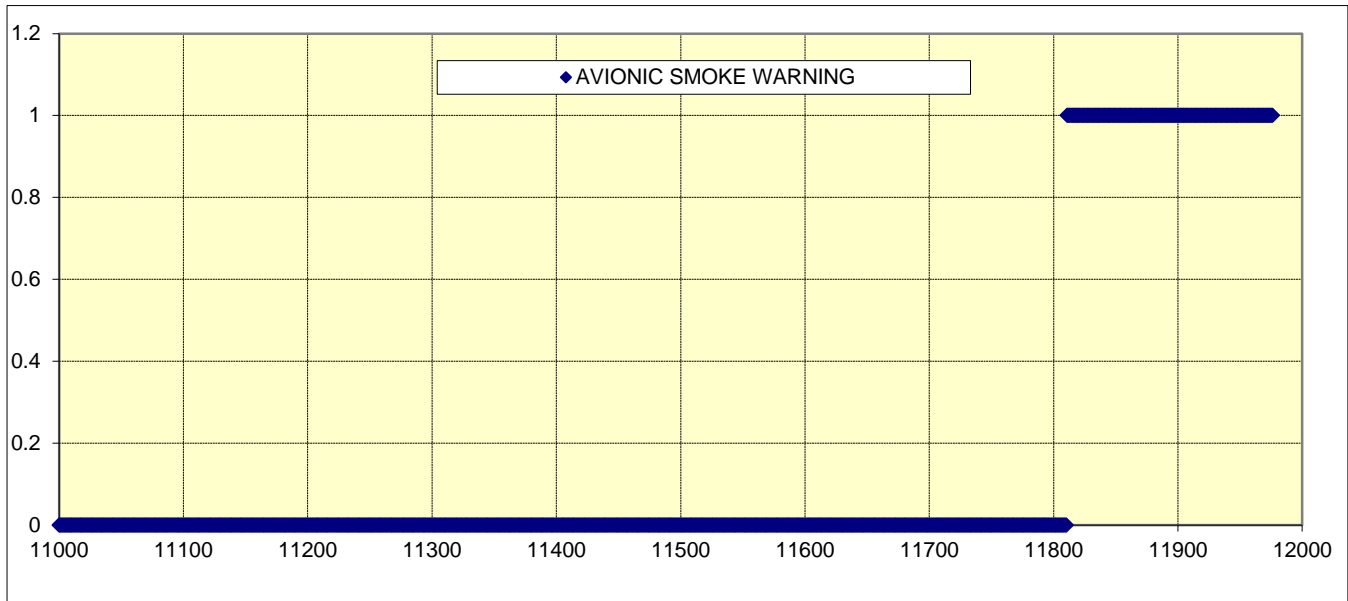
- AVIONIC SMOKE WARNING  
(1 smoke warning)

Avionic smoke warning (closer view at the end of the recording)

Avionic smoke started at 00:27:00 UTC (11811 seconds plot time) and continued to the end of the recording 00:29:45 UTC

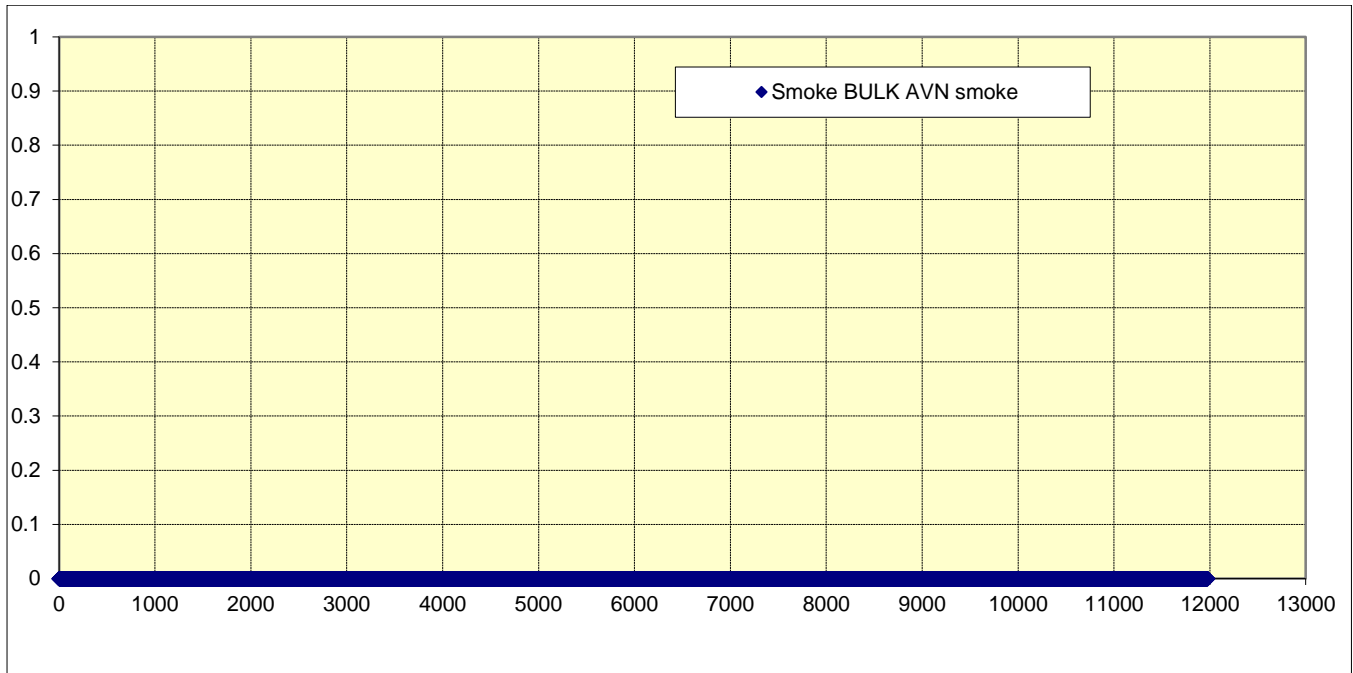
- Smoke BULK AVN smoke  
(1 smoke)

No bulk avionics smoke detected

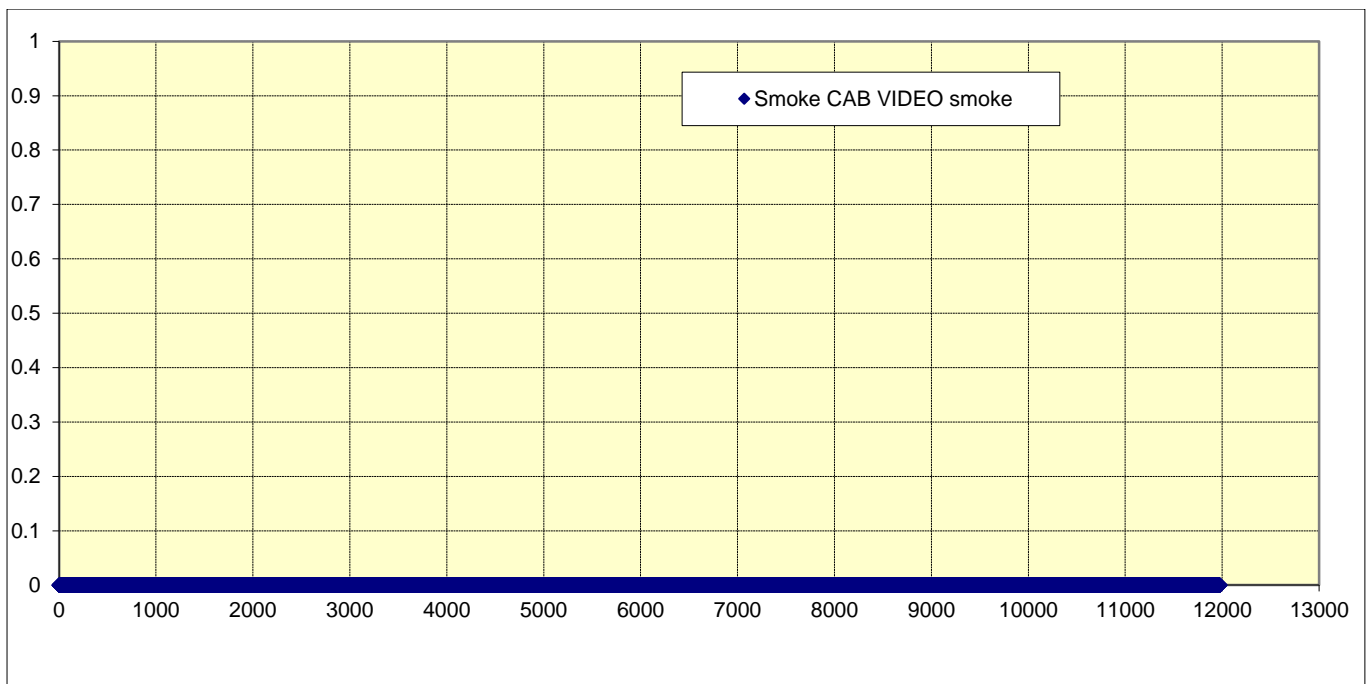
- Smoke CAB VIDEO smoke  
(1 smoke)

No smoke in cabin video
