## Final Report

**EgyptAir A320 Aircraft crash in the Mediterranean, registered SU-GCC,  
flight number MSR804, from Charles De-Gaulle Airport, Paris to Cairo  
International Airport, on 19/05/2016**

EGAI2016-01

October 2024

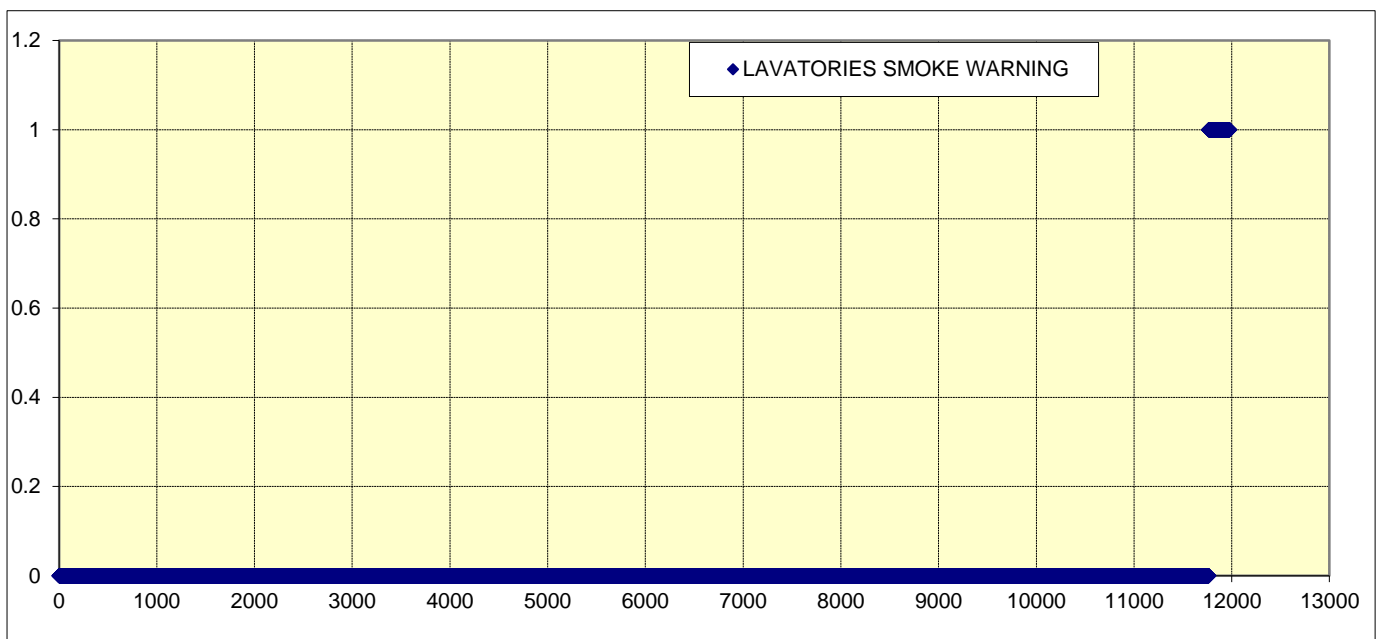
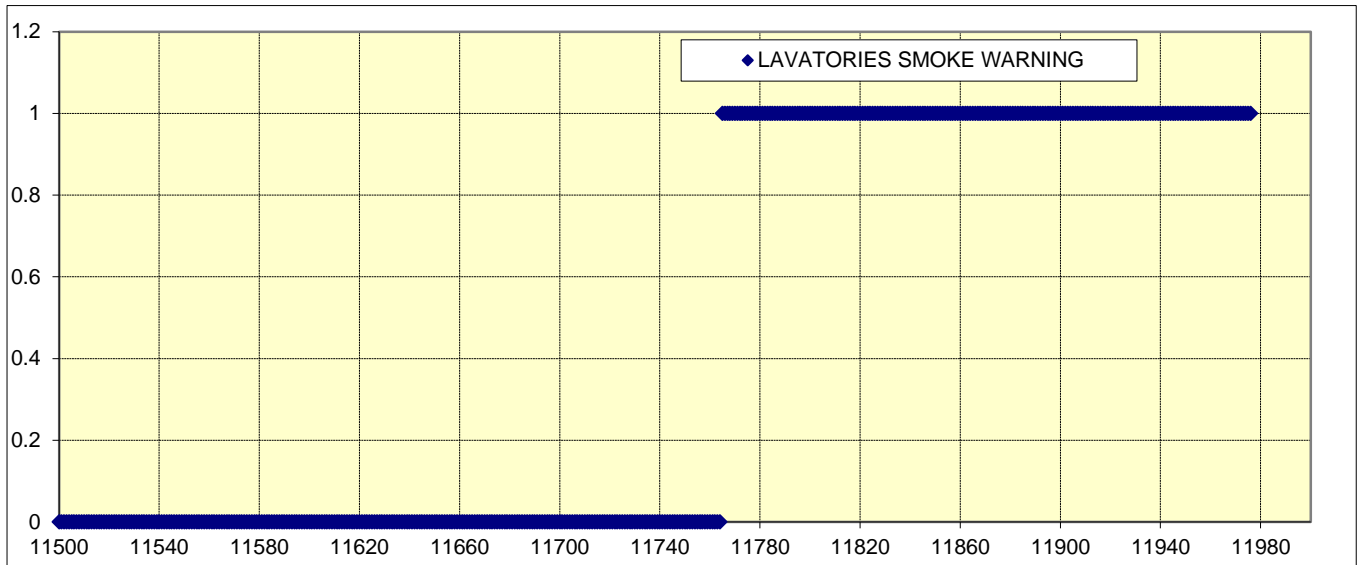
- LAVATORIES SMOKE WARNING  
(1 smoke)

Lavatories smoke warning (closer view at the end of the recording)

Lavatory smoke started at 00:26:14 UTC (11765 seconds plot time) and continued to the end of the recording 00:29:45

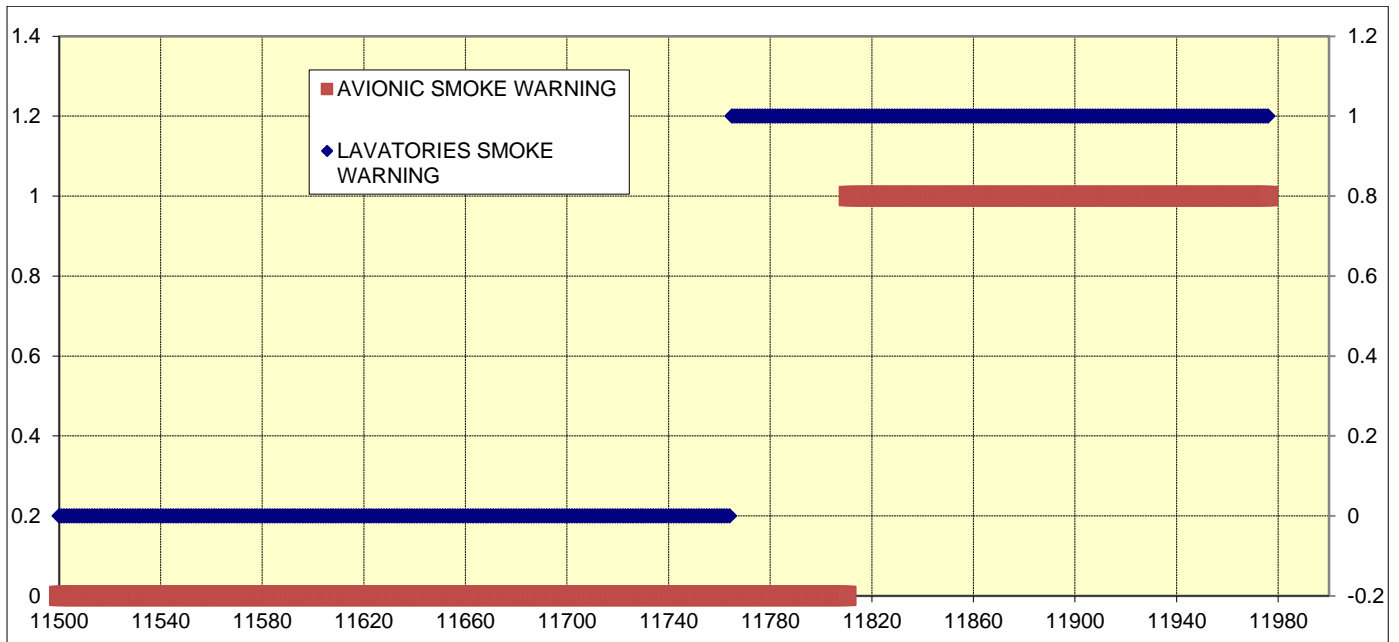
Combined plot for Avionic and lavatory smoke

Smoke location	start time	end time
Lavatory smoke	00:26:14 UTC (11765 seconds plot time)	00:29:45
Avionic smoke	00:27:00 UTC (11811 seconds plot time)	00:29:45

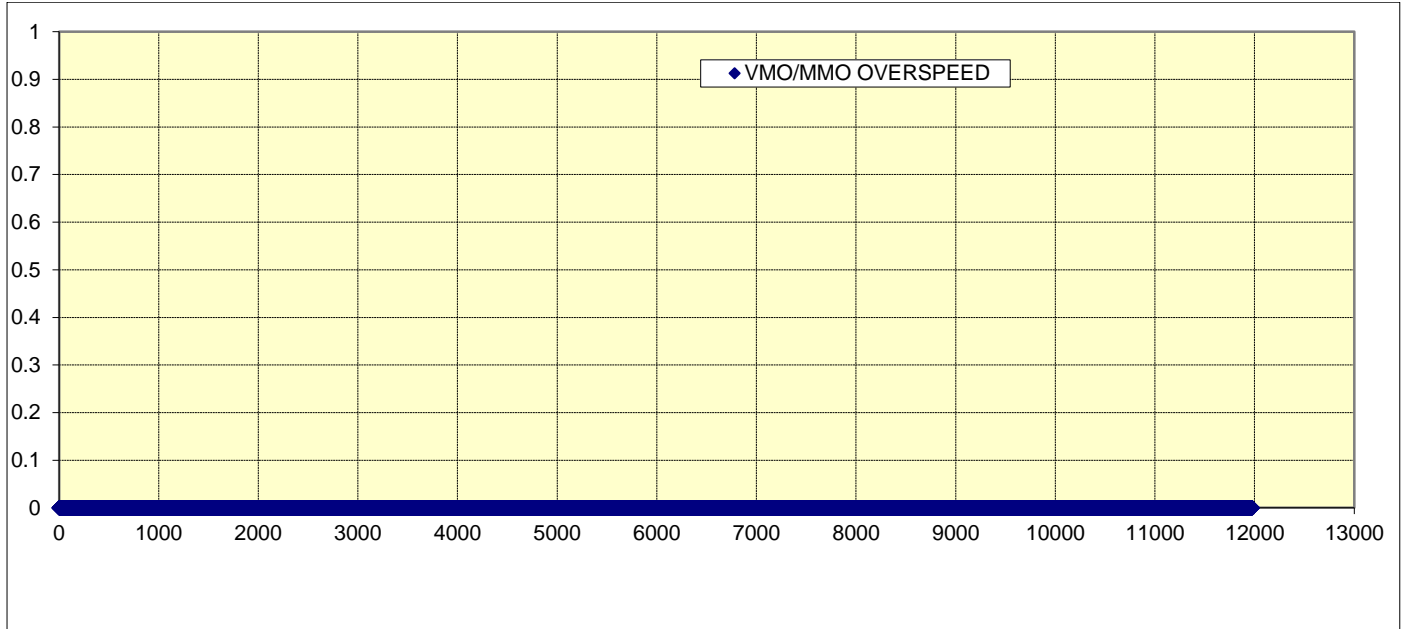
- VMO/MMO OVERSPEED  
(1 Overspeed)

No overspeed throughout the whole recording

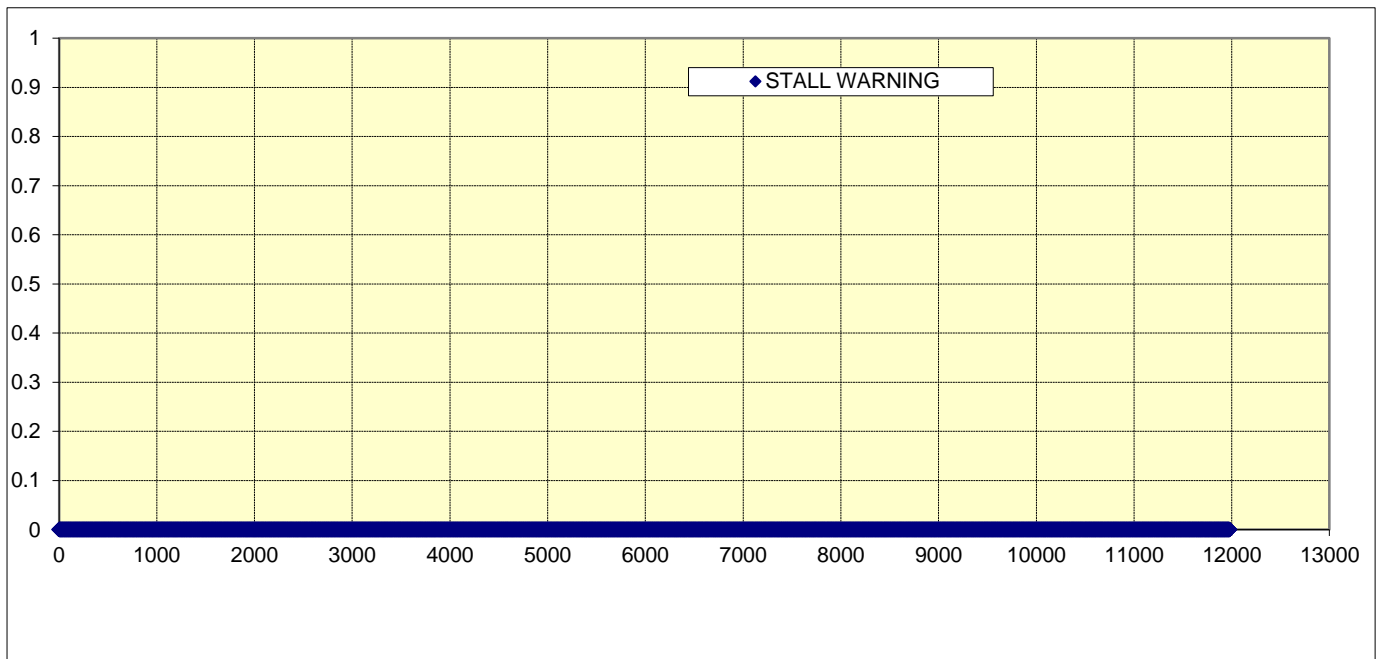
- STALL WARNING  
(1 warning)

No stall throughout the whole recording

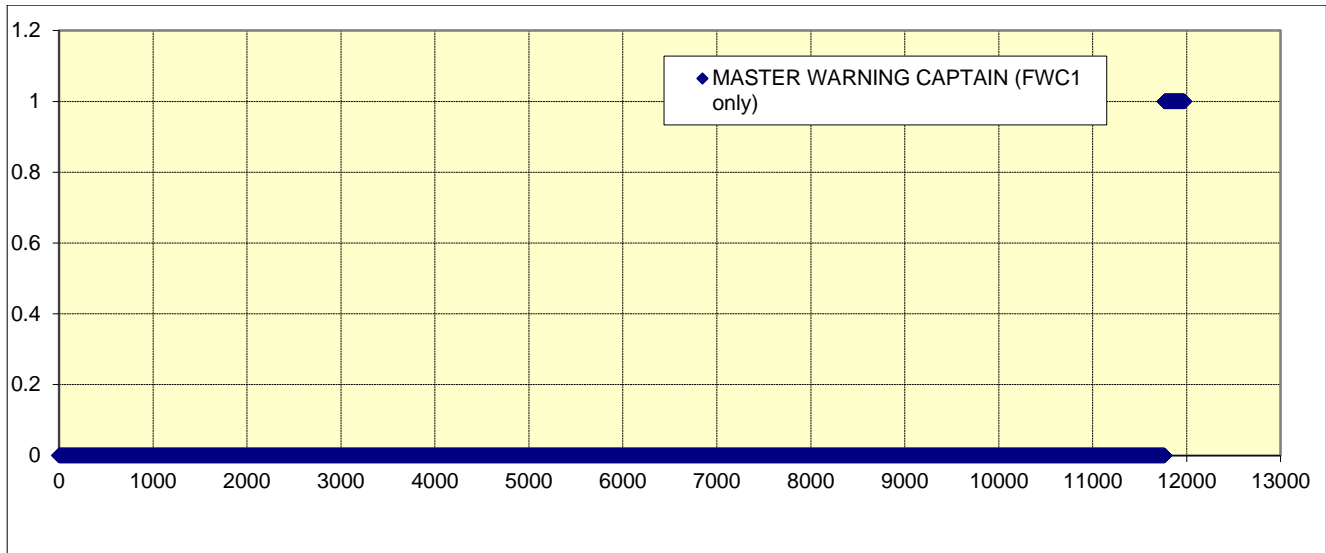
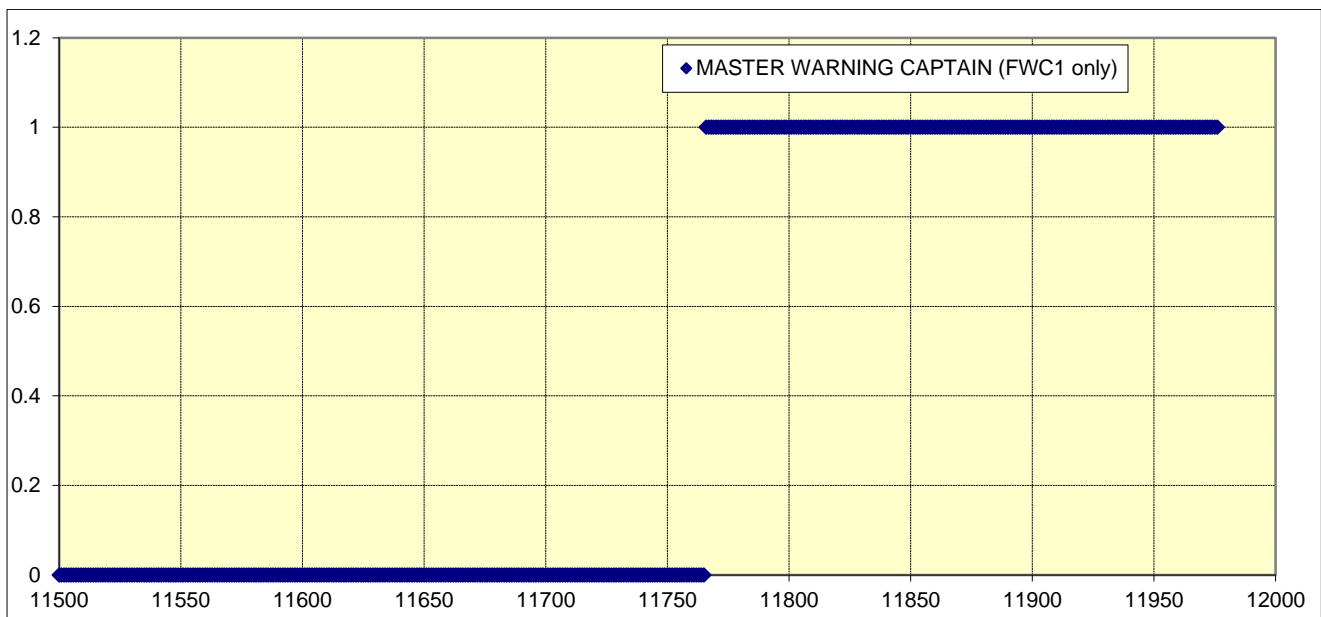
- MASTER WARNING CAPTAIN (FWC1 only)

Master warning Captain FWC1 only (closer view at the end of the recording)

"Master warning Captain FWC1 only" started at 00:26:15 UTC (11766 seconds plot time) continued up to the end of the recording at 00:29:45 (11976 seconds plot time)

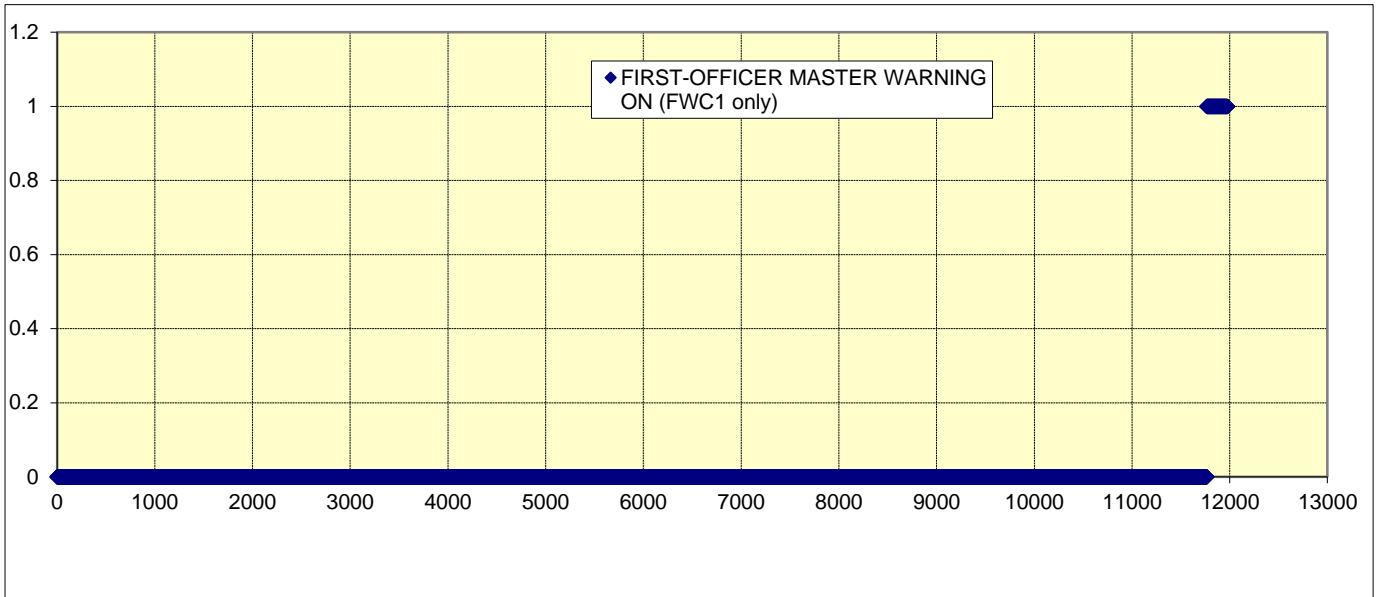
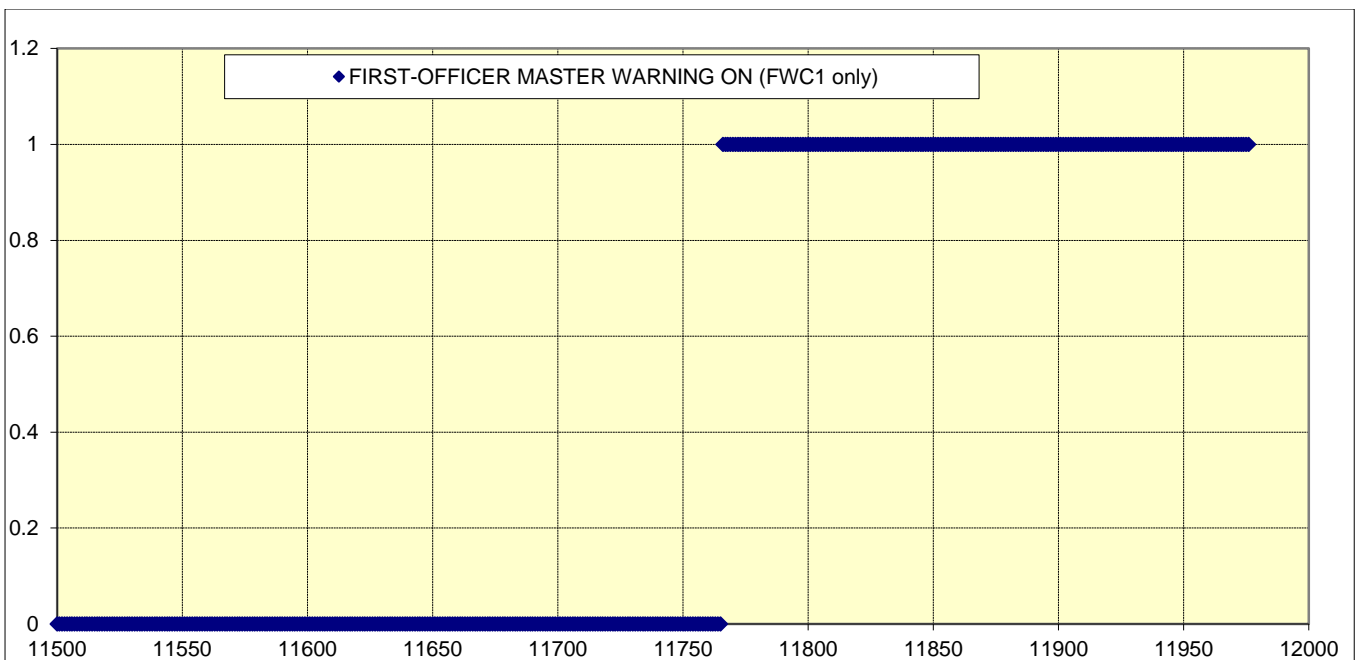
- FIRST-OFFICER MASTER WARNING ON (FWC1 only)  
(1 Master warning)

Master warning First Officer FWC1 only (closer view at the end of the recording)

"Master warning F/O FWC1 only" started at 00:26:15 UTC (11766 seconds plot time) continued up to the end of the recording at 00:29:45 (11976 seconds plot time)

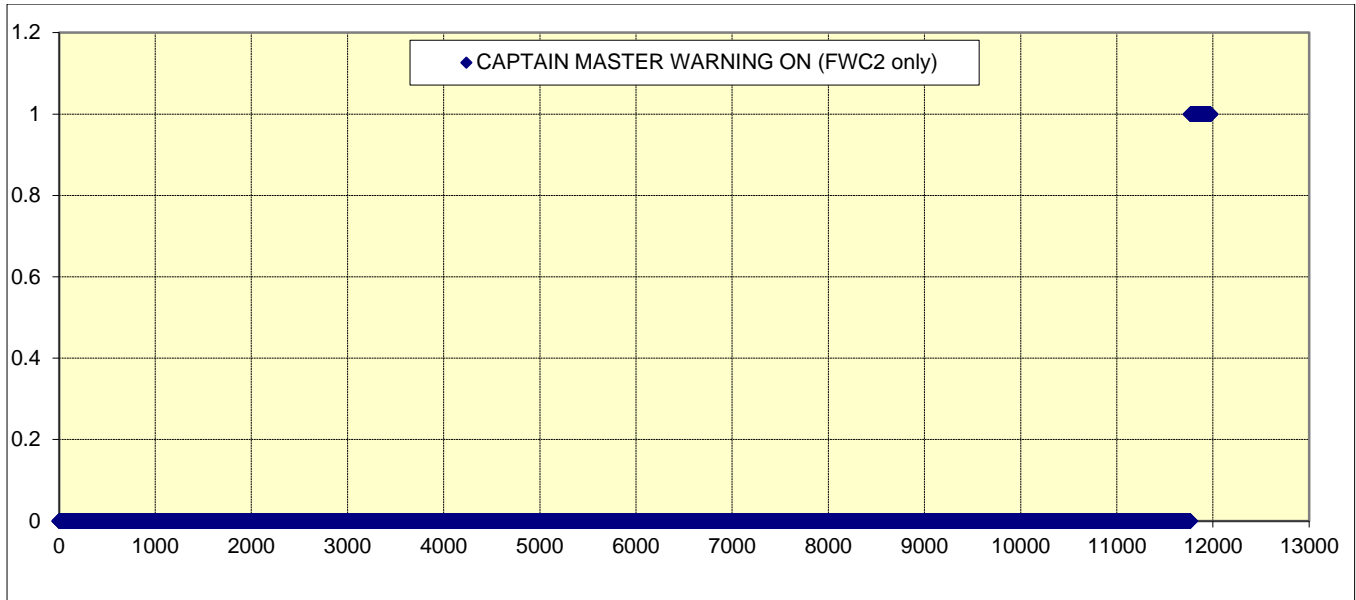
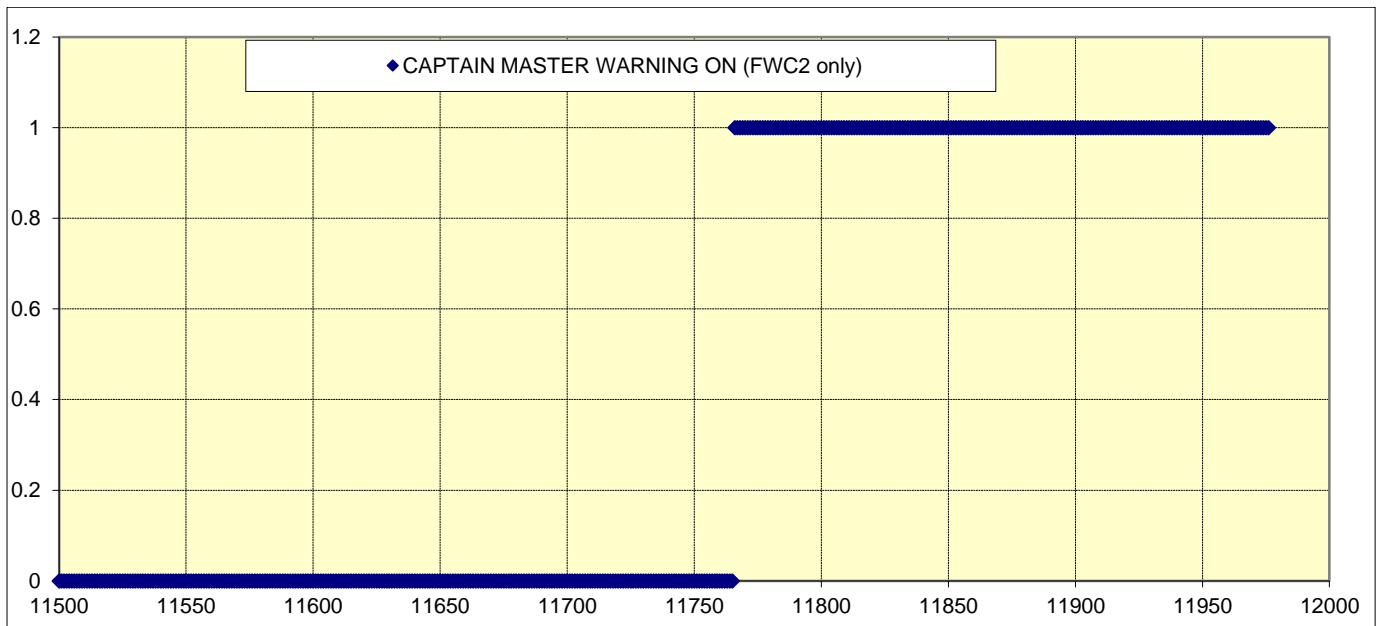
– CAPTAIN MASTER WARNING ON (FWC2 only)

Master warning Captain ON FWC2 only (closer view at the end of the recording)

"Master warning Captain FWC2 only" started at 00:26:15 UTC (11766 seconds plot time) continued up to the end of the recording at 00:29:45 (11976 seconds plot time)

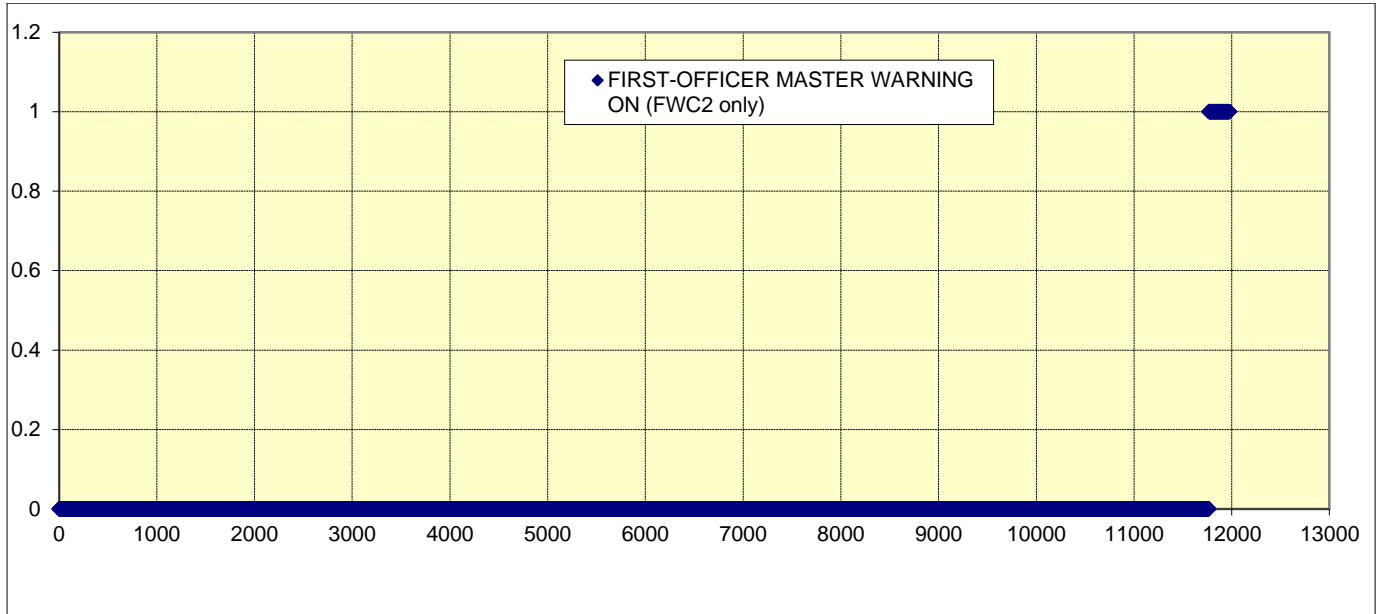
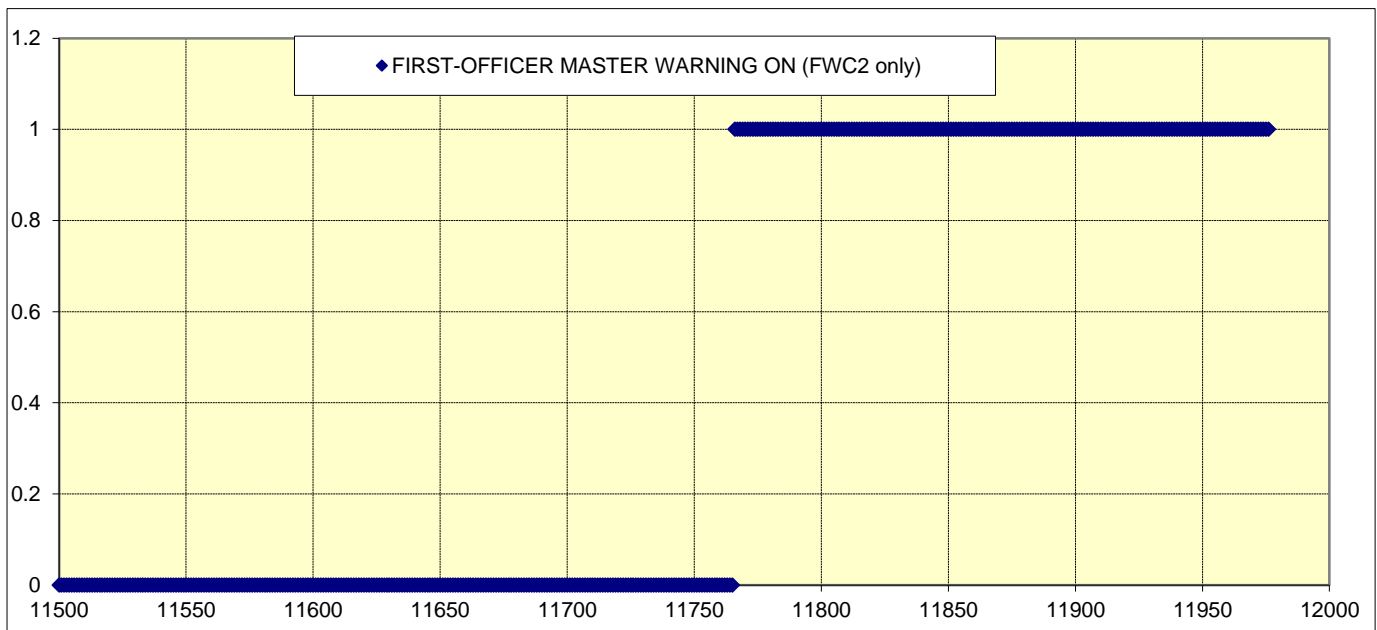
- FIRST-OFFICER MASTER WARNING ON (FWC2 only)

Master warning First Officer FWC2 only (closer view at the end of the recording)

"Master warning F/O FWC2 only" started at 00:26:15 UTC (11766 seconds plot time) continued up to the end of the recording at 00:29:45 (11976 seconds plot time)

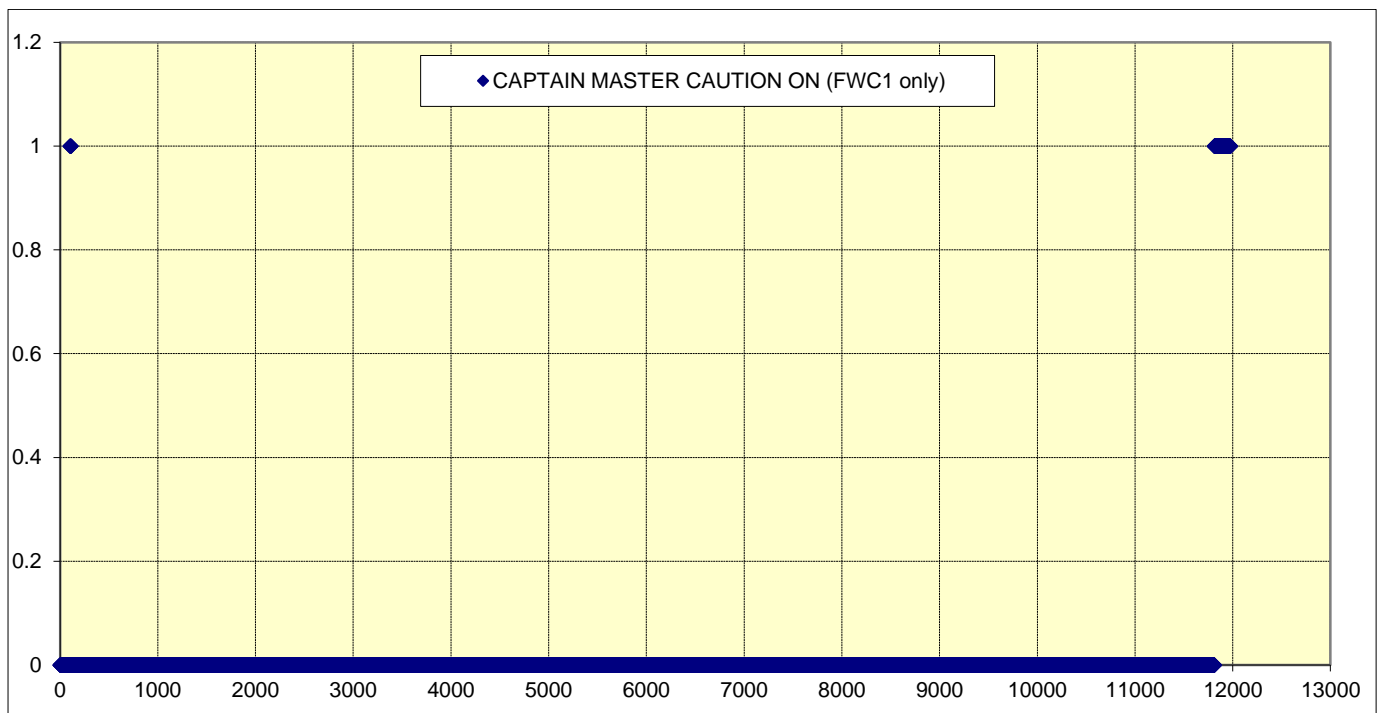
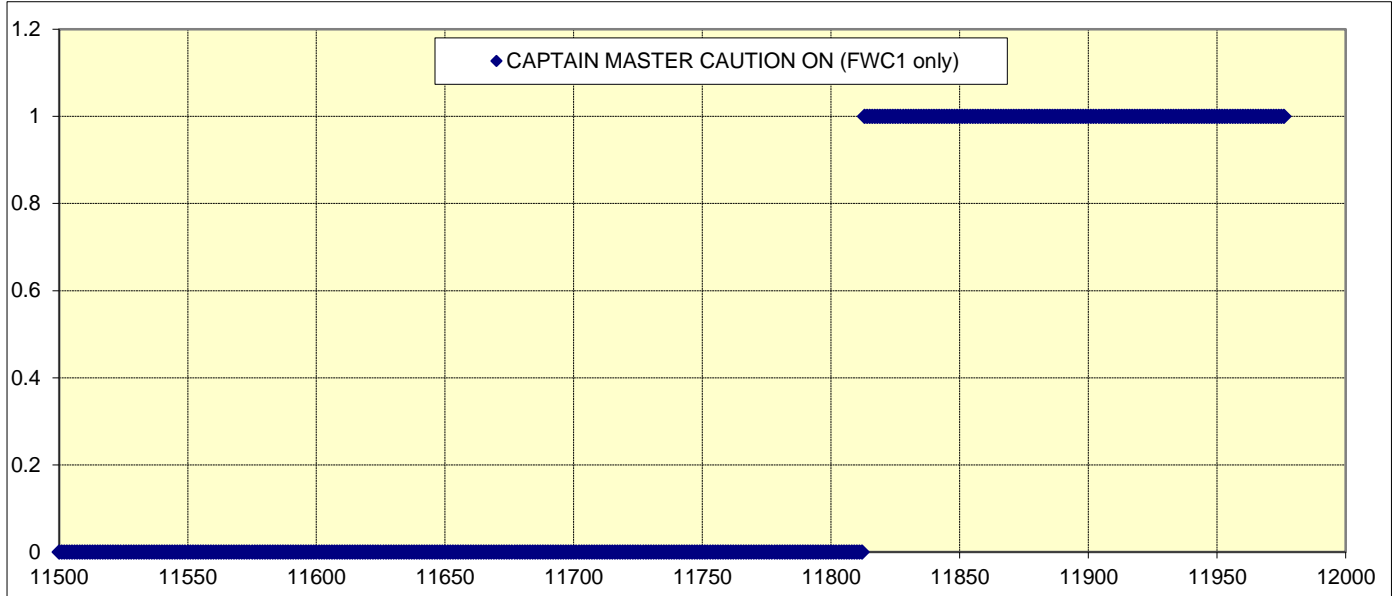
- CAPTAIN MASTER CAUTION ON (FWC1 only)

Captain Master Caution on FWC1 only (closer view at the end of the recording)

"Master Caution Captain FWC1 only" started at 00:27:02 UTC (11813 seconds plot time) continued up to the end of the recording at 00:29:45 (11976 seconds plot time)

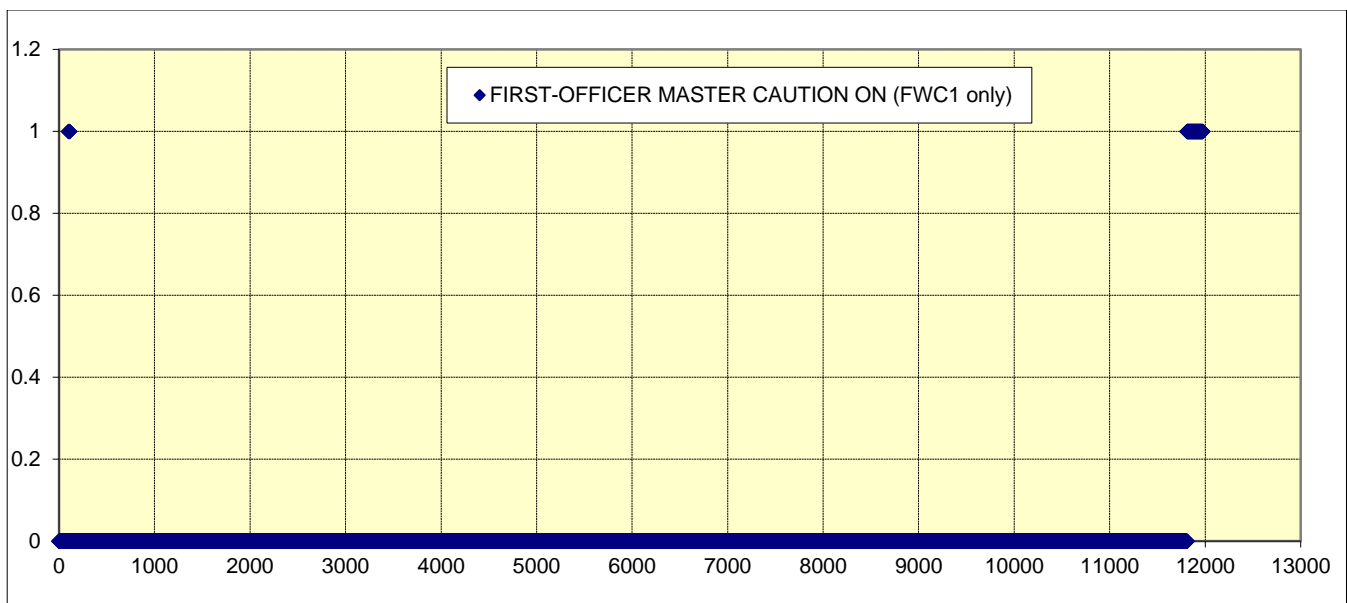
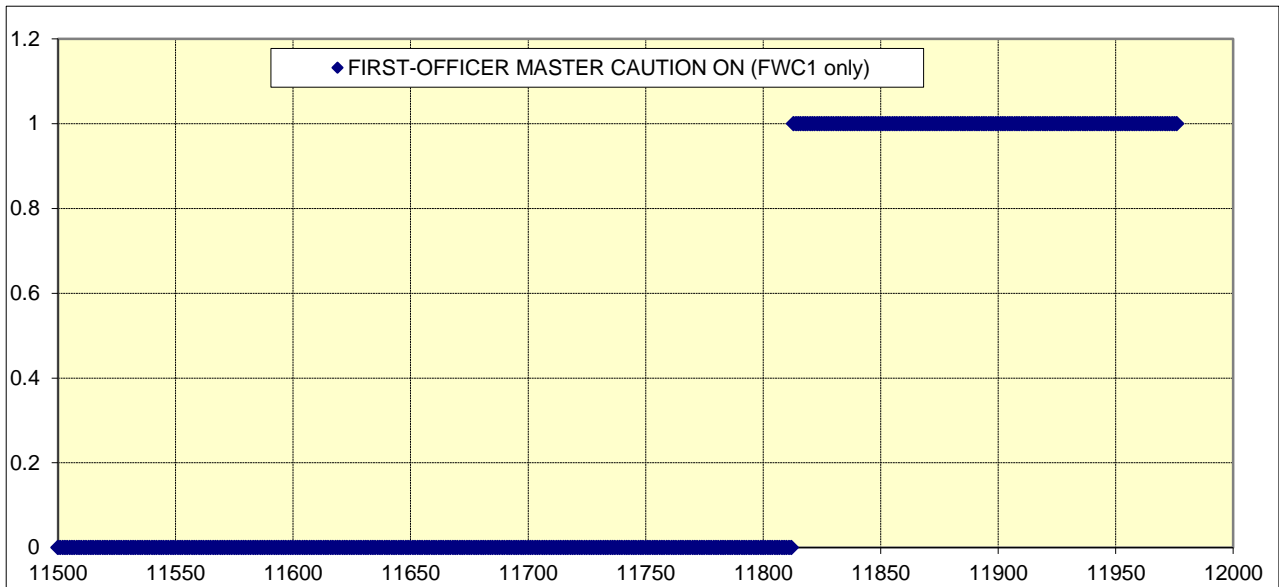
- FIRST-OFFICER MASTER CAUTION ON (FWC1 only)

"Master Caution F/O FWC1 only" started at 00:27:02 UTC (11813 seconds plot time) continued up to the end of the recording at 00:29:45 (11976 seconds plot time)

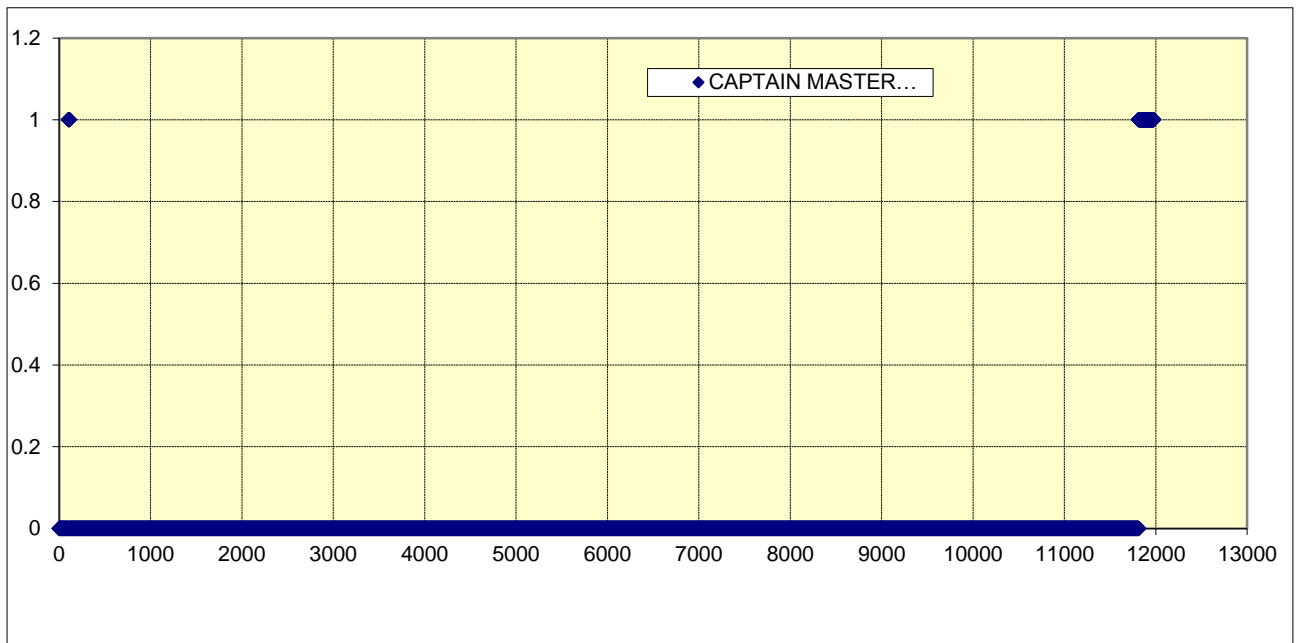
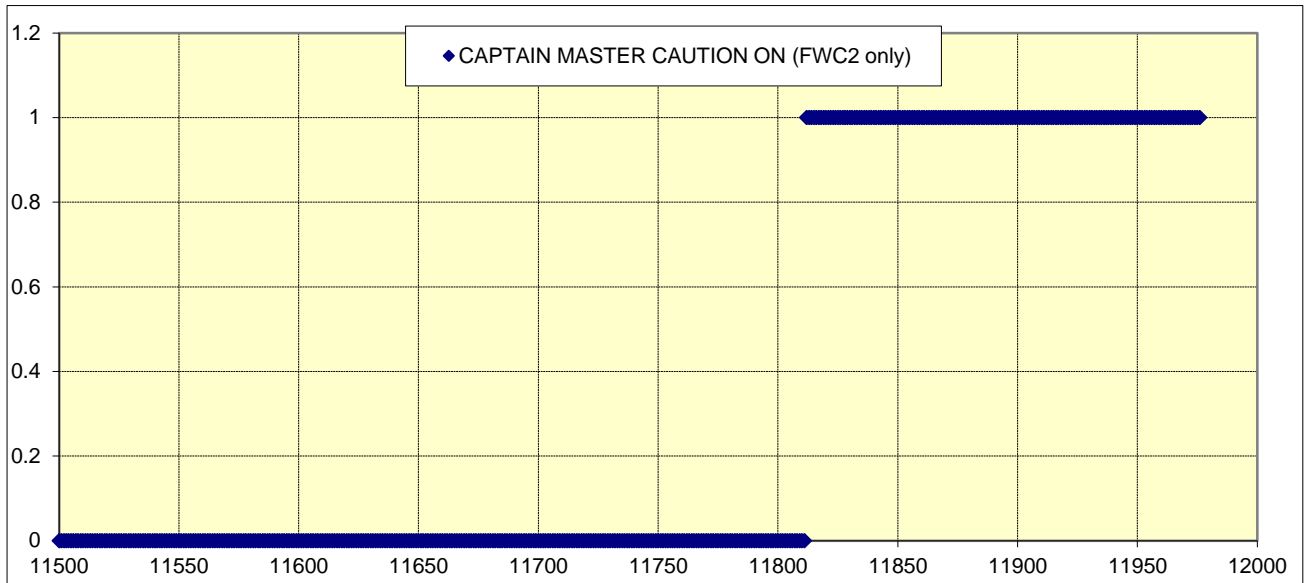
- CAPTAIN MASTER CAUTION ON (FWC2 only)  
(1 Master Caution)

Captain Master Caution on FWC2 only (closer view at the end of the recording)

"Master Caution Captain FWC2 only" started at 00:27:01 UTC (11812 seconds plot time) continued up to the end of the recording at 00:29:45 (11976 seconds plot time)

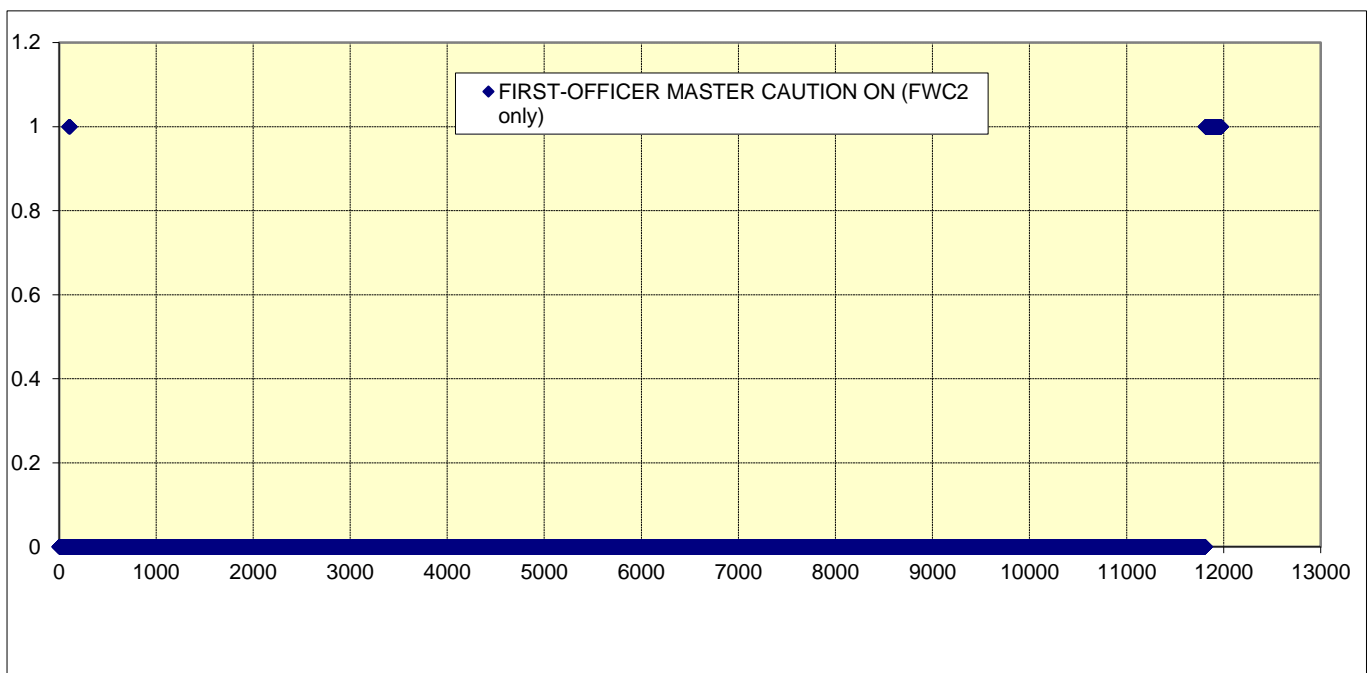
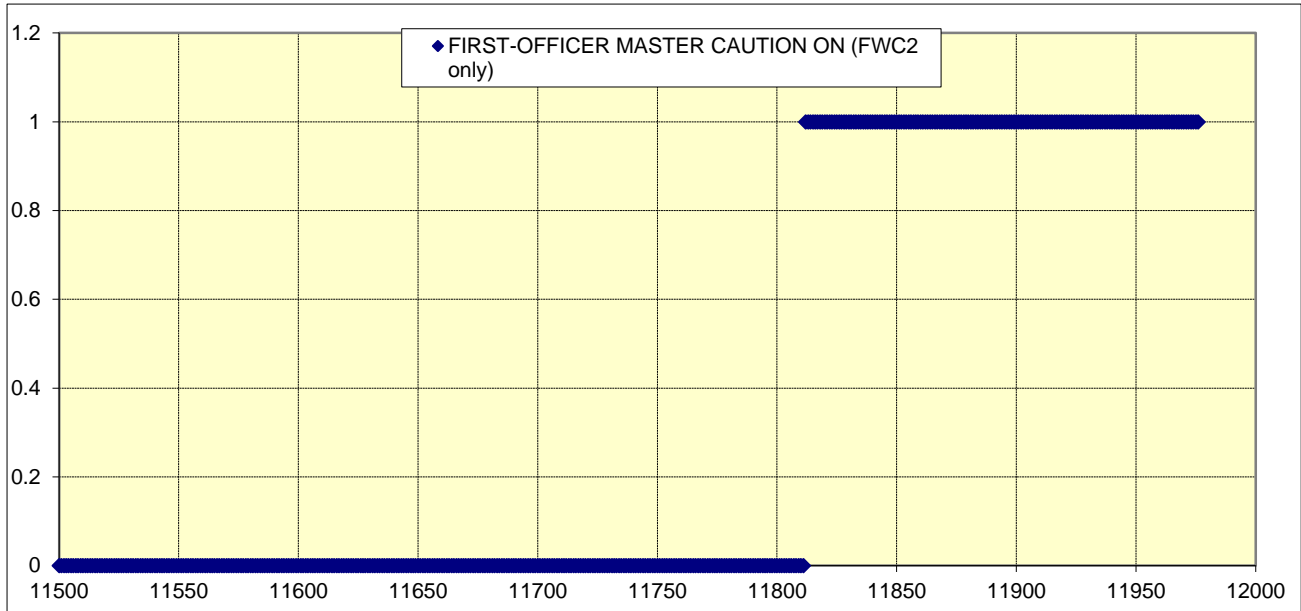
- FIRST-OFFICER MASTER CAUTION ON (FWC2 only)  
(Master Caution)

"Master Caution F/O FWC2 only" started at 00:27:01 UTC (11812 seconds plot time) continued up to the end of the recording at 00:29:45 (11976 seconds plot time)

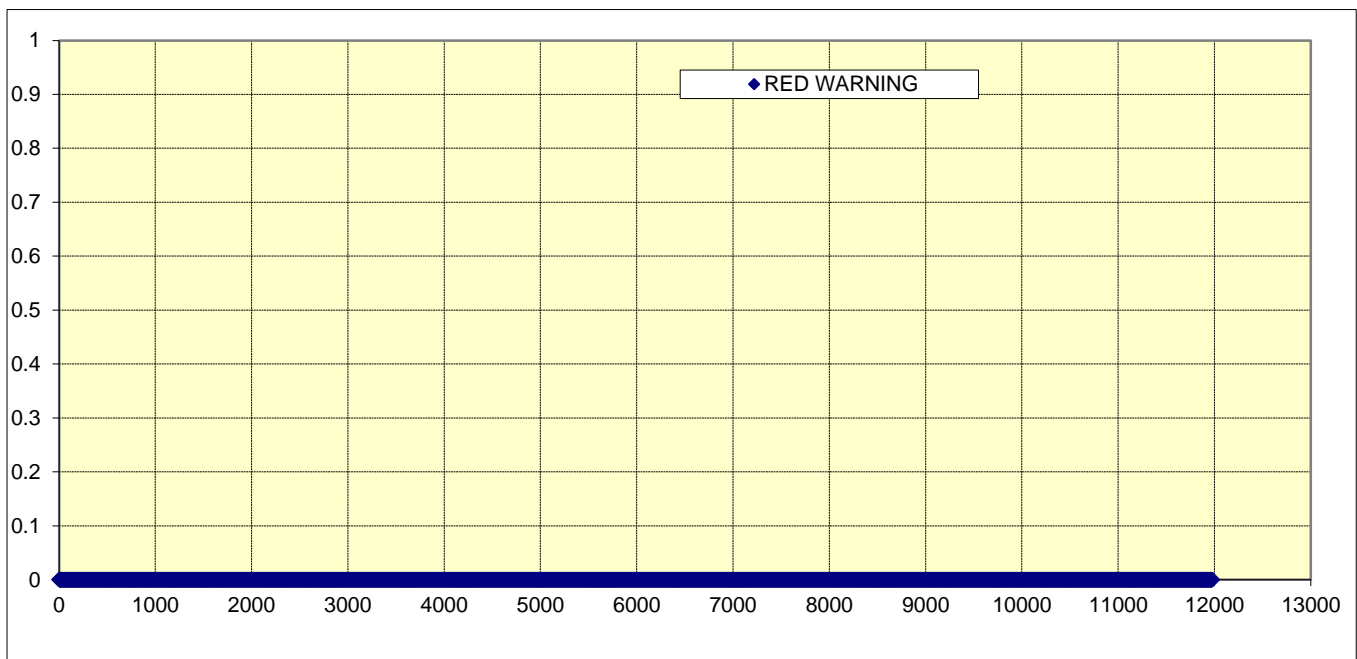
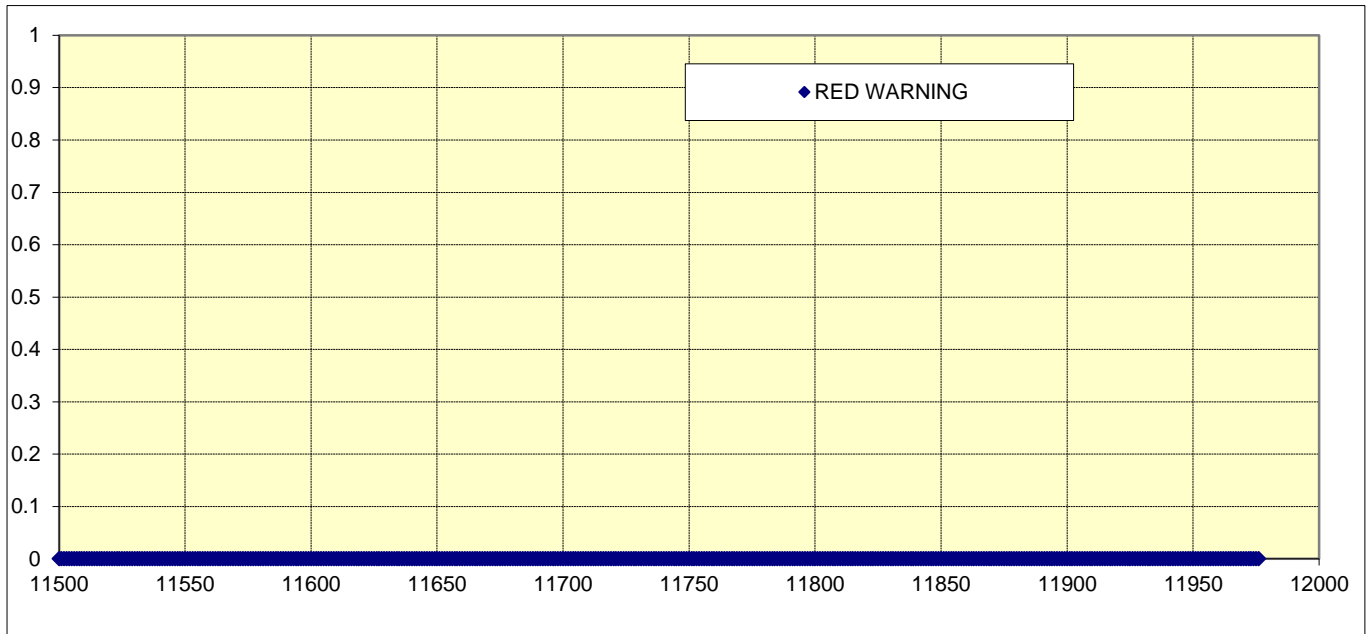
- RED WARNING

Red Warning shown at the end portion of the recording

No detected Red Warning

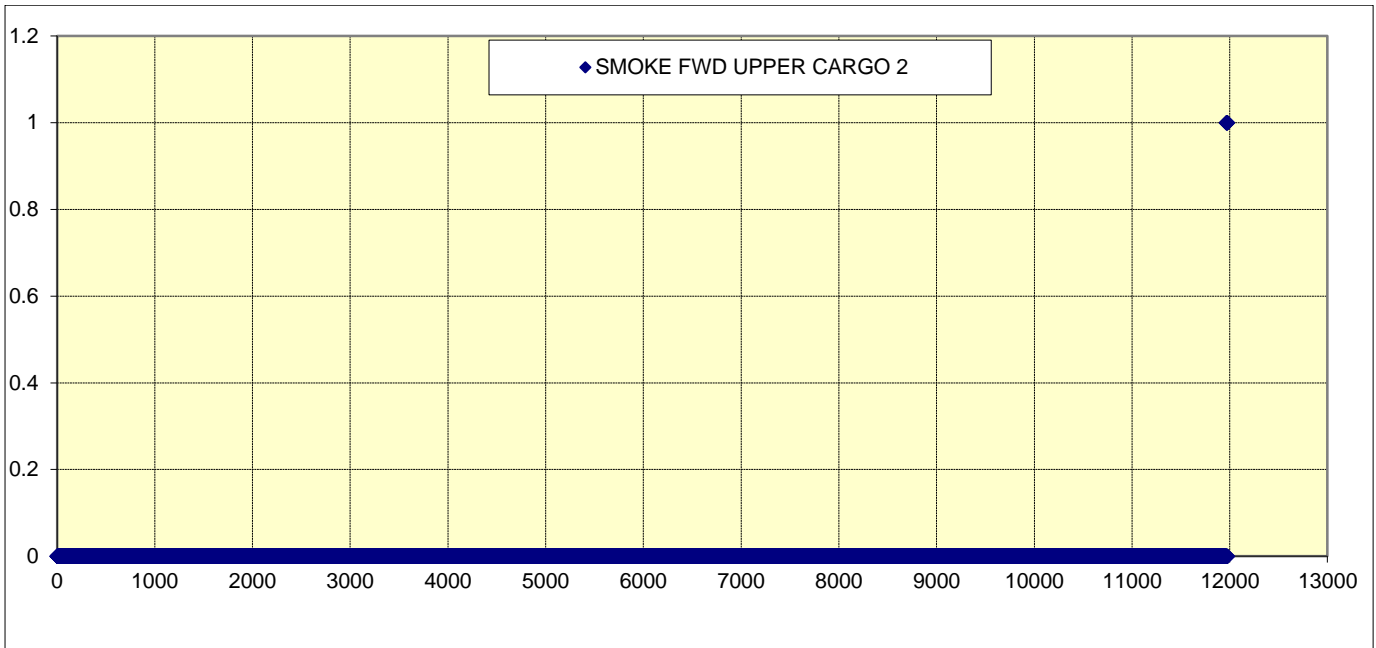
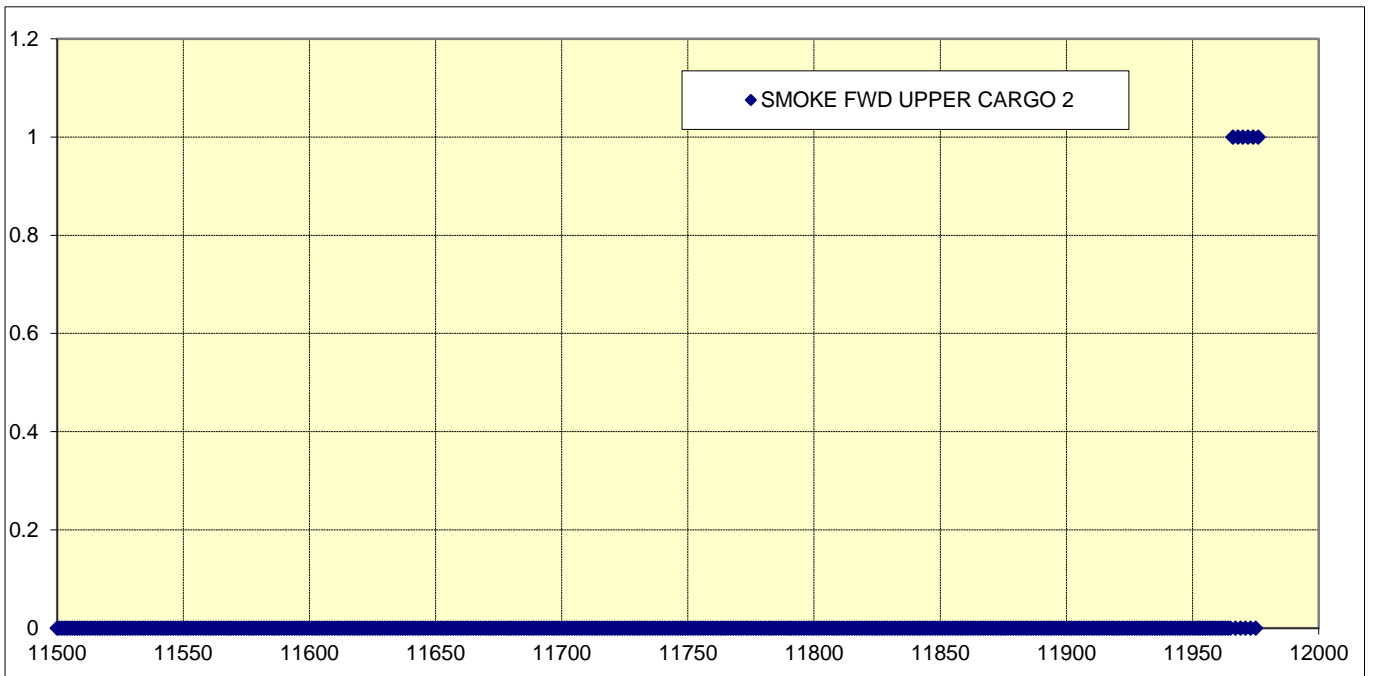
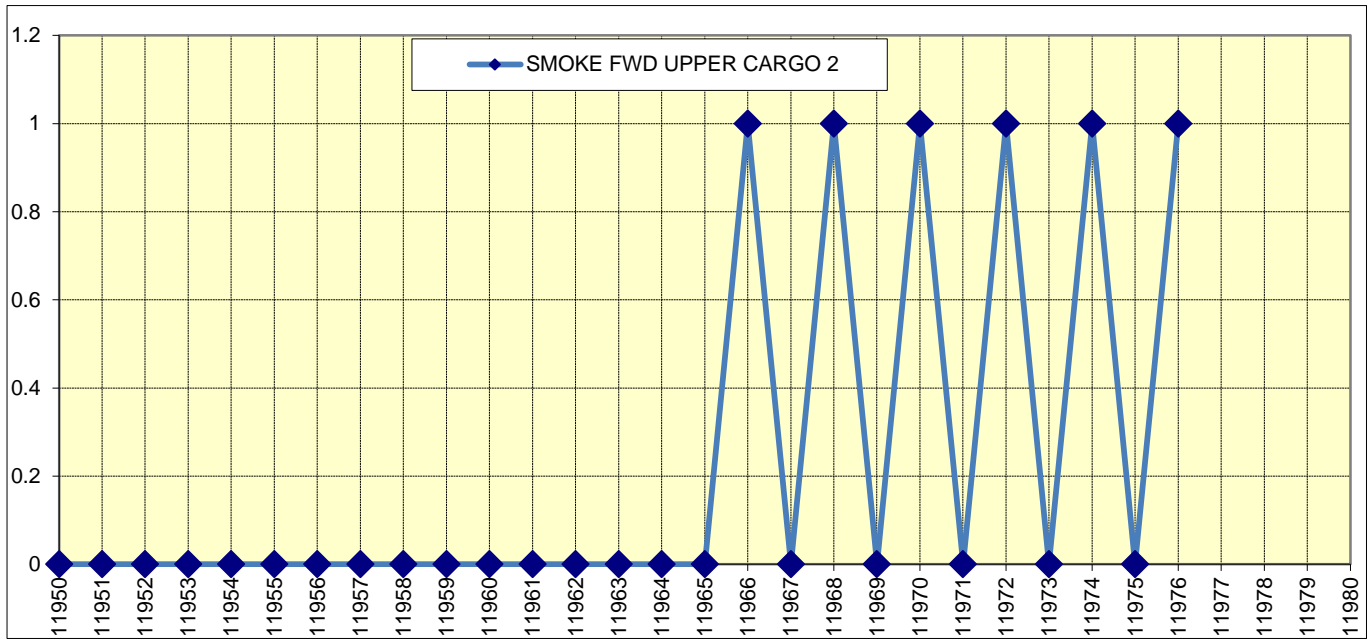
– SMOKE FWD UPPER CARGO 2  
(1 smoke warning)

SMOKE FWD UPPER CARGO 2 at the last portion of the recording

SMOKE FWD UPPER CARGO 2 very close to the recording end

Smoke FWD upper cargo 2 showed smoke six times in the interval between 00:29:34 UTC (11965 seconds plot time) and the end of recording 00:29:45 UTC (11976 seconds plot time)
