## Final Report

**EgyptAir A320 Aircraft crash in the Mediterranean, registered SU-GCC,  
flight number MSR804, from Charles De-Gaulle Airport, Paris to Cairo  
International Airport, on 19/05/2016**

EGAI2016-01

October 2024

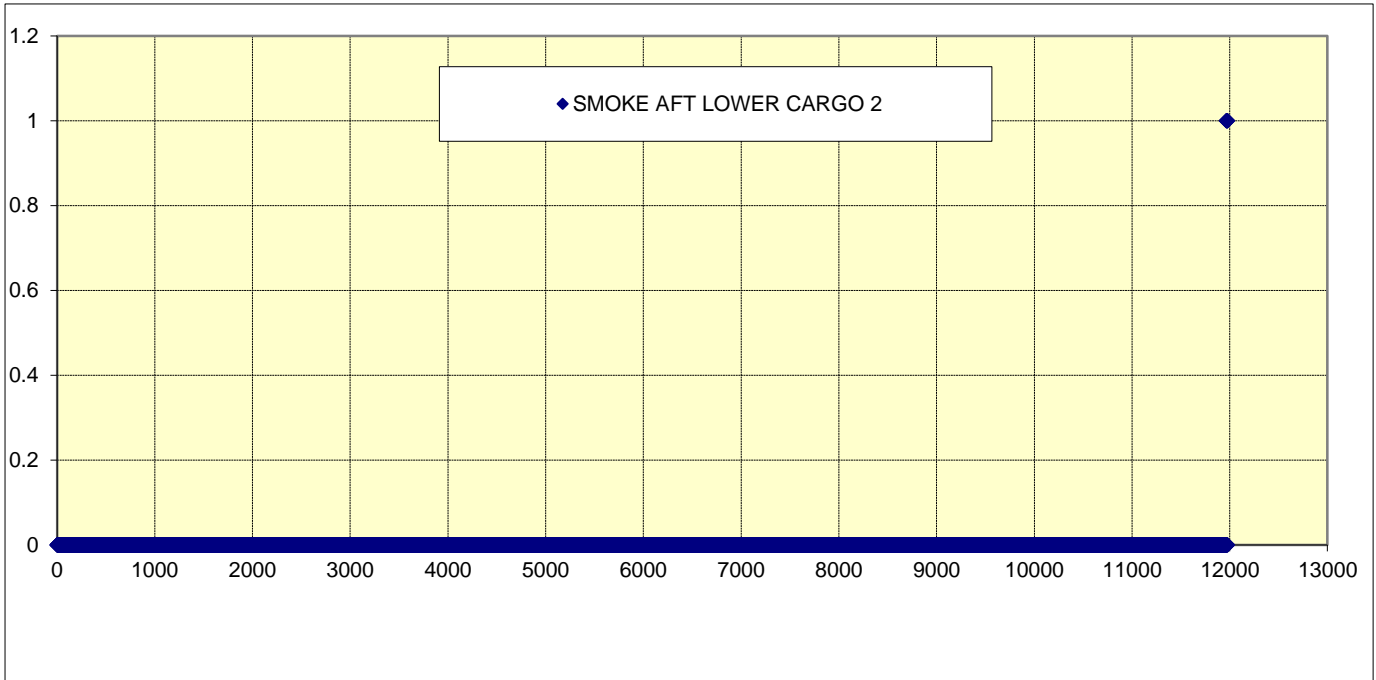
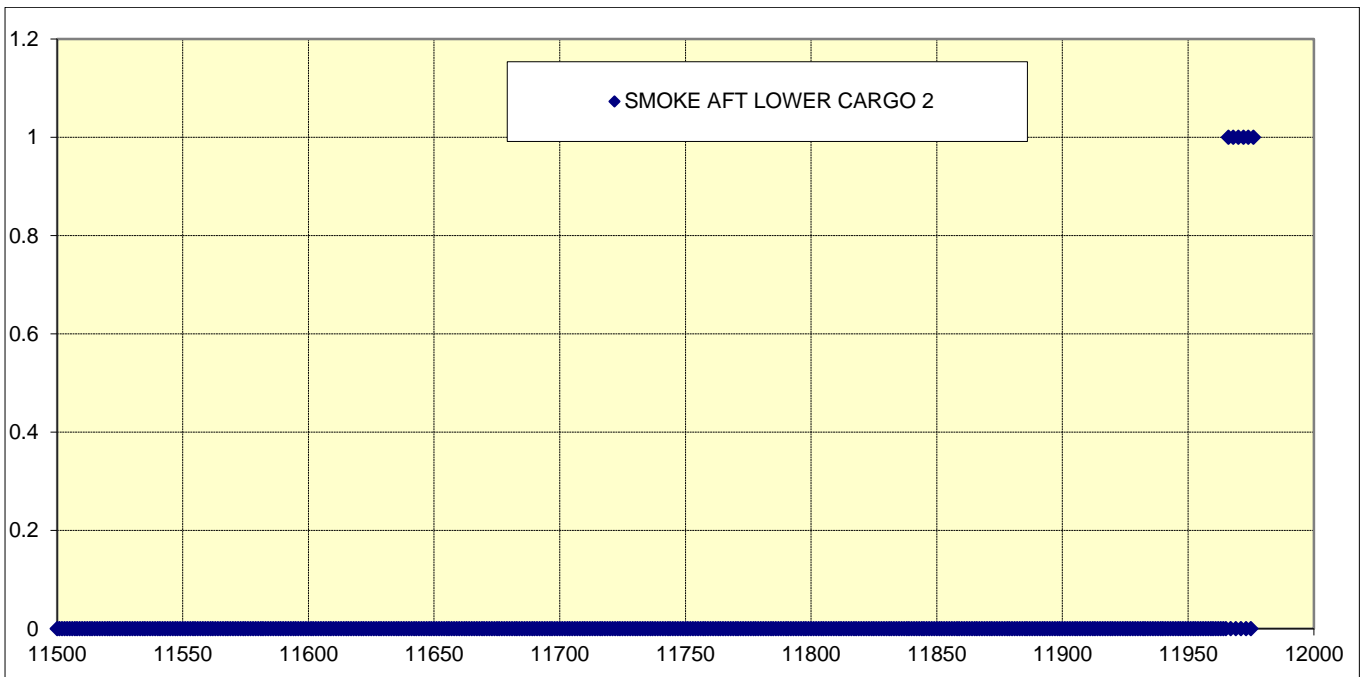
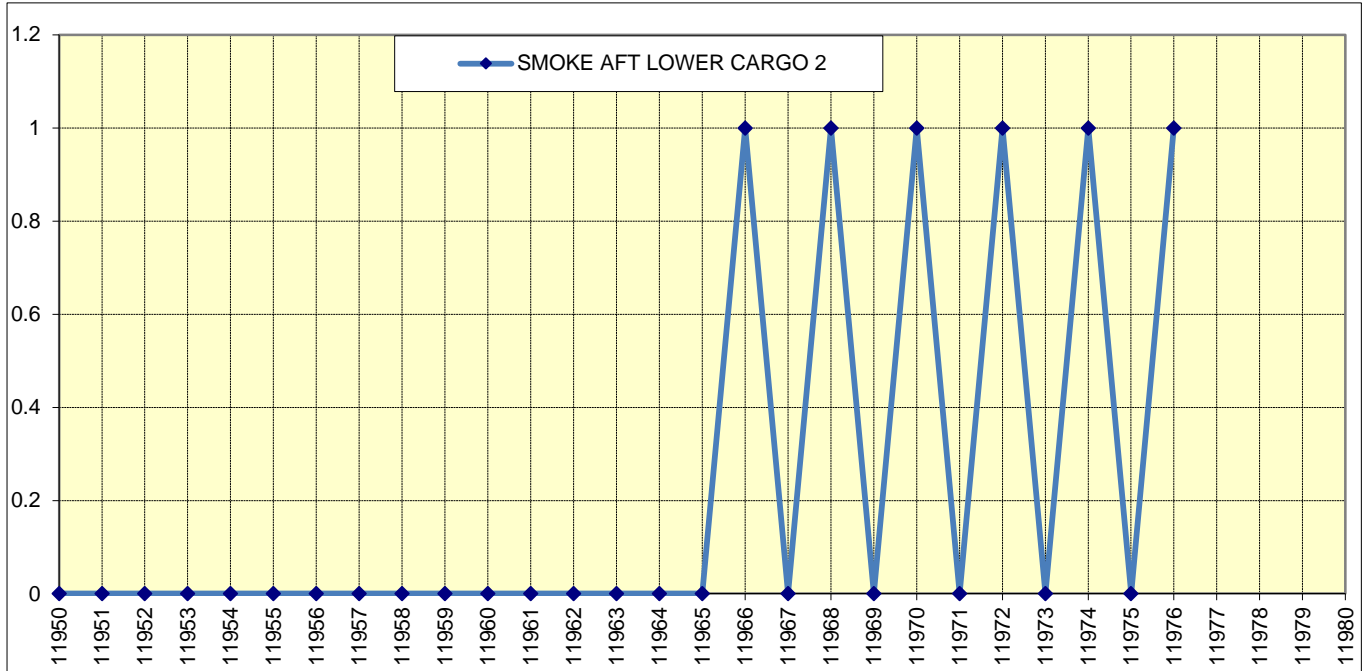
– SMOKE AFT LOWER CARGO 2  
(1 smoke warning)

SMOKE AFT LOWER CARGO 2 shown at the end portion of the recording

SMOKE AFT LOWER CARGO 2 very close to the recording end

Smoke AFT lower cargo 2 showed smoke six times in the interval between 00:29:34 UTC (11965 seconds plot time) and the end of recording 00:29:45 UTC (11976 seconds plot time)

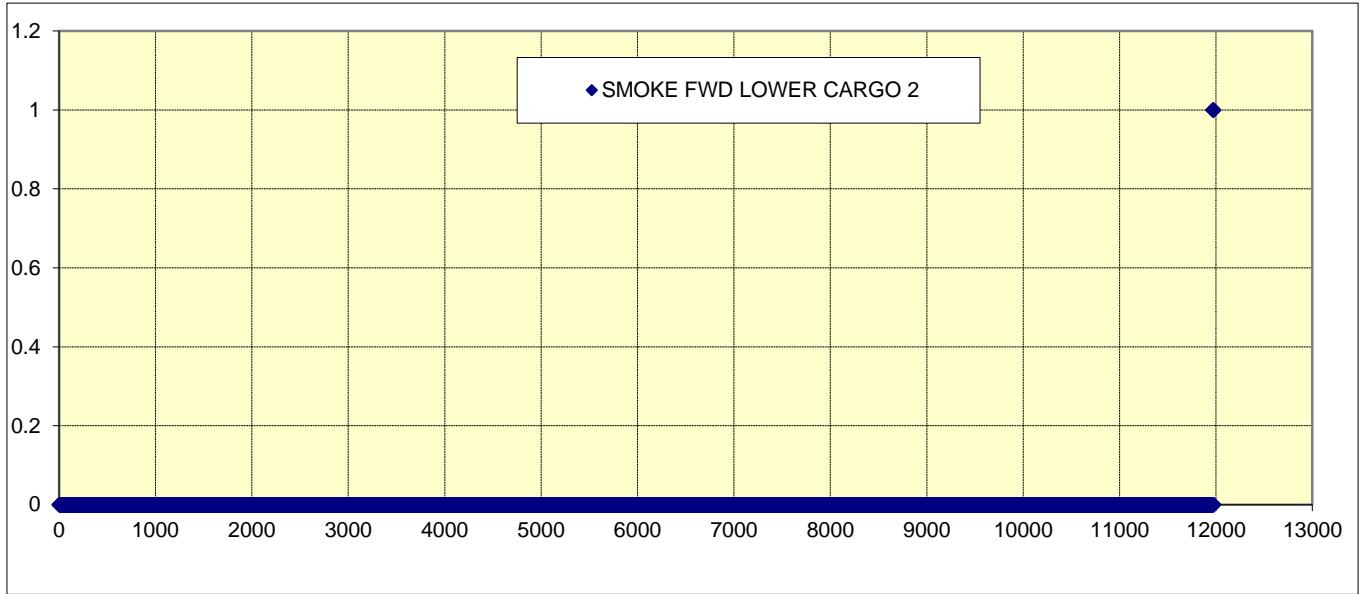
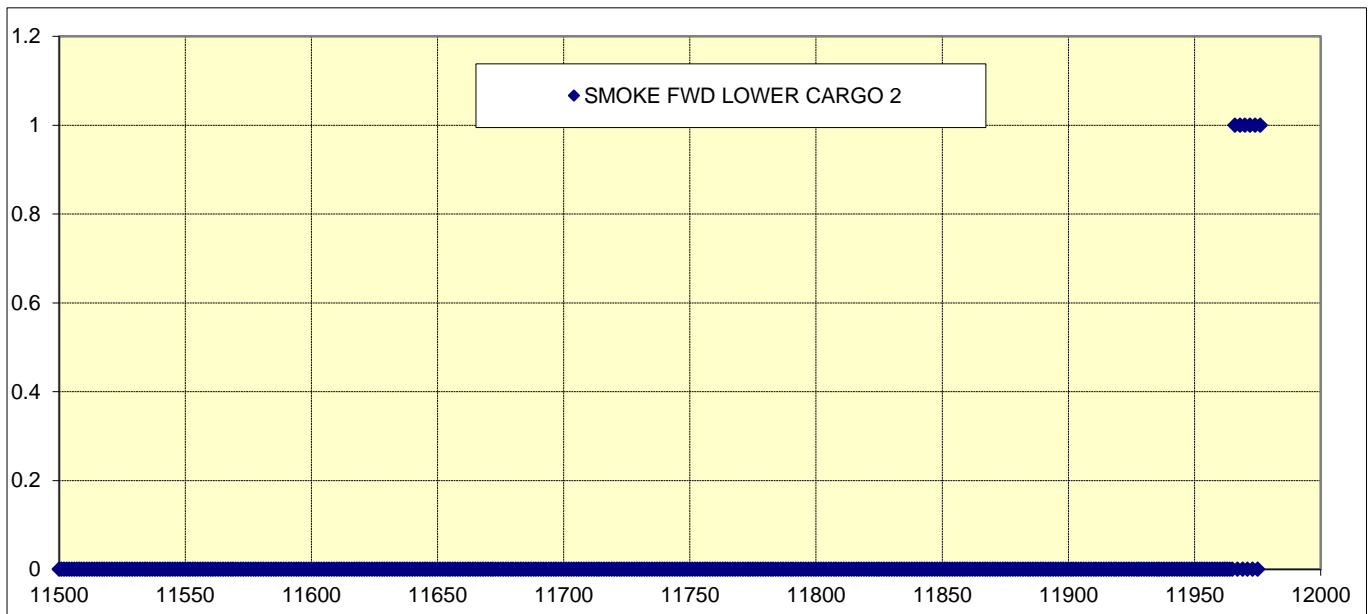
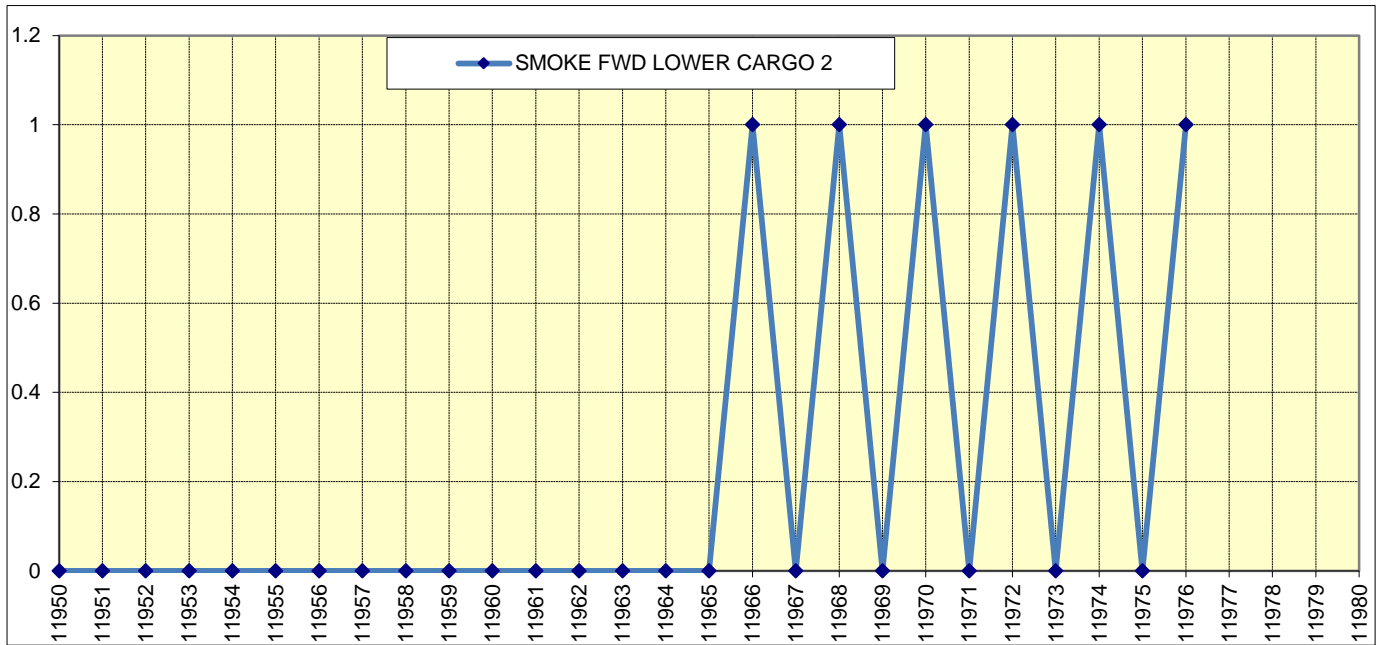
- SMOKE FWD LOWER CARGO 2  
(1 smoke warning)

SMOKE FWD LOWER CARGO 2 shown at the end portion of recording

SMOKE FWD LOWER CARGO 2 very close to the recording end

Smoke FWD lower cargo 2 showed smoke six times in the interval between 00:29:34 UTC (11965 seconds plot time) and the end of recording 00:29:45 UTC (11976 seconds plot time)

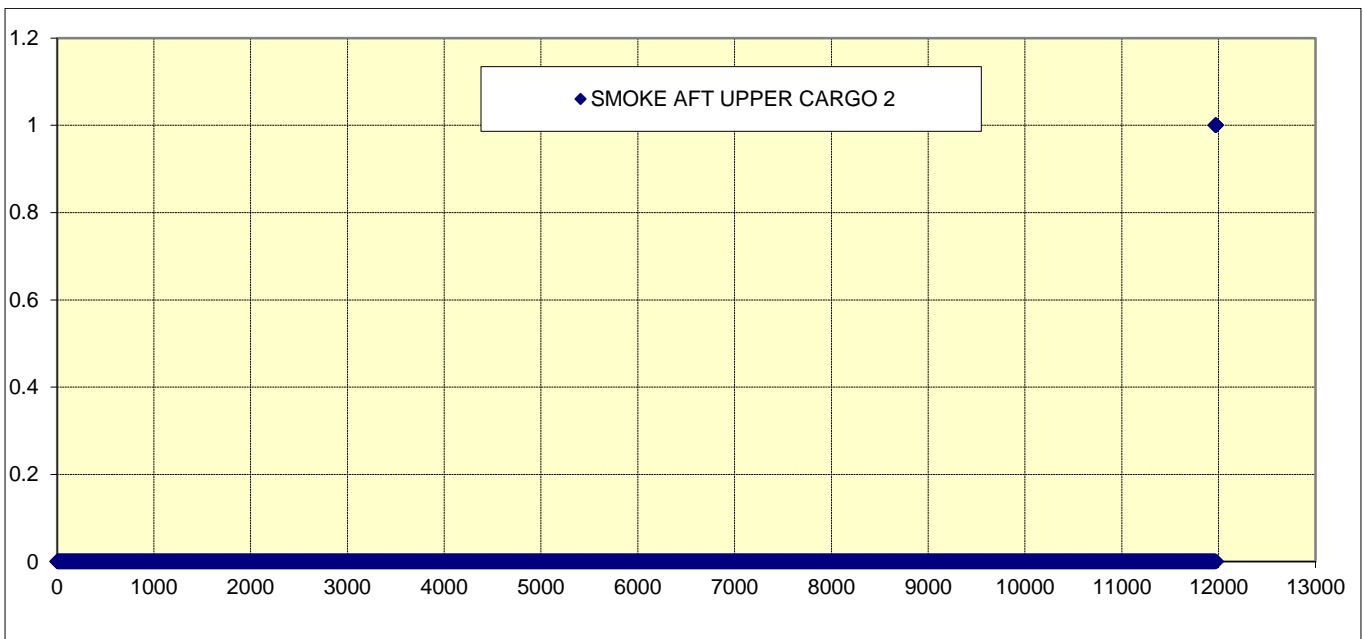
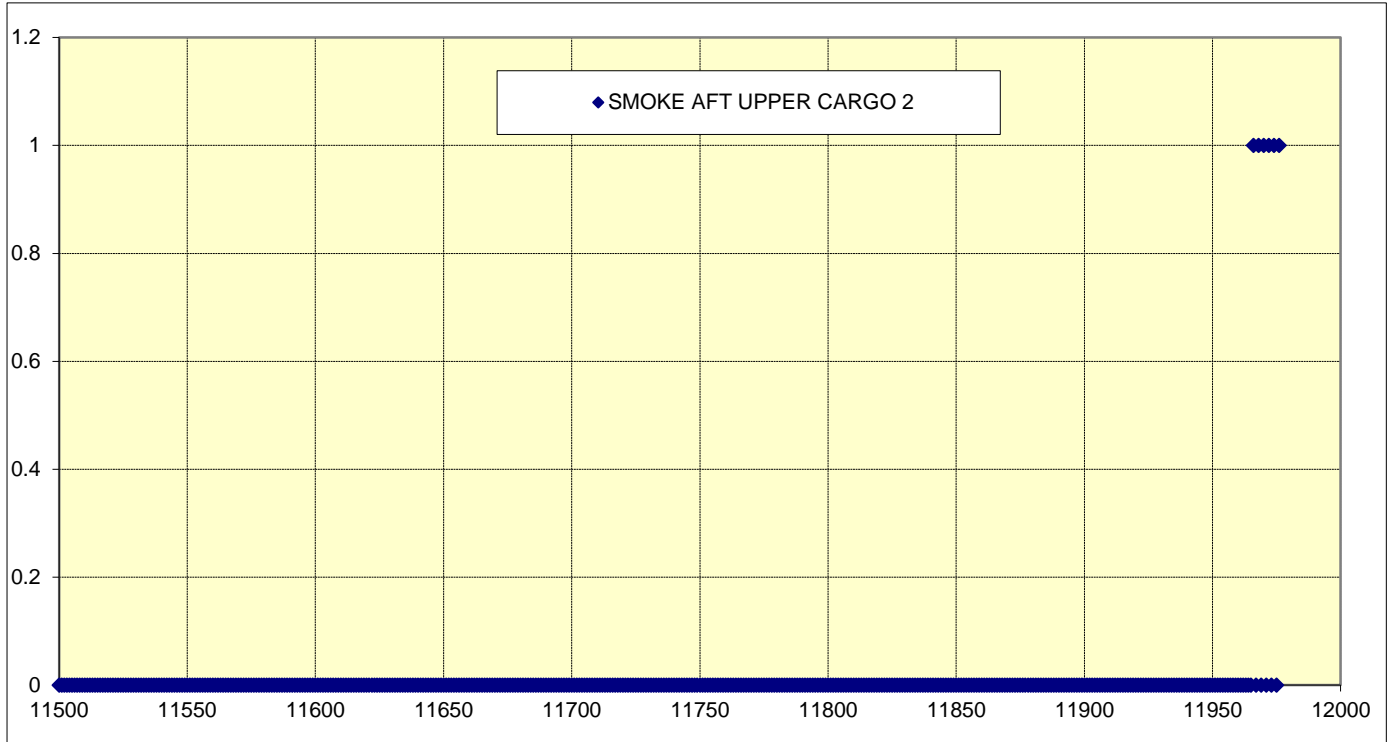
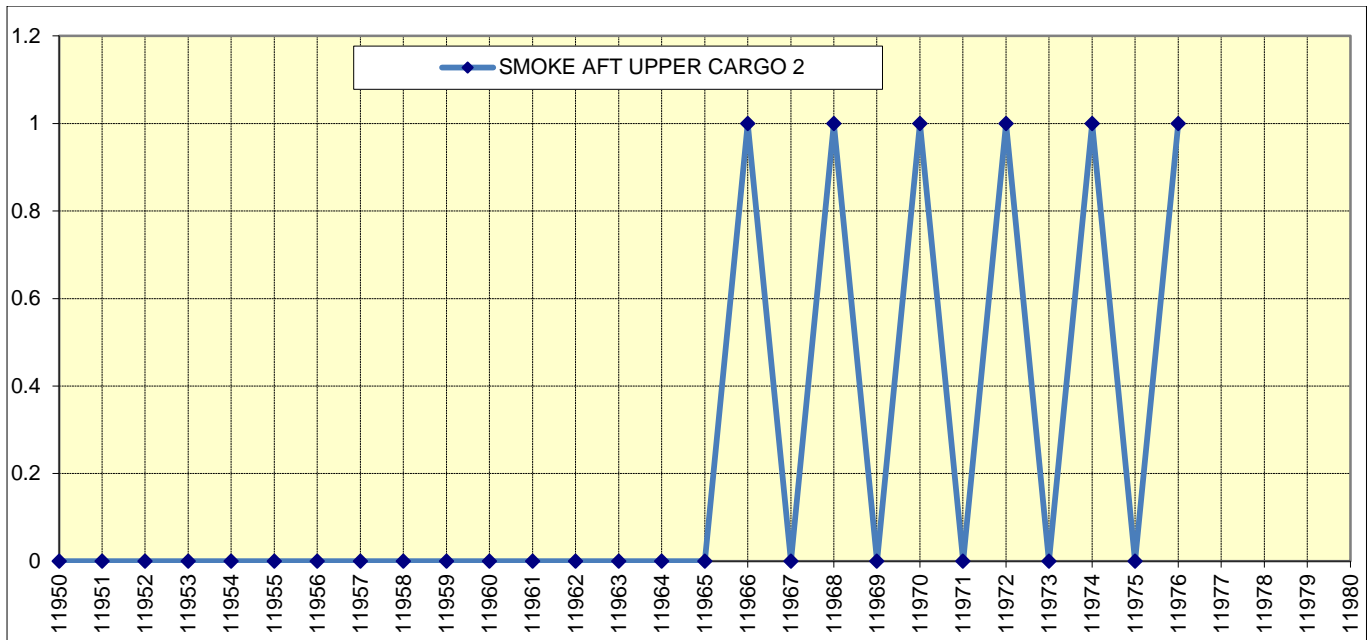
- SMOKE AFT UPPER CARGO 2

SMOKE AFT UPPER CARGO 2 t the end portion of recording

SMOKE AFT UPPER CARGO 2 very close to the recording end

Smoke AFT UPPER cargo 2 showed smoke six times in the interval between 00:29:34 UTC (11965 seconds plot time) and the end of recording 00:29: 45 UTC (11976 seconds plot time)

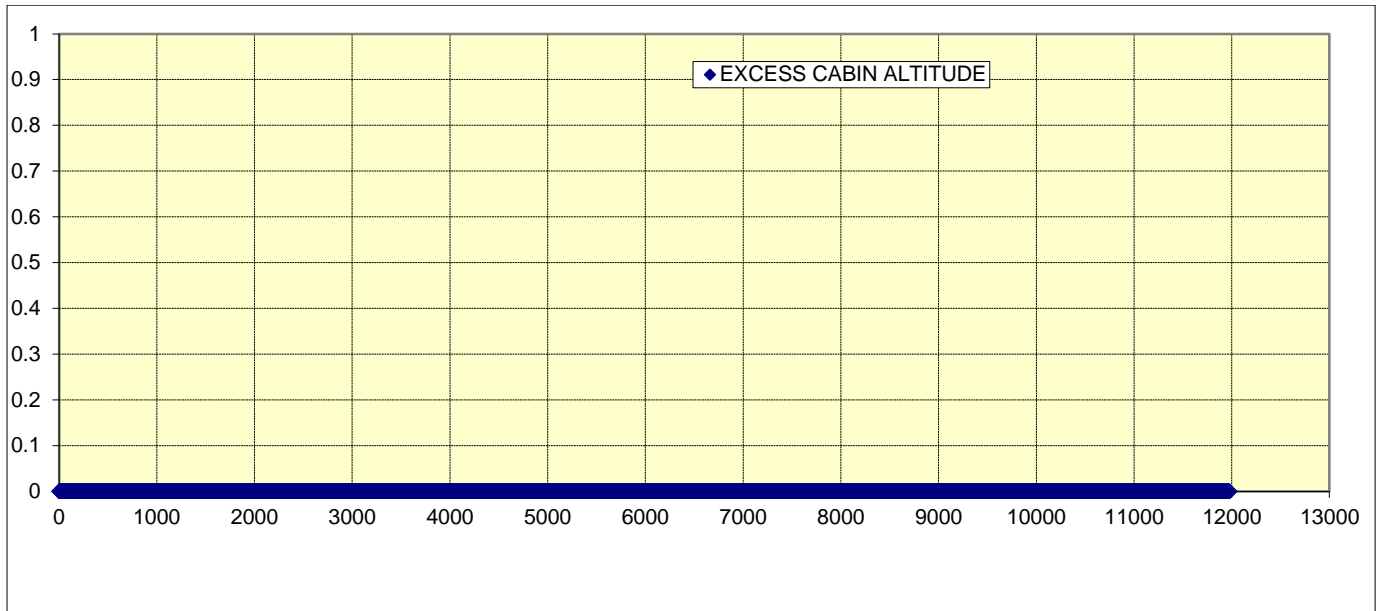
- EXCESS CABIN ALTITUDE

No Cabin Altitude Excess

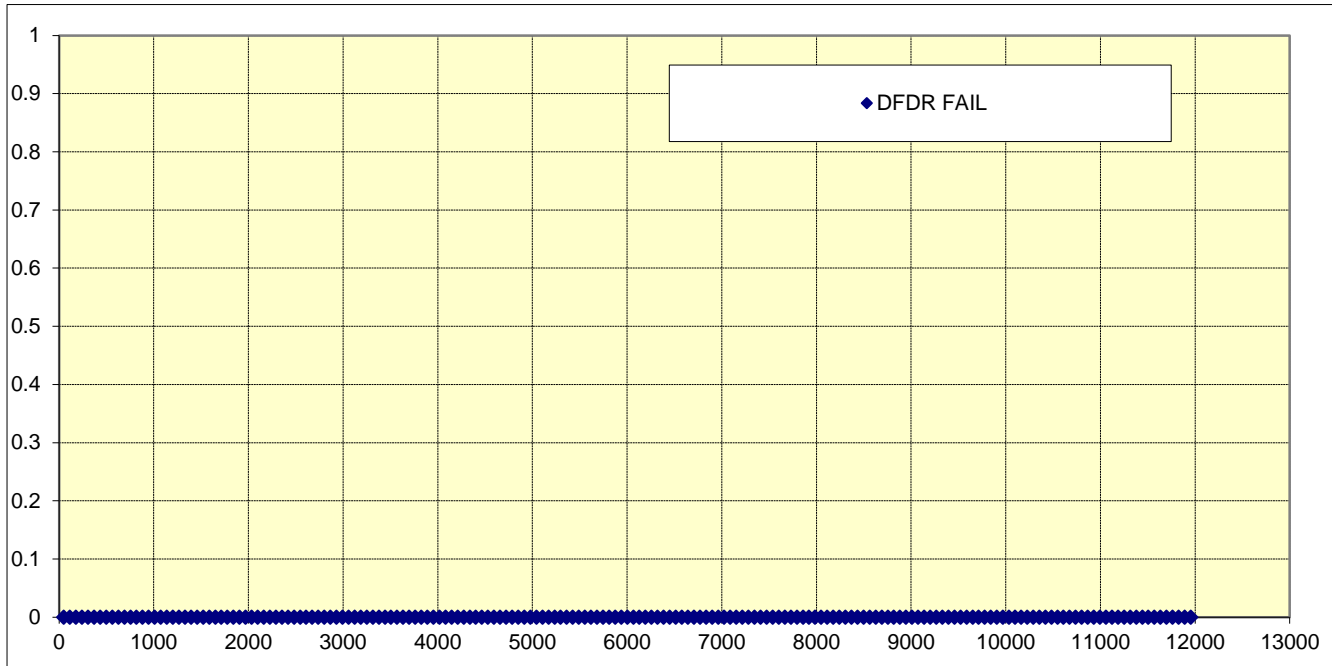
- DFDR FAIL (Digital Flight Data Recorder Fail)

- No detected failure up to the end of the valid data

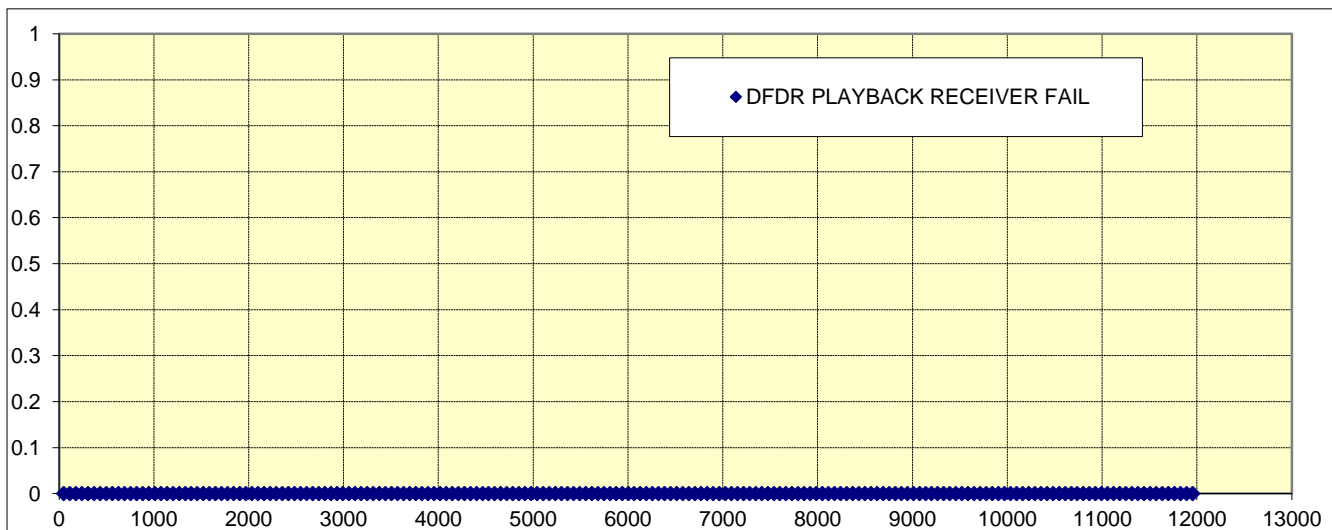
- DFDR PLAYBACK RECEIVER FAIL (Digital Flight Data Recorder Playback receiver fail)

- No detected failure up to the end of the valid data

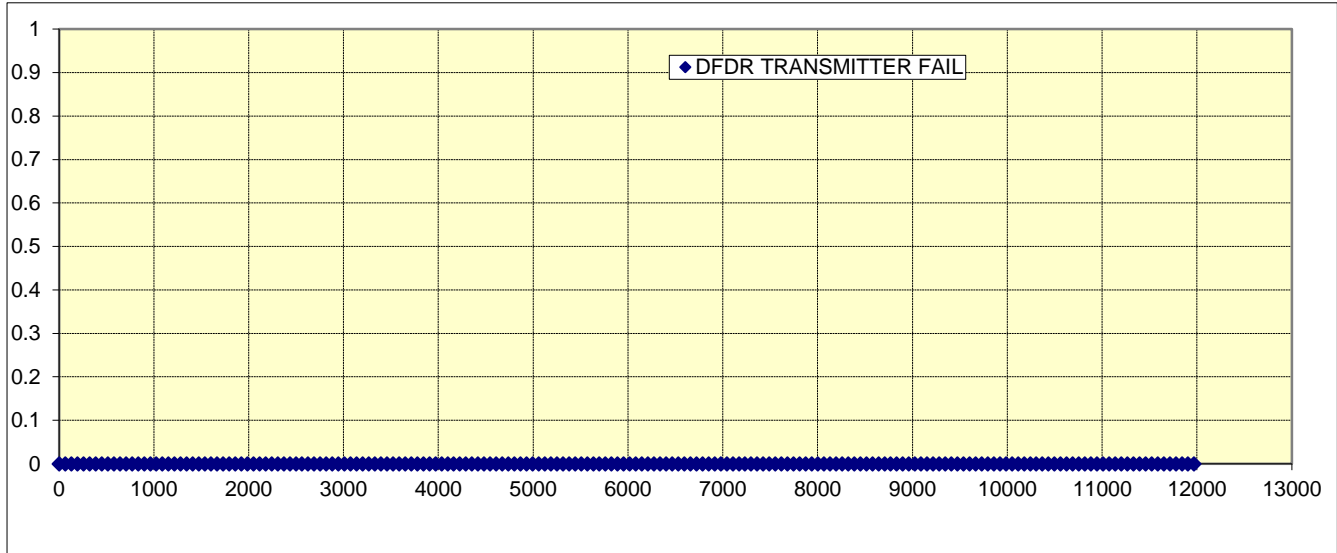
- DFDR TRANSMITTER FAIL (Digital Flight Data Recorder Transmitter fail)

- No detected failure up to the end of the valid data

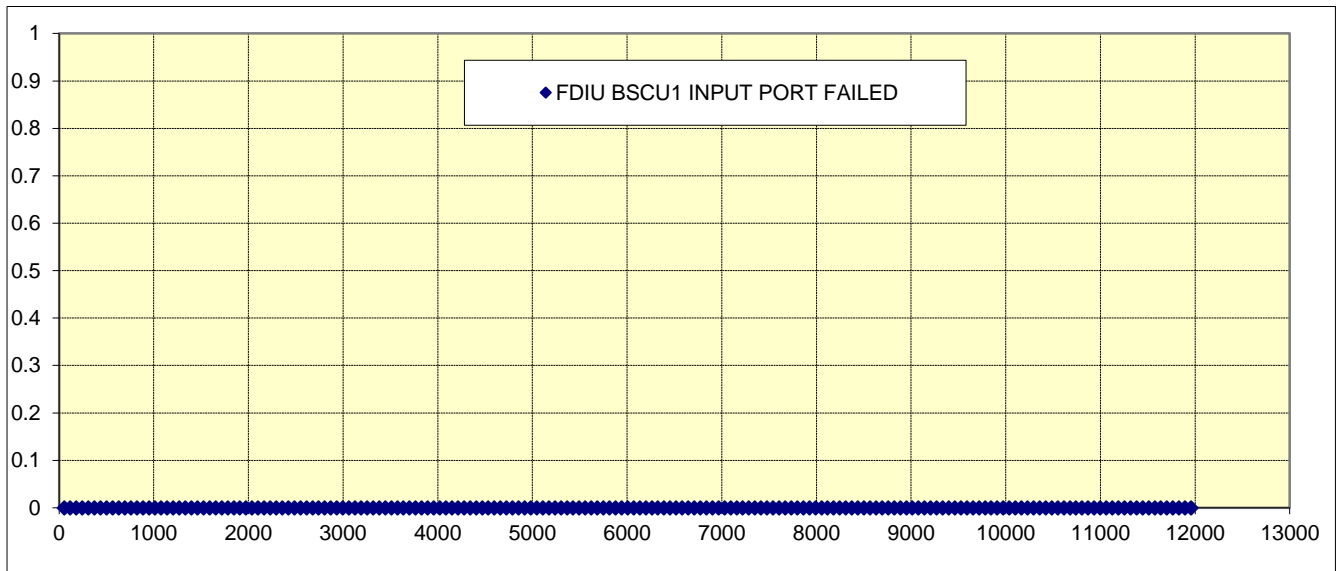
- FDIU BSCU1 INPUT PORT FAILED (Flight Data Interface Unit Braking/Steering Control Unit 1 input port failed)

- No detected failure up to the end of the valid data

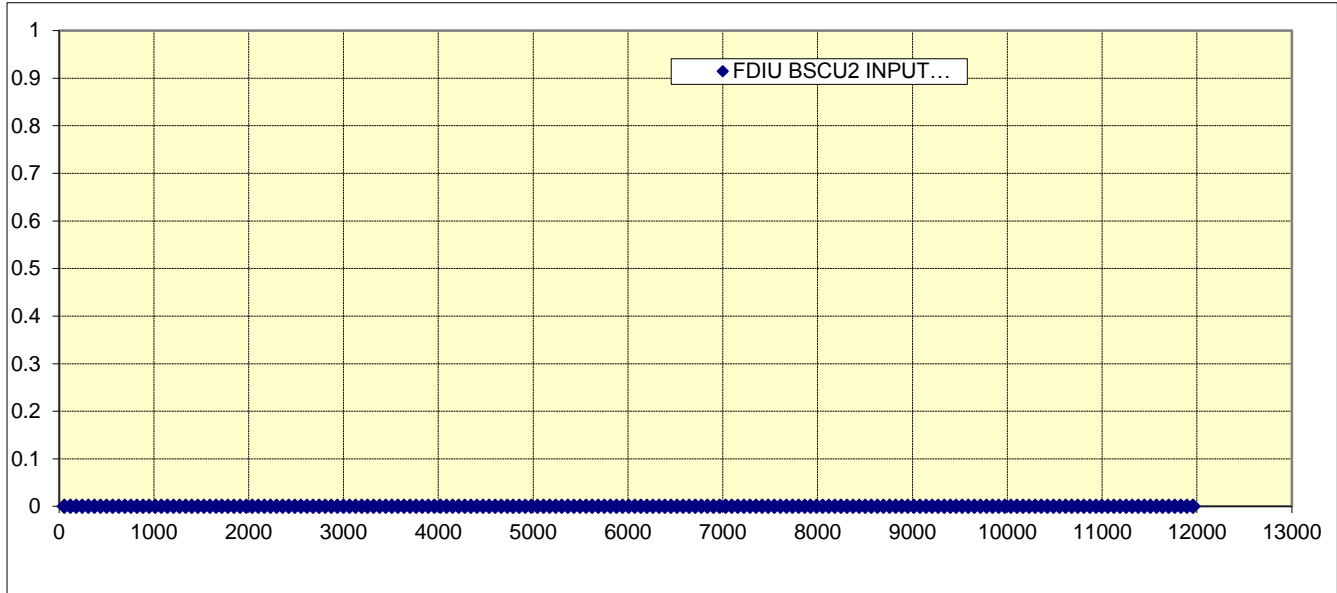
- FDIU BSCU2 INPUT PORT FAILED (Flight Data Interface Unit Braking/Steering Control Unit 2 input port failed)

- No detected failure up to the end of the valid data

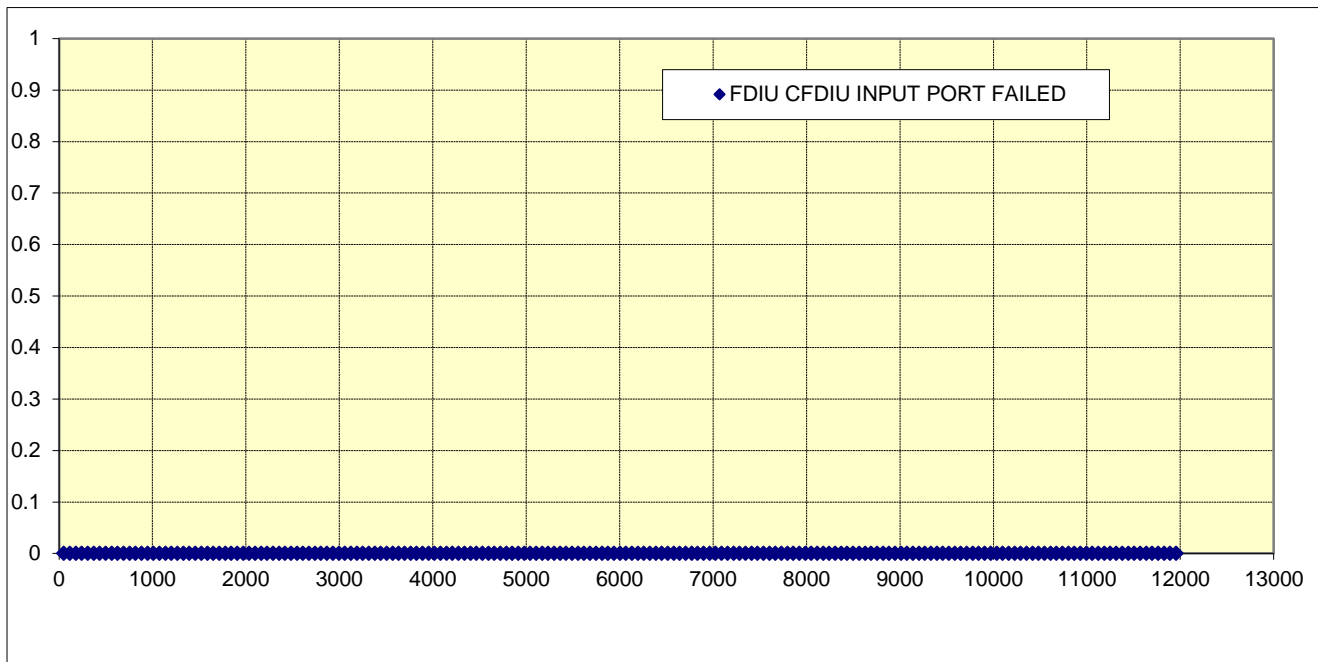
- FDIU CFDIU INPUT PORT FAILED (Flight Data Interface Unit Centralized Fault Display Interface Unit input port failed)

- No detected failure up to the end of the valid data

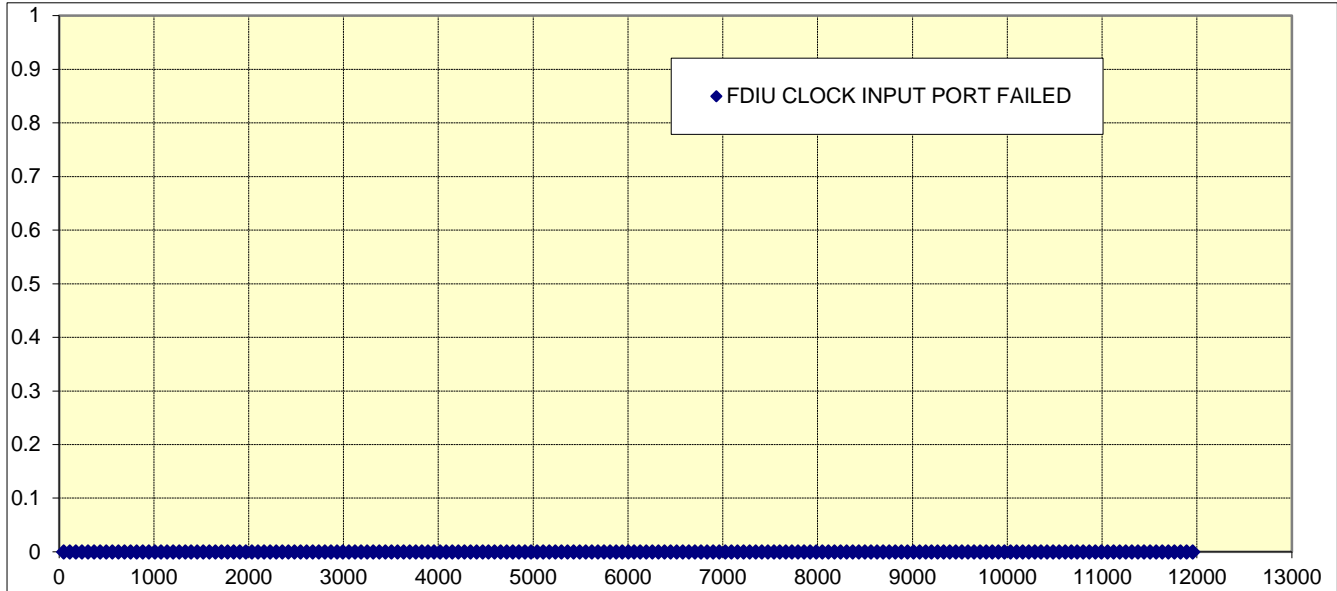
- FDIU CLOCK INPUT PORT FAILED (Flight Data Interface Unit Clock input port failed)

- No detected failure up to the end of the valid data

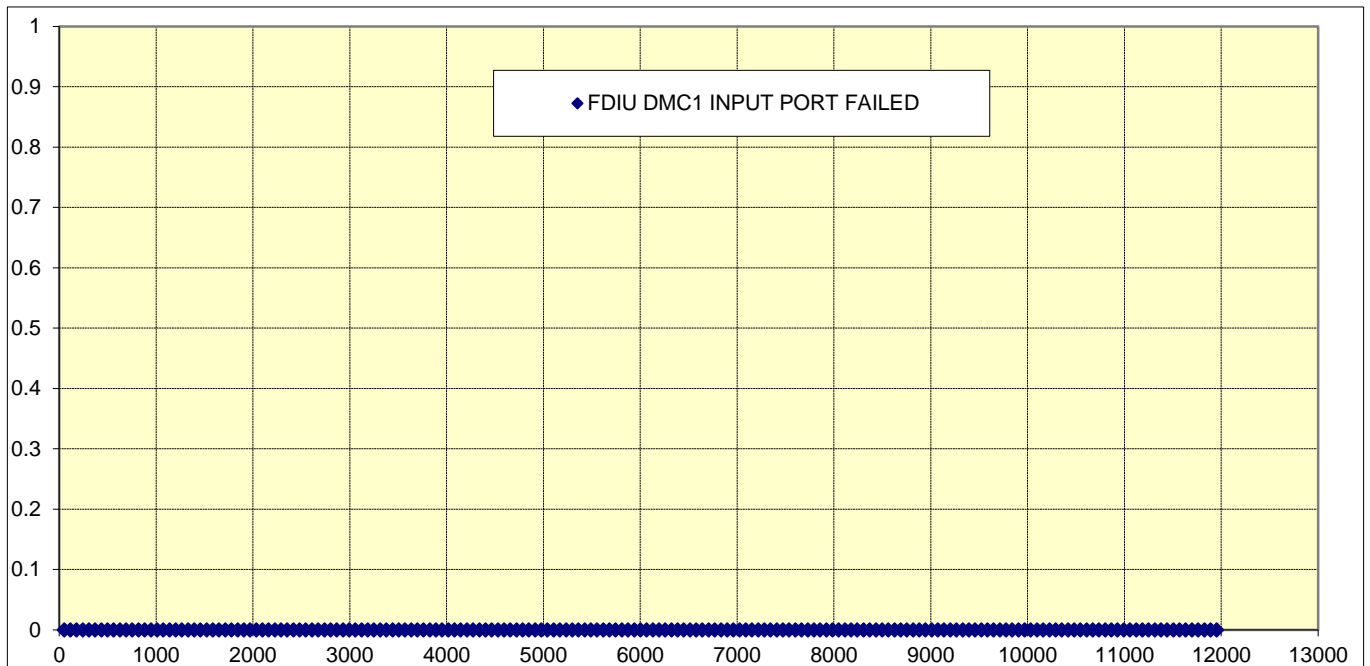
- FDIU DMC1 INPUT PORT FAILED (Flight Data Interface Unit Display Management Computer 1 input port failed)

- No detected failure up to the end of the valid data

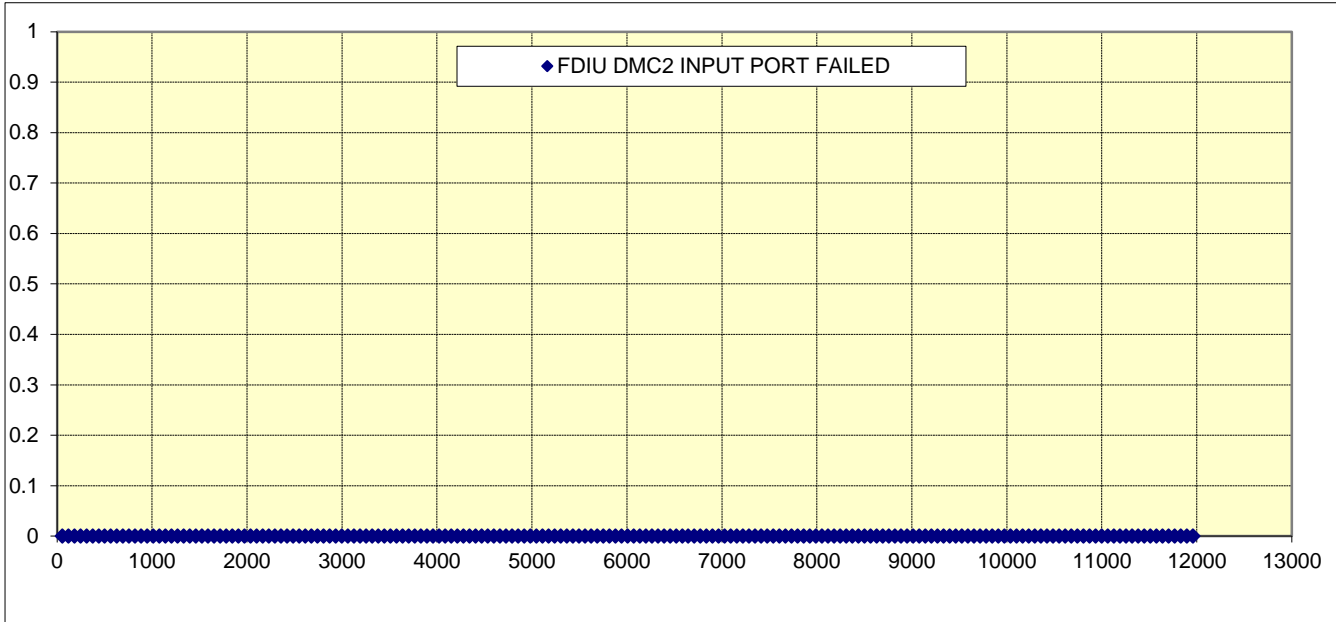
- FDIU DMC2 INPUT PORT FAILED (Flight Data Interface Unit Display Management Computer 1 input port failed)

- No detected failure up to the end of the valid data

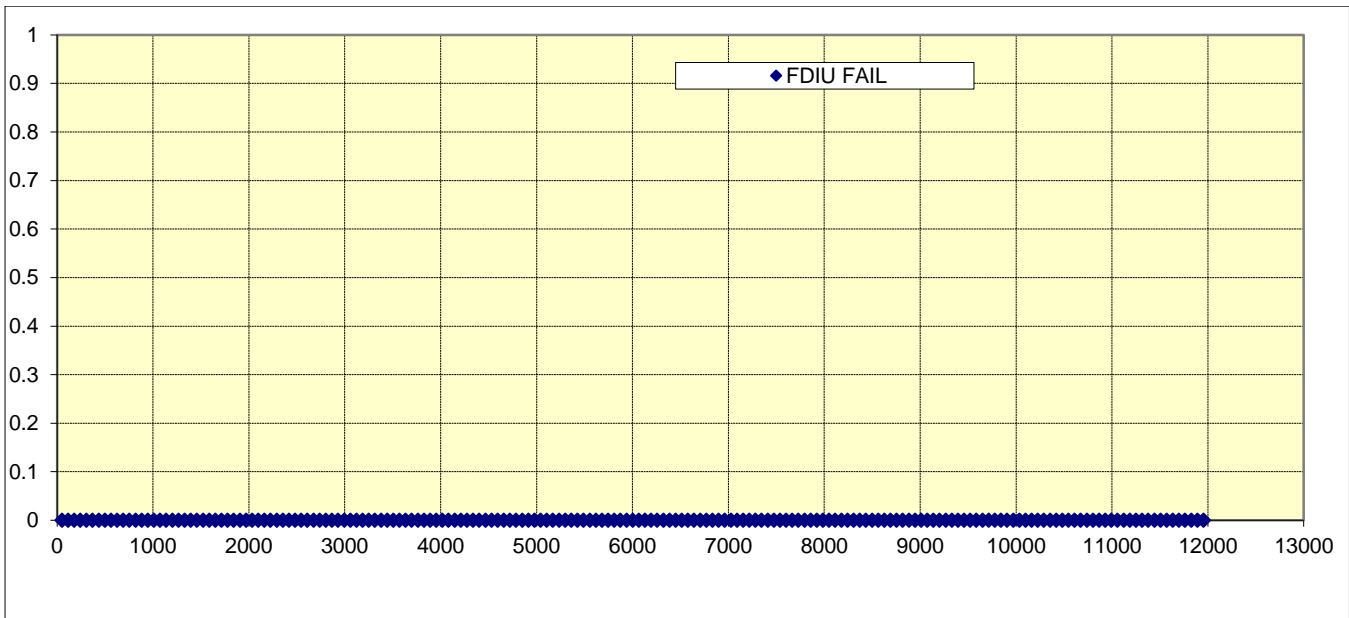
- FDIU FAIL (Flight Data Interface Unit)

- No detected failure up to the end of the valid data

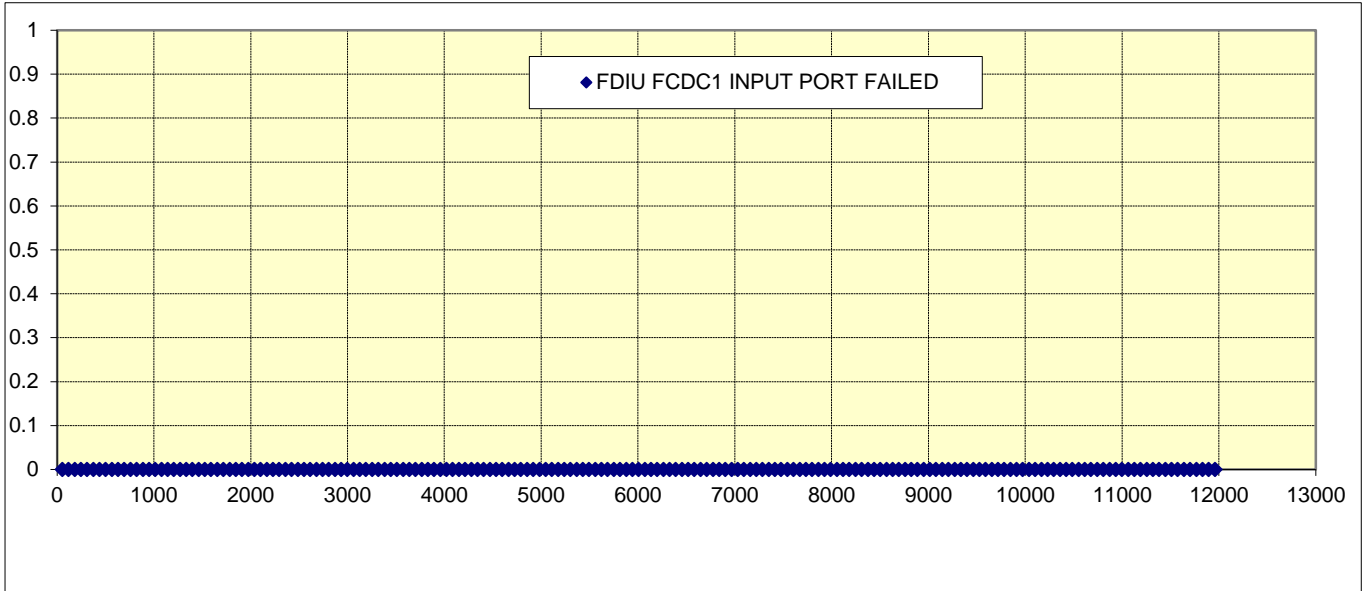
- FDIU FCDC1 INPUT PORT FAILED (Flight Data Interface UnitFlight Control Data Concentrator 1 failed)

- No detected failure up to the end of the valid data

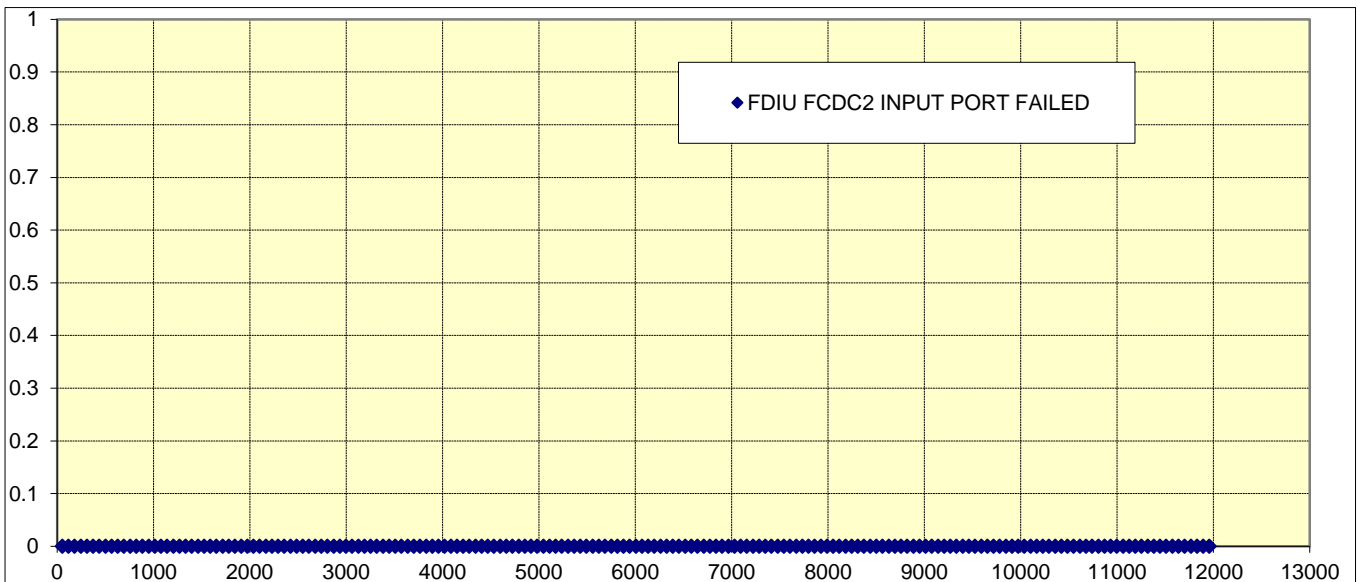
- FDIU FCDC2 INPUT PORT FAILED (Flight Data Interface UnitFlight Control Data Concentrator 2 failed)

- No detected failure up to the end of the valid data

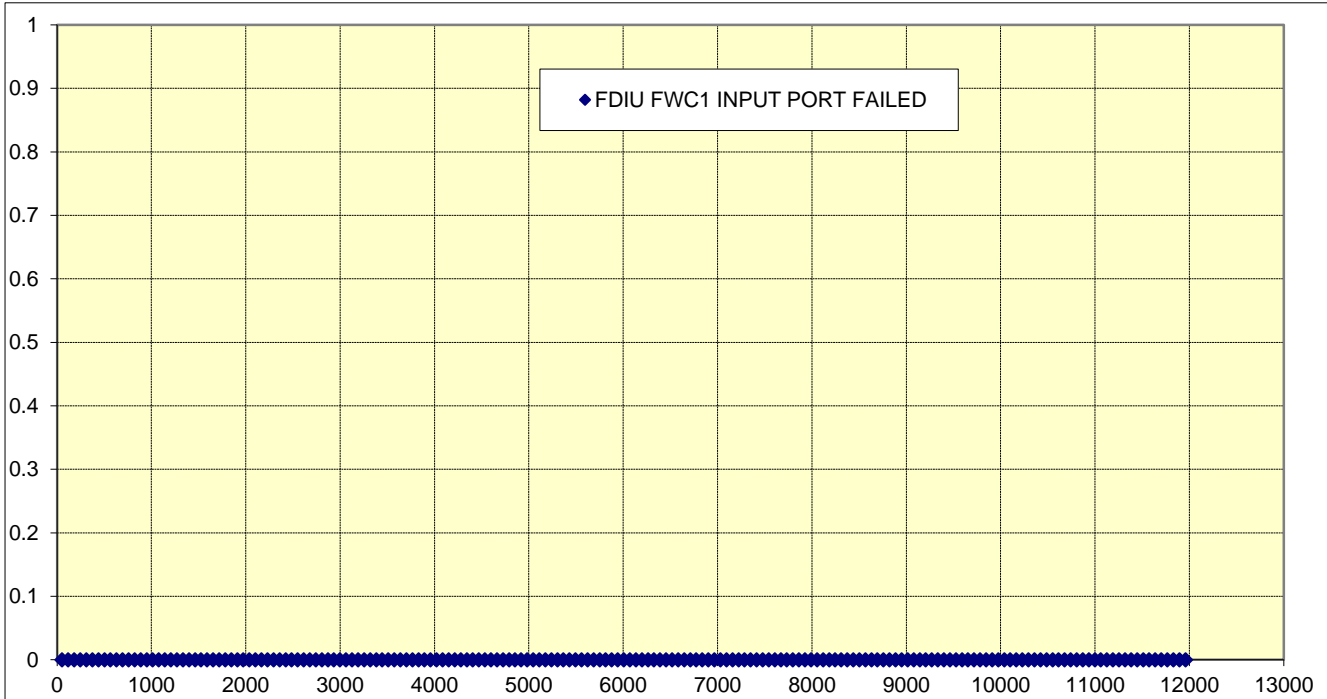
- FDIU FWC1 INPUT PORT FAILED (Flight Data Interface Unit Flight Warning Computer 1 failed)

- No detected failure up to the end of the valid data

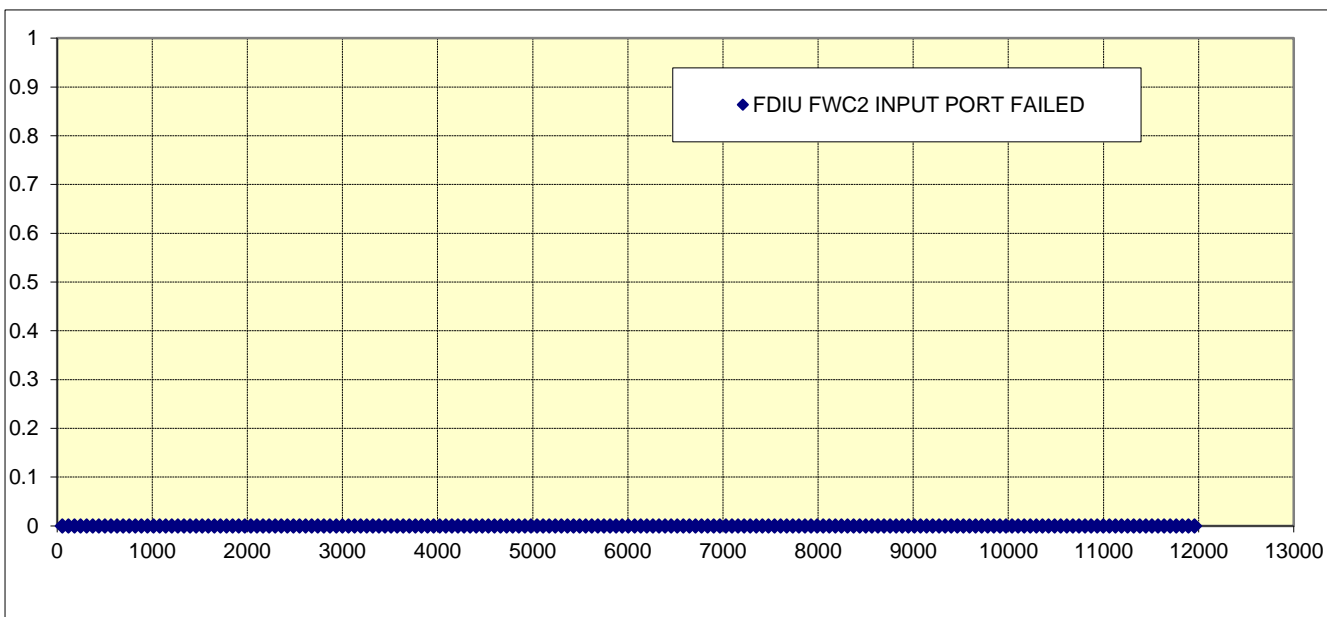
- FDIU FWC2 INPUT PORT FAILED (Flight Data Interface Unit Flight Warning Computer 2 failed)

- No detected failure up to the end of the valid data

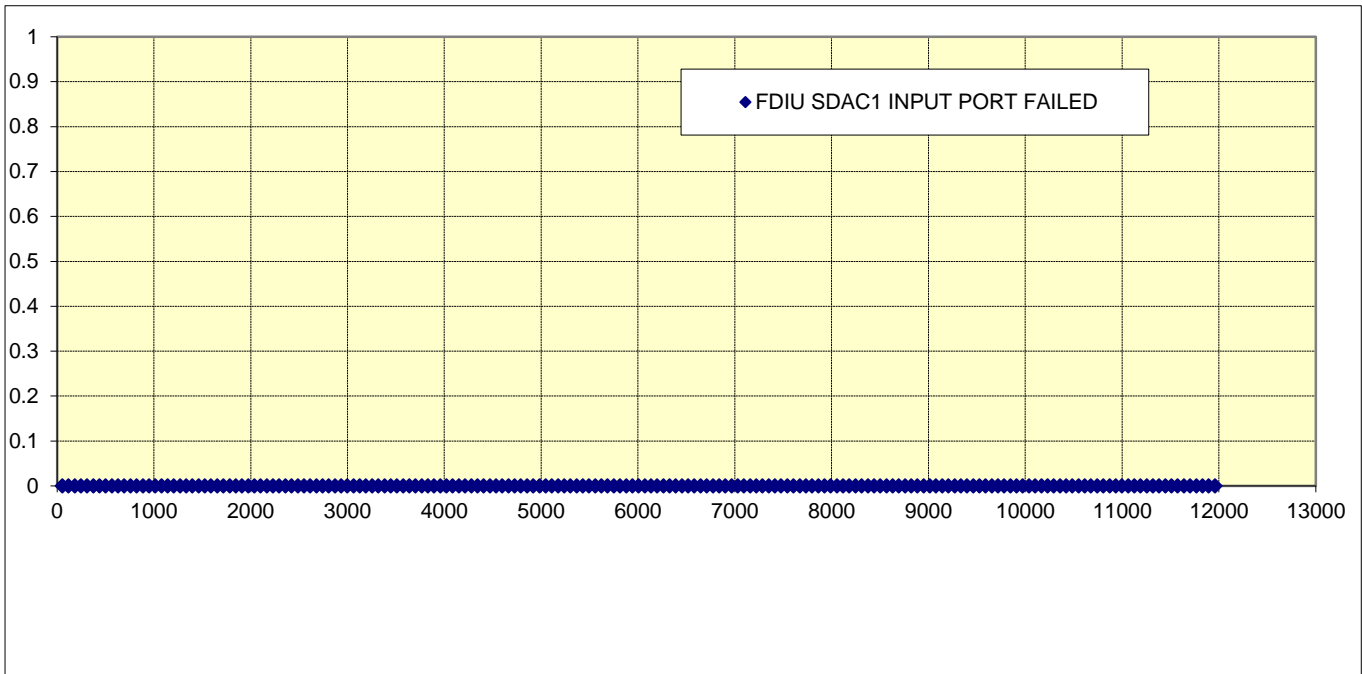
- FDIU SDAC1 INPUT PORT FAILED (Flight Data Interface Unit System Data Analog Converter 1 failed)

- No detected failure up to the end of the valid data

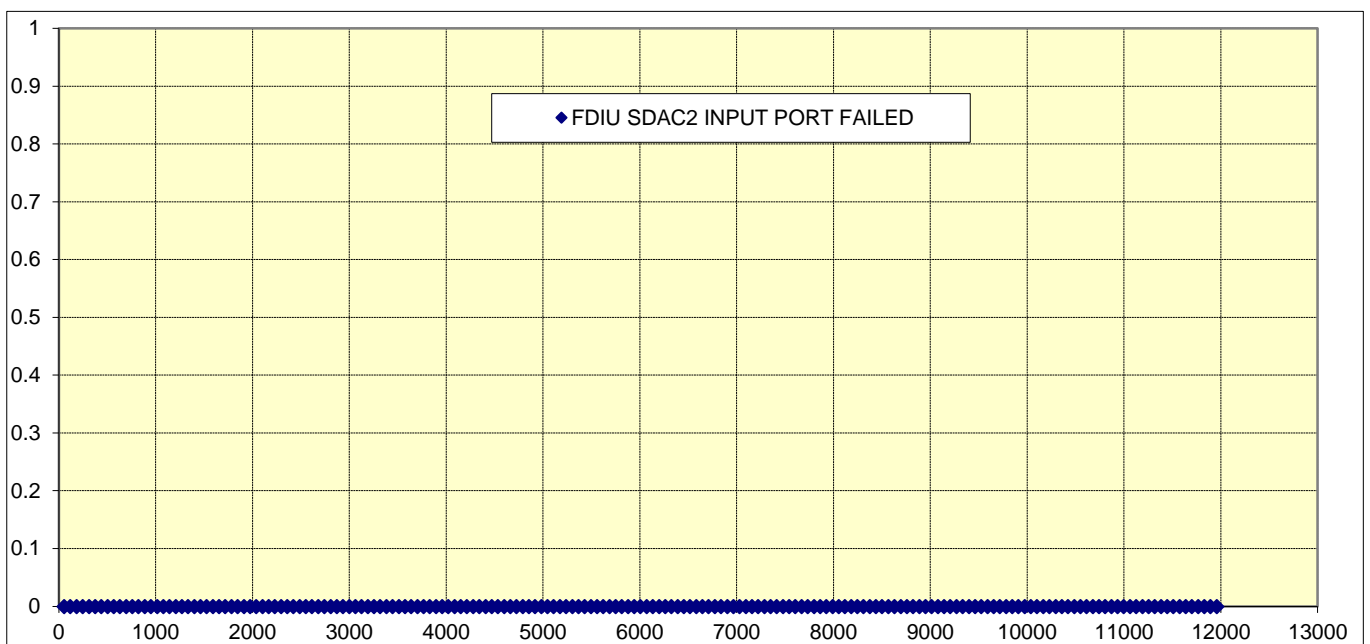
- FDIU SDAC2 INPUT PORT FAILED (Flight Data Interface Unit System Data Analog Converter 1 failed)

- No detected failure up to the end of the valid data
