## Final Report

**EgyptAir A320 Aircraft crash in the Mediterranean, registered SU-GCC,  
flight number MSR804, from Charles De-Gaulle Airport, Paris to Cairo  
International Airport, on 19/05/2016**

EGAI2016-01

October 2024

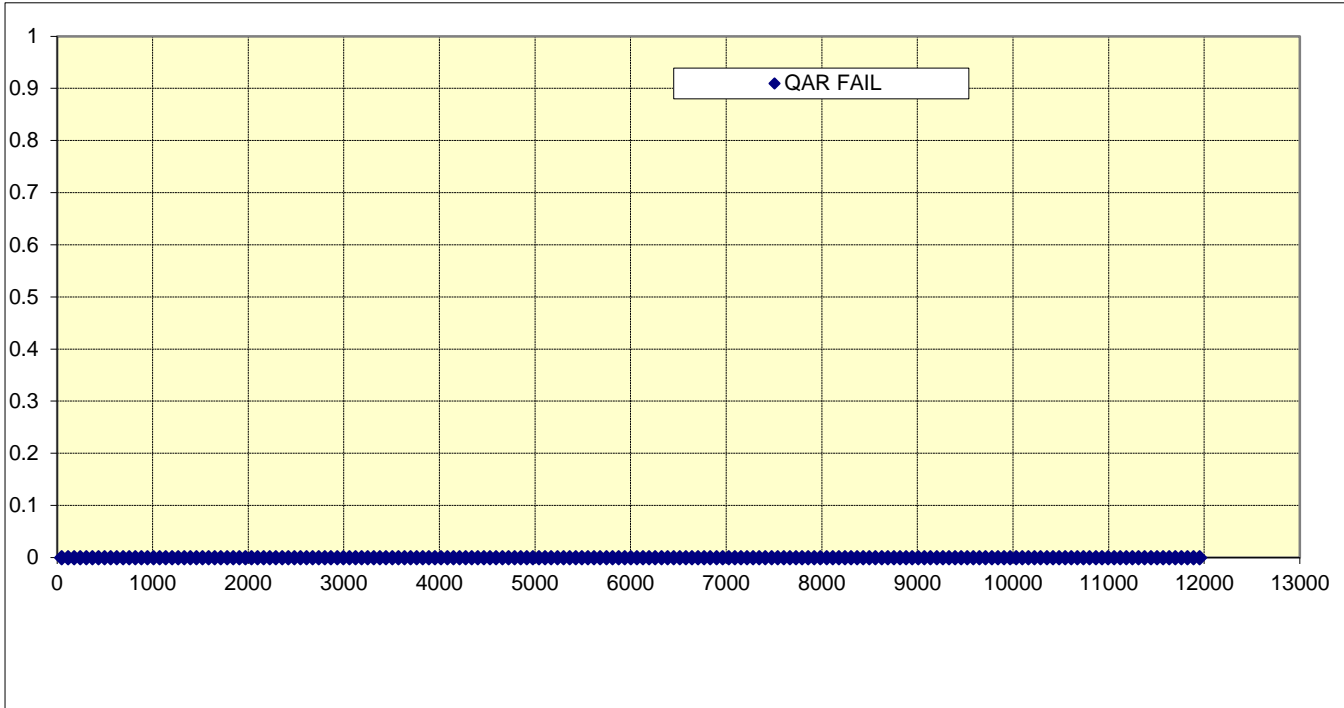
- QAR FAIL (Quick Access Recorder)

- No detected failure up to the end of the valid data

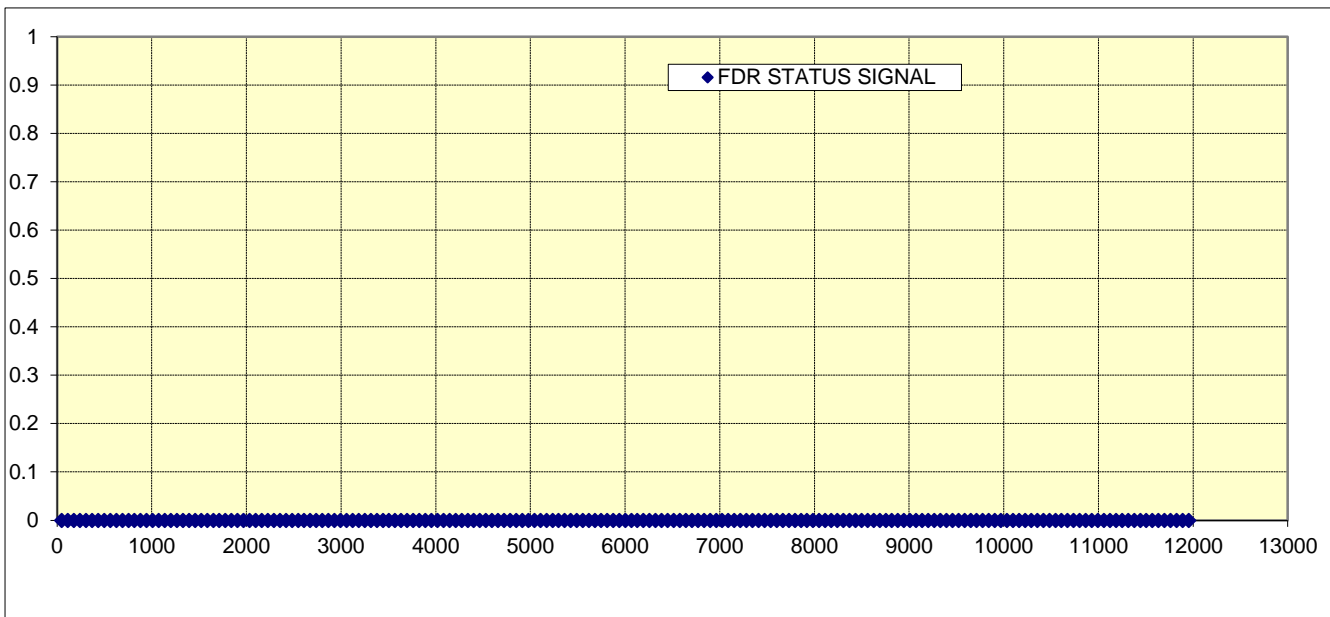
- FDR STATUS SIGNAL (Flight Data Recorder Status Signa)

- No detected failure up to the end of the valid data

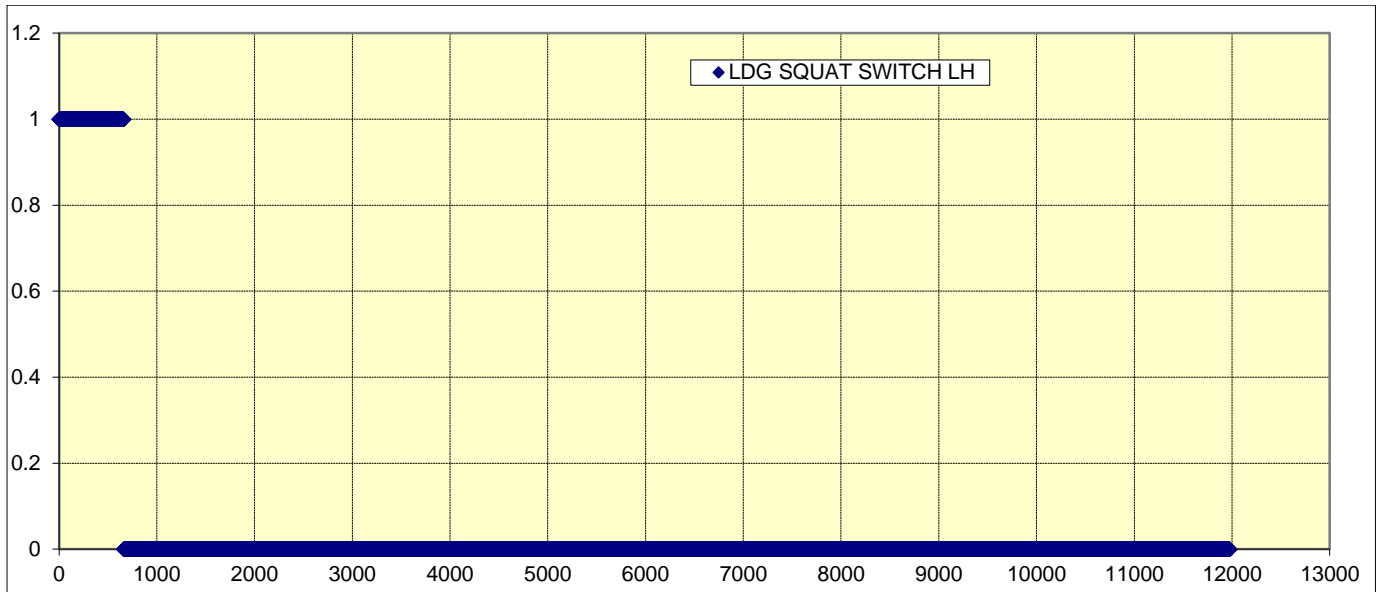
### - LDG SQUAT SWITCH LH

LDG LH Squat switch changed status from ground to flight at 21:21:10 UTC (661 seconds on the plot)

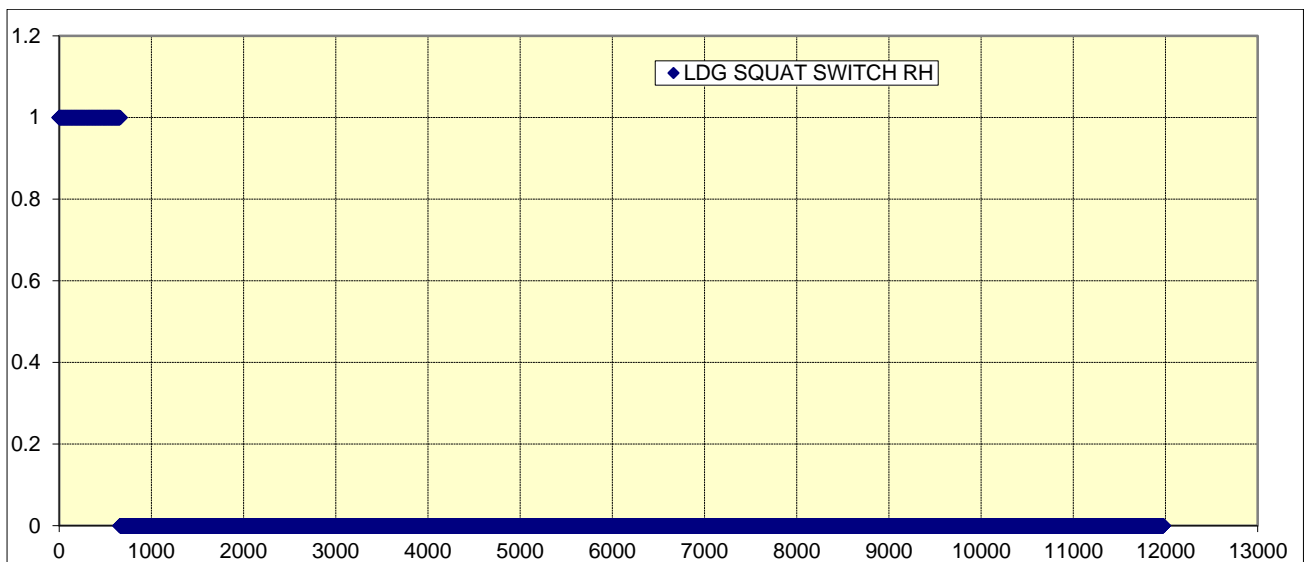
### - LDG SQUAT SWITCH RH

LDG RH Squat switch changed status from ground to flight at 21:21:09 UTC (660 seconds on the plot)

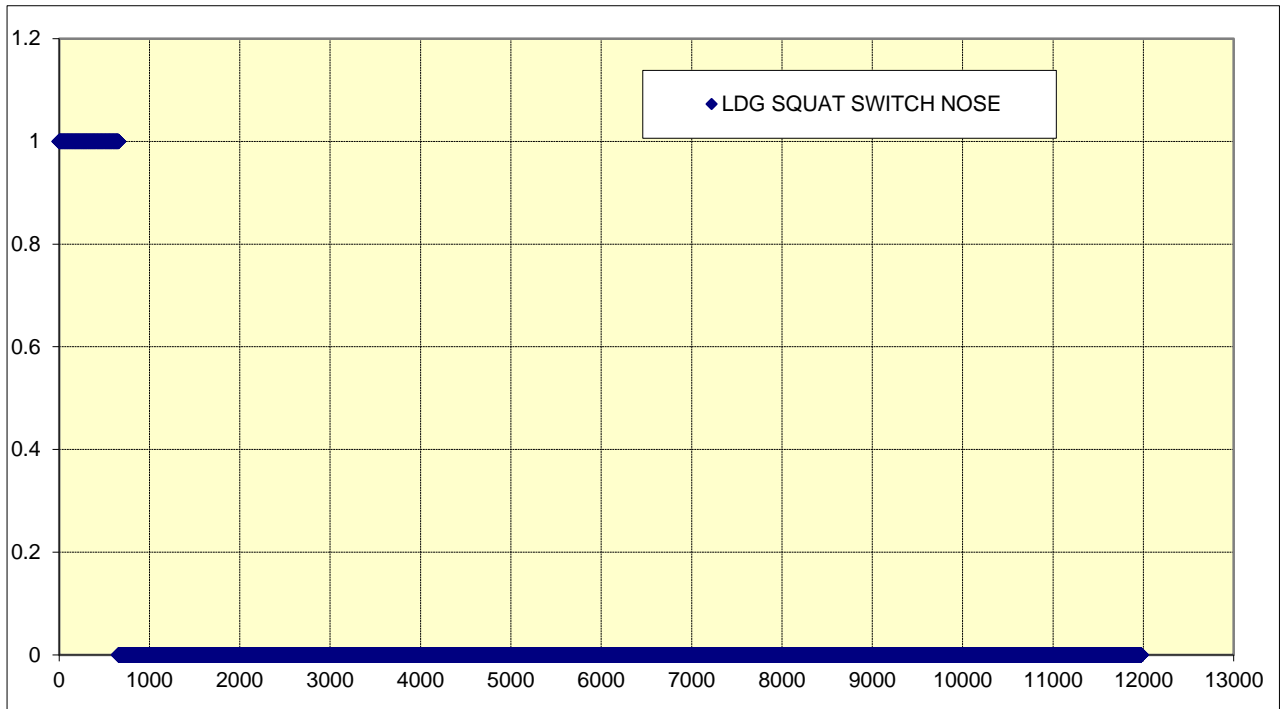
- LDG SQUAT SWITCH NOSE

LDG NOSE Squat switch changed status from ground to flight at 21:21:06 UTC (657 seconds on the plot)

No anomalies detected with the landing gear position

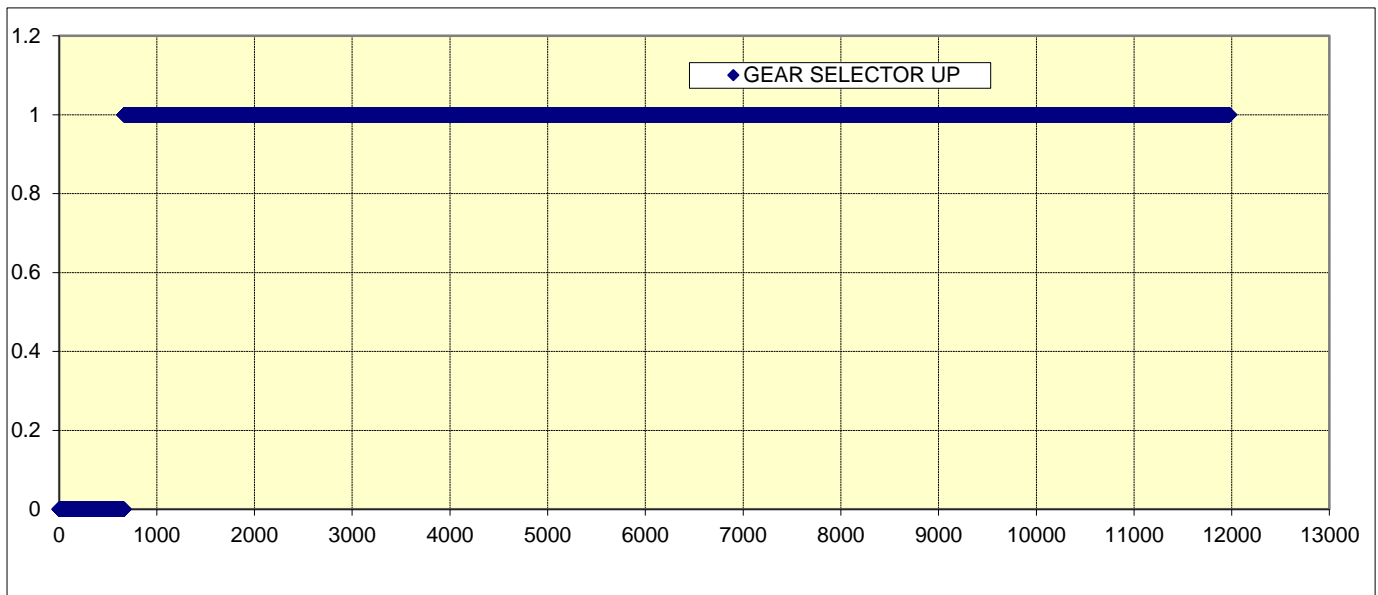
- GEAR SELECTOR UP

The L/G lever was selected up at 21:21:14 UTC (665 seconds on the plot)

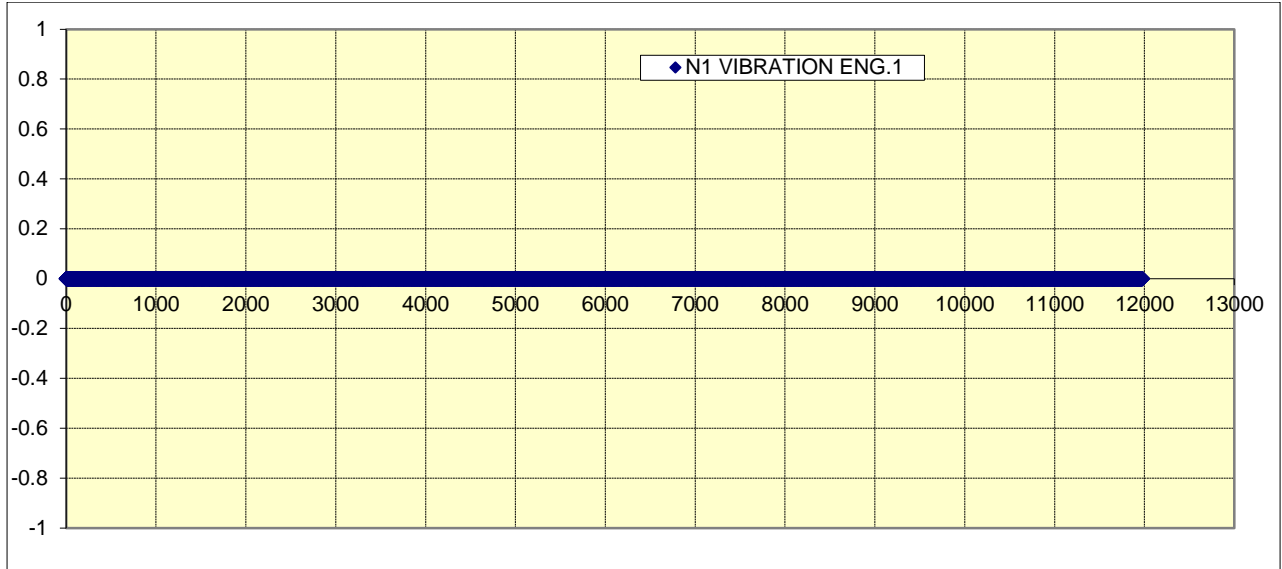
(4 - N1 VIBRATION ENG.1

N1 VIBRATION ENG.1 was 0 throughout the whole recording

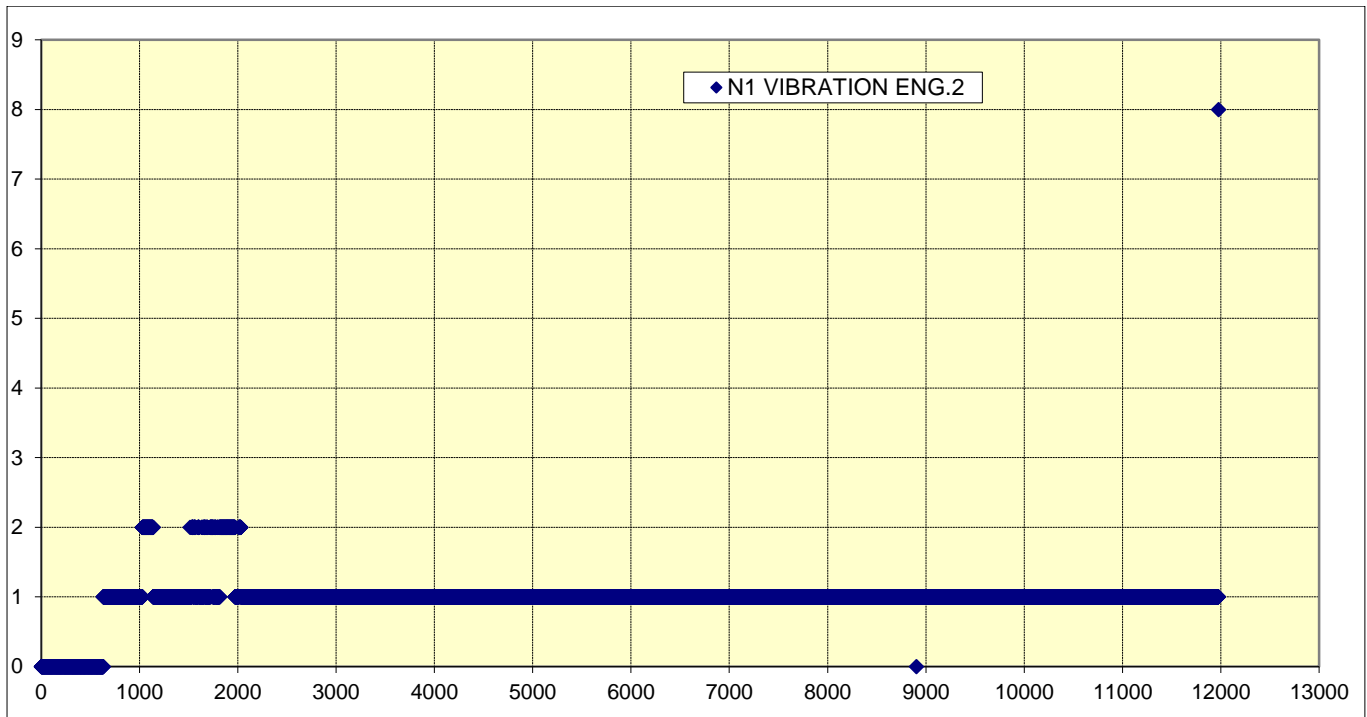
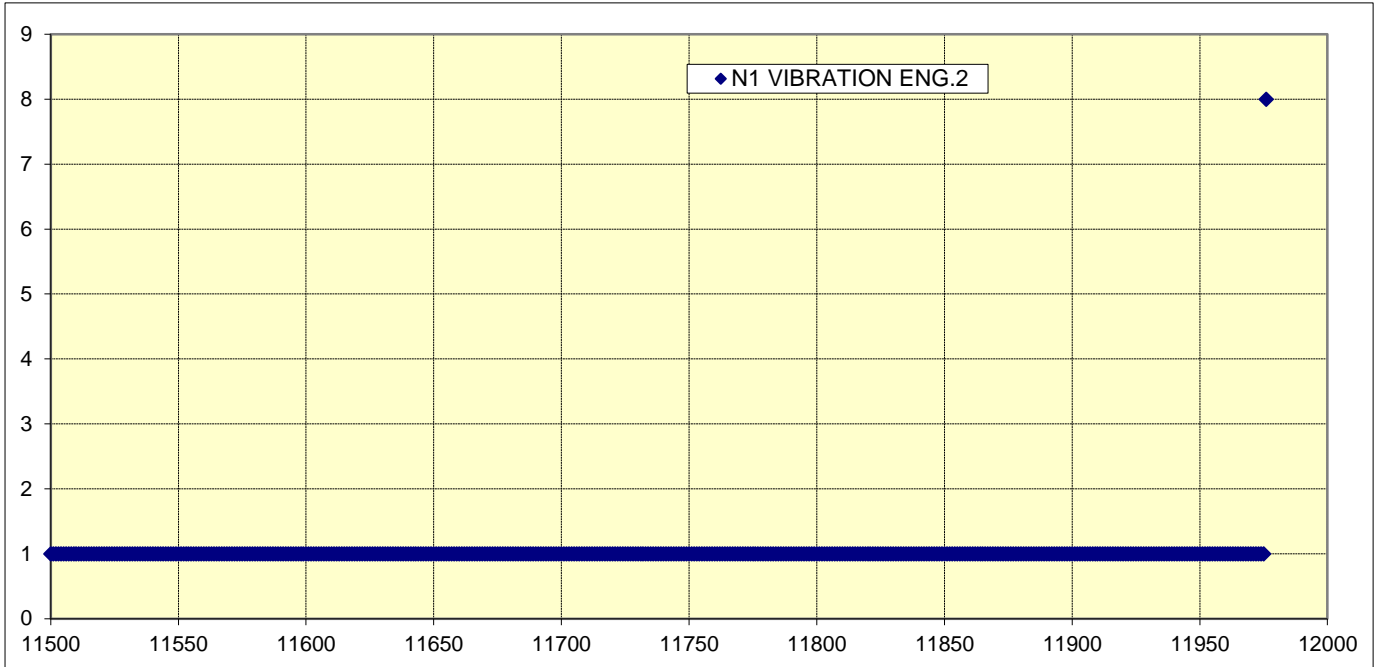
(5 - N1 vibration Engine 2

ENG 2 Vibration N1 shown at the end portion of the recording

Only at one point 00:29:45 (11976 seconds on the plot) the ENG 2 Vibration N1 value changed from 0 to 8

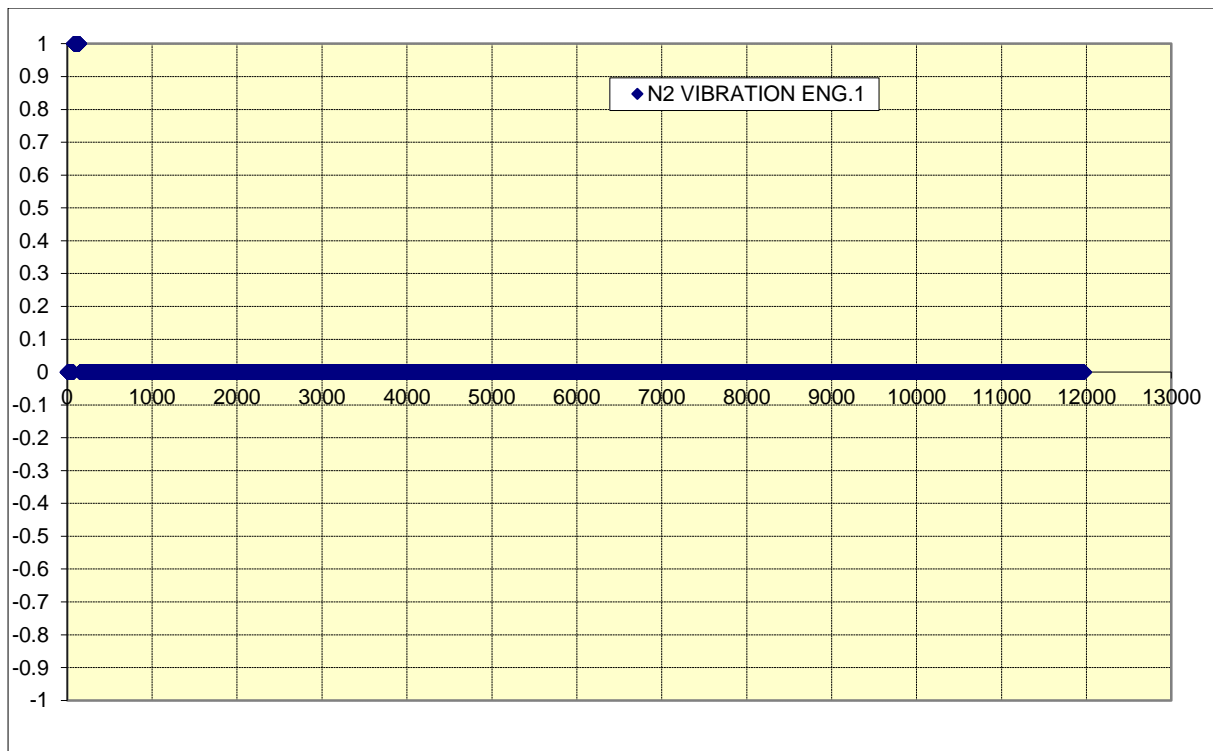
(6 - N2 VIBRATION ENG.1

N2 VIBRATION ENG.1 was 0 throughout the whole recording

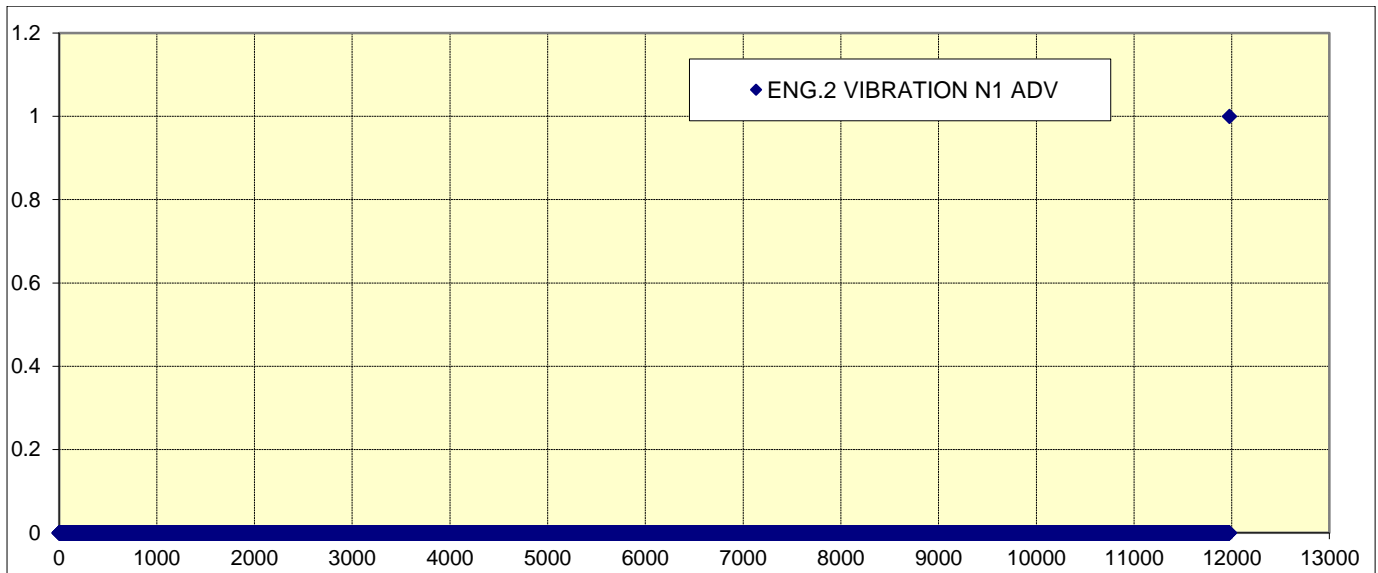
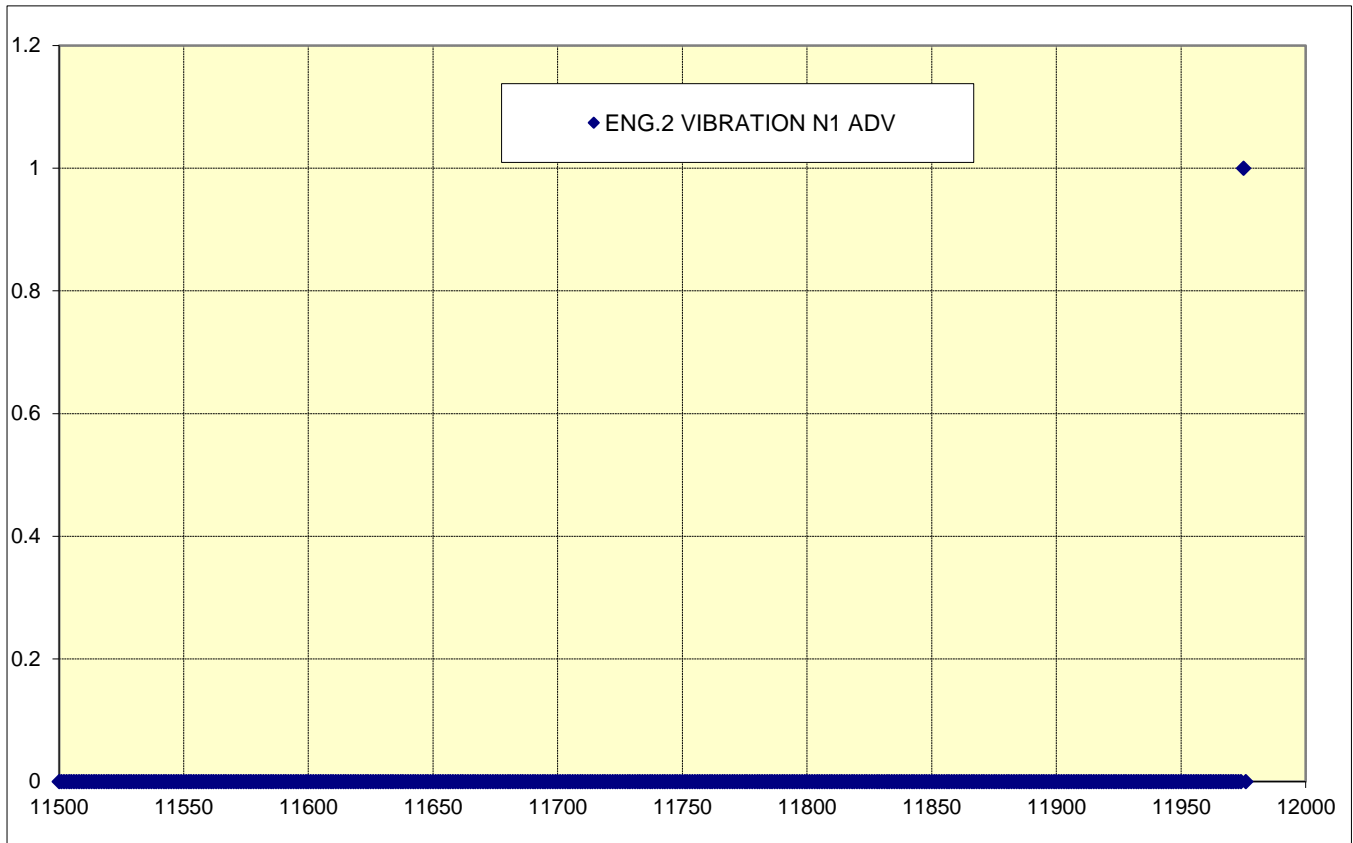
(8 ENG 2 VIBRATION N1 ADV

ENG 2 Vibration N1 ADV shown at the end portion of the recording

Only at one point 00:29:45 (11975 seconds on the plot) the vibration value changed from 0 to 1

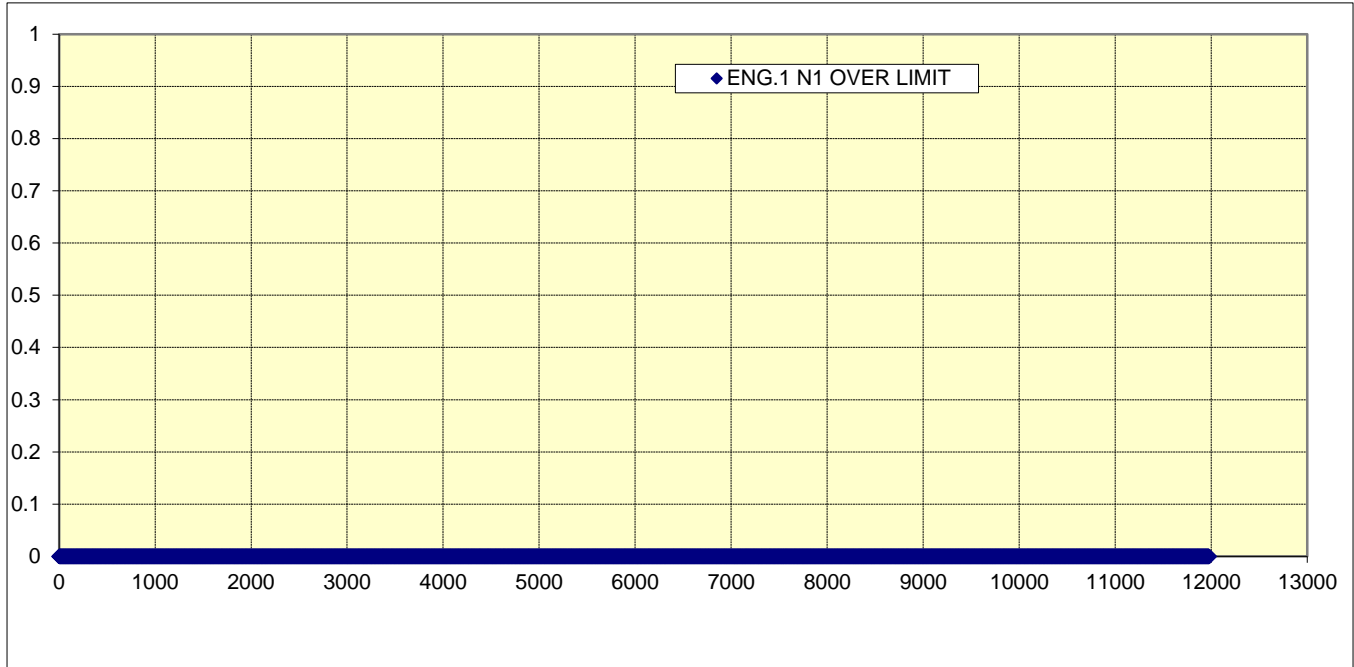
(9 Engine 1 N1 over limit:

No engine 1 N1 over limit

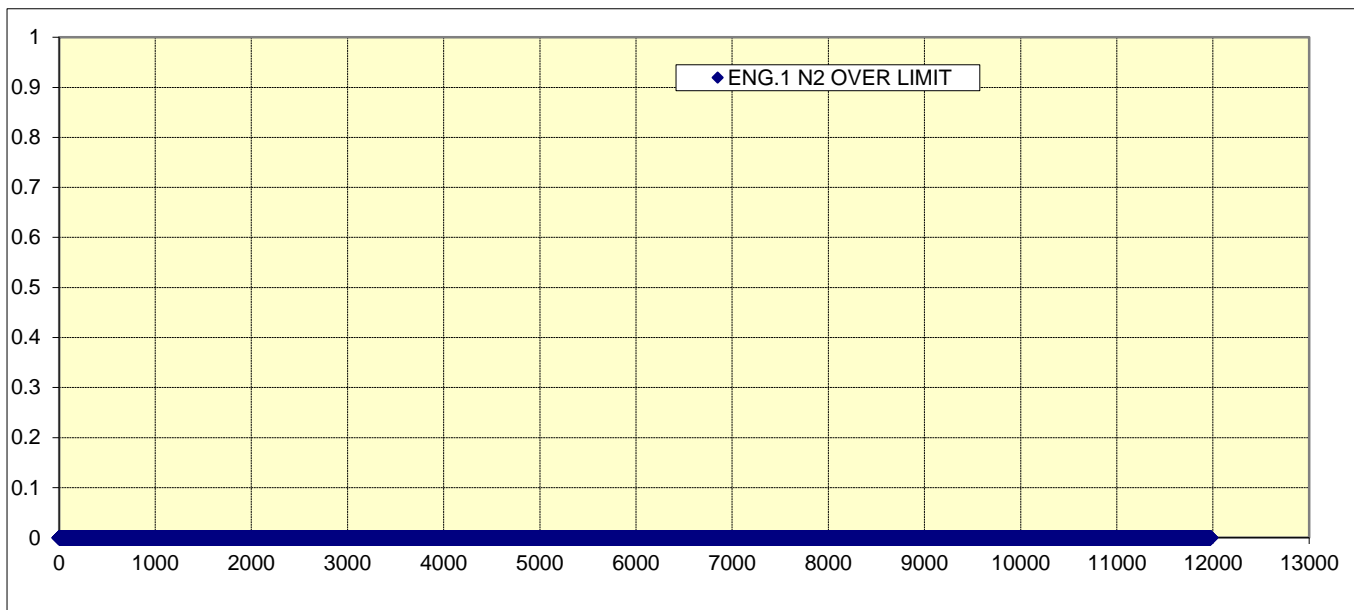
(10 Engine 1 N2 over limit:

No engine 1 N2 over limit

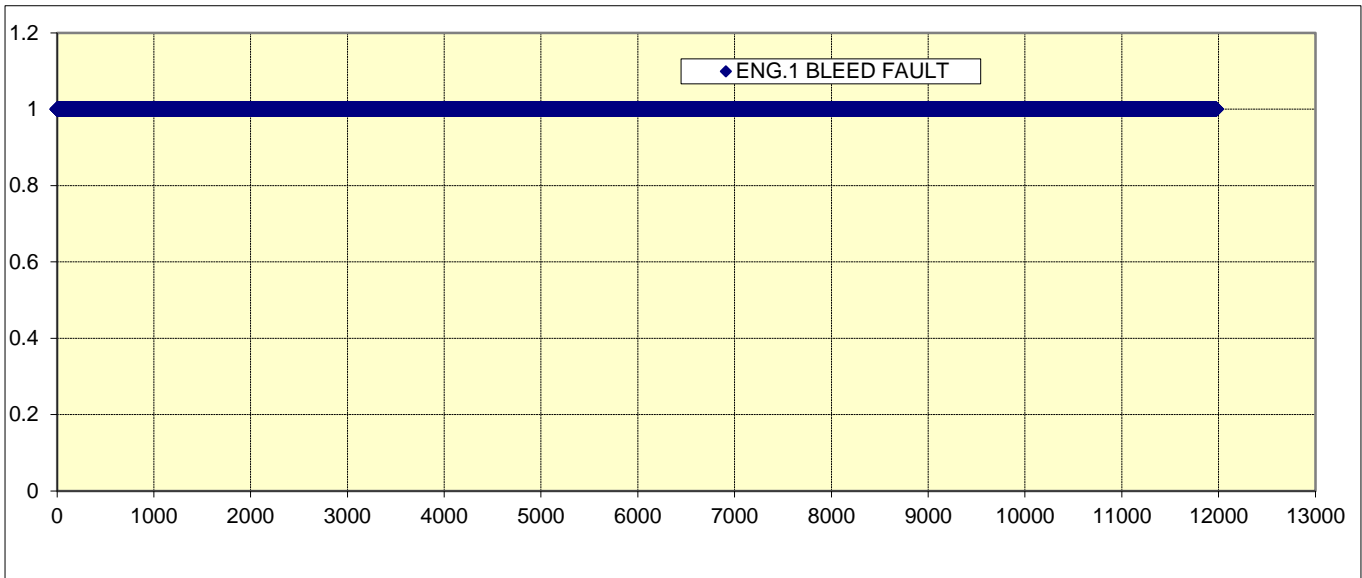
(13-ENG.1 BLEED FAULT

No ENG.1 BLEED FAULT

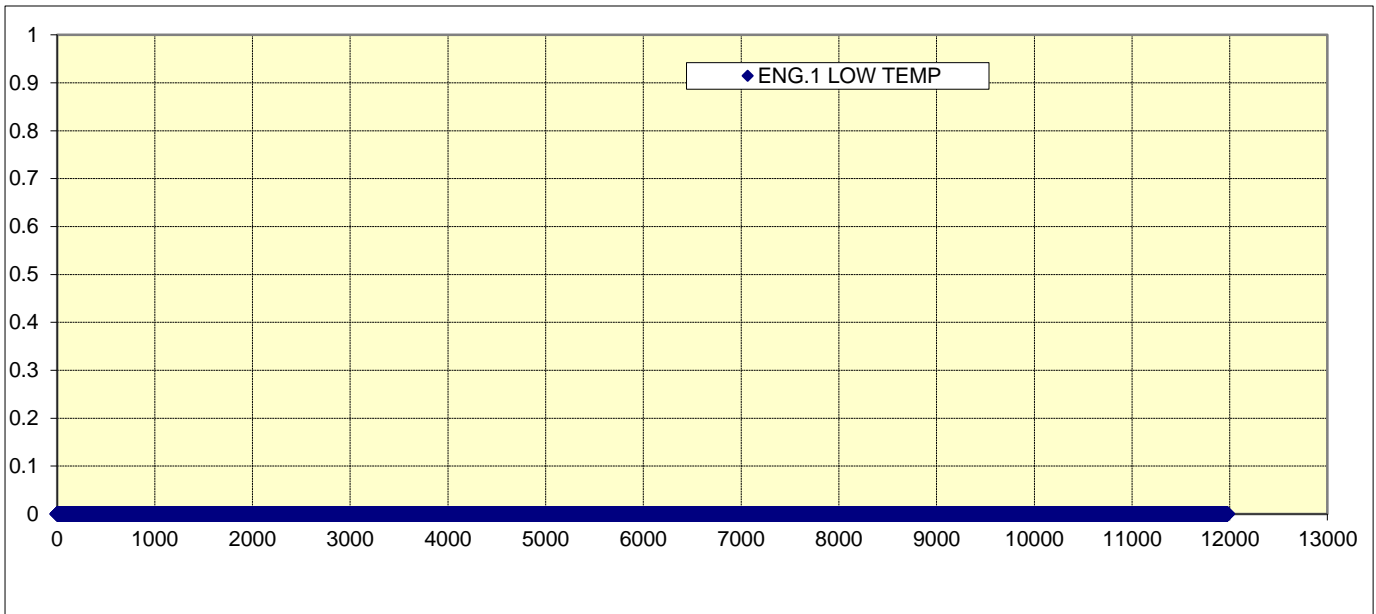
(14-ENG.1 LOW TEMP

No ENG.1 LOW TEMP

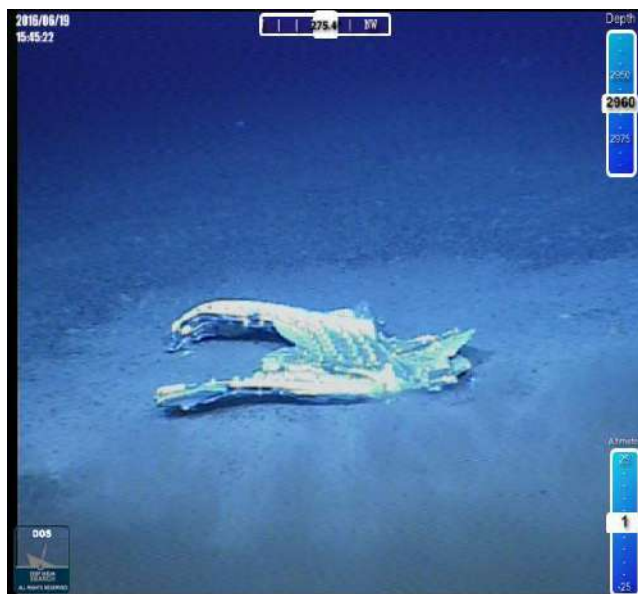
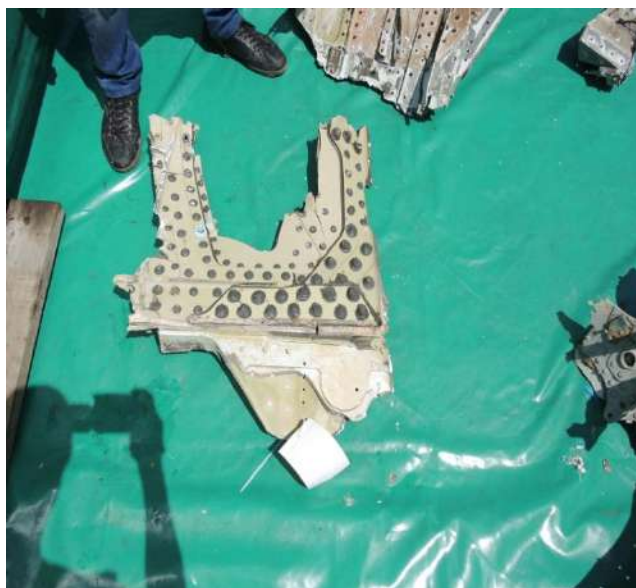
EAAID Identification No. 31

Part Description: Forward fuselage static port (RH) from frame 3 to frame 11

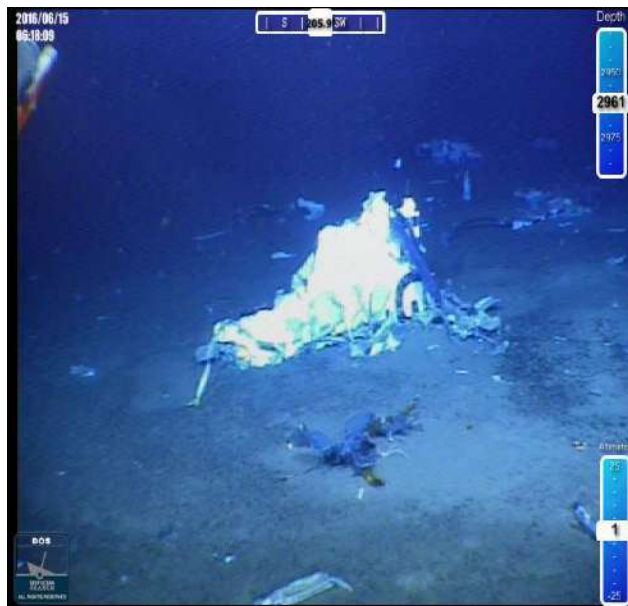
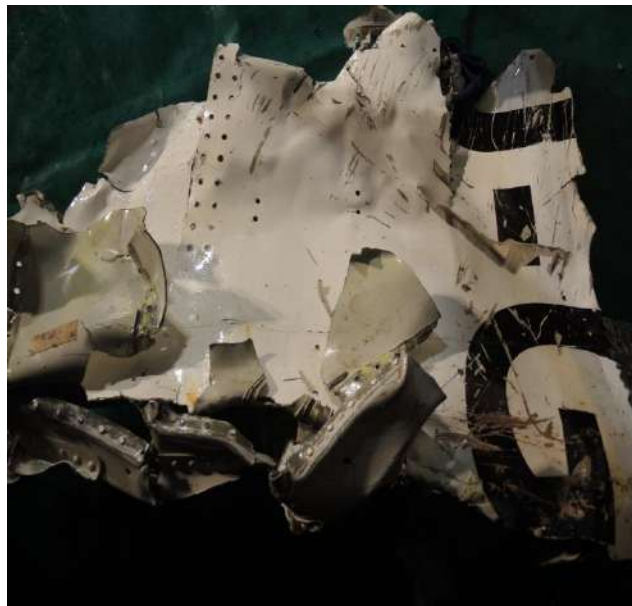
EAAID Identification No. 30 C

Part Description: Pinger from CVR (found inside the fuselage)

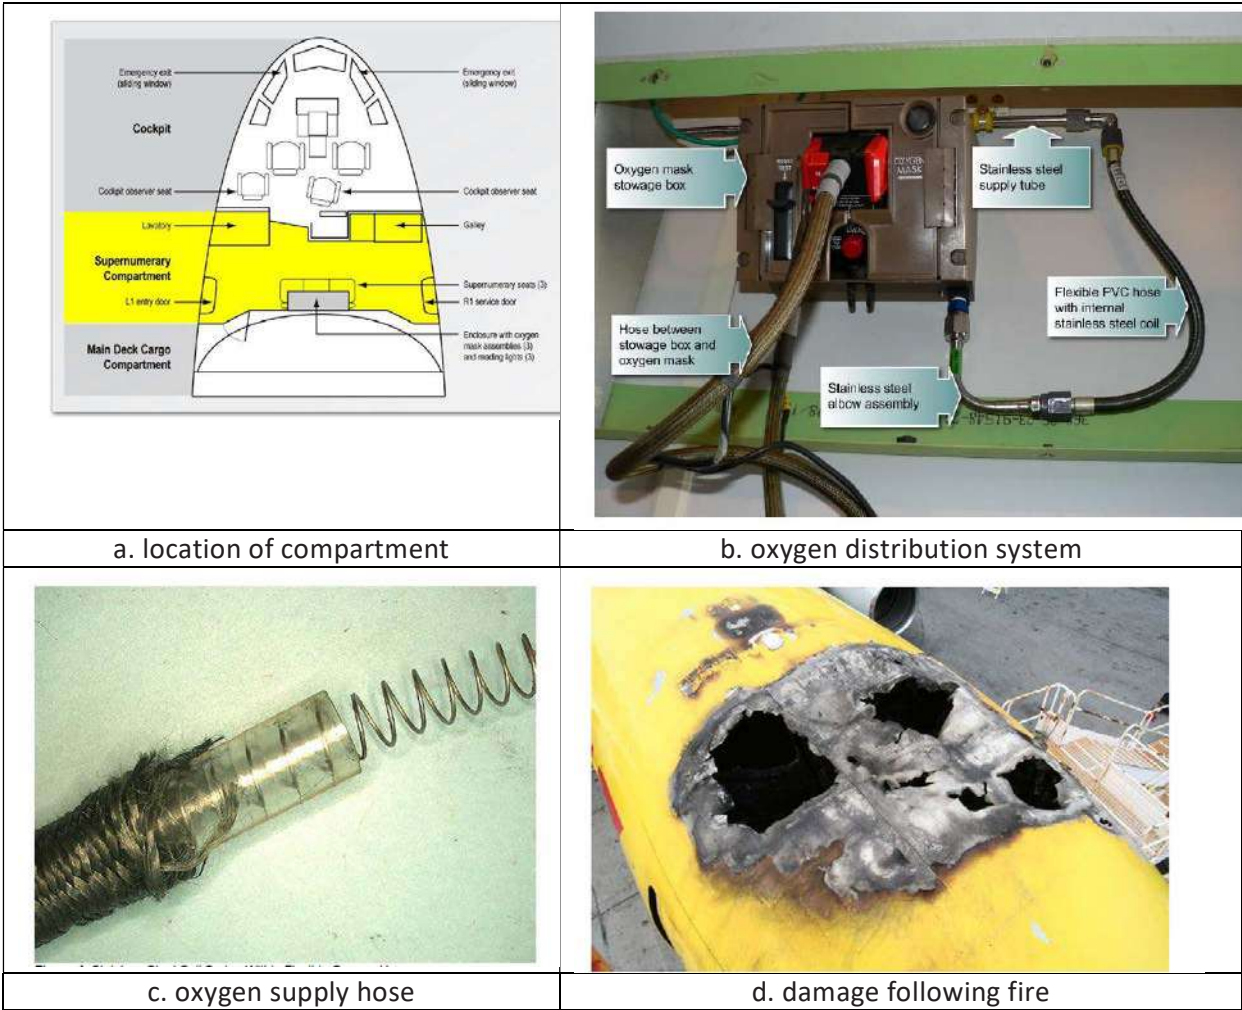
Figure 7: images from investigation report (source: NTSB)

The fire broke out during flight preparation, in the compartment between the cockpit and the cargo area (see Figure 7a).

The captain and co-pilot evacuated the aeroplane through the cockpit windows after closing the cockpit door and calling in the aircraft rescue and firefighting service. The aeroplane was considered destroyed due to the extent of the damage (see Figure 7d).

The mechanism involved in the accident to N799AX was an internal ignition in the system (linked to the design of the hoses) which caused a rupture in the oxygen hose and consequently a fire fuelled by an oxygen leak which led to the destruction of the aeroplane. The crew evacuated the aeroplane without trying to put out the fire.

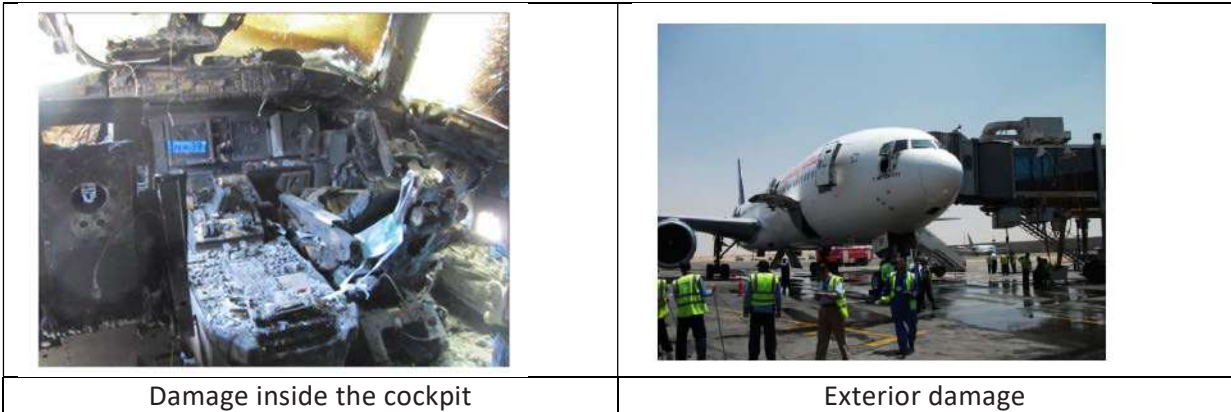
**Figure 8: photos from investigation report (source: EAAID)**

The evidence gathered during the investigation did not make it possible to determine whether the oxygen system ruptured first, creating a flammable environment, or whether the oxygen system ruptured as a result of the aeroplane fire.

1. *An electrical fault or short circuit resulted in electrical heating of flexible hoses in the flight crew oxygen system (electrical short circuits; contact between aircraft wiring and oxygen system components may be possible if multiple wire clamps are missing or fractured or if wires are incorrectly installed).*
2. *Exposure to electrical current.*

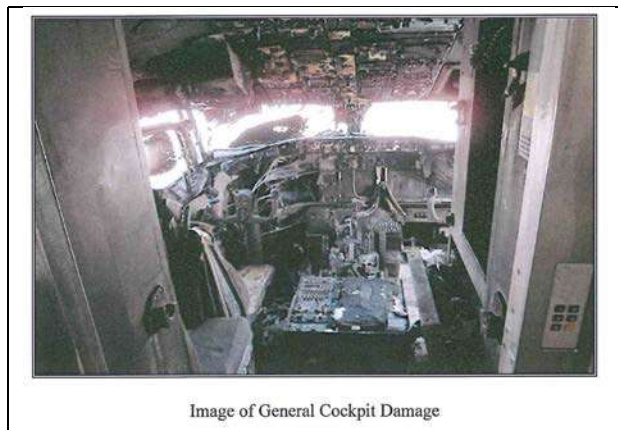
**Figure 9: photo from draft investigation report (source: safety investigation authority)**

It is believed that the crew reported seeing a ball of sparks heading towards the captain's oxygen mask and that the mask and its surroundings burst into flames accompanied by the noise of escaping oxygen. The fire was out of control and the flames very high within approximately five seconds. Thick black smoke escaped from the cockpit.

It is thought that the event began with an initial continuous leak of pure oxygen, this oxygen leak then spreading into the cockpit. The fire started as a result of a perfume and a burning cigarette meeting. The fire then spread inside the cockpit after the captain opened the mask storage box in order to fight the fire.

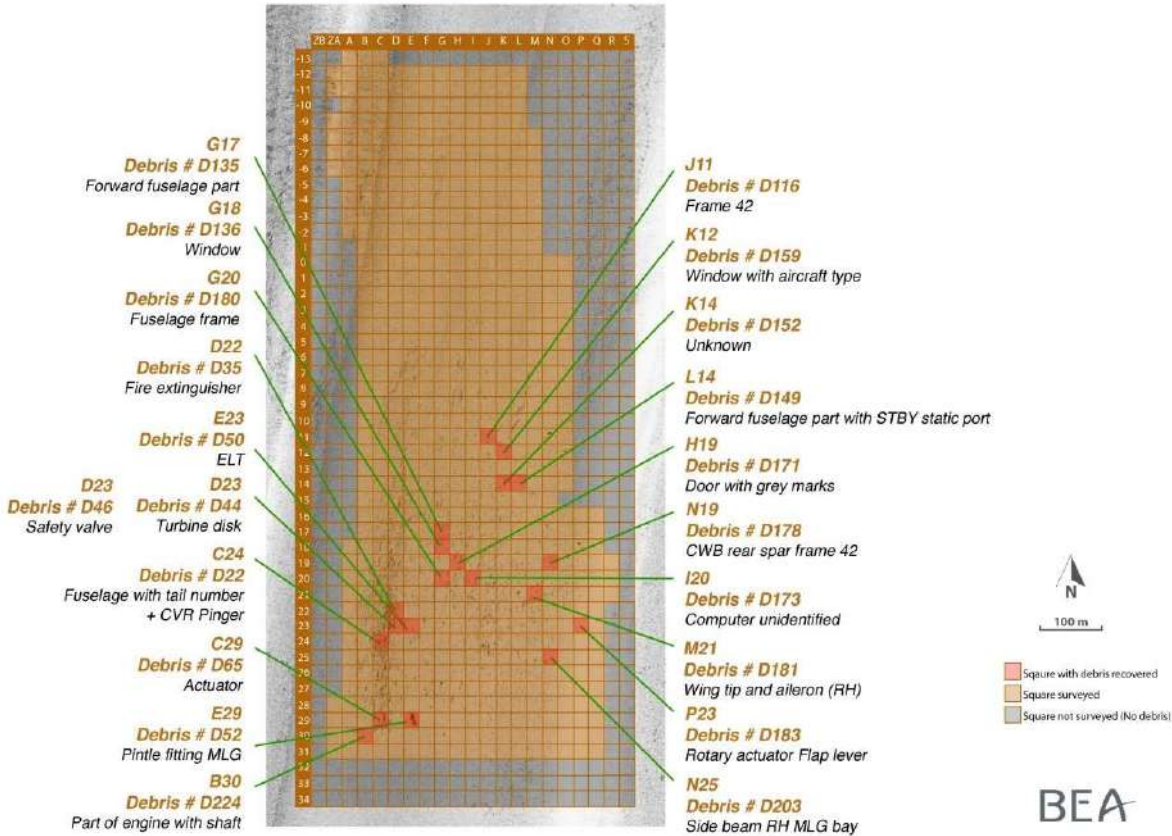
A sonar search located the wreckage and defined the limits of the field of debris. The debris was scattered in a rectangle measuring 1.2 km by 525 m. The debris was then identified, mapped and some pieces recovered. All the extremities of the aeroplane were within the identified rectangle: the cockpit, the wings and the tail. These observations, together with the small size of the debris, made it possible to conclude that the aeroplane had collided with the surface of the water under high energy and ruled out the scenario of the aeroplane having broken up in flight.

**Figure 15: field of debris (source: BEA/EAAID)**

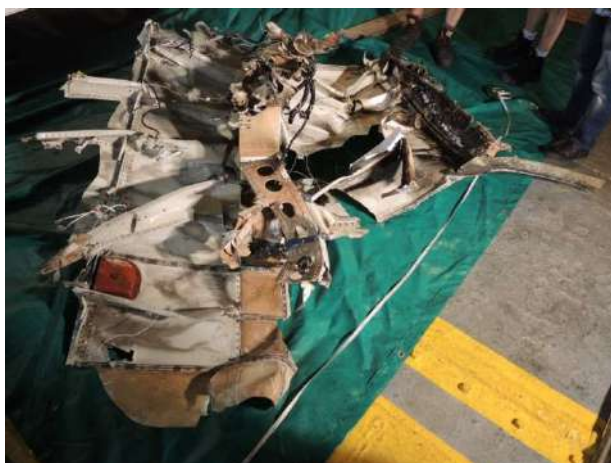
Some debris showed signs of having been subject to high temperatures, and traces of soot. In particular, soot was visible on the side of the cockpit between frames 4 and 8 as illustrated in the image below.

Figure 16: cockpit debris showing black deposits (source: BEA/EEAID)

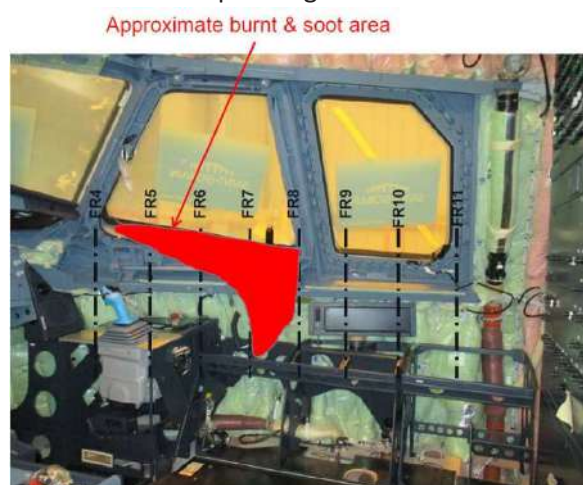
Figure 17: corresponding area on an A320 (source: BEA/EEAID)

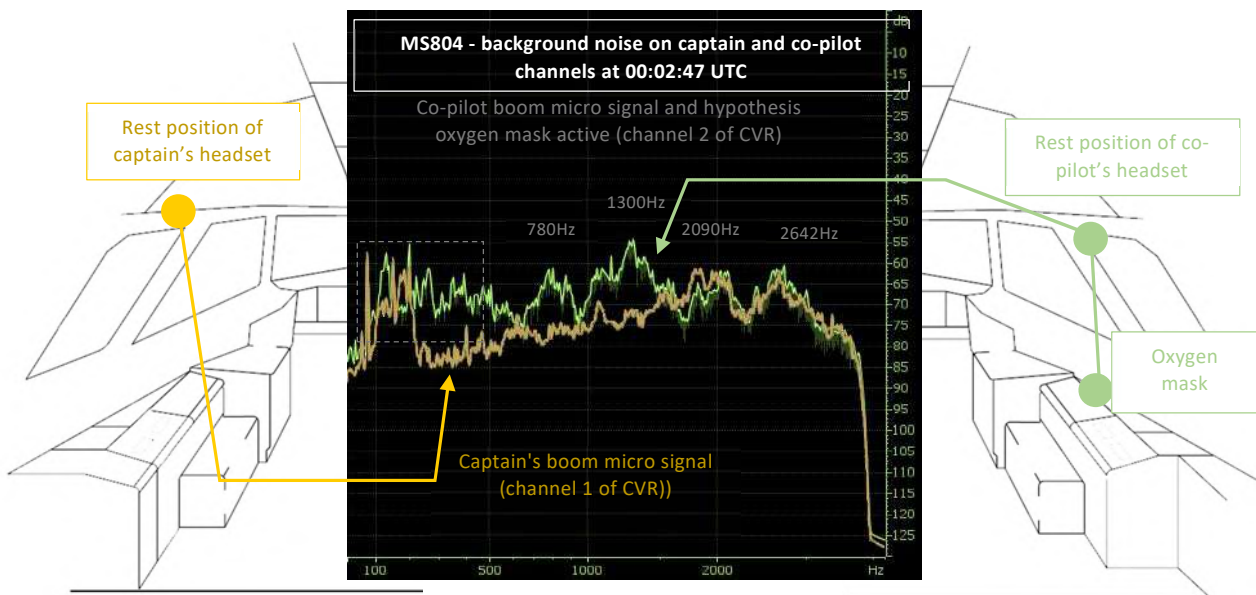
The sound picked up by the oxygen mask microphone had an acoustic signature consisting of the emergence of five characteristic noise bumps. The appendix Sound pick-up by the oxygen mask microphone presents the comparison made with a series of audio samples taken from the BEA’s audio database. The spectral view below shows the comparison between the signal recorded by the captain’s CVR channel and that recorded by the co-pilot’s CVR channel.

The low-frequency noise bump (from 100 to 500 Hz) and the four broadband bumps (780 Hz, 1300 Hz, 2090 Hz and 2642 Hz) confirmed that the microphone of the co-pilot’s oxygen mask was active.

**Figure 19: comparison of noise spectrum picked up by captain’s and co-pilot’s boom mikes**

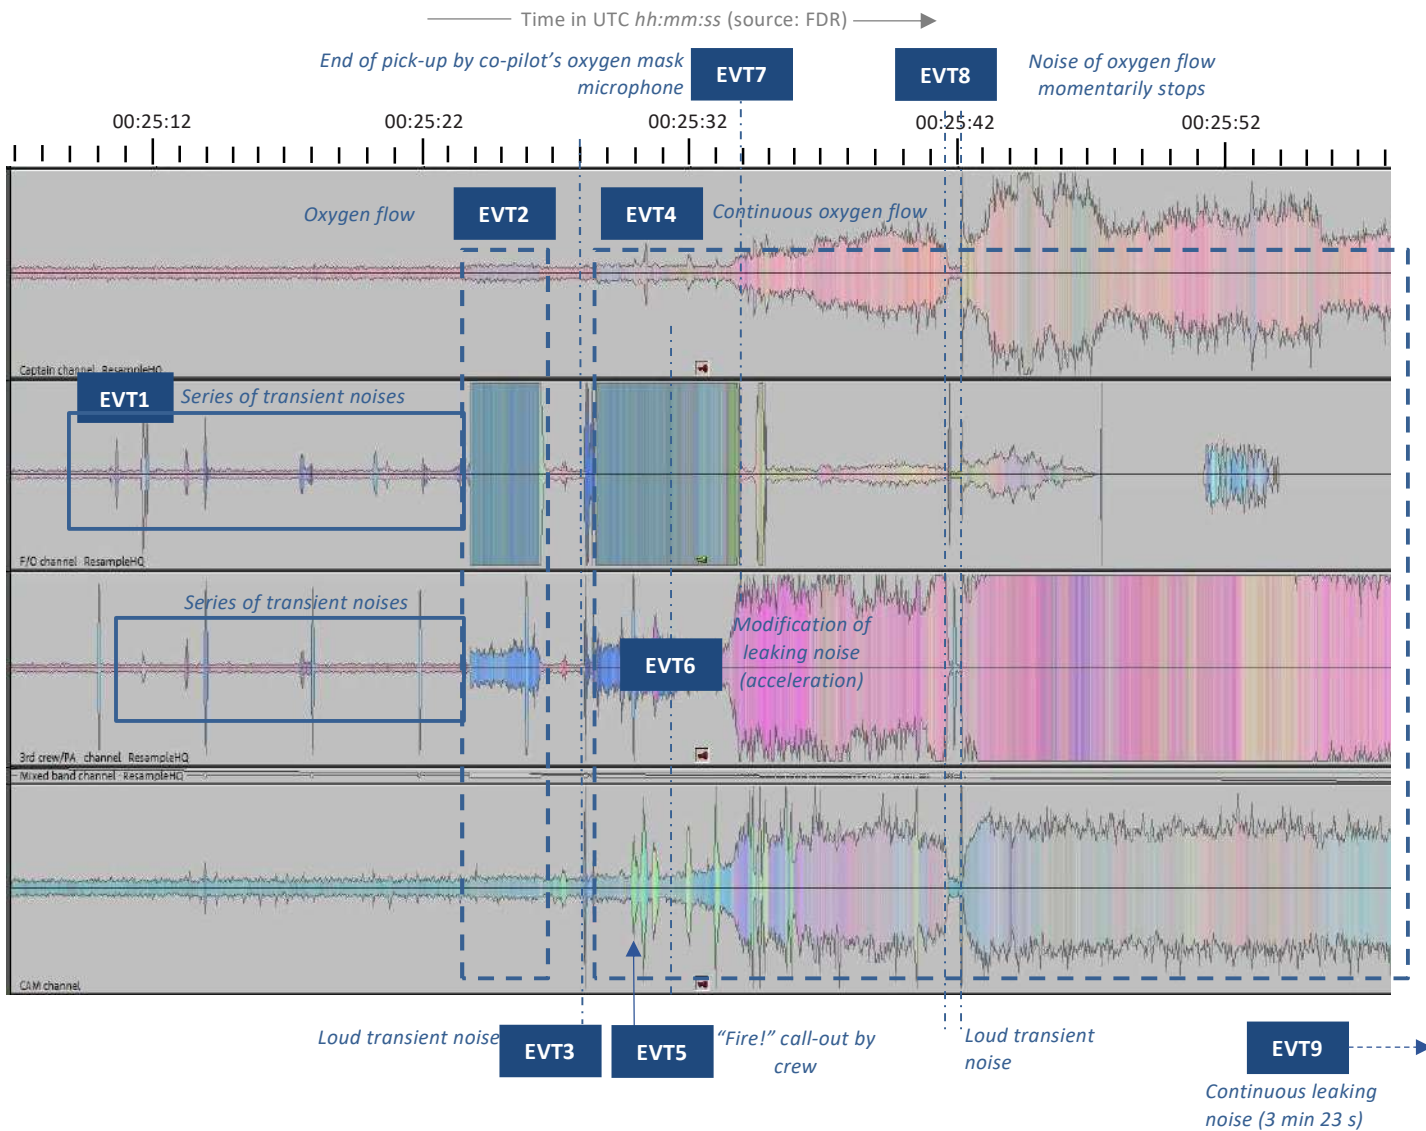
immediately followed by a hissing sound, a sound runaway phenomenon<sup>25</sup> and a continuous leaking noise<sup>26</sup>.

**Figure 20: sequence of aural events - chronological detail (view of waveform – source: BEA)**
