## Final Report

**EgyptAir A320 Aircraft crash in the Mediterranean, registered SU-GCC,  
flight number MSR804, from Charles De-Gaulle Airport, Paris to Cairo  
International Airport, on 19/05/2016**

EGAI2016-01

October 2024

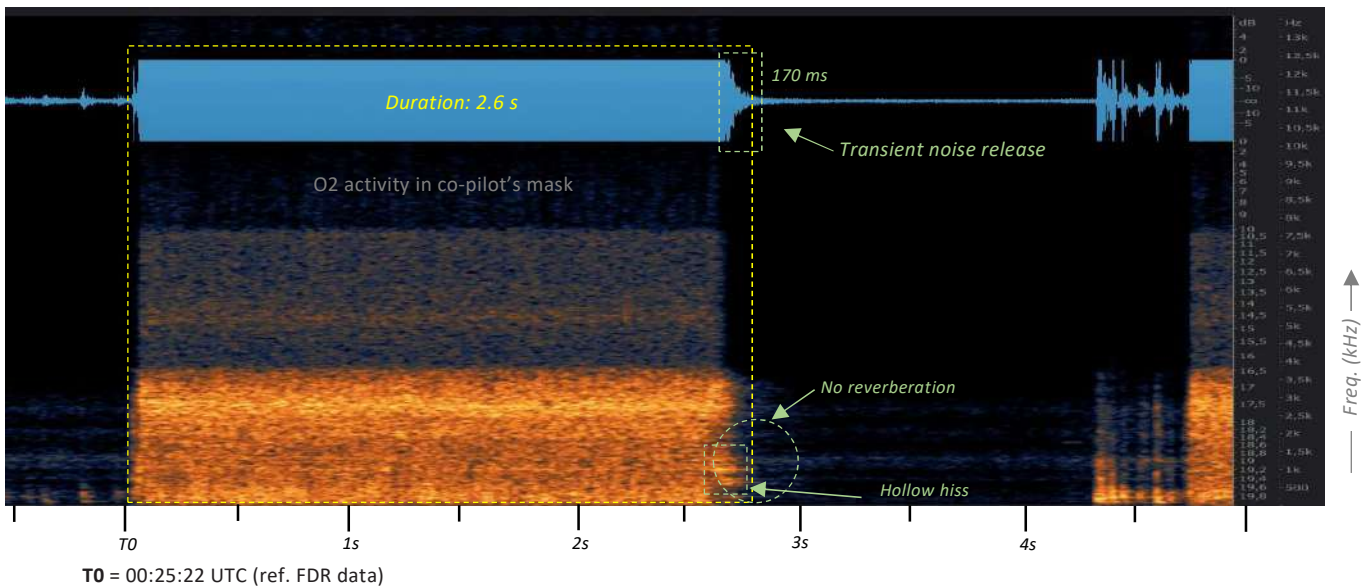
**Figure 21: first oxygen flow activity in co-pilot's mask (spectral view – source: BEA)**

The flow is equivalent to that caused by pressing the *EMERGENCY* knob on the mask.

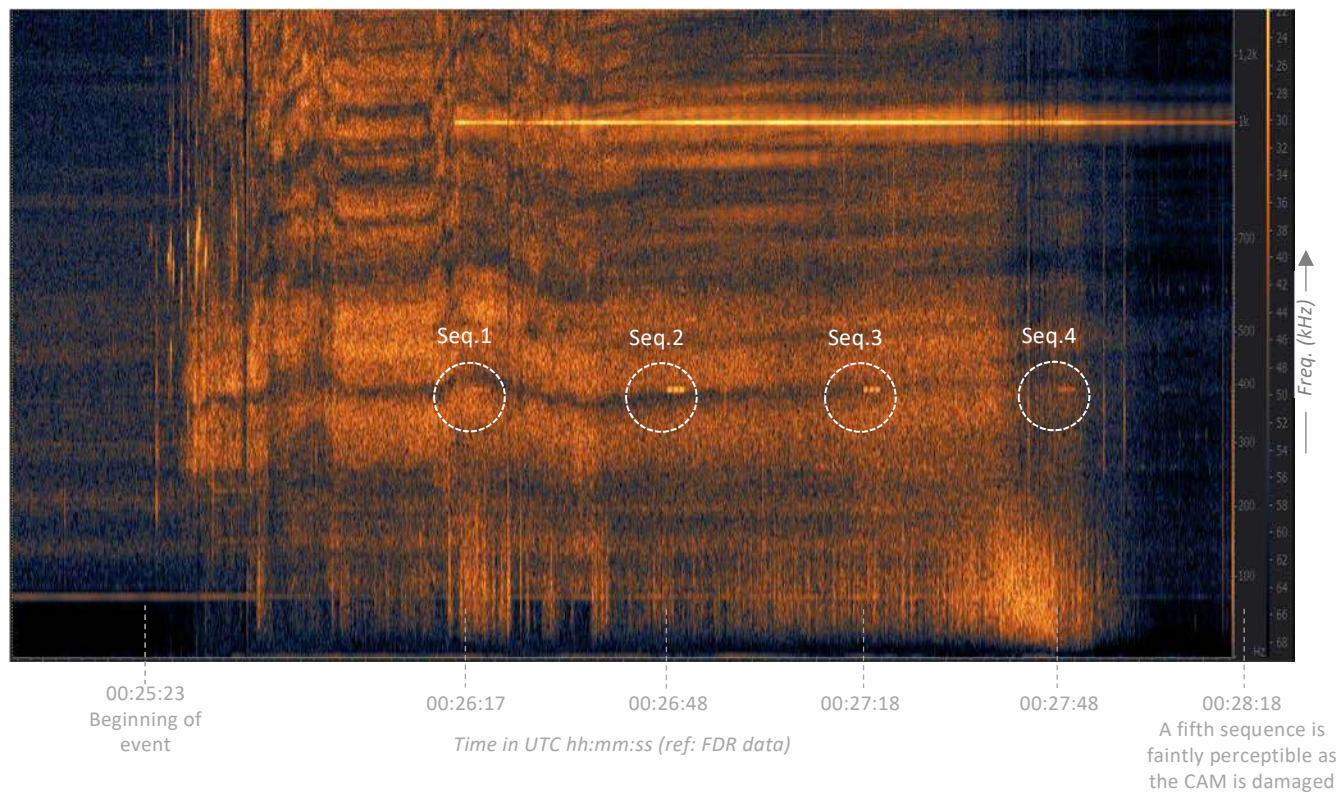
**Figure 22: Lavatory Smoke warning sequences (*triple low chime*) - (spectral view)**

The "triple low chime" corresponding to the "Lavatory Smoke" warning can be perceived on the CVR (first transmission at 00:26:17 i.e.  $t_0 + 47$  s) via the CAM channel. This signal was generated on the cabin loudspeakers every thirty seconds. The next three transmissions are also perceptible; the CAM was then too damaged to pick them up.

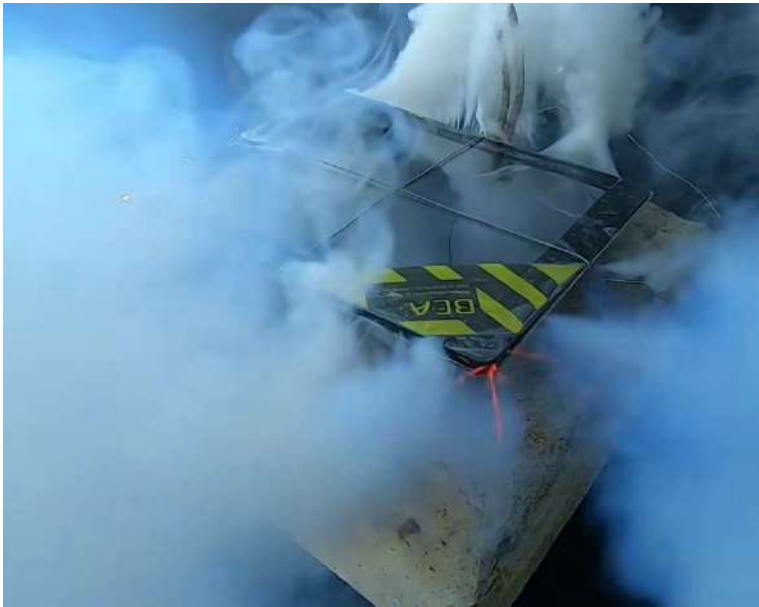
During the tests, the thermal runaway of the batteries was visually characterised by a sudden release of thick white smoke. No sudden loud sound (snapping, detonation) was produced; only a whooshing sound or hiss could be heard during the ejection of gases. The ejection of incandescent particles was often observed during these tests, but the combustion of these particles proved to be very rapid and insufficient to spread the fire to the environment. The runaways were all preceded by the release of smoke over several minutes.

**Figure 24: example of release of smoke during thermal runaway of battery (Lithium\_Battery\_04 test)**

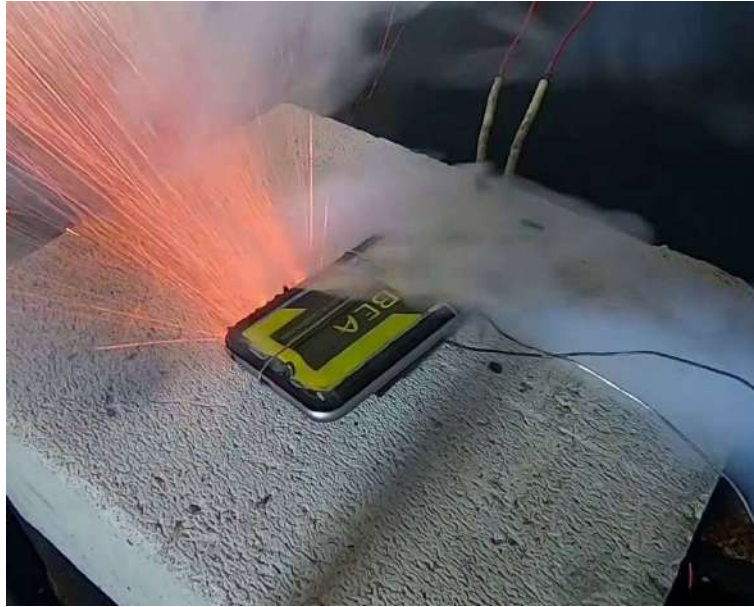
**Figure 25: ejection of incandescent particles during thermal runaway of battery (Lithium\_Battery\_02 test)**

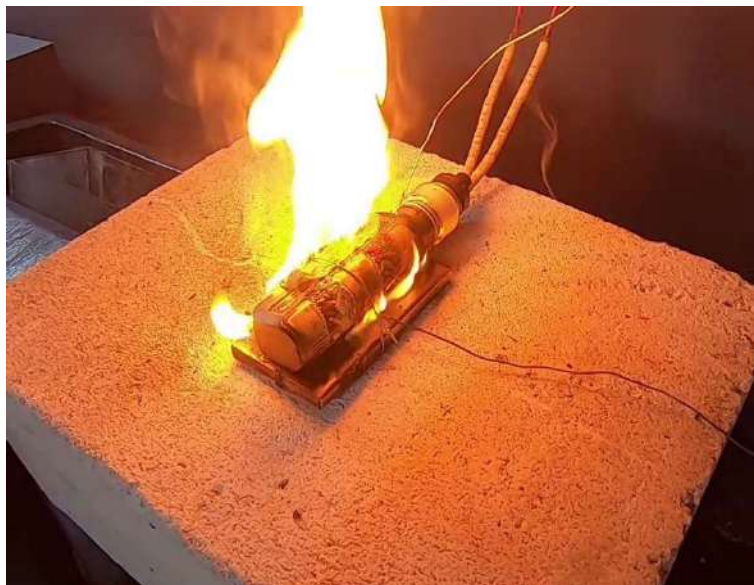
The appearance of flames was observed only once, during a test carried out on an electronic cigarette in the free field (Lithium battery\_07 test). It is likely that the fire broke out due to the presence of adhesive tape affixed<sup>31</sup> to the body of the cigarette, which burst into flames during the test.

**Figure 26: visible flames during Lithium\_Battery\_07 test**

In the conditions of the tests, only one element external to the electronic cigarette (adhesive tape) probably contributed to the outbreak of fire after the thermal runaway of the battery.

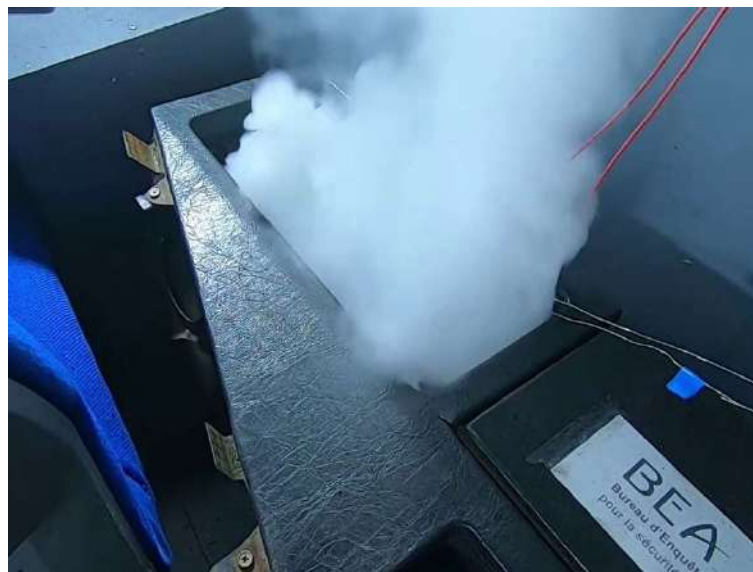
During the tests carried out on the equipment placed in the document storage compartments, no outbreak of fire was observed. Only the release of dense white smoke was seen.

**Figure 27: release of smoke during Lithium\_Battery\_05 test**

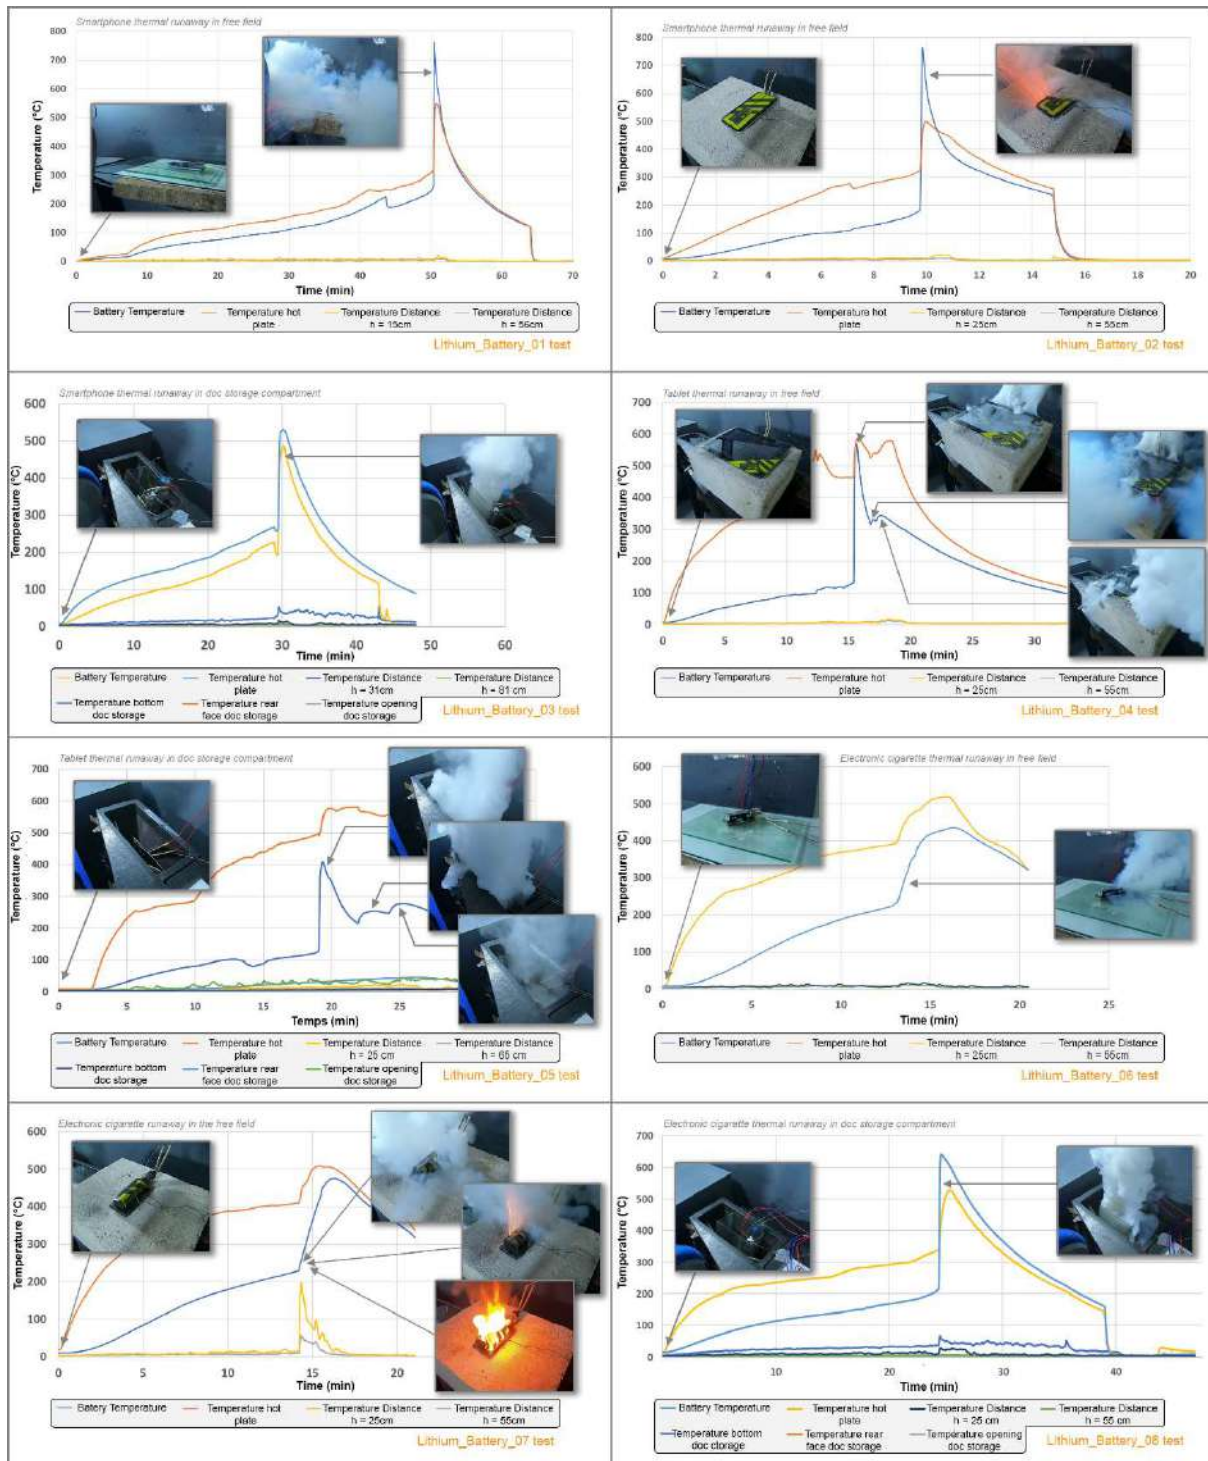
**Figure 28: temperature curves - Lithium battery tests (source: BEA - INERIS)**

Thermal runaway occurred at battery temperatures of between 100°C (tablets) and 250°C (smartphones), depending on the device. The battery temperature then rose almost instantaneously to an average of 550°C, with values as high as 750°C (in the case of smartphones). No significant rise in temperature in the air surrounding the batteries was measured. During tests carried out in the document storage compartment, the temperature inside the compartment rose without exceeding 50°C.

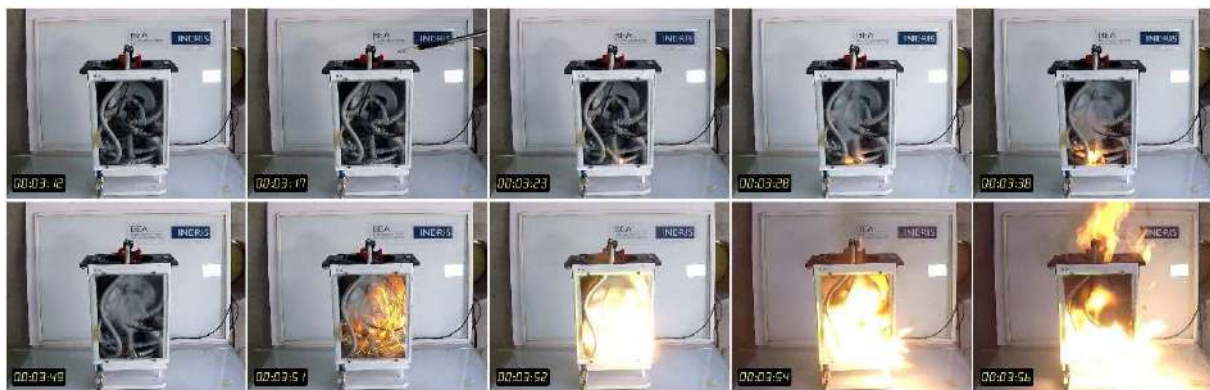
Cigarette\_03 test: crackling noises for 28 s were audible on the recording, corresponding to the combustion of the hose casing. The subsequent piercing of the hose produced a broadband noise. 1 s later, the mask ignited, causing a sound runaway. The mask microphone stopped working 6 s after the mask ignited.

Figure 33: cigarette\_03 test - video sequence (source: BEA)

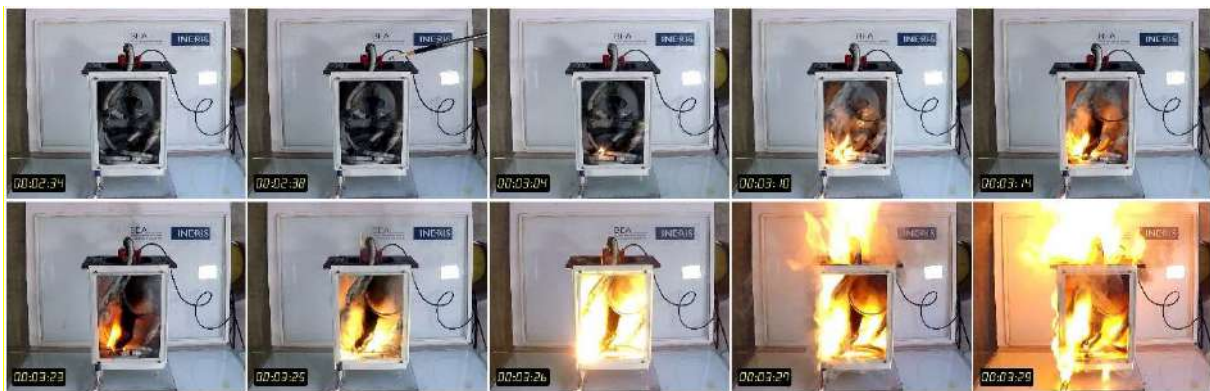
Cigarette\_04 test: crackling noises for 22 s were audible, corresponding to the combustion of the hose casing. The subsequent piercing of the hose produced a broadband noise. The mask ignited 0.5 s later, causing a sound runaway. The oxygen supply was cut off before the mask microphone was damaged.

Figure 34: cigarette\_04 test - video sequence (source: BEA)

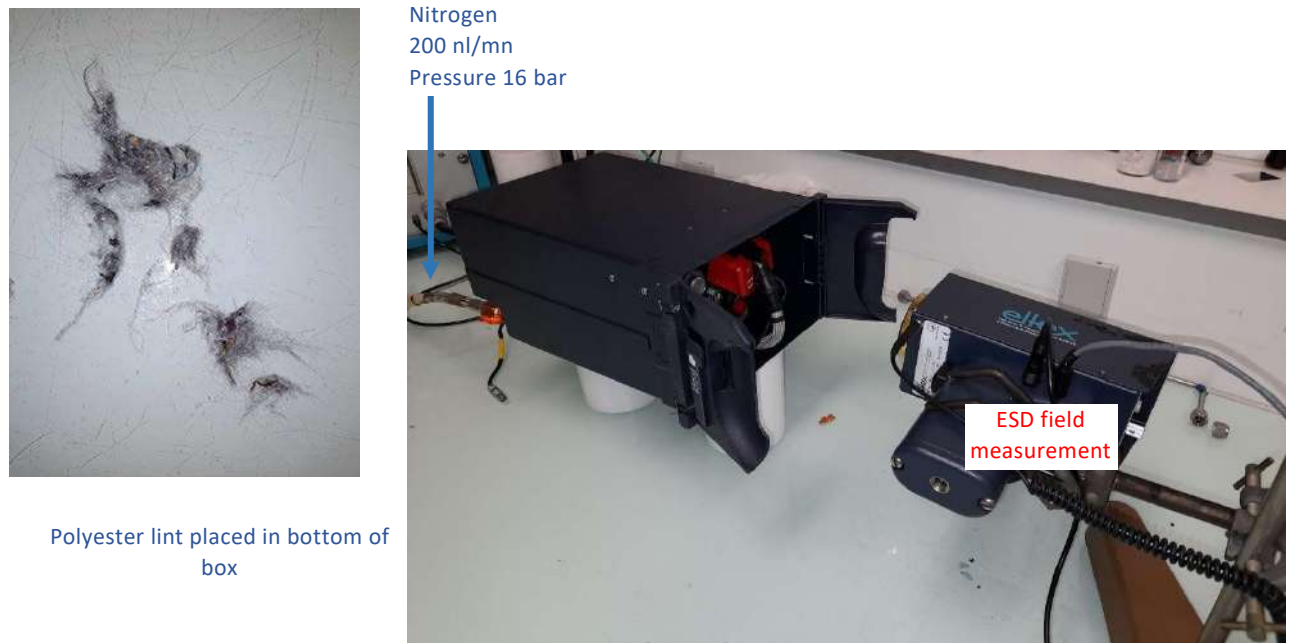
**Figure 44: measurement of electrostatic fields created on accumulated synthetic debris at bottom of storage box (source: INERIS)**

The maximum voltage observed was 255 V; this voltage was too low to generate an electrostatic charge likely to produce sparks capable of igniting dust or metal particles. In an explosive environment, the formation of dangerous sparks is considered for a value greater than 2 kV.

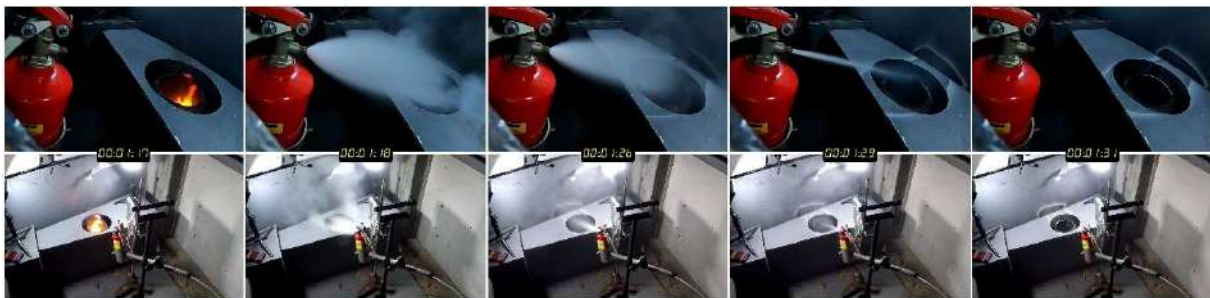
A first test was carried out without the addition of oxygen (Extinguisher\_01 test); the flames disappeared as soon as the extinguisher was activated. The fire did not restart again. There was no change in visibility in the room.

Figure 49: extinguisher\_01 test - video sequence (source: BEA)

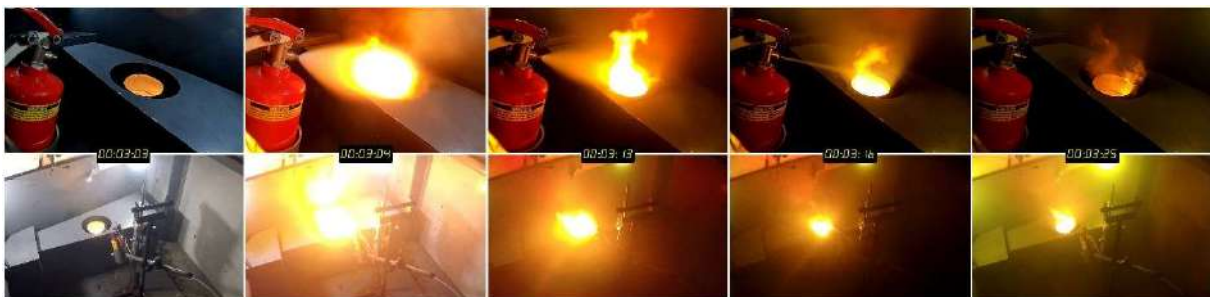
During the fire extinguisher\_02 test, the fire was enriched with oxygen. The halon extinguisher was unable to extinguish the fire. No effect on the flames was observed. On activation of the extinguisher, thick smoke appeared, significantly reducing visibility.

Figure 50: extinguisher\_02 test - video sequence (source: BEA)

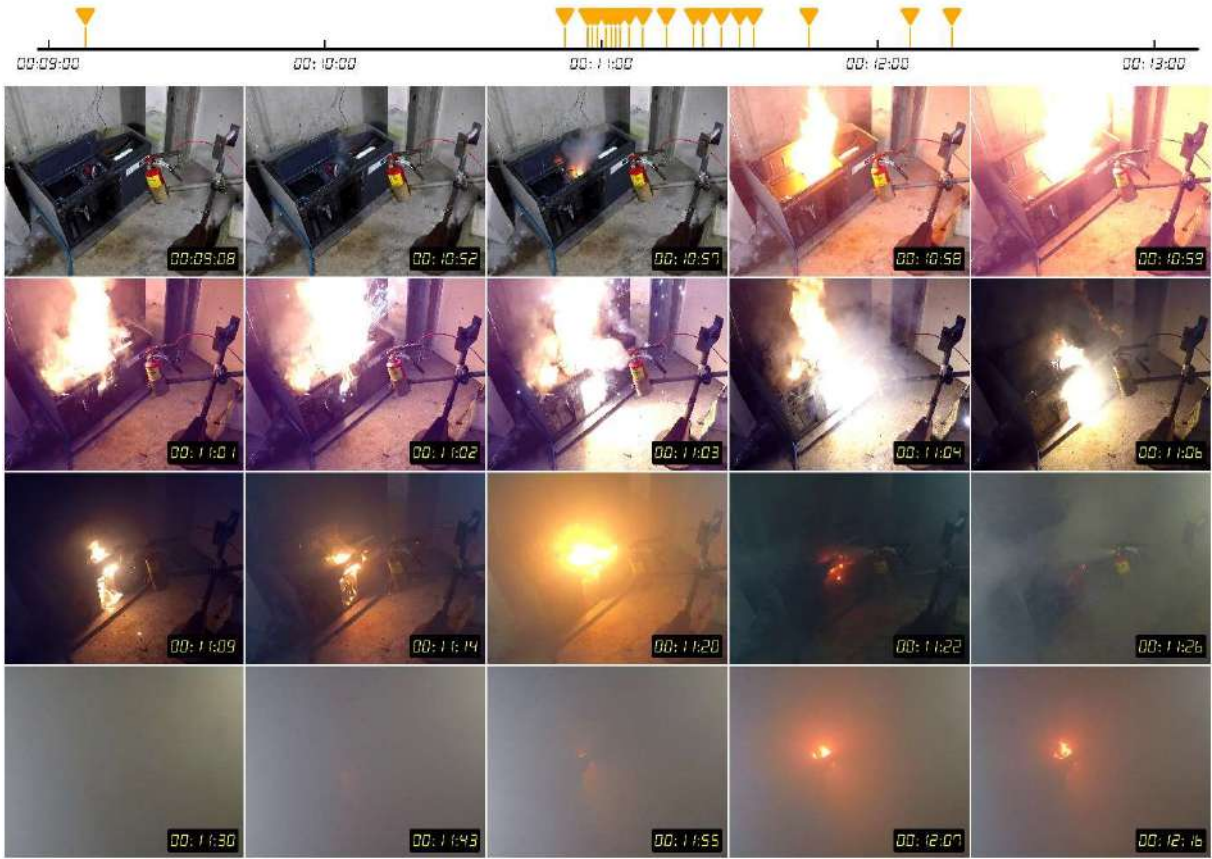
Audio elements: the piercing of the mask hose 13 s after the reactivation of the fire was preceded by crackling noises (picked up by the microphone on the oxygen mask). The piercing of the hose produced a broadband noise (leaking noise). The mask microphone stopped working 5 s after the hose of the oxygen mask was pierced.

The fire that followed the piercing of the hose spread rapidly to the surrounding components. No sound runaway or interruption in the leaking sound was observed.

Figure 55: Propagation\_02 test - video sequence (source: BEA)

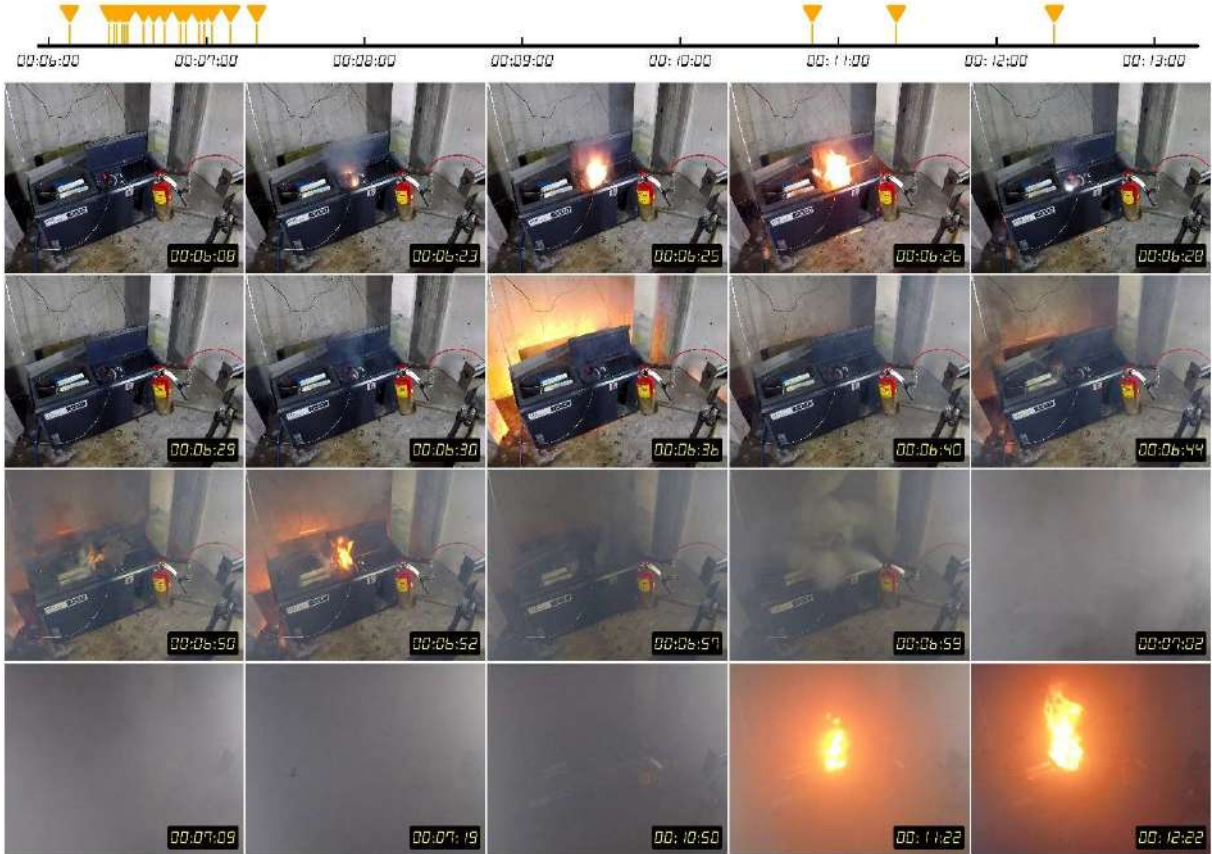
Audio elements: the piercing of the mask hose 14 s after the fire was started was preceded by crackling noises (picked up by the microphone of the oxygen mask). When the hose was pierced, there was a broadband noise (leaking noise) followed 0.5 s later by a sound runaway. Cutting off the oxygen supply - which preceded the use of the extinguisher - interrupted the leaking noise.

Figure 56: Propagation 03 test - video sequence (source: BEA)

During the test, the fire was concealed in the lateral compartment. The technique of fighting the fire with a halon fire extinguisher could not be applied. It is recommended to aim at the base of the flames, and if necessary, when the flames are inaccessible, to perforate the vertical wall of the compartment and slide the nozzle of the extinguisher into it before activating it. As the extinguisher was activated from the outside, it was not possible to accurately direct the extinguishing jet onto the flames, which may explain why the fire started up again after several minutes.

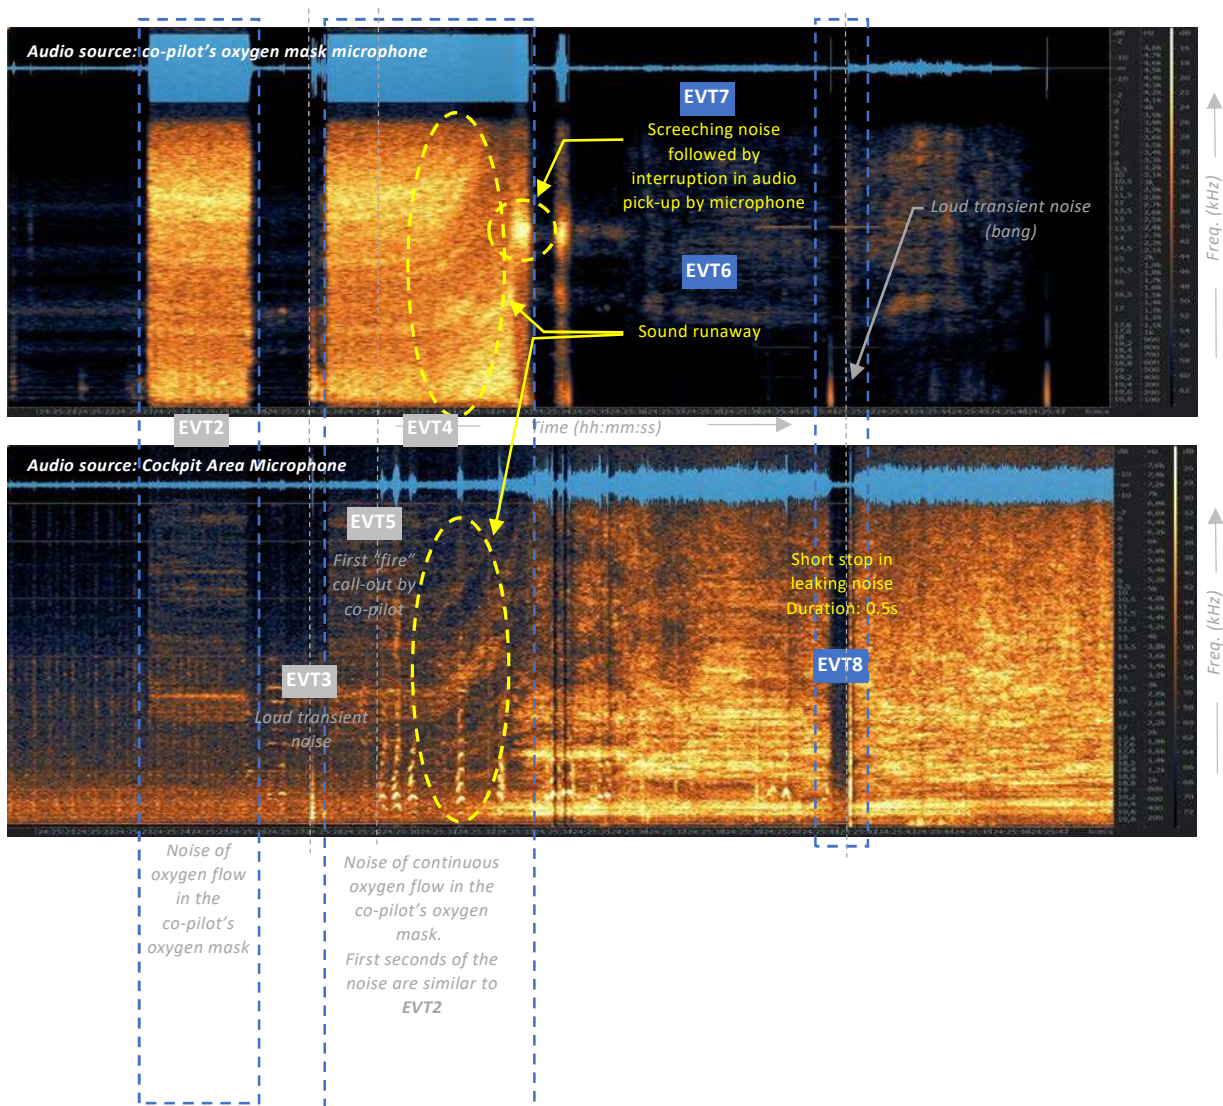
- no crackling noise was present in the mask microphone recording;
- a sound runaway could be heard on the co-pilot mask microphone and CAM channels at 00:25:31 (EVT6);
- a screeching noise preceded the loss of the co-pilot mask microphone signal at 00:25:33 (EVT7);
- a momentary interruption (510 ms) in the oxygen leaking noise occurred at 00:25 :42 (EVT8).

**Figure 57: part of spectrum - waveform - flight MS804 (source: BEA)**

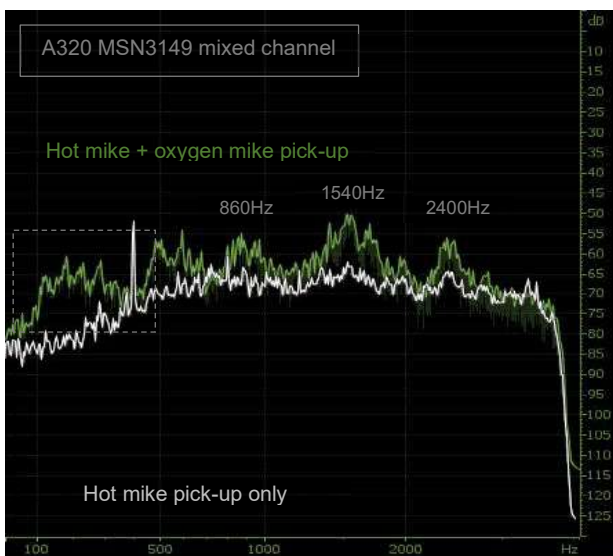
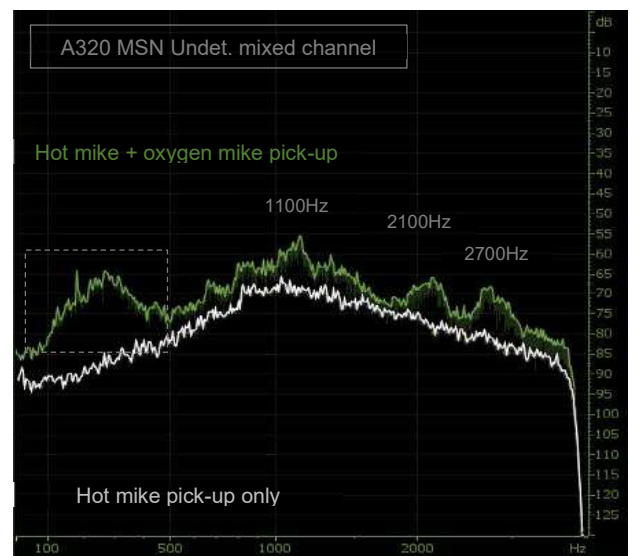
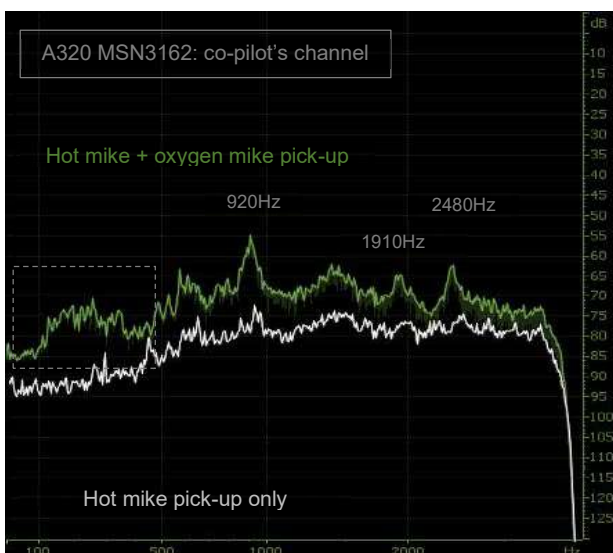
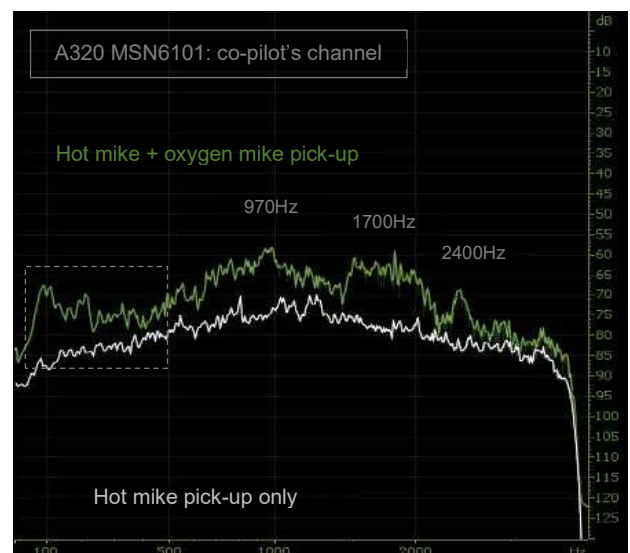
The analysis of the frequency spectrum shows that the sound picked up by the oxygen mask microphone has the following acoustic signature on the A320:

- A LF energy bump from 100 to 500 Hz on average
- A pseudo sawtooth PSD spectrum
- A few (3 or 4) energy bumps distributed between 900 and 2400 Hz

**Acoustic signature of audio pick-up by the oxygen mask microphone - Detailed PSD views of samples from pilot channels (with and without active oxygen microphone).**

A similar acoustic signature was observed on the noise spectrum of the MS804 CVR.

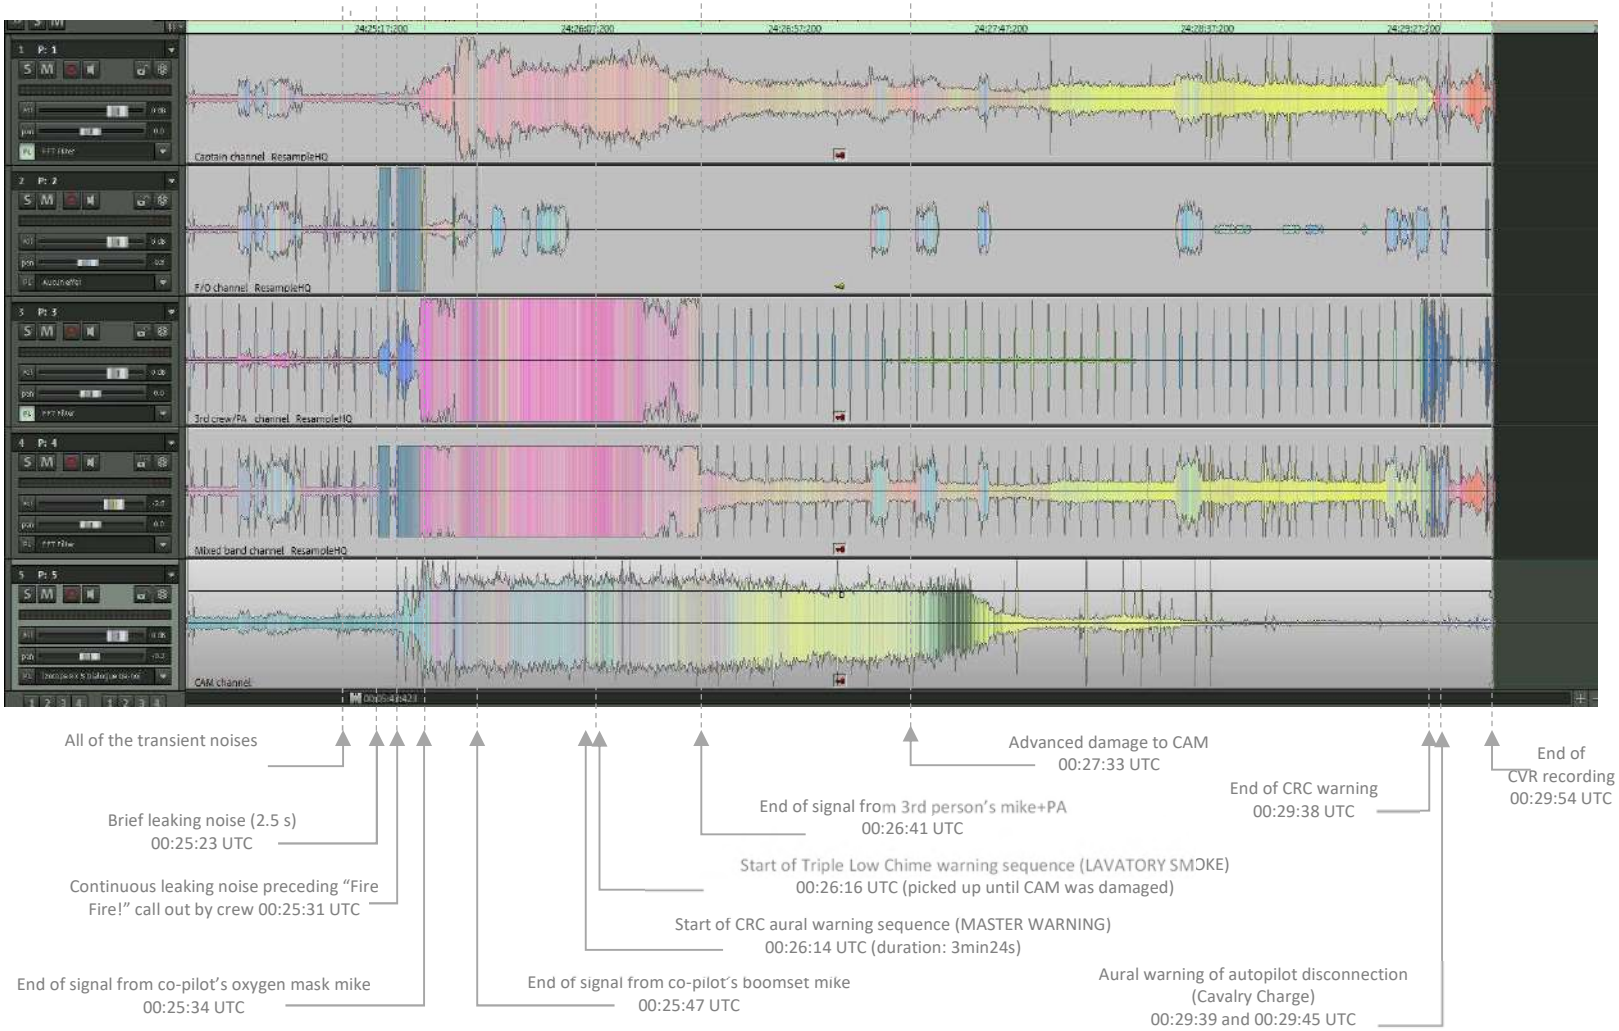
The view below shows the waveform of the last 5 minutes of the audio recording:

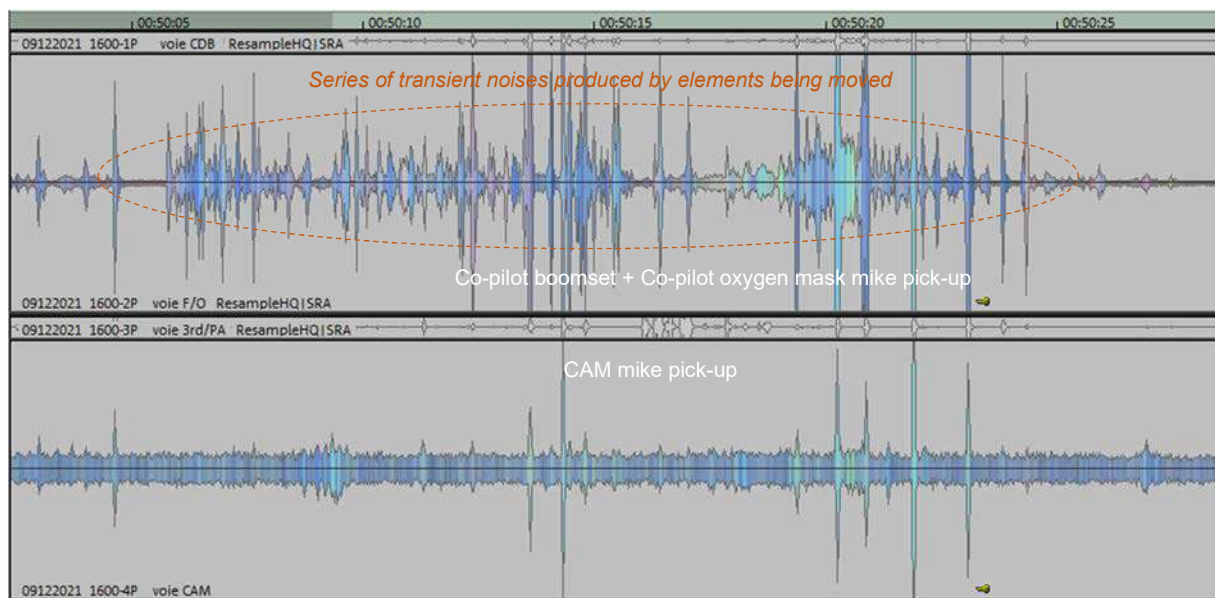
The waveform below shows, for the audio signal of the co-pilot channel, the predominance of transient noises produced by these different actions.

The noise from elements being moved (transient noises) were broadcast on the co-pilot's LS and were perceptible by an operator sat in the co-pilot's seat. They were picked up to a small extent or not at all by the CAM microphone (with the exception of those which were loud). This phenomenon can possibly be explained by the position of the CAM at the base of the overhead panel, set back from the vertical of the instrument panel (i.e. the FCU console masks the sound cone of the loudspeakers).

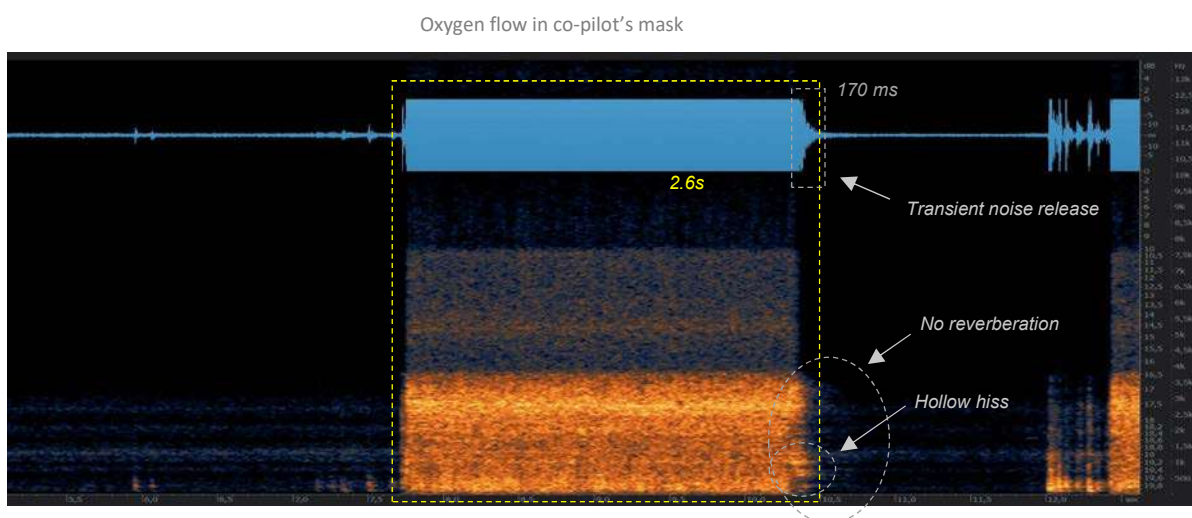
## SU-GCC – CVR event sequence (first oxygen activity noise / co-pilot's mask)

Note 1: audio pick-up by oxygen mask microphone

Note 2: the co-pilot's fixed oxygen equipment on flight MS804 was composed of an MF20 oxygen mask and an MXP801 mask storage box.

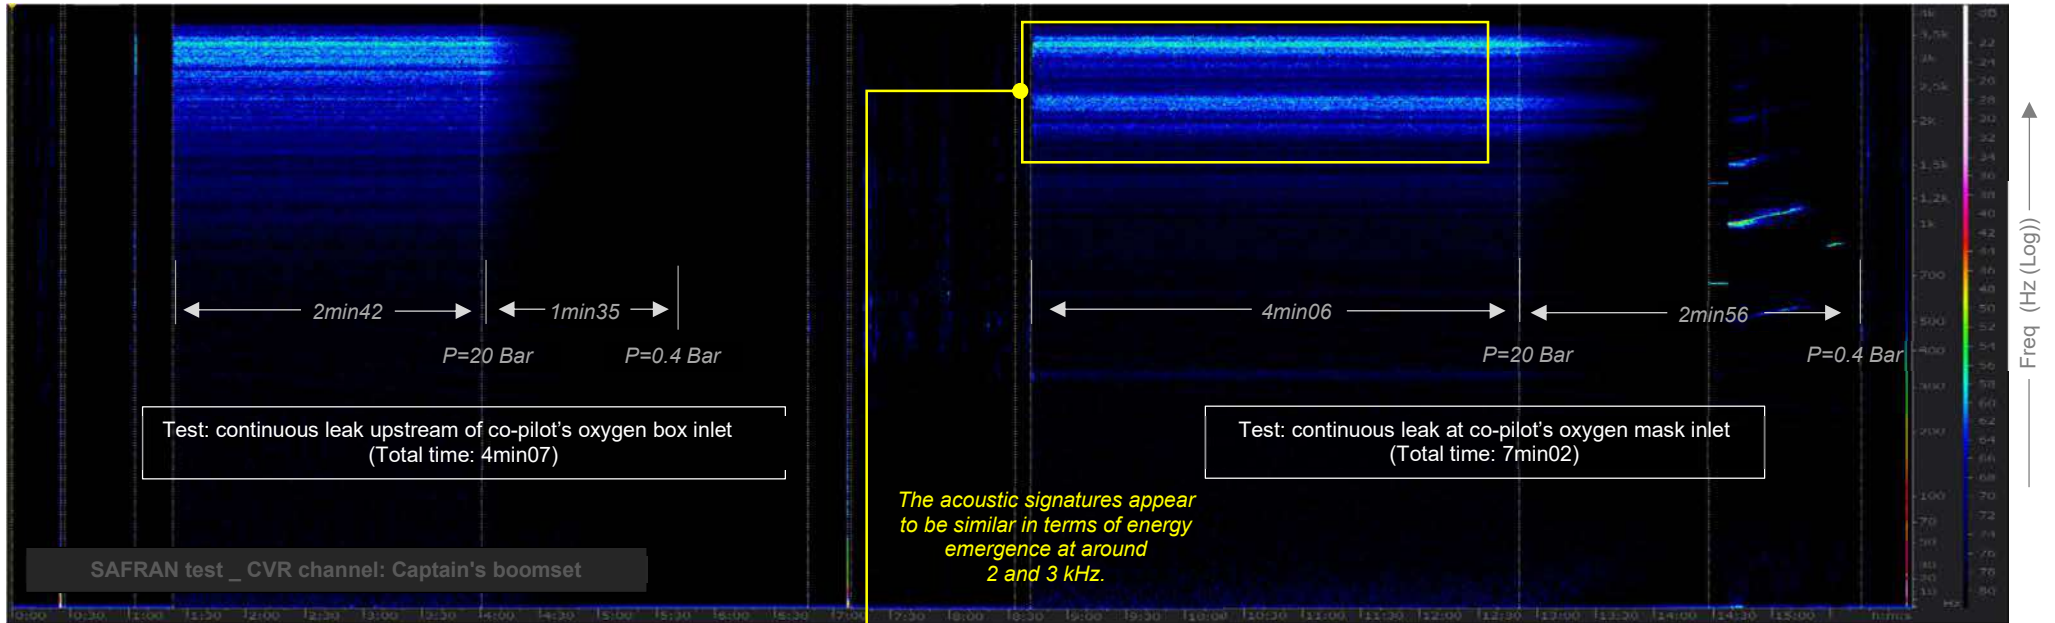
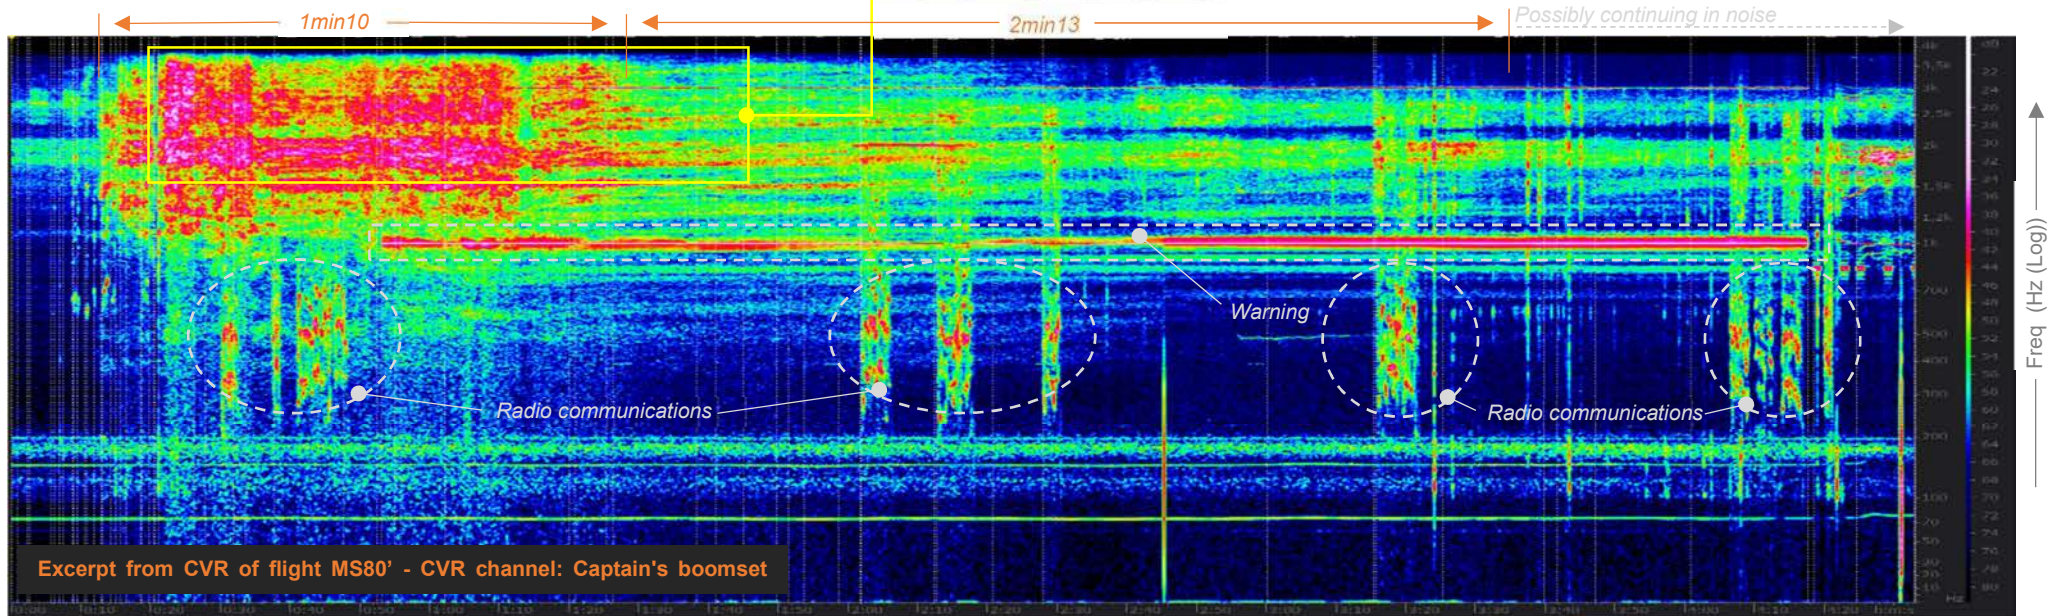
The following information was observed:

Continuous leak sequence	Source of leak	Total leak time	Noise bumps	Leak time before 20 bar threshold	Leak time after 20 bar threshold
Test 1	In oxygen box	6min53s	Reinforced between 2 and 3 kHz	3min53s	3min
Test 2	Outside oxygen box	4min16s	Several swathes distributed from 1 to 2.8kHz	2min42s	1min34s
Test 3	Outside oxygen box	4min17s	Several swathes distributed from 1 to 2.8kHz	2min42s	1min35s
Test 4	In oxygen box	7min02	Reinforced between 2 and 3 kHz	4min06s	2min56s
Flight MS804	Undetermined	Estimated at 3min23s	Reinforced between 2 and 3 kHz	Estimated at 1min10s	Possibly 2min13s (difficult to determine due to background noise in cockpit).

An oxygen leak produced by the rupture of a hose, either upstream of the oxygen box or upstream of the mask generated a broadband noise lasting several minutes, the sound level of which decreased progressively when a remaining pressure of less than 20 bar was reached.

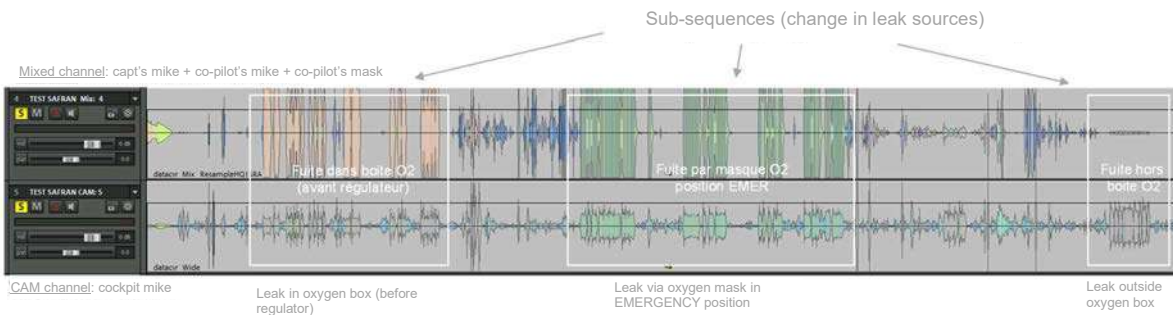
Electrical control of oxygen supply valve

Pressing the pushbutton twice in quick succession generated in all the cases, a **minimum interruption of 0.9 s** in the leaking noise to within the accuracy of the measurement.
