## Final Report

**EgyptAir A320 Aircraft crash in the Mediterranean, registered SU-GCC,  
flight number MSR804, from Charles De-Gaulle Airport, Paris to Cairo  
International Airport, on 19/05/2016**

EGAI2016-01

October 2024

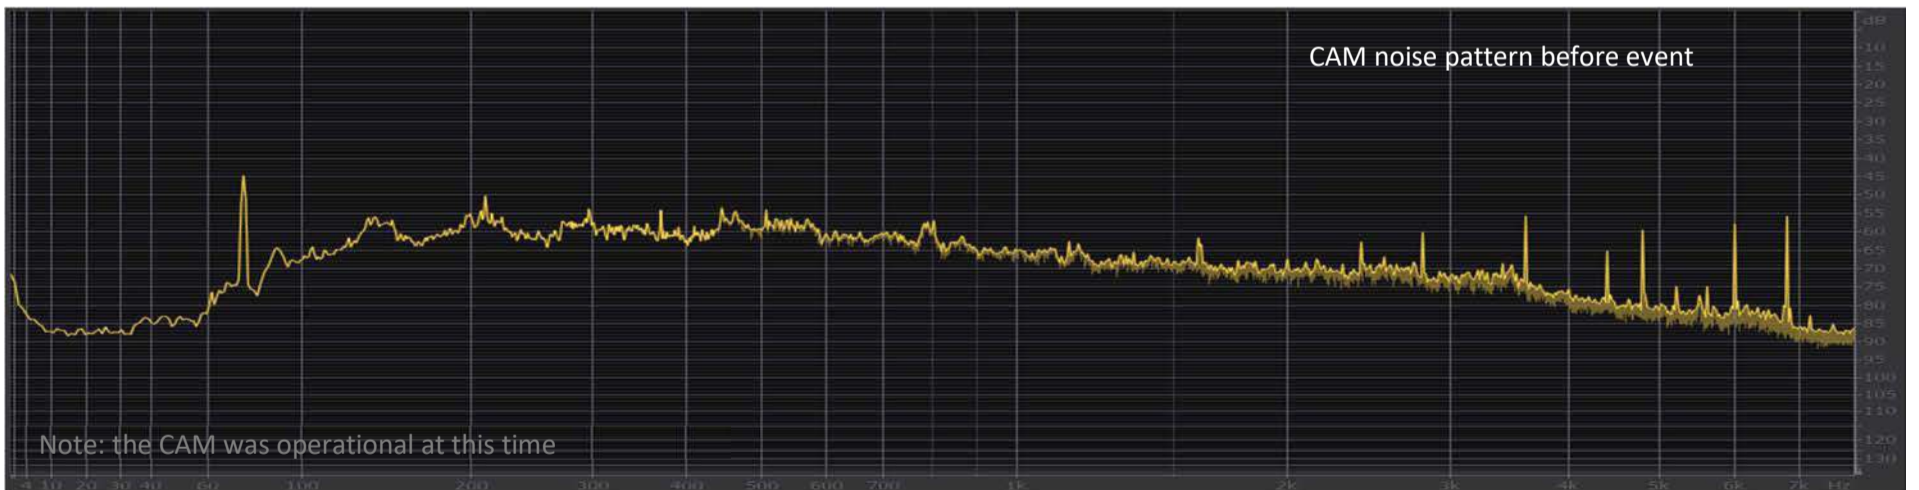
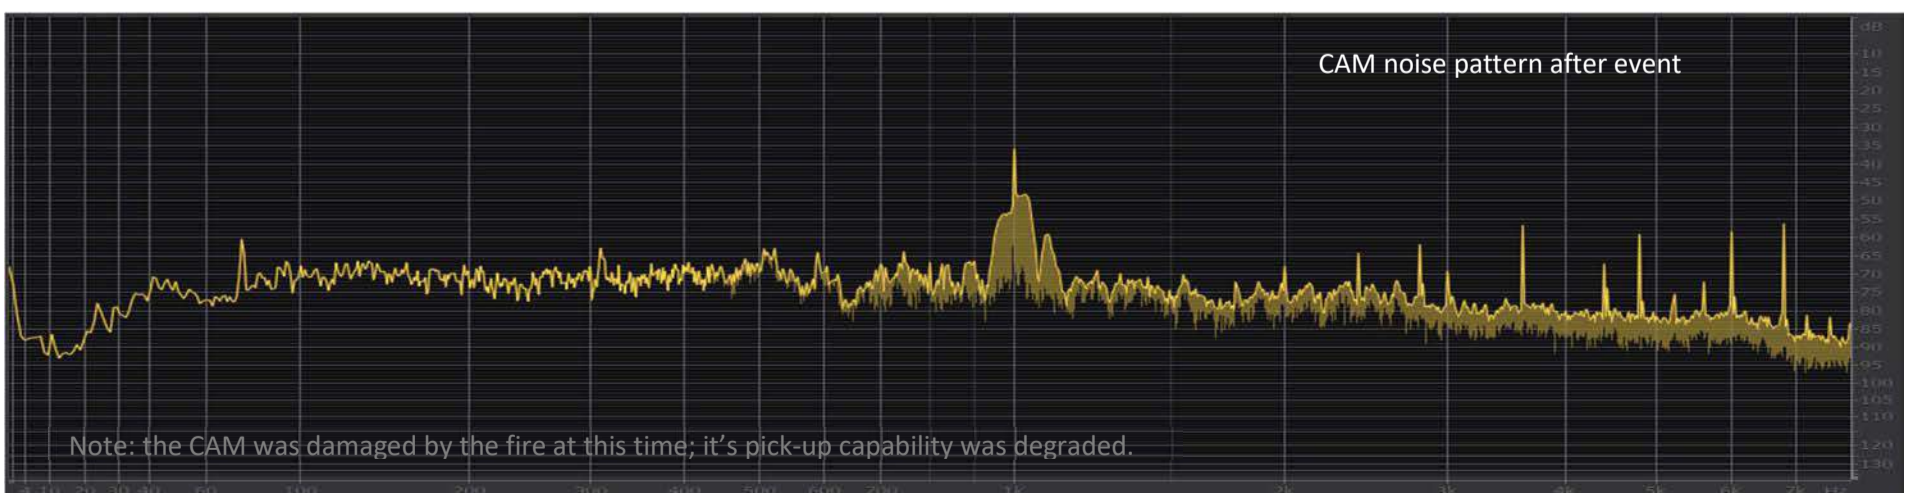
### Comparison of the overall noise pattern before and after the event

Note: There is an average dynamic loss of -15 to -20 dB over all of the CAM's bandwidth.

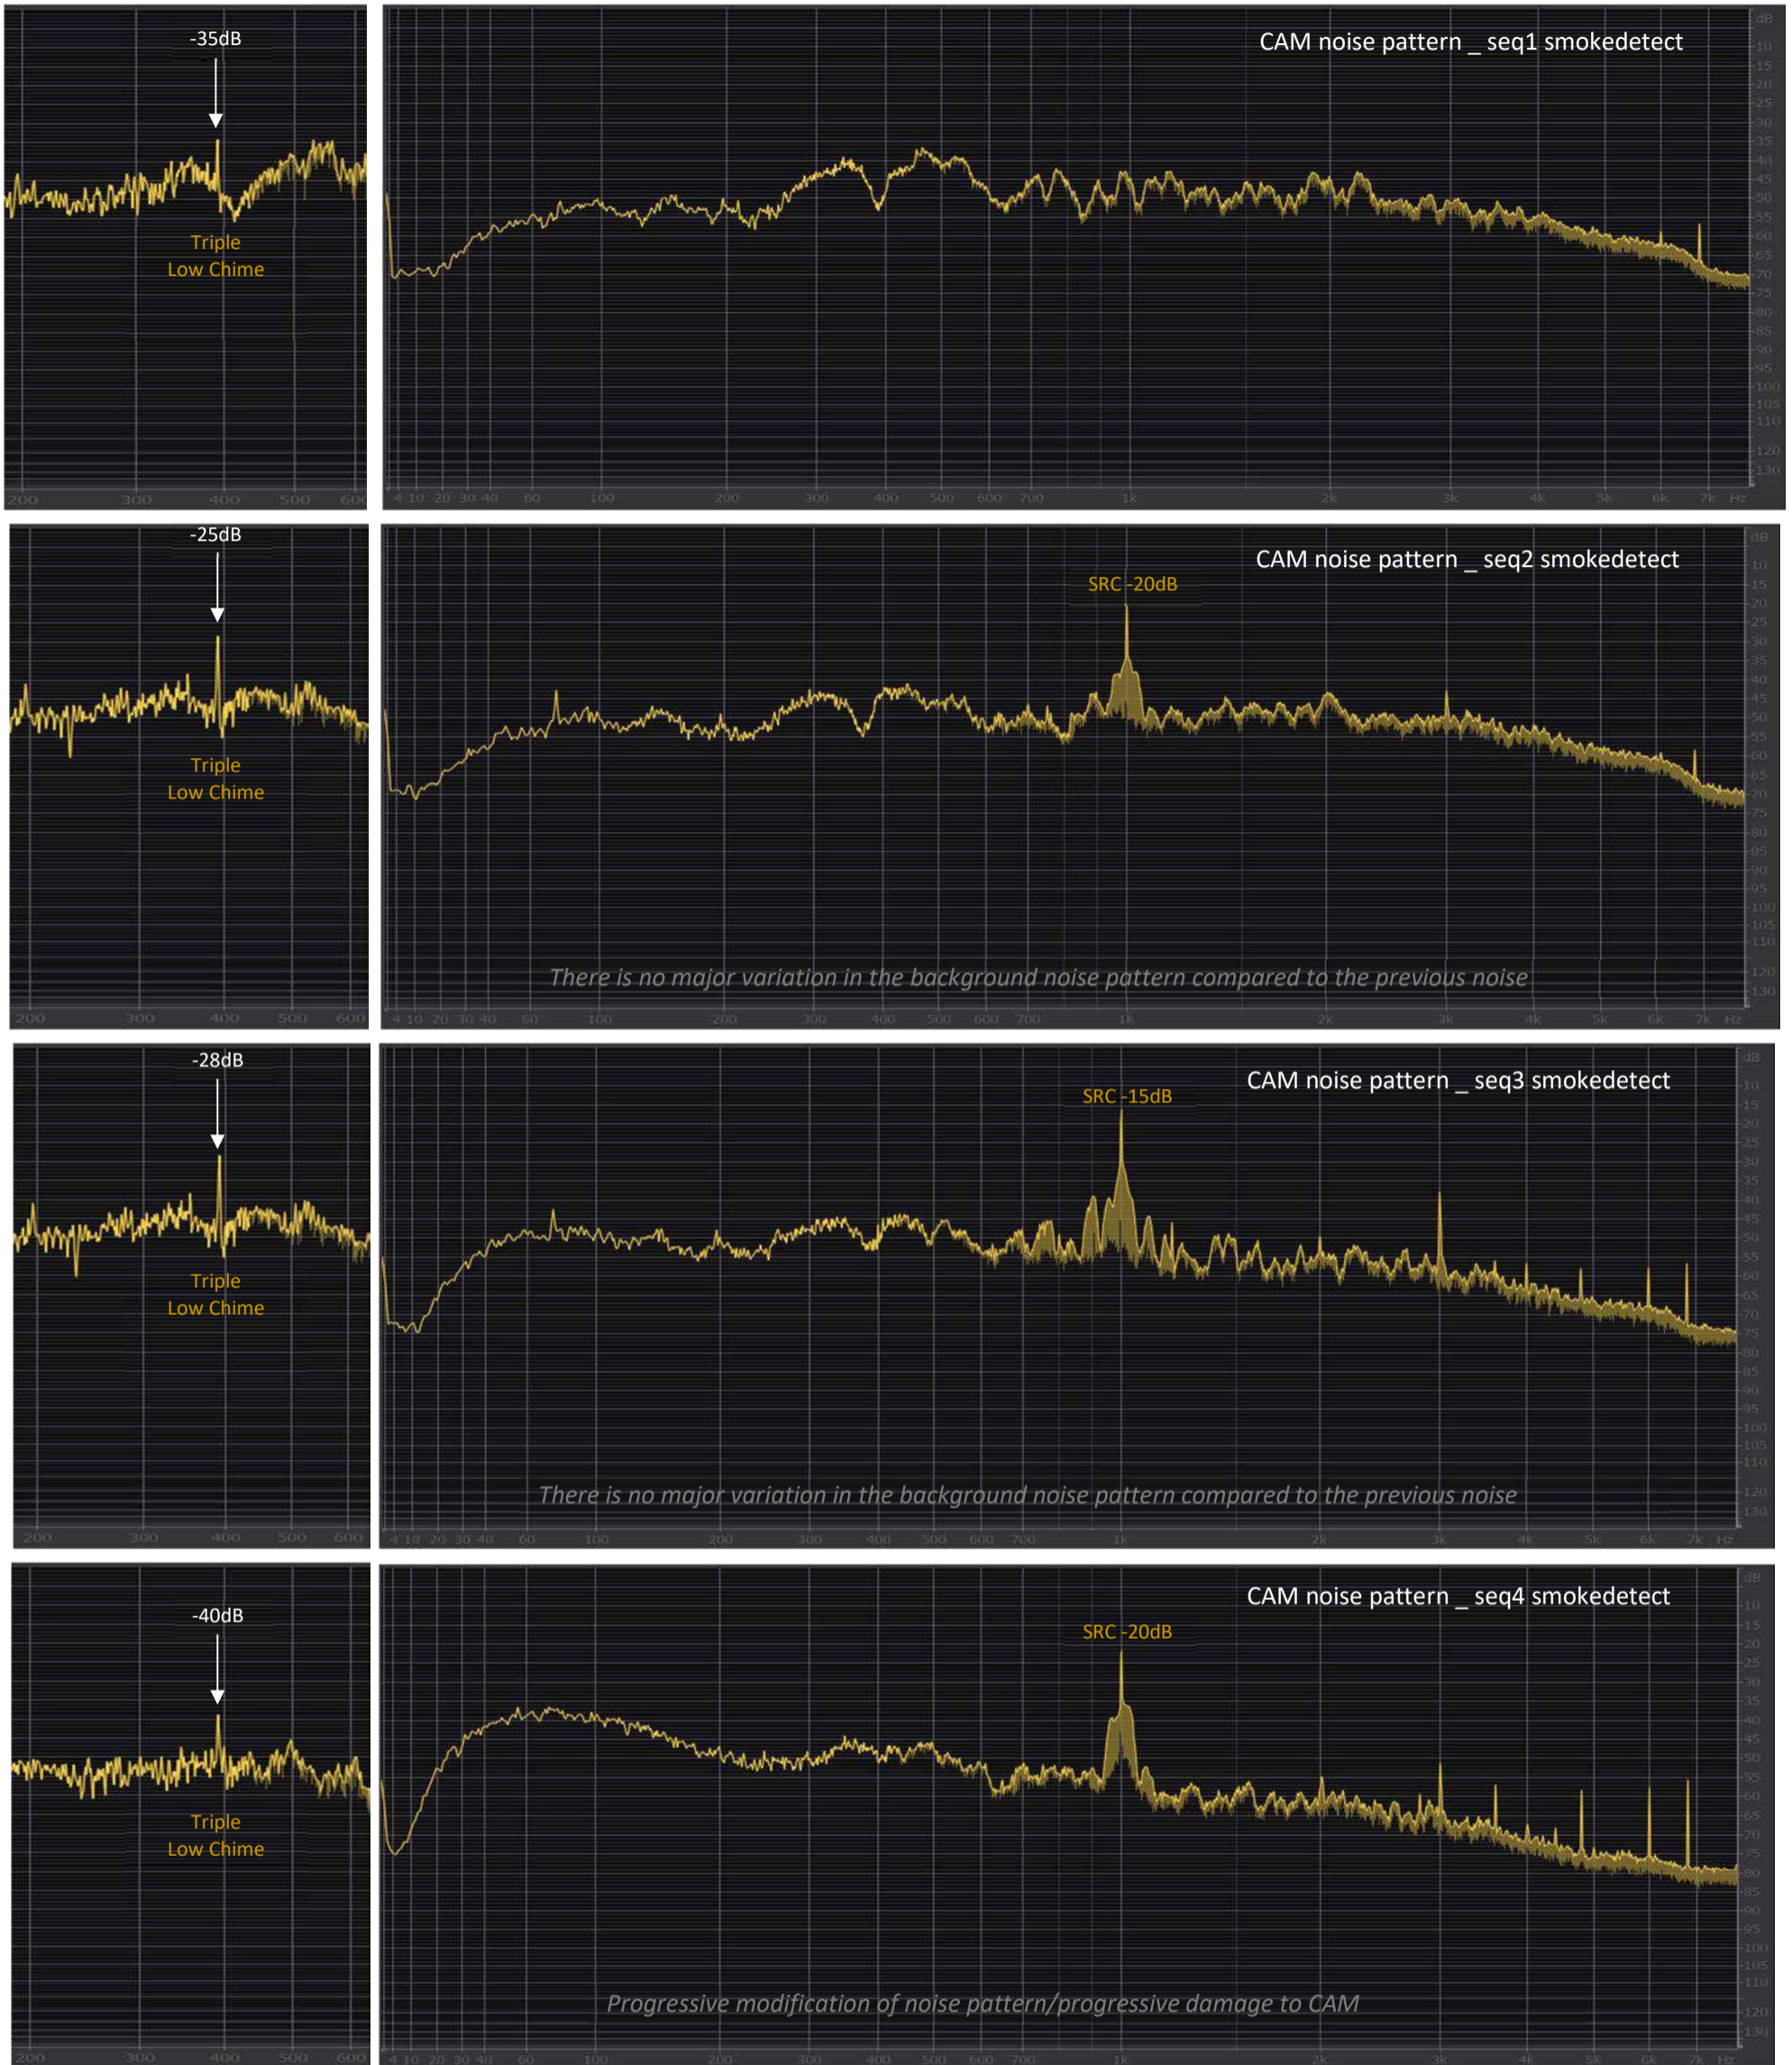
Chronology and pick-up level of "triple low chime" signal via the CAM in the cockpit

A 10 dB increase in the "triple low chime" signal was measured for sequences 2 and 3 (perceived at 00:26:48 and 00:27:18 UTC). This increase was compatible with the warning being picked up when the cockpit door was open.

De facto, sequences 1 and 4 were probably recorded with the door closed.

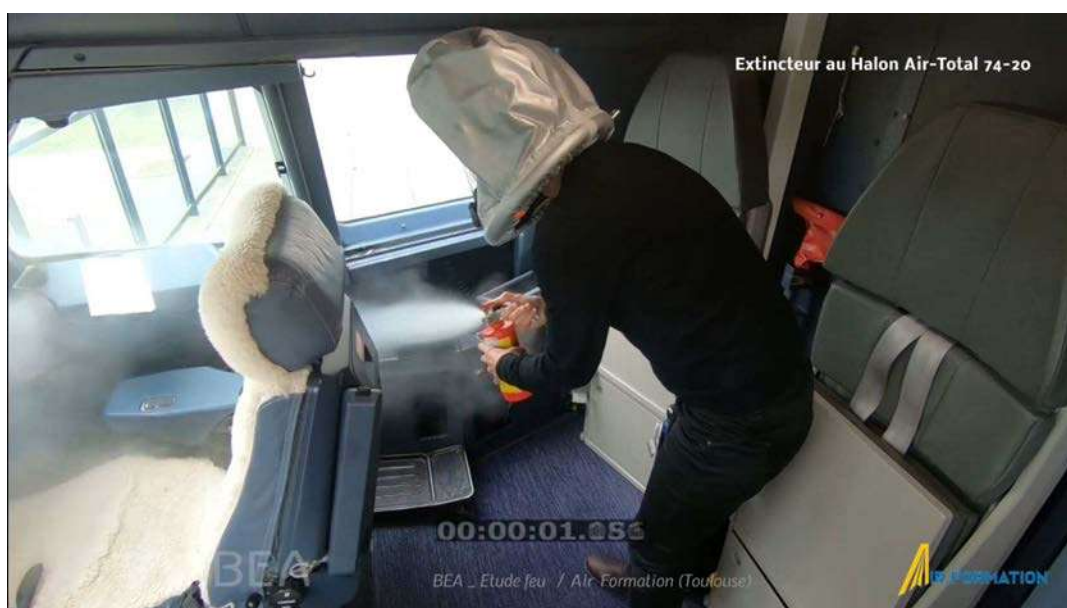
Activation of a cockpit fire extinguisher in the cockpit of Air Formation's A340

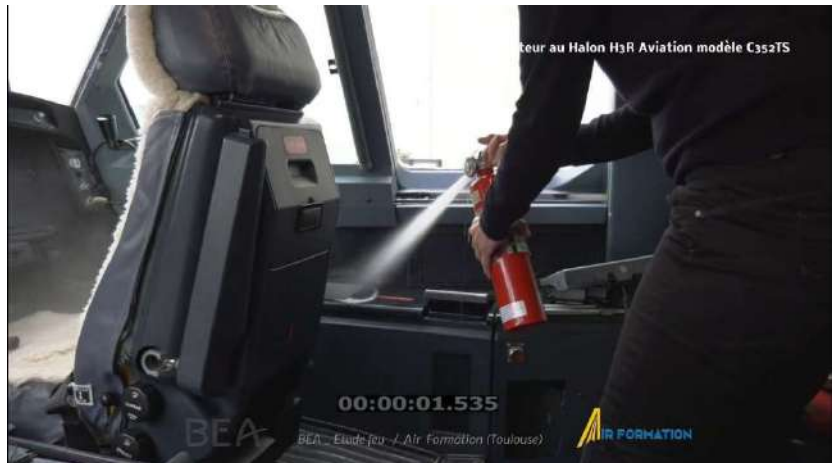
Model H3R Aviation C352TS  
(extinguisher widely used on commercial transport aircraft and in business aviation):

Note: the extinguisher emptied in 19.4s of uninterrupted spraying.

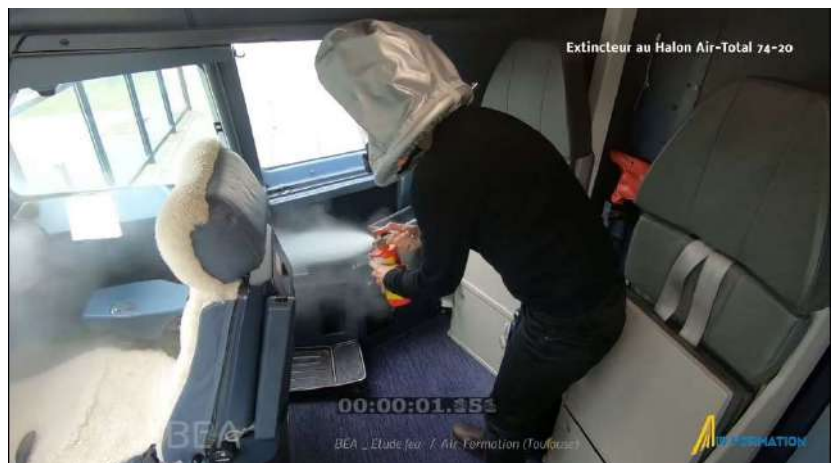
Model Air Total 74-20  
(extinguisher in the cockpit of the SU-GCC):

Note: the extinguisher emptied in 15 s of uninterrupted spraying.

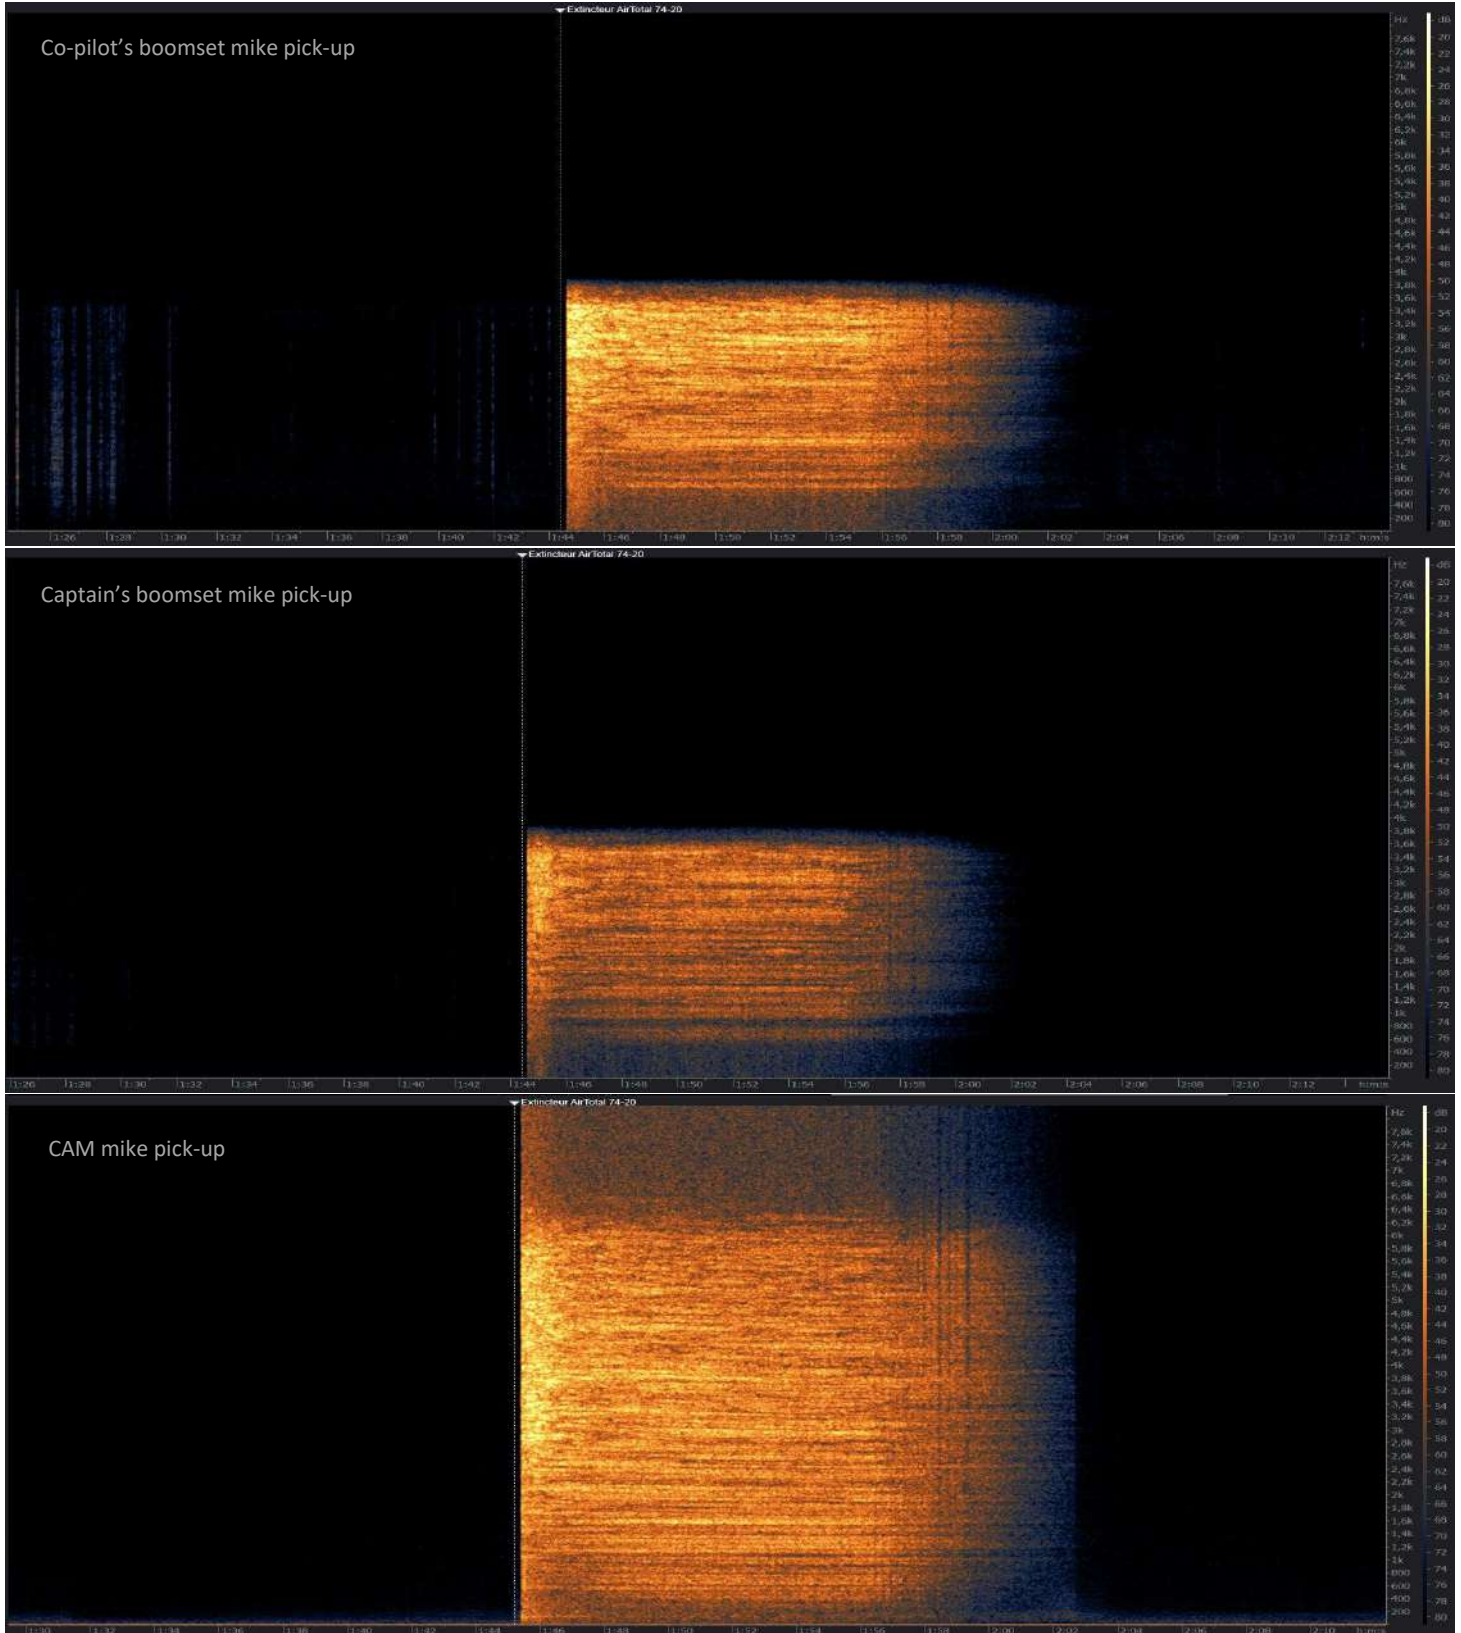
**Activation and emptying of an Air Total 74-20 halon fire extinguisher**  
 (A340 cockpit - fire extinguisher directed towards the co-pilot's doc storage compartment)

Summary Total time = 15 s

- Flight crew boomset channels: broadband noise from 800 Hz to 3.8 kHz, fairly pronounced between 2 and 3.8 kHz
- CAM channels: broadband noise over the entire 6200 Hz width of the CVR CAM channel

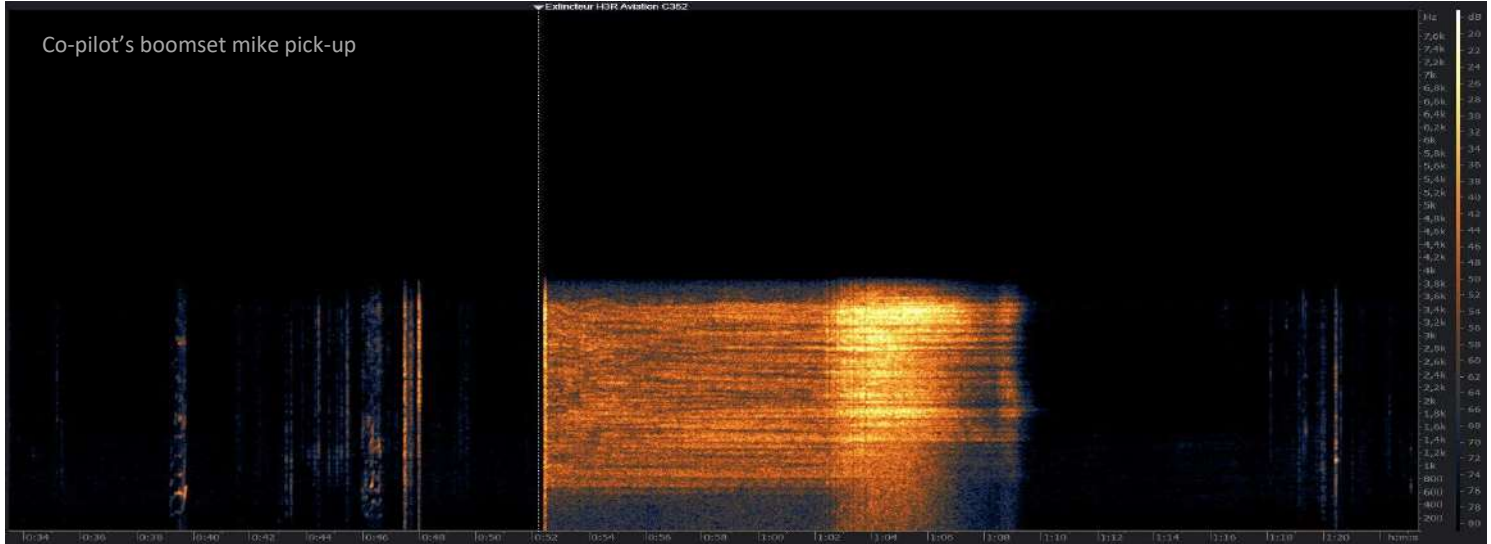
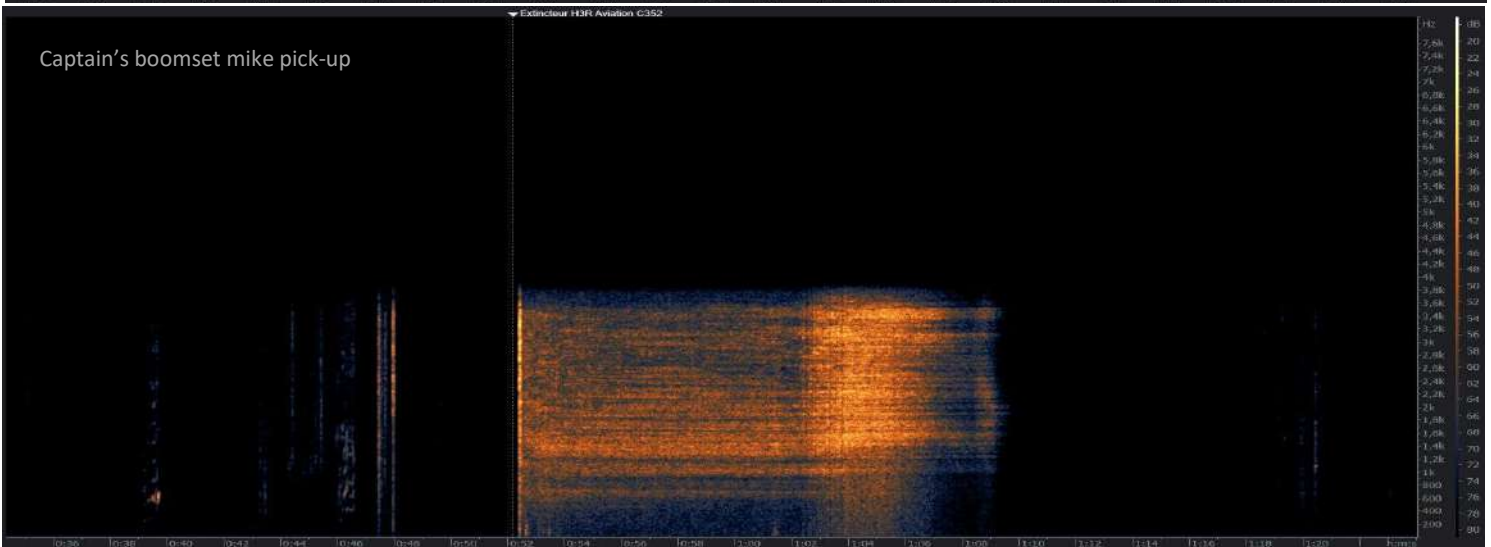
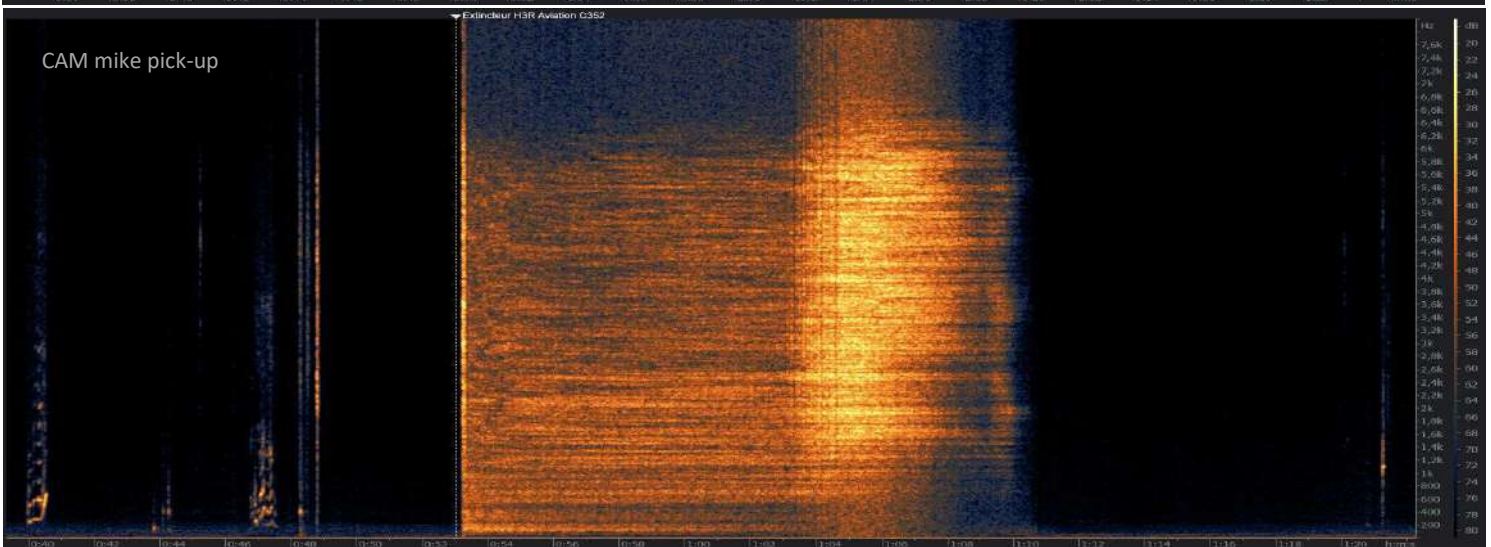
**Activation and emptying of an H3R Aviation C352T halon fire extinguisher**  
 (A340 cockpit - fire extinguisher directed towards the co-pilot's doc storage compartment)

Summary Total time = 19.4 s

- Flight crew boomset channels: broadband noise from 800 Hz to 3.8 kHz. Noise reinforcing between 1.4 and 3.8 kHz when cylinder emptied of two-thirds of the content.
- CAM channels: diffuse broadband noise over the entire bandwidth of the CVR CAM channel. Noise reinforcing between 1.4 and 3.8 kHz when cylinder emptied of two-thirds of the content.

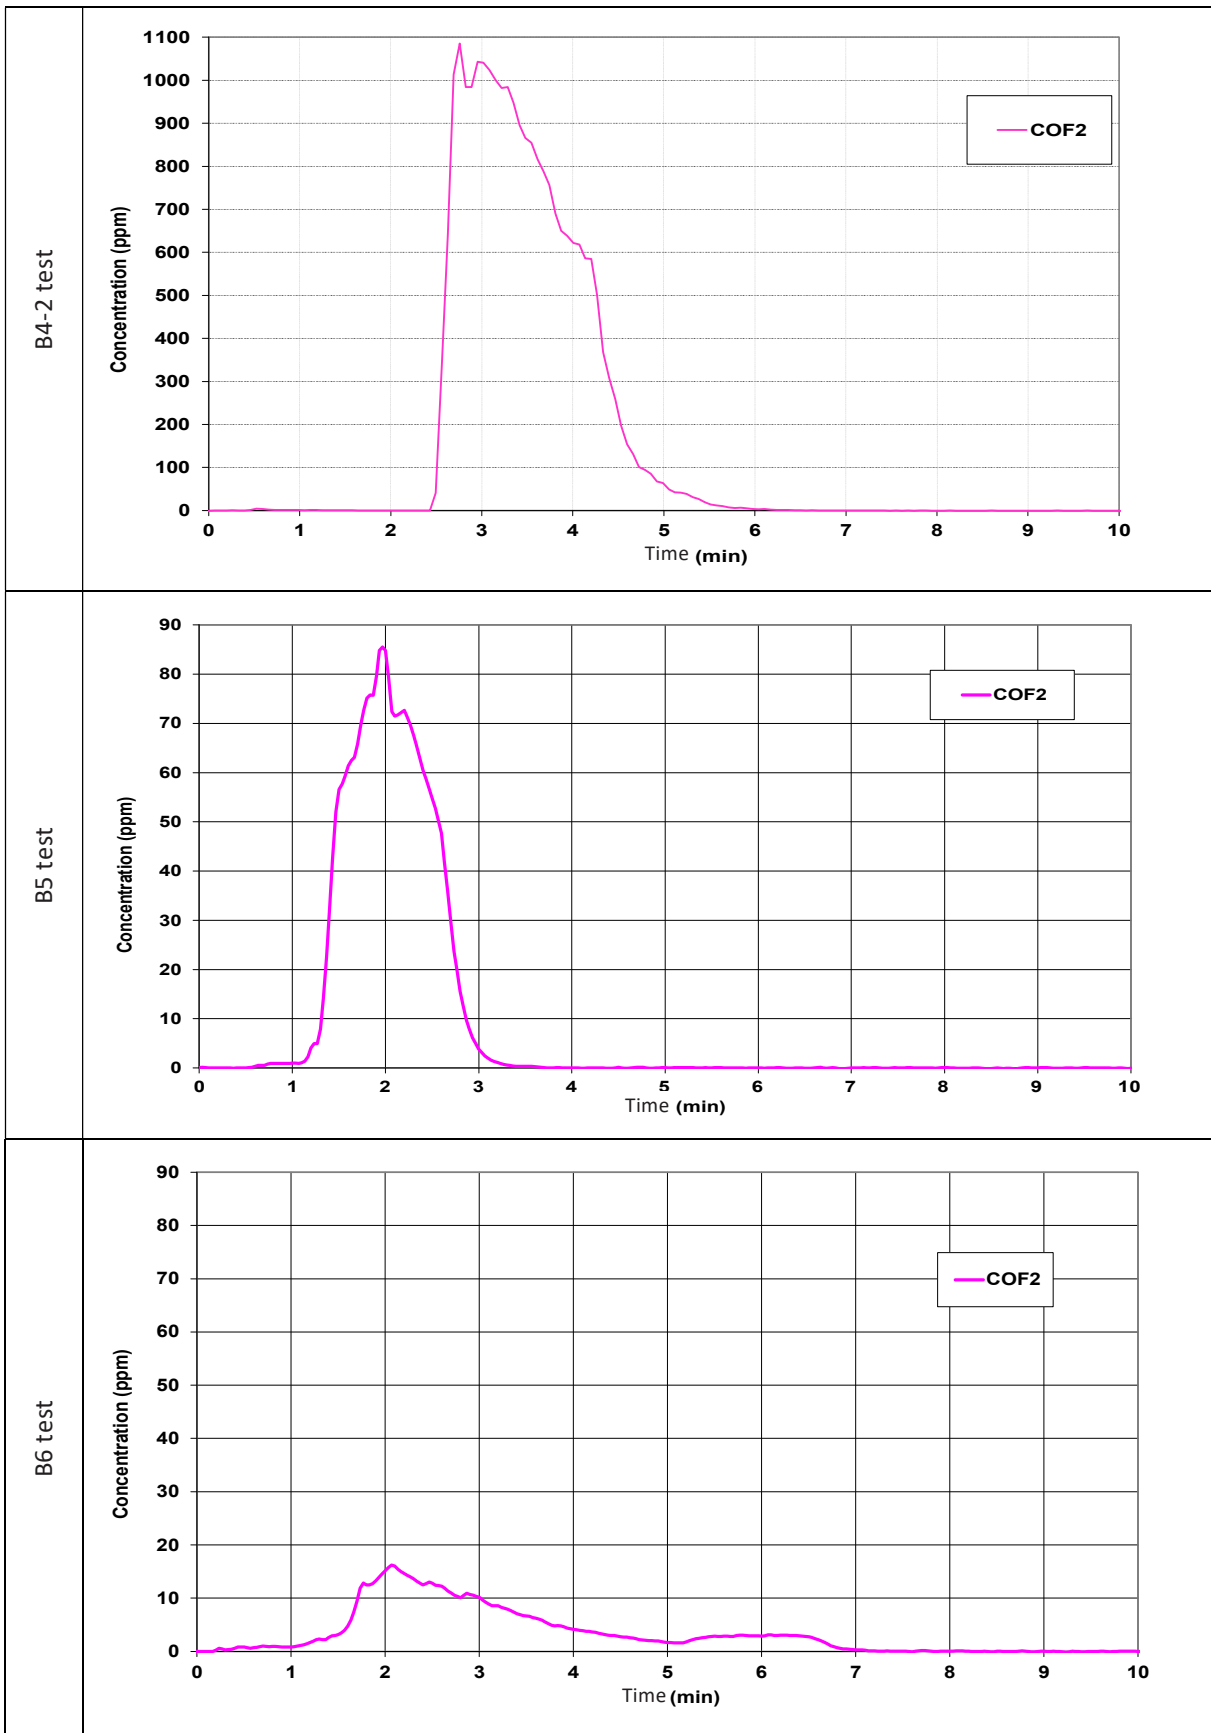
Concentration of COF2 measured during the three tests

Comparison of concentrations observed and risk thresholds  
COF2

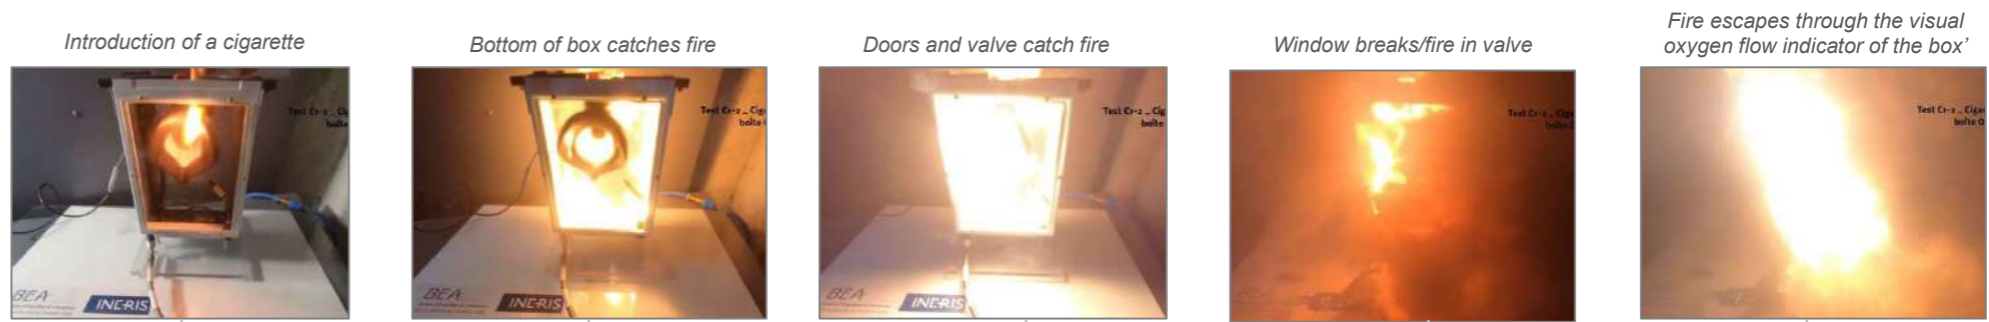
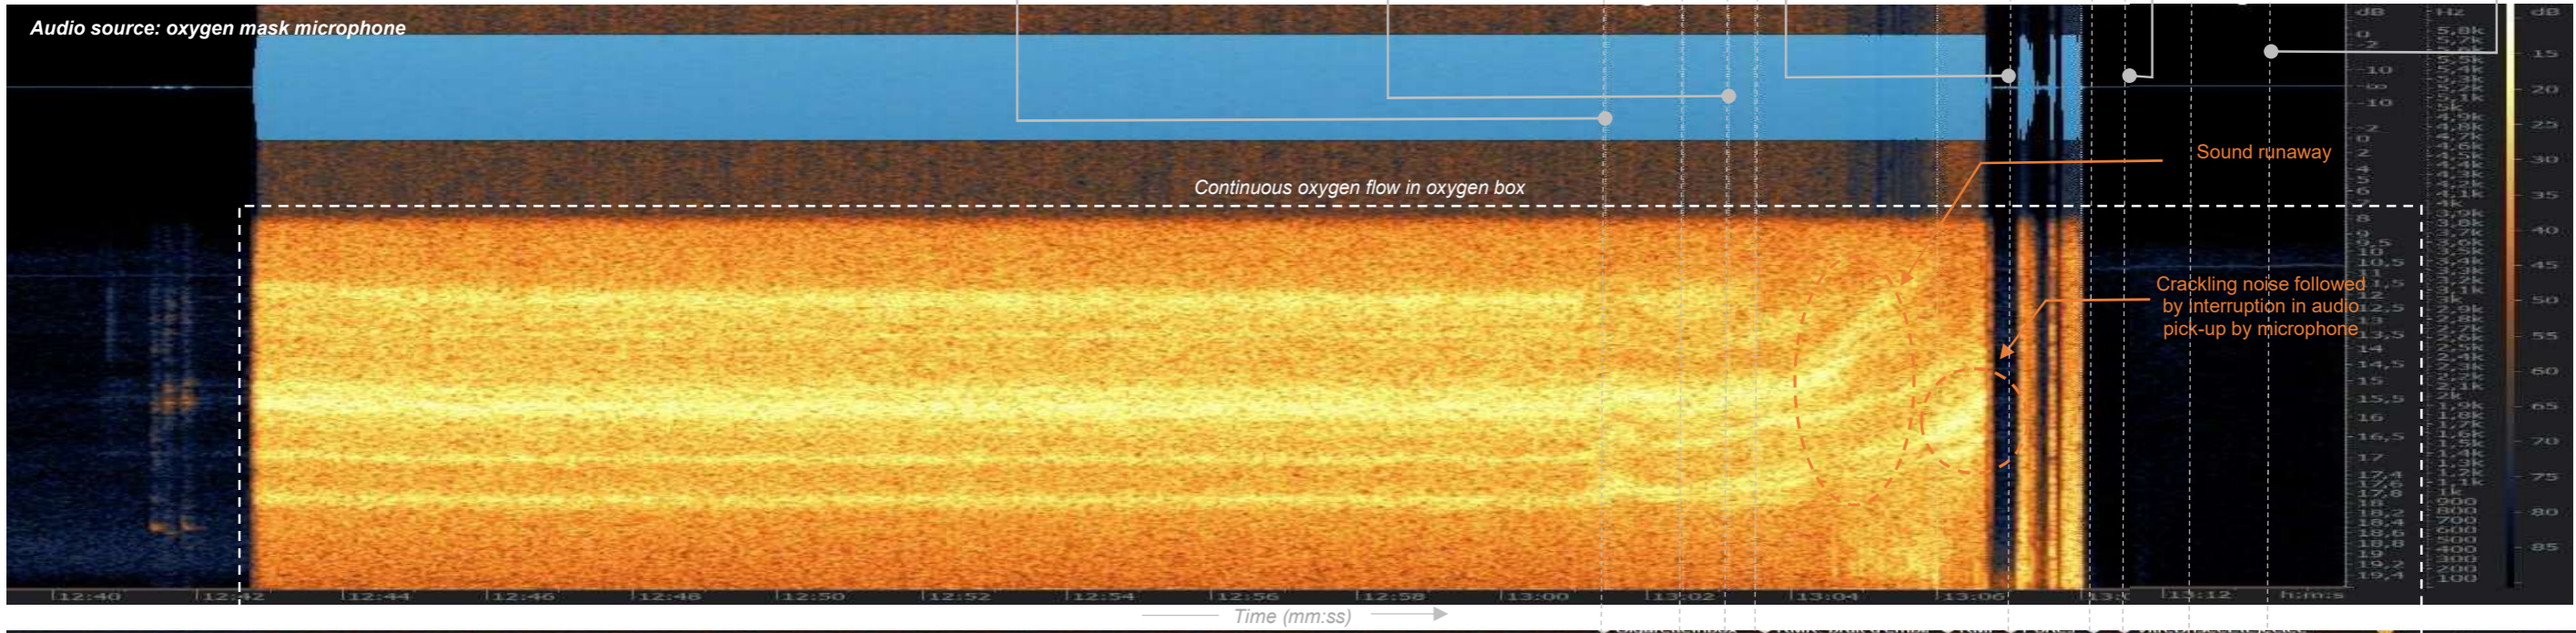
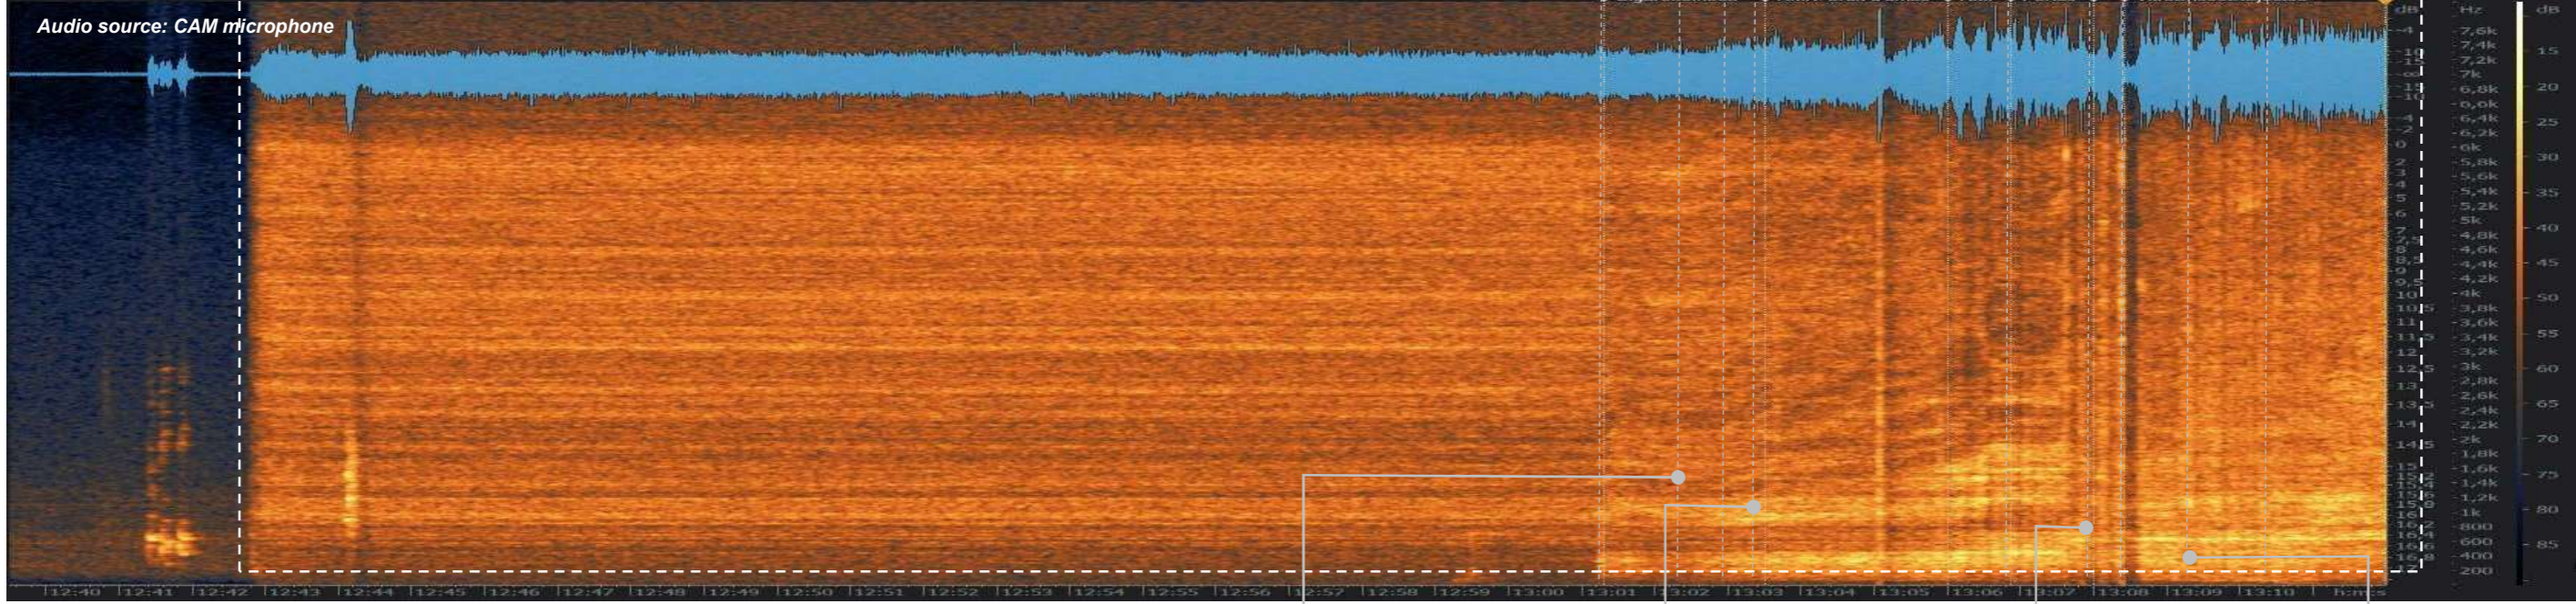
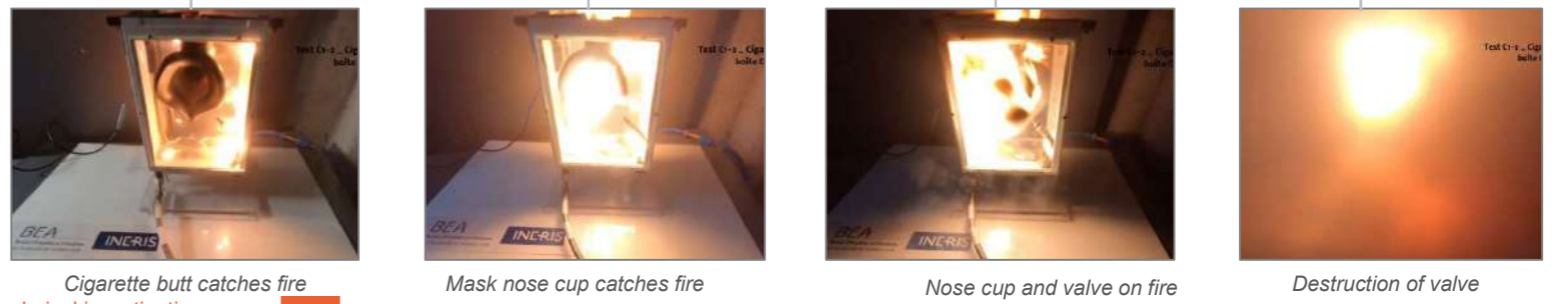
# 1 \_\_\_ Spectrum and waveform of audio recording of "Cigarette\_00" test

- Page #1 shows the waveform of the audio recording (oxygen mask microphone signal and CAM signal) during the "Cigarette\_00" test and the associated sequence of images. In the presence of an established oxygen leak, the cigarette introduced into the box immediately ignited, and very quickly set fire to the entire box and its contents (oxygen mask). There was a sound runaway 2.5 s after the cigarette was introduced and the microphone on the oxygen mask stopped working 3.5 s after the mask ignited.

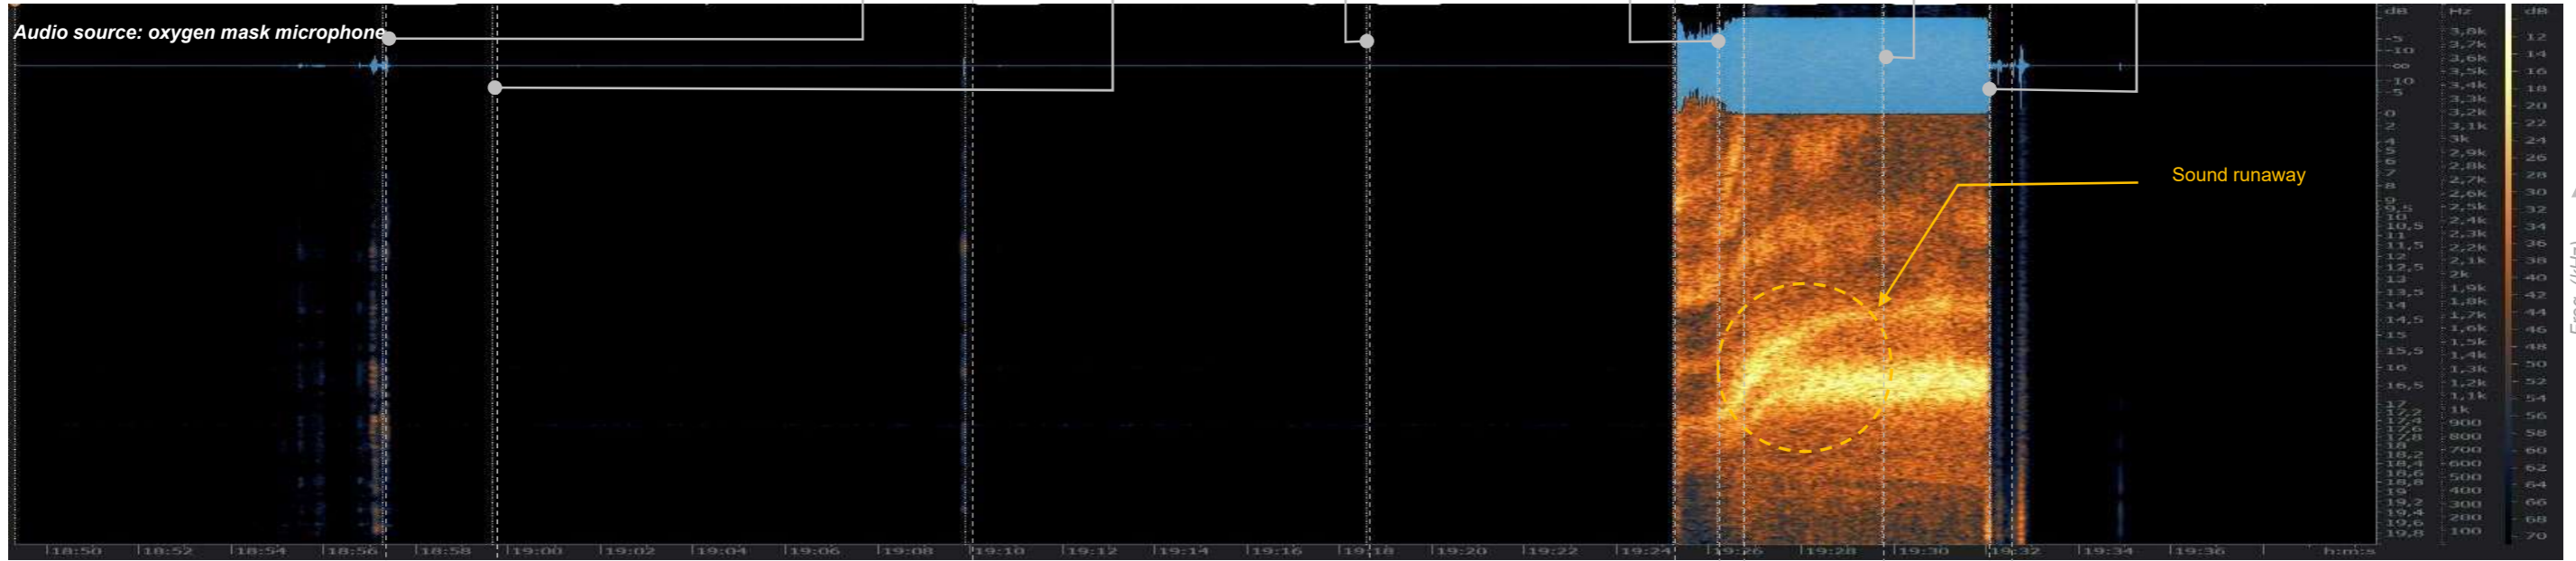
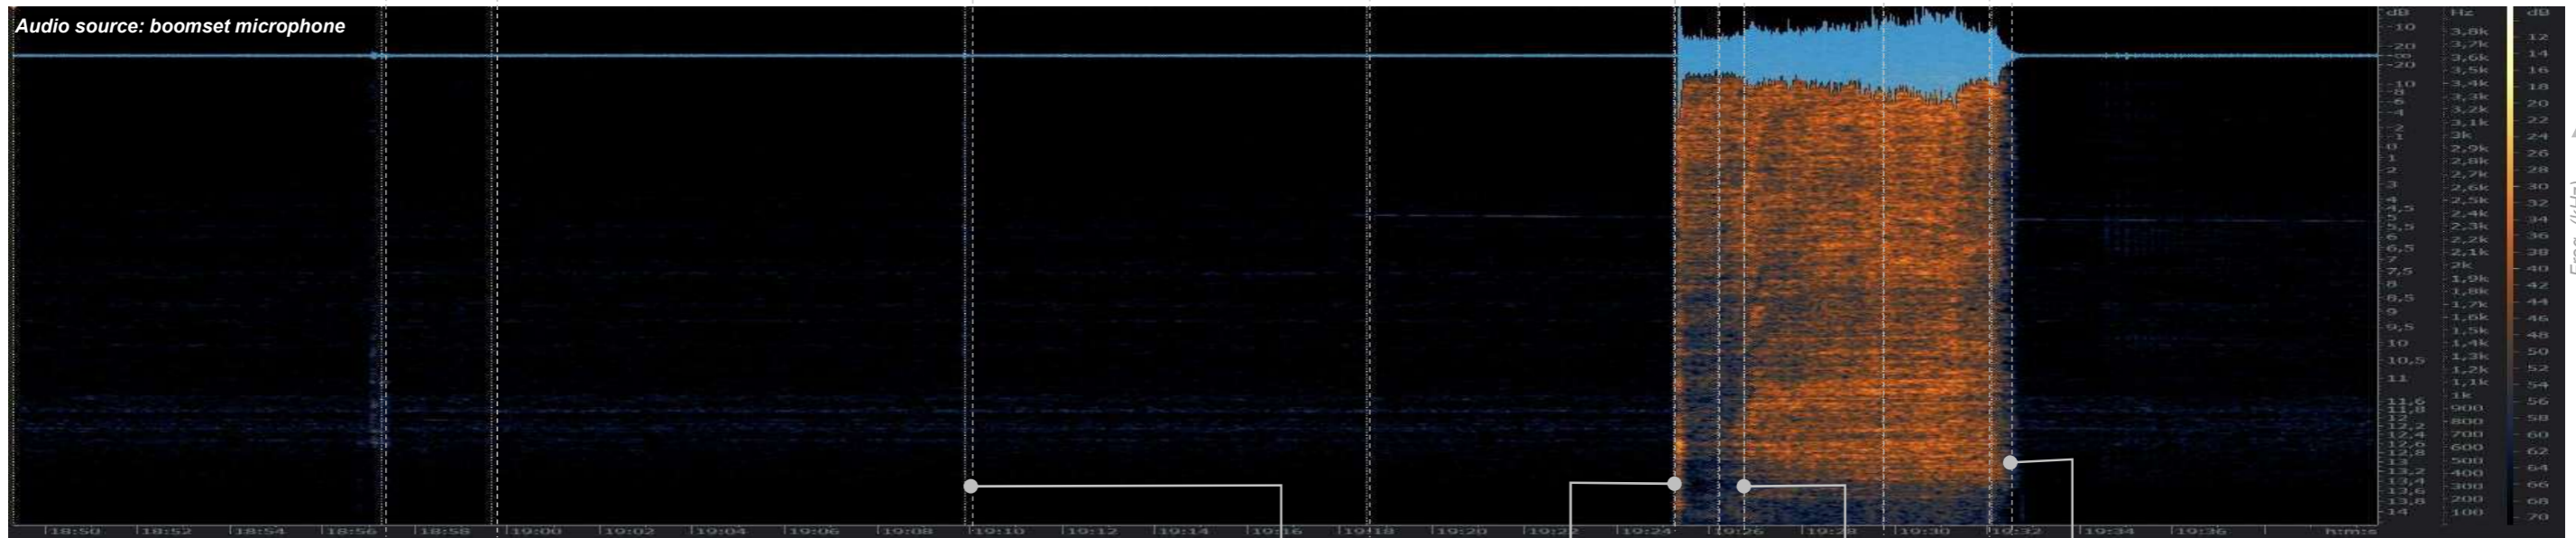
- Page #2 shows the waveform of the audio recording (oxygen mask microphone signal and boomset microphone signal) during the "Cigarette\_03" test and the associated sequence of images. The cigarette introduced into the oxygen-enriched box progressively damaged the oxygen mask hose (28 s of crackling noises are present during which the combustion of the braided protection is visible) until the core of the hose was pierced. When the hose was pierced, there was a broadband noise followed 1s later by a sound runaway. The fire that immediately followed the piercing of the hose very quickly engulfed the entire box and its contents (oxygen mask). The oxygen mask microphone stopped working 6 s after the mask caught fire.

Slight crackling noises/combustion of envelope of mask oxygen hose

End of audio pick-up by oxygen mask microphone
