## Final Report

**EgyptAir A320 Aircraft crash in the Mediterranean, registered SU-GCC,  
flight number MSR804, from Charles De-Gaulle Airport, Paris to Cairo  
International Airport, on 19/05/2016**

EGAI2016-01

October 2024

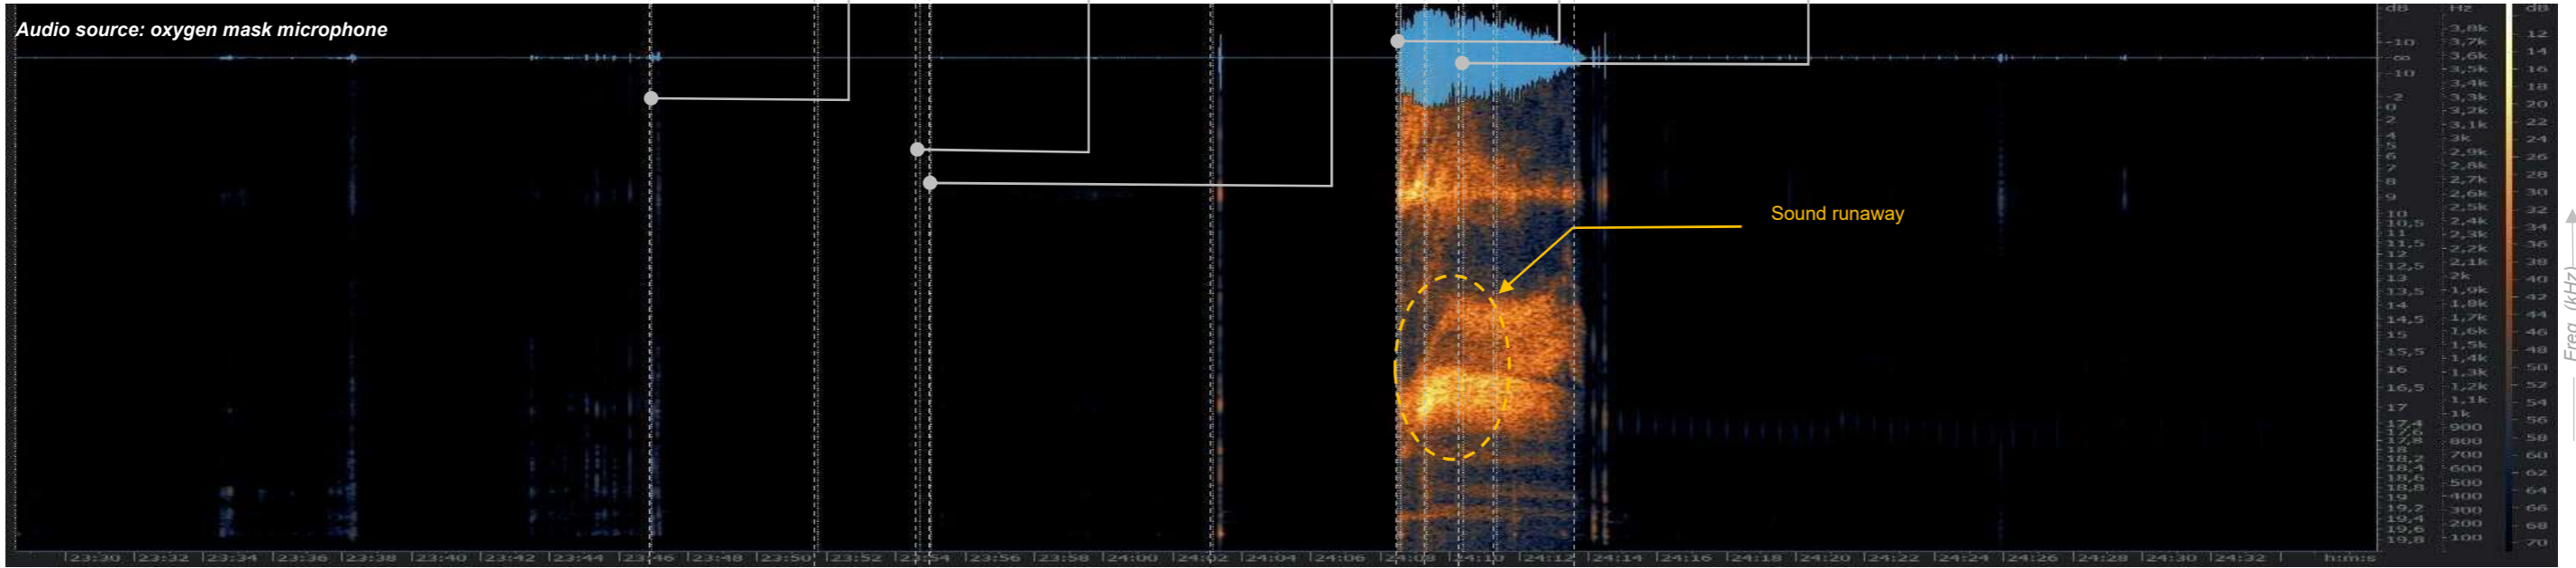
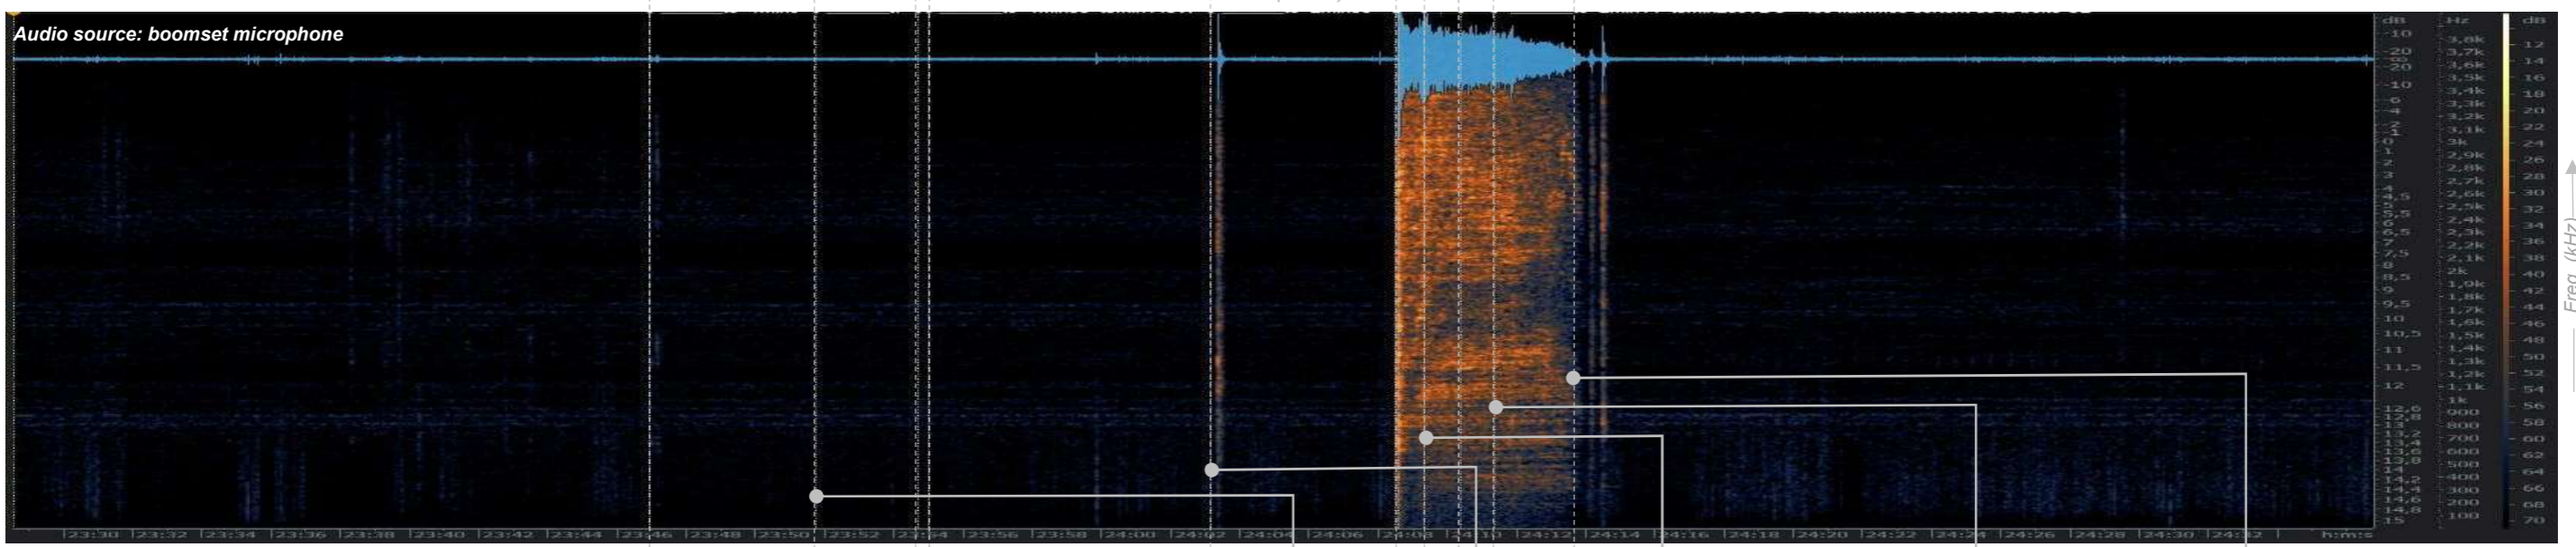
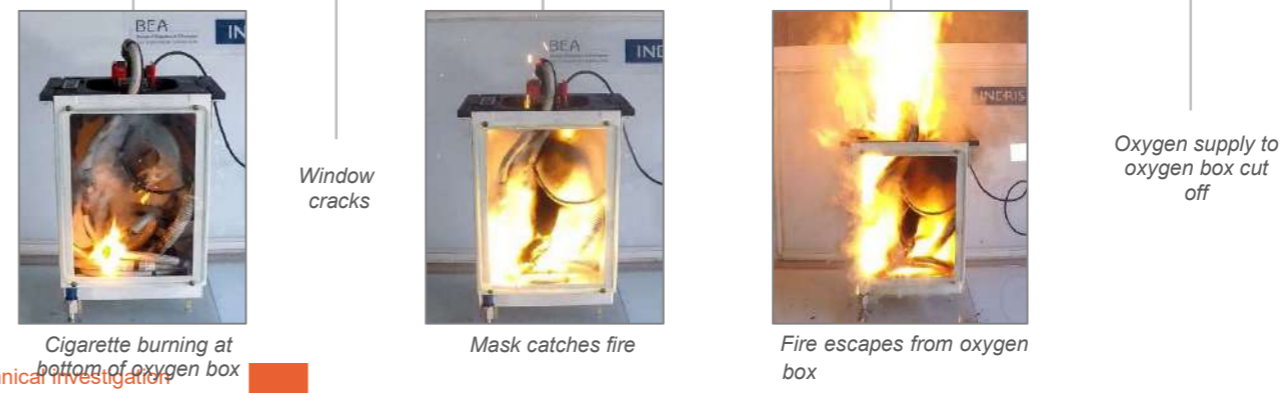
- Page #3 shows the waveform of the audio recording (oxygen mask microphone signal and boomset microphone signal) during the "Cigarette\_04" test and the associated sequence of images. The cigarette introduced into the oxygen-enriched box progressively damaged the oxygen mask hose (22 s of crackling noises are present during which the combustion of the braided protection is visible) until the core of the hose was pierced. When the hose was pierced, there was a broadband noise followed 0.5 s later by a sound runaway. The fire that followed the piercing of the hose very quickly engulfed the entire box and its contents (oxygen mask). The oxygen supply was cut off 5 s after the mask ignited and before the oxygen mask microphone was damaged.

Slight crackling noises/combustion of envelope of mask oxygen hose

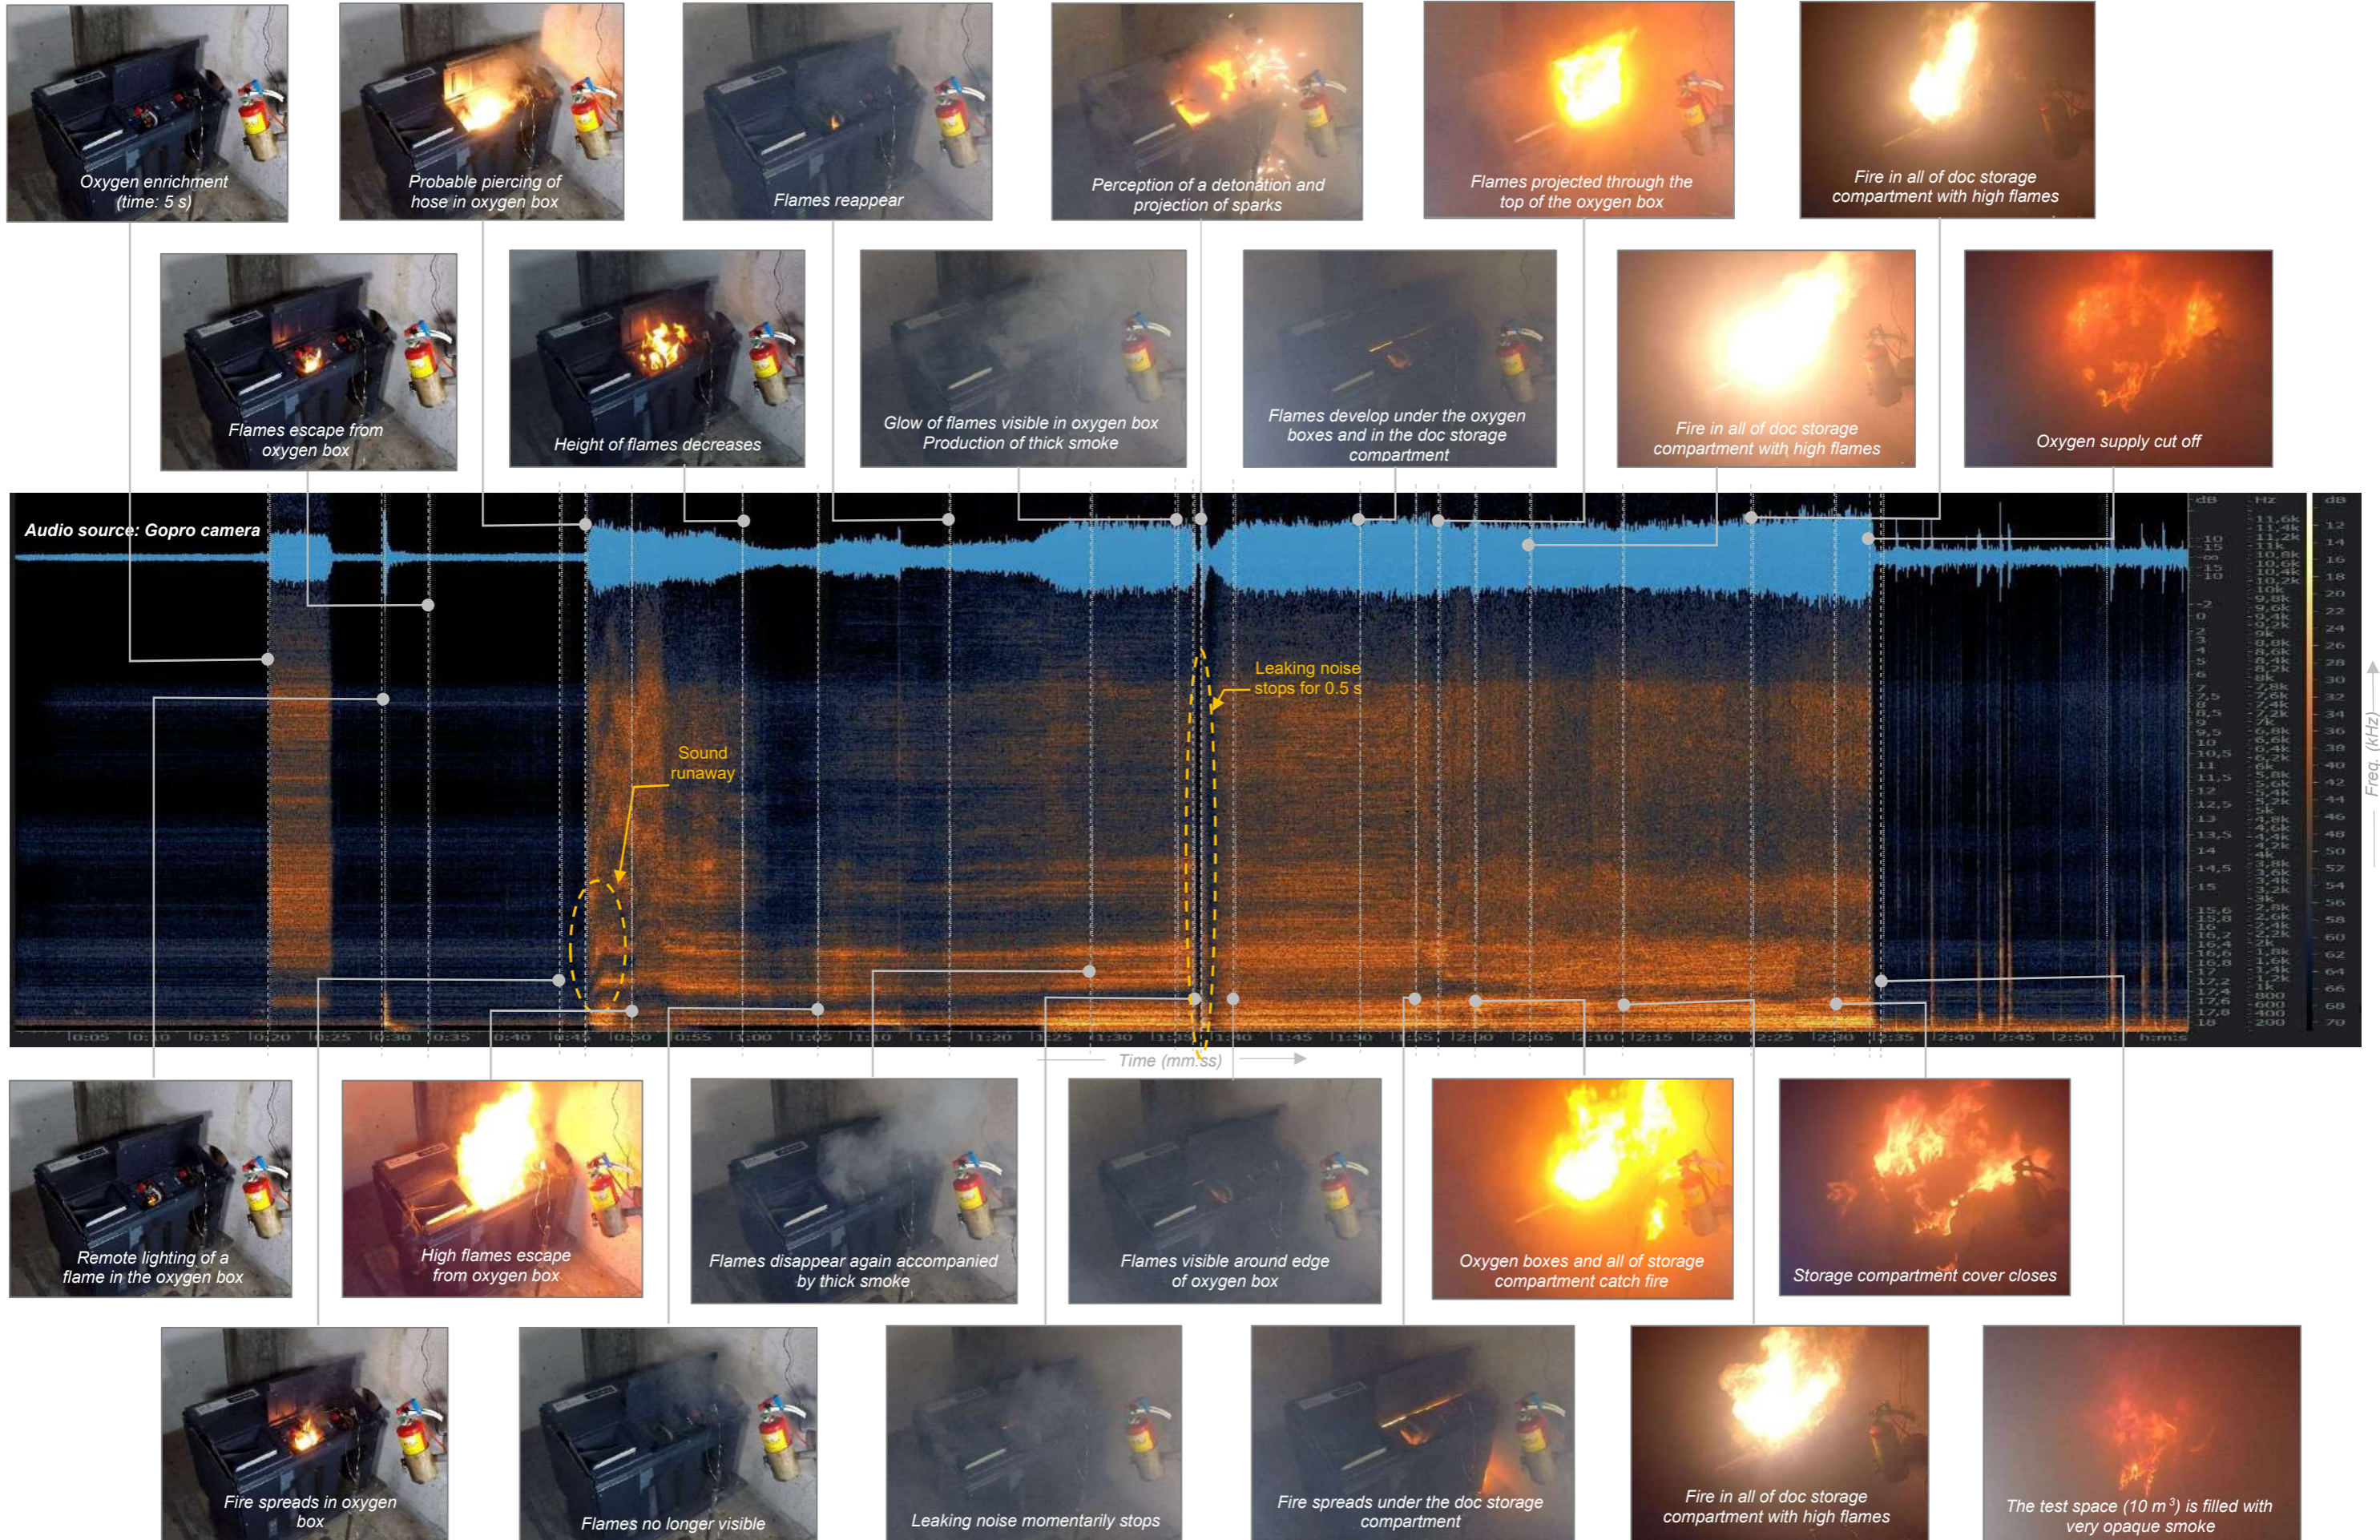
# 4 \_\_\_ Spectrum and waveform of audio recording of "Propagation\_01" test

- Page #4 shows the waveform of the audio recording (GOPRO camera sound band) during the "Propagation\_01" test and the associated sequence of images. Smoke and flames could be seen coming out of the oxygen box 5 s after the remote lighting of a cotton pad placed in the bottom of the oxygen box. The mask hose was probably pierced 18 s after the start of the fire. This was shown by a broadband noise followed 1s later by a sound runaway. The fire that followed the piercing of the hose spread rapidly to the surrounding elements. The leaking noise suddenly stopped for 0.5 s - without any action by the test operators - 50 s after the mask hose was probably pierced. This short interruption in the leak preceded a detonation, the resumption of the leak and the enrichment of the fire.

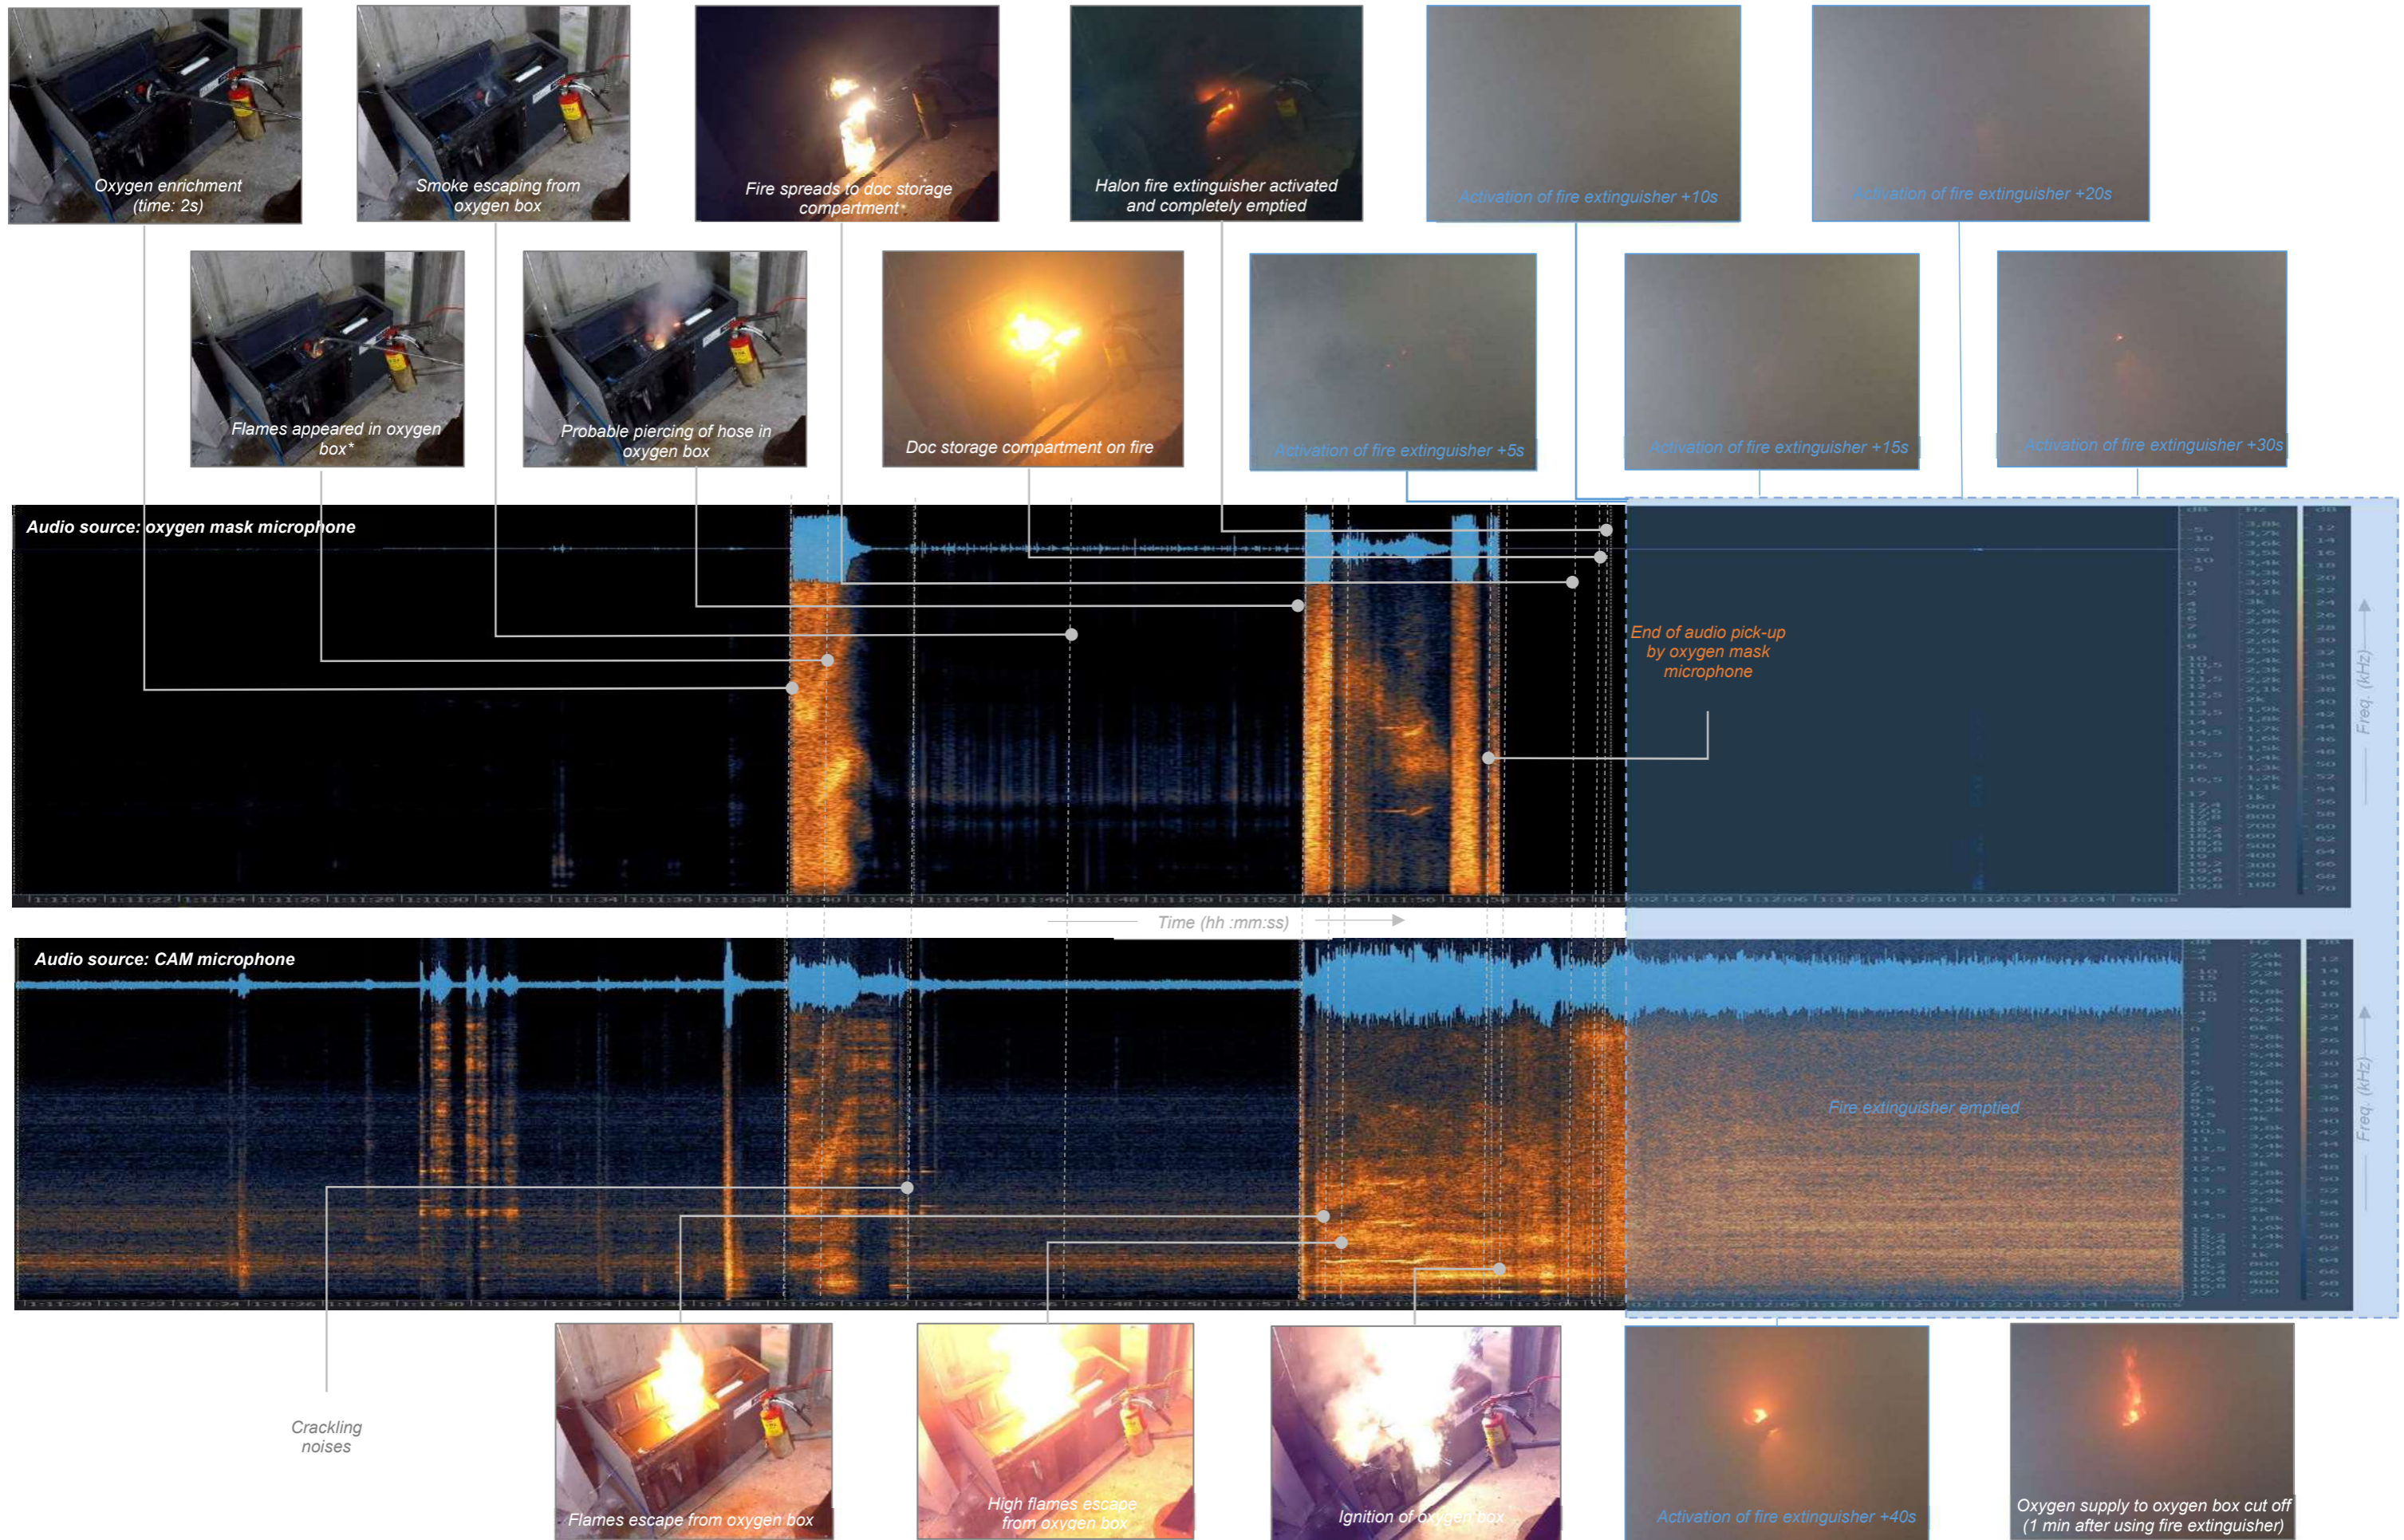
# 5 \_\_\_ Spectrum and waveform of audio recording of "Propagation\_02" test

- Page #5 shows the waveform of the audio recording (oxygen mask microphone signal and CAM signal) during the "Propagation\_02" test and the associated sequence of images. Smoke and flames could be seen coming out of the oxygen box 6 s after the remote reactivation of the cotton pad fire in the bottom of the oxygen box<sup>4</sup>. The mask hose was probably pierced 13 s after the reactivation of the fire. It was preceded over the same period by cracking noises picked up by the oxygen mask microphone. The probable piercing of the hose produced a broadband noise. The sound runaway described for the previous tests was not perceived. The fire that followed the piercing of the hose spread rapidly to the surrounding elements. The leaking noise was continuous until the oxygen supply of the test set-up was cut off.

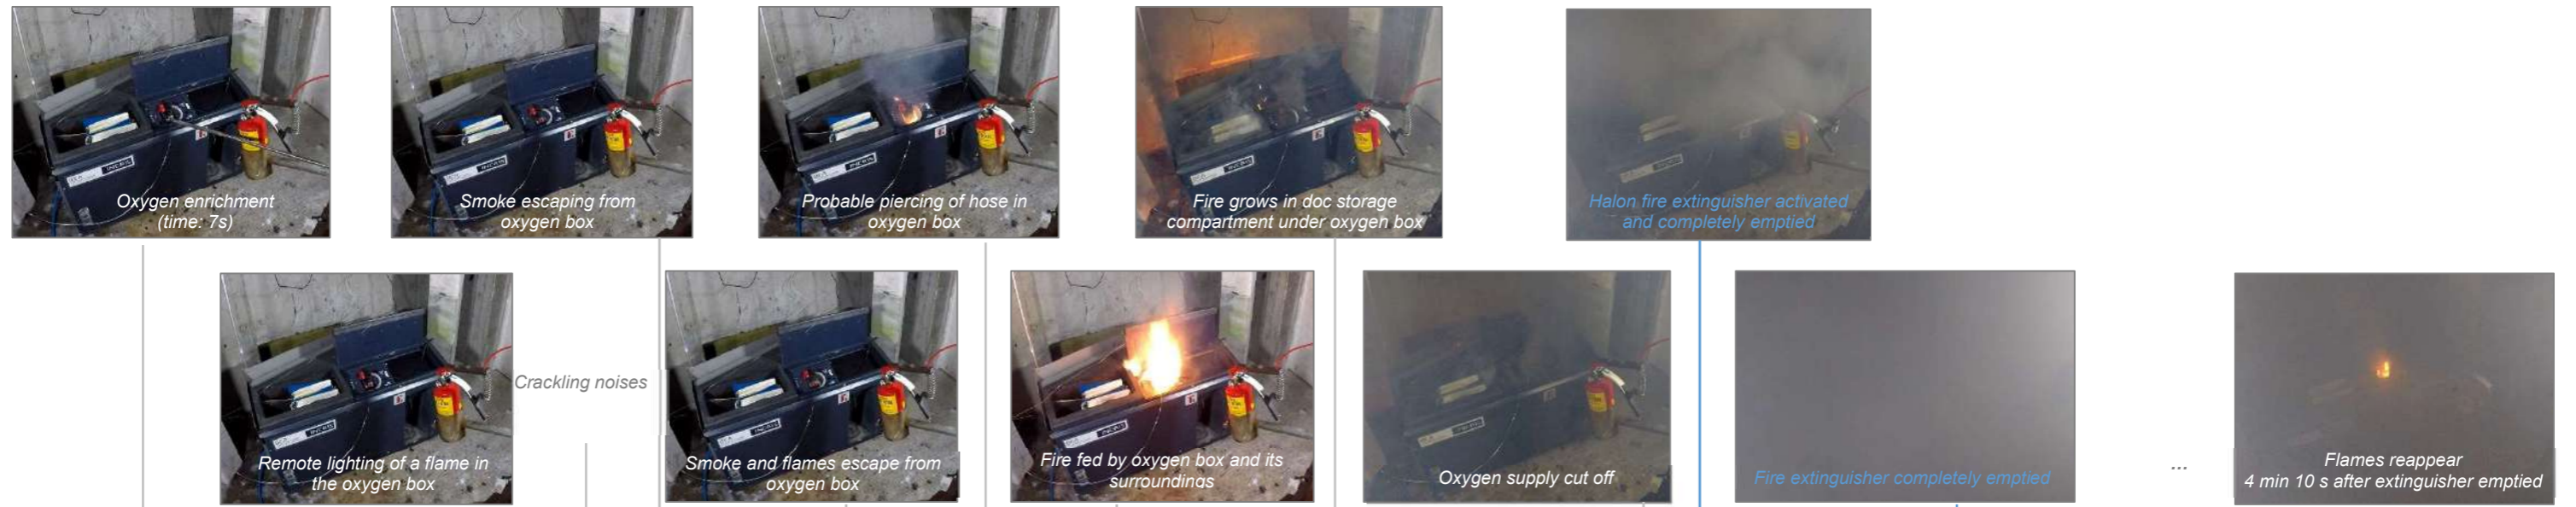
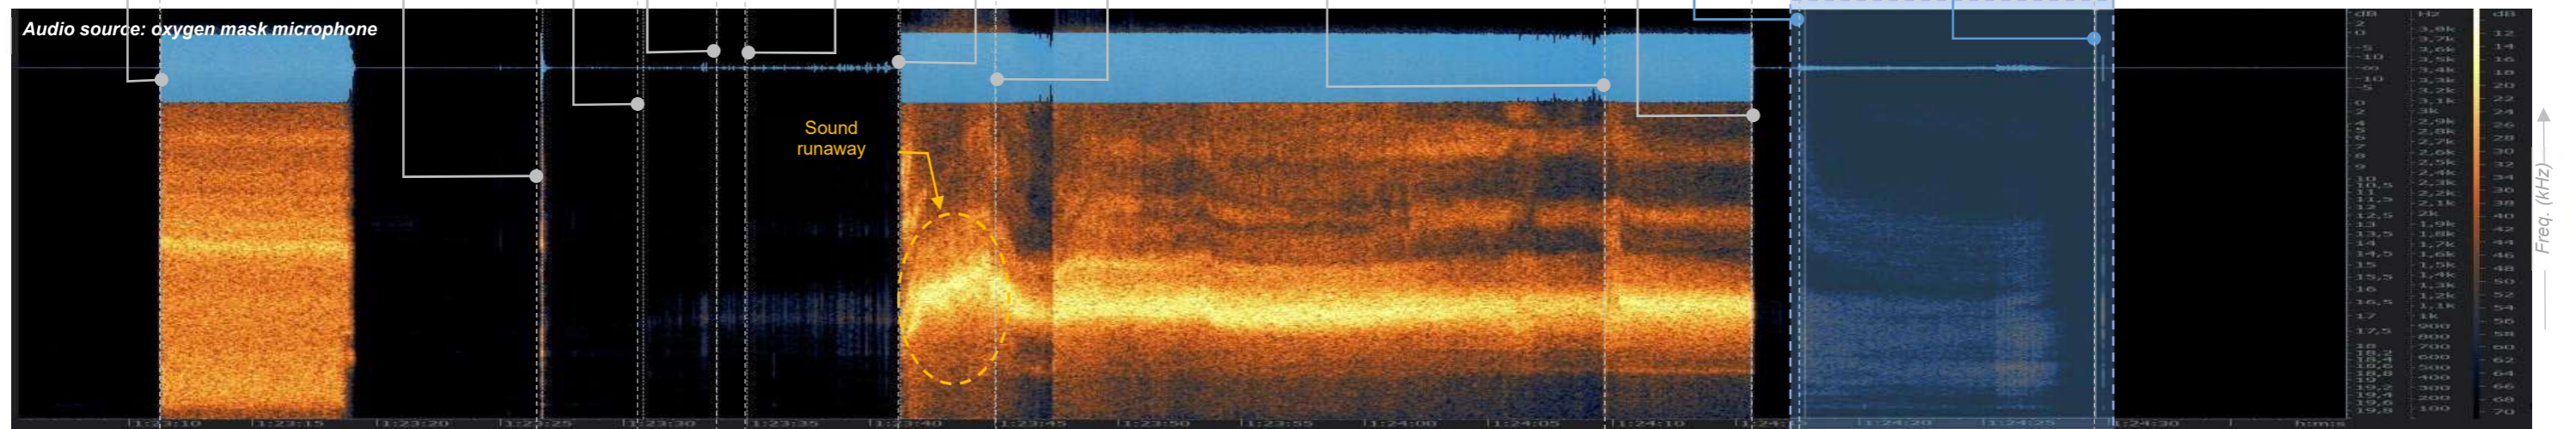
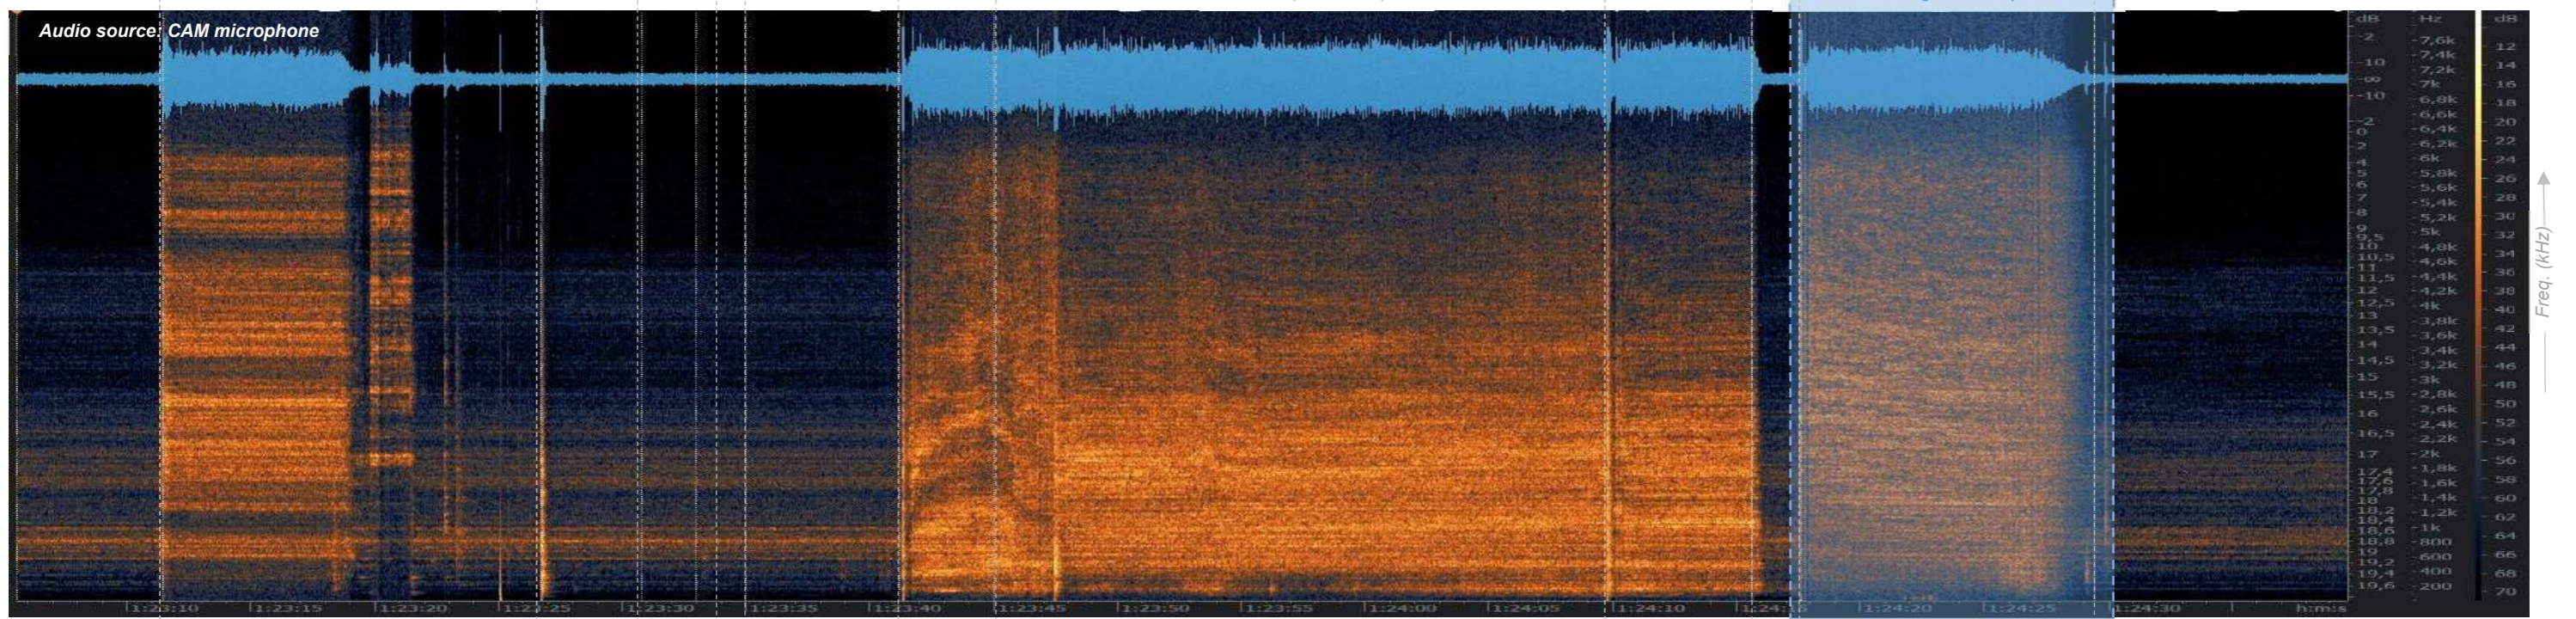
# 6 \_\_\_ Spectrum and waveform of audio recording of "Propagation\_03" test

- Page #6 shows the waveform of the audio recording (oxygen mask microphone signal and CAM signal) during the "Propagation\_03" test and the associated sequence of images. Smoke and flames could be seen coming out of the oxygen box 7 s after the remote lighting of a cotton pad placed in the bottom of the oxygen box. The mask hose was probably pierced 14 s after the start of the fire. It was preceded over the same period by cracking noises picked up by the oxygen mask microphone. The probable piercing of the hose produced a broadband noise followed 0.5 s later, by a sound runaway. The fire that followed the piercing of the hose spread rapidly to the surrounding elements. Cutting off the oxygen supply - which preceded the use of the fire extinguisher - stopped the leaking noise.

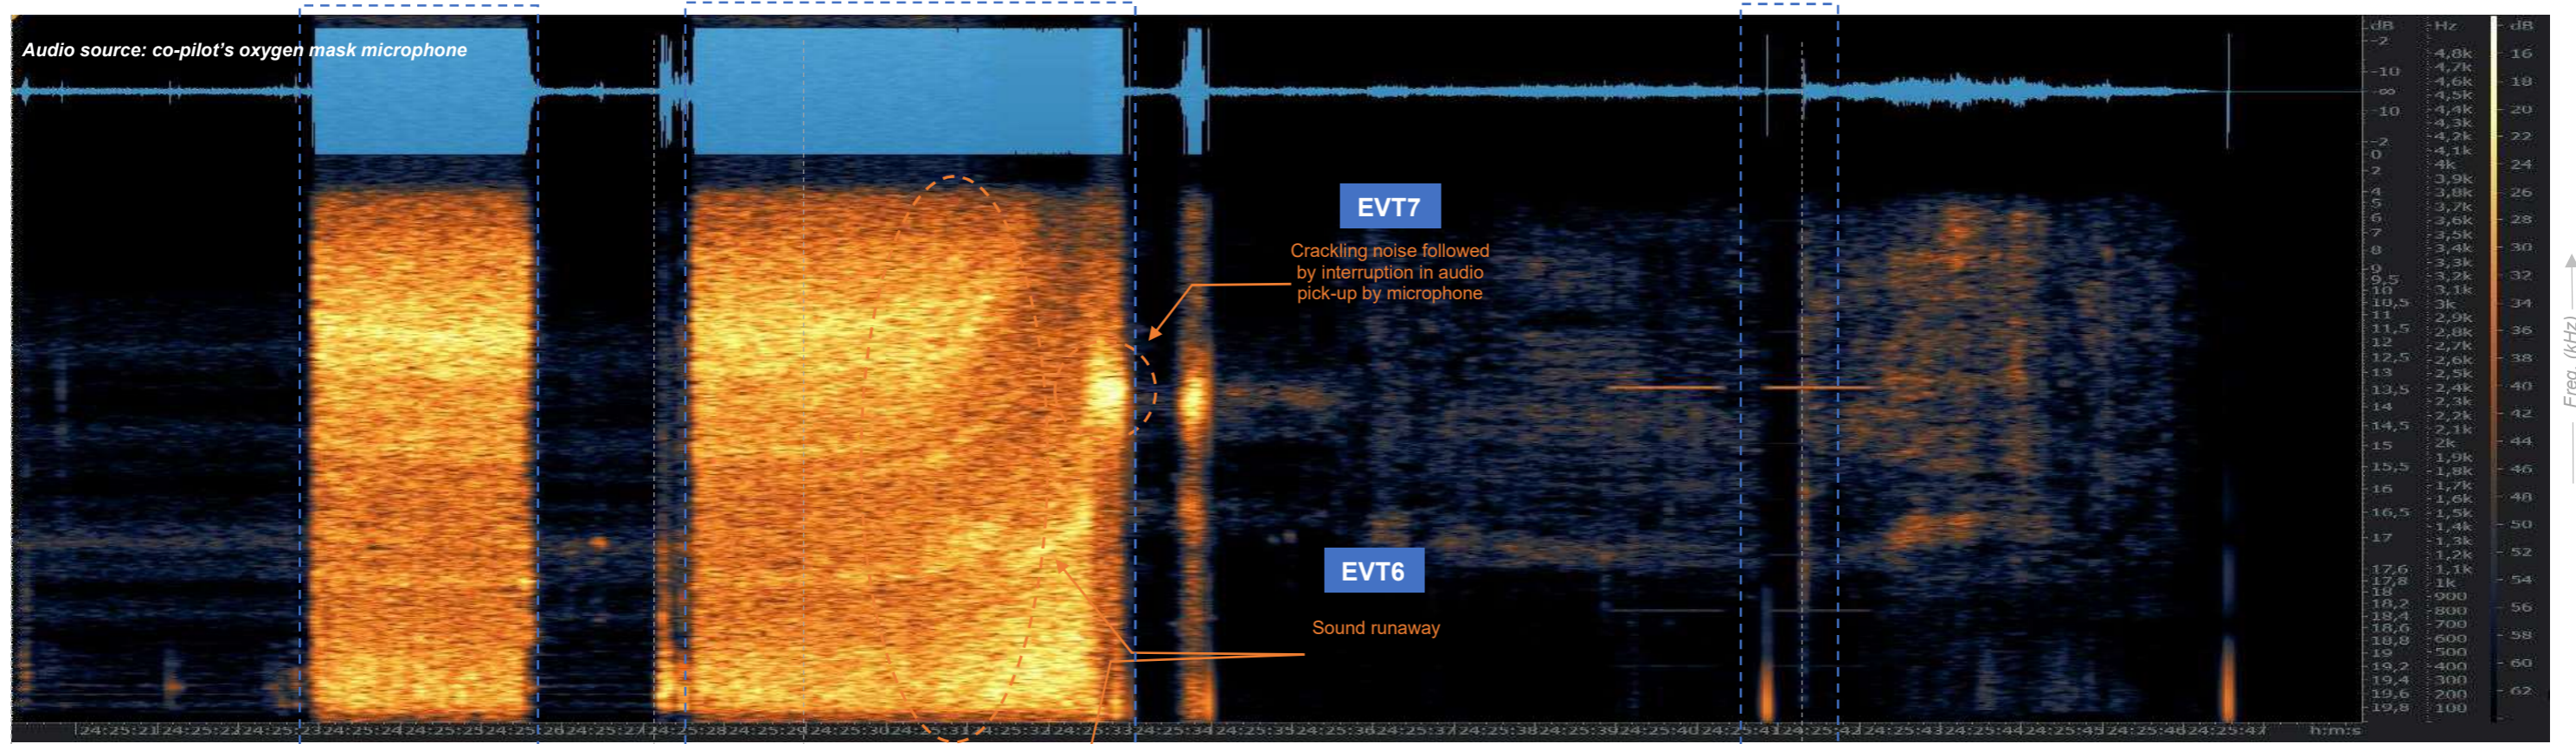
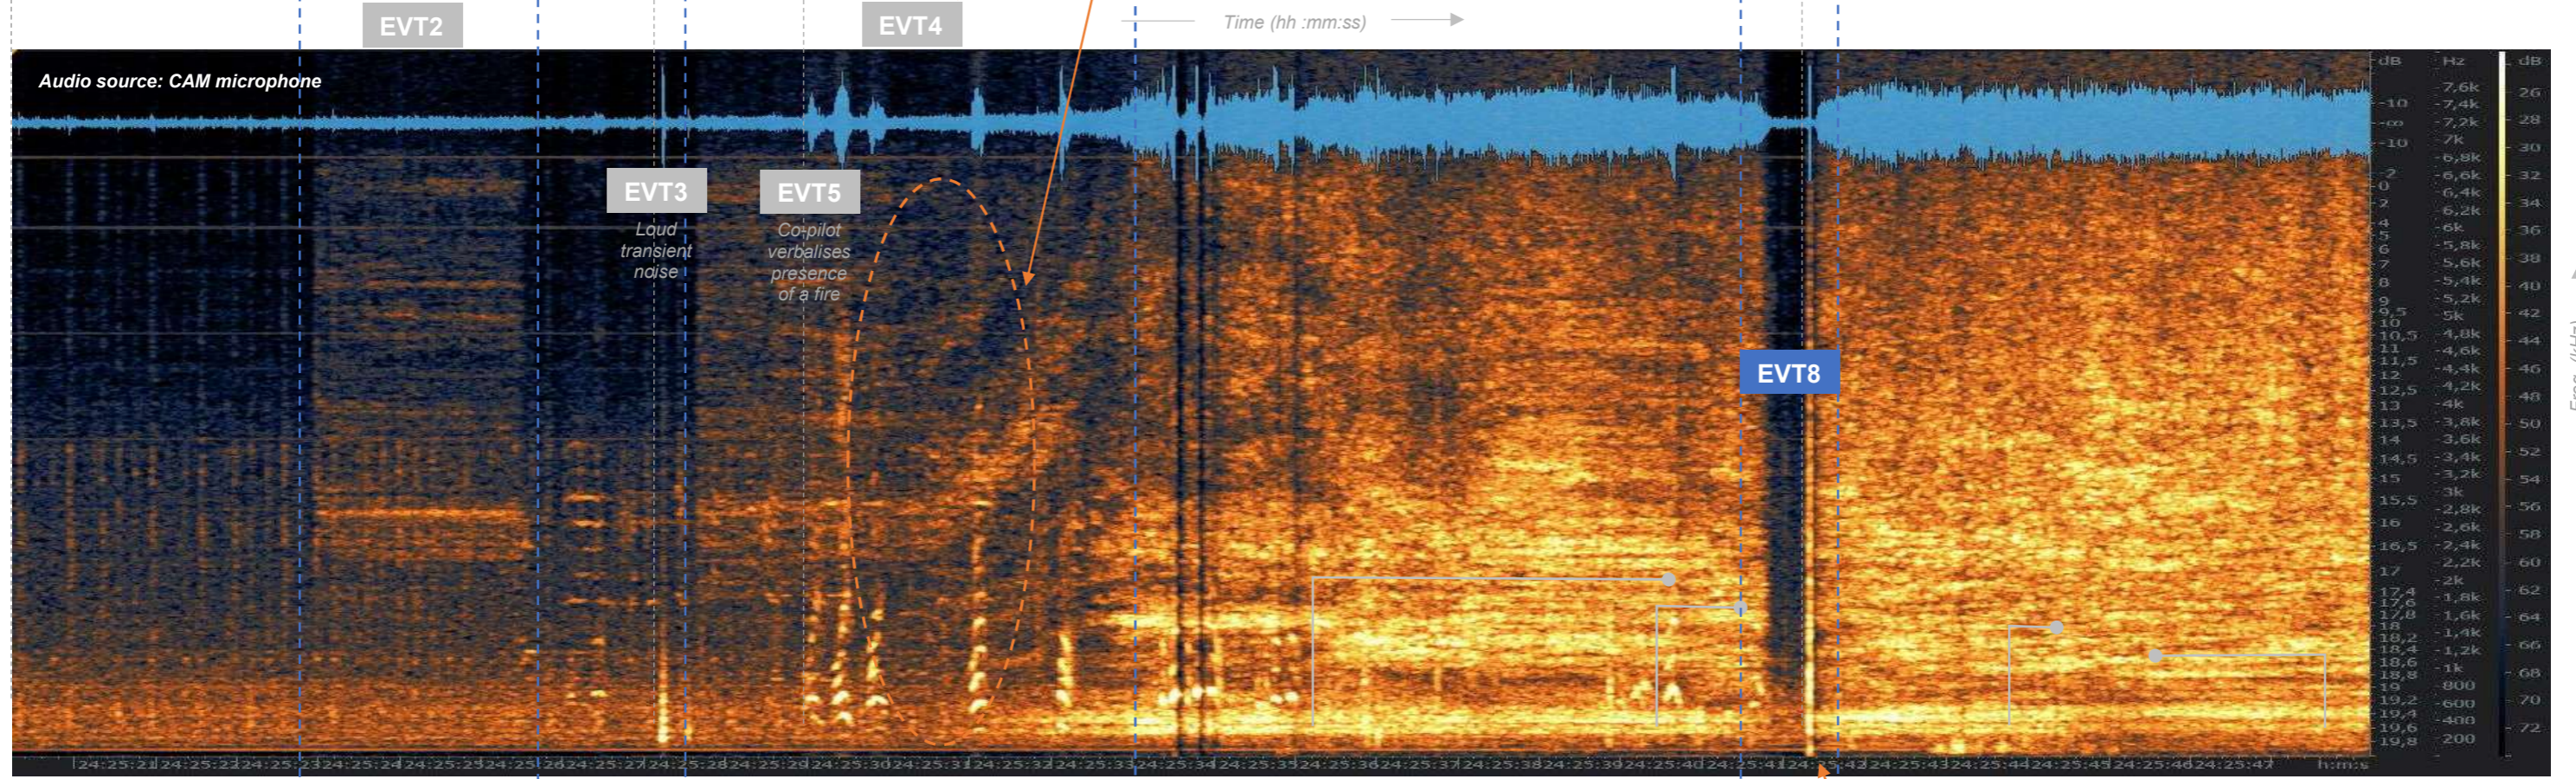
# 7 \_\_\_ Spectrum and waveform of occurrence recorded on CVR of MS804

- No crackling noise can be perceived in the recording from the co-pilot's oxygen mask microphone.
- A sound runaway was present on the co-pilot's oxygen mask microphone and CAM channels at 00:25:31 (EVT6). This noise can probably be attributed to the co-pilot's oxygen mask catching fire.
- The screeching noise that preceded the loss of the microphone signal from the co-pilot's oxygen mask at 00:25:33 (EVT7) was probably produced by the destruction of the mask microphone by the flames.
- The momentary interruption (510 ms) of the oxygen leak at 00:25:42 (EVT8) was probably produced by damage to the oxygen assembly<sup>5</sup> located in and/or under the lateral storage compartment.

Noise of oxygen flow in co-pilot's mask

Probable cause: mask EMERGENCY knob being pressed

Undetermined cause/start of leaking noise has a very similar spectrum to EVT2

Crackling noise followed by interruption in audio pick-up by microphone

Leaking noise momentarily stops

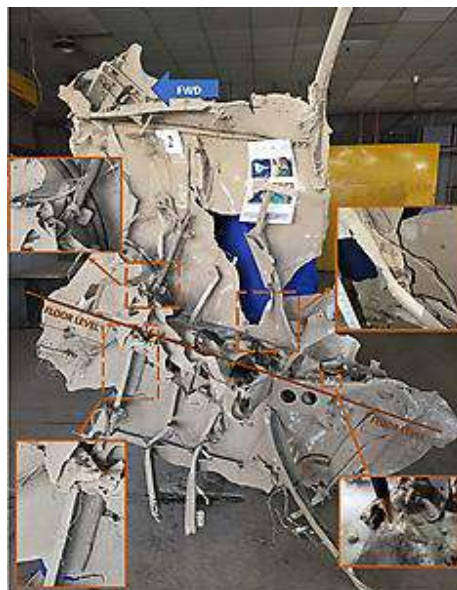
Photo of the debris below, shows the intact insulation wire immediately below the RHS window side console significantly above cockpit floor level. (Refer to Draft final report item 2.11 (sub-item 3).

BEA contribution report page 11/29 Fig. 3, Airbus Debris survey –part identification page 49, Pic. 4/5 nose fuselage frame 3 to 8 area (D149) show the intact wire insulation above floor level.
