Ministry of Transport and Civil Aviation of Federal Republic of Somalia

Aircraft Accident Investigation Branch

Final Report

Accident to the AIRBUS - A321
registered **SX-BHS**
operated by Daallo Airlines
on 2nd February 2016
On initial climb from AD Mogadishu
(Somalia)

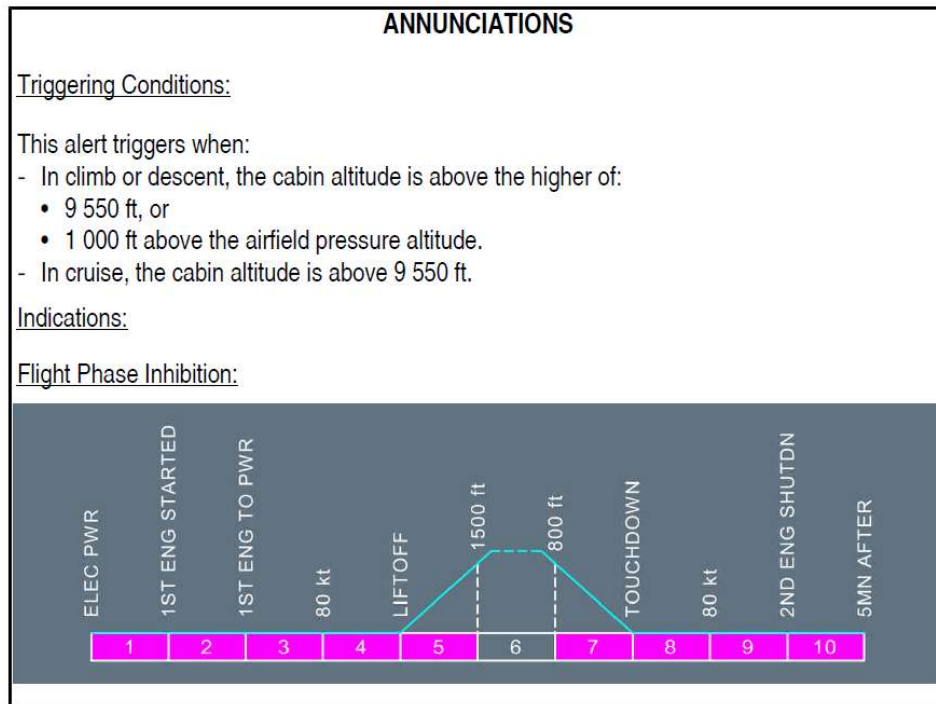
1.6.3.1.1 “CAB PR EXCESS CAB ALT”

This ECAM message is triggered when the cabin altitude reaches 9550ft.

The fuselage perforation occurred at an altitude of 10390ft. This ECAM message is consistent with a cabin altitude above 9550ft.

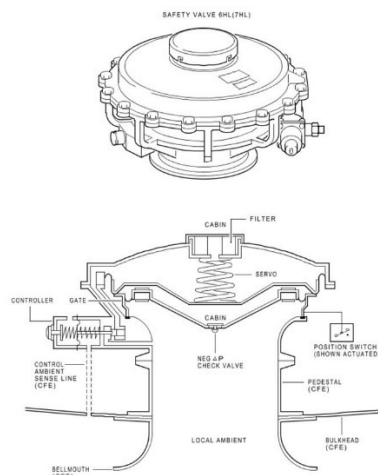
Safety valves

If the internal pressure is more than the design goal of 8.6 psi (0.59bar) above the external pressure, the poppet moves and air flows out of the fuselage.

For negative delta-P condition it is ensured by a minimum of one safety valve operating, that the internal pressure is not more than 0.07 bar (1.02 psi) below the external pressure.

The triggering of **“CAB PR SAFETY VALVE OPEN”** ECAM alert was consistent with the activation of the Safety Valve for more than one minute after the dynamic internal overpressure event. Its activation resulted either from the blast inherent to the dynamic internal overpressure, or indicated sustained differential pressure resulting from the airflow through the fuselage hole.

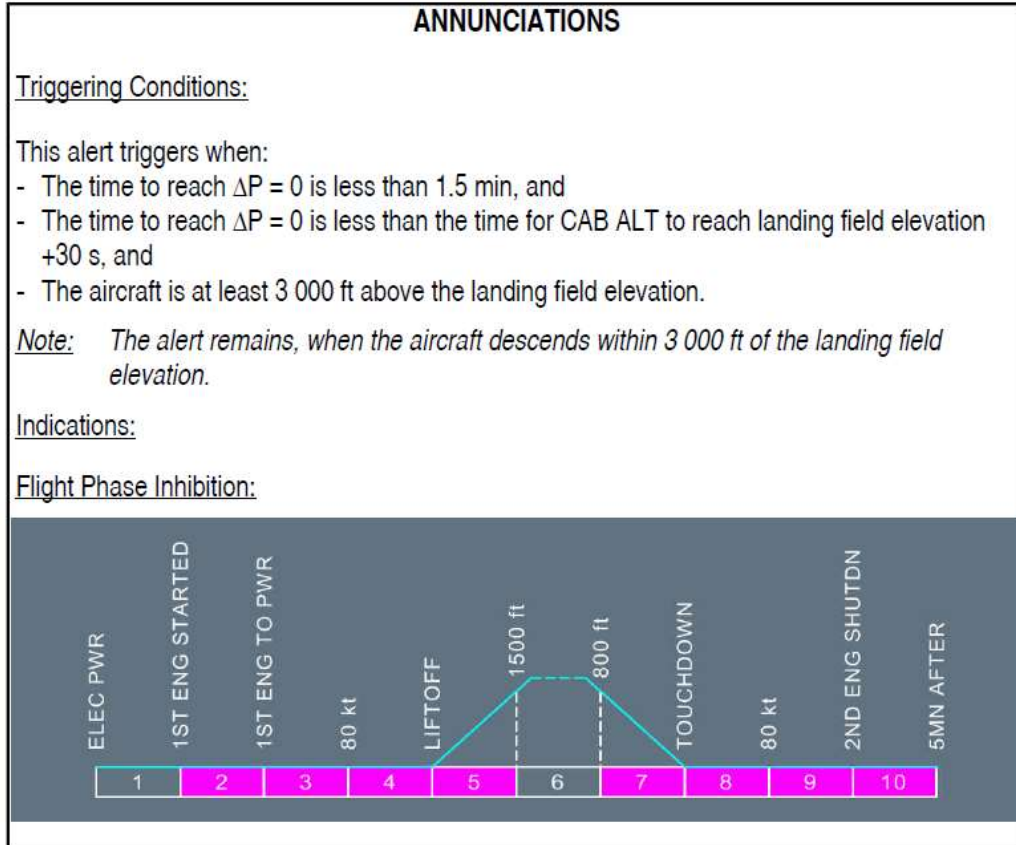
The ECAM message “CAB PR LO PRES DIFF PR” is generated when the Cabin Pressure Controller (CPC) predicts that the cabin differential pressure will be zero in 1.5 min time assuming that the aircraft continues the descent to landing at the existing rate of descent.

Given the fuselage damage created by dynamic internal overpressure, the triggering of this message was consistent with sudden delta P drop in cruise.

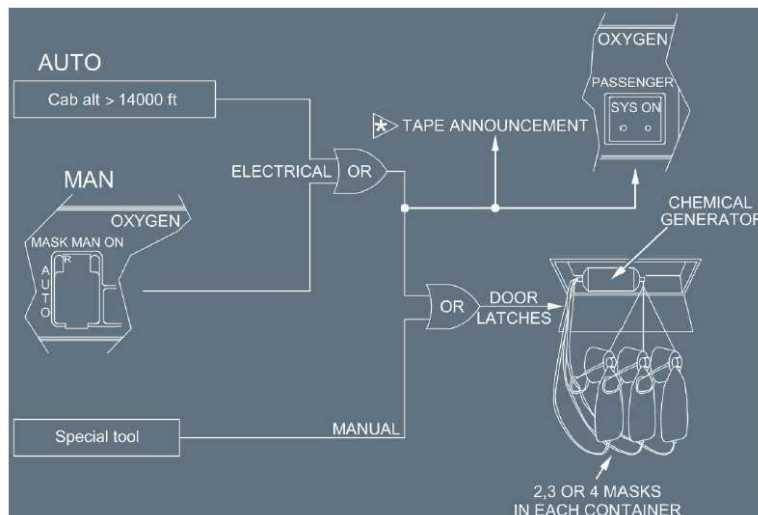
Here follows a mapping of the cabin representing masks deployed (green), masks not deployed (yellow) or no information (grey).

The majority (68%) of cabin masks were found deployed. Based on the aircraft altitude and pilot report, the oxygen masks were not deployed automatically.

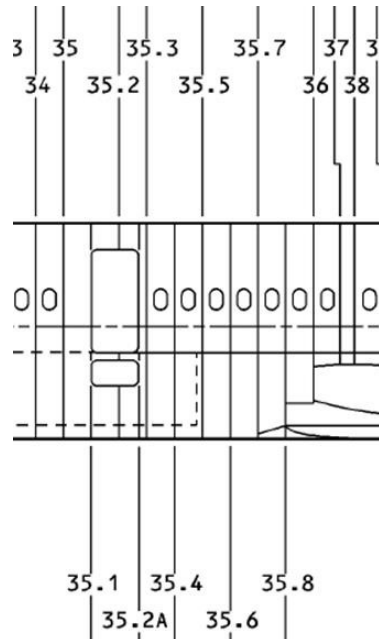
Figure 11 - Frames labelling

Relevant frames are detailed in SRM 53-21-12 for frames before FR 35.8 and SRM 53-31-12 for frame from FR 35.8 and after.

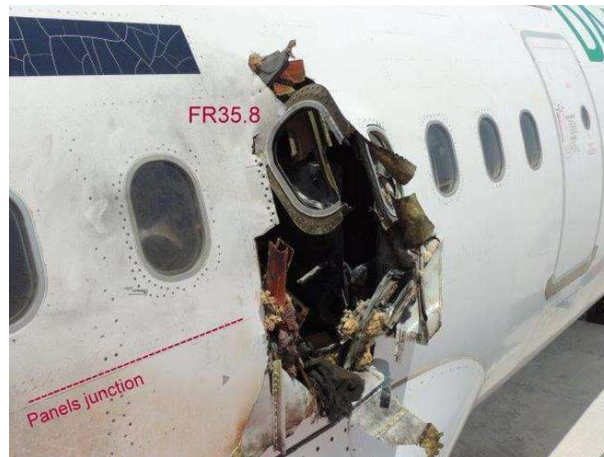
Figure 12 - FR 35.8 position

The fuselage structure showed evidence of skin failure mode in dynamic shear consistent with a dynamic internal overpressure located between frames 35.7 to 35.8, stringers 18 to 20RH, above the passenger floor.
