Serious incident between
the AIRBUS A320 registered **TS-INP** operated by Nouvelair
and
the AIRBUS A320 registered **OE-IJZ** operated by easyJet Europe
on Sunday 21 September 2025
at Nice

This is a courtesy translation by the BEA of the Preliminary Report on the Safety Investigation. As accurate as the translation may be, the original text in French is the work of reference.

Approach at night on a runway engaged by an aeroplane lined up ready for take-off, near-collision, rejected landing

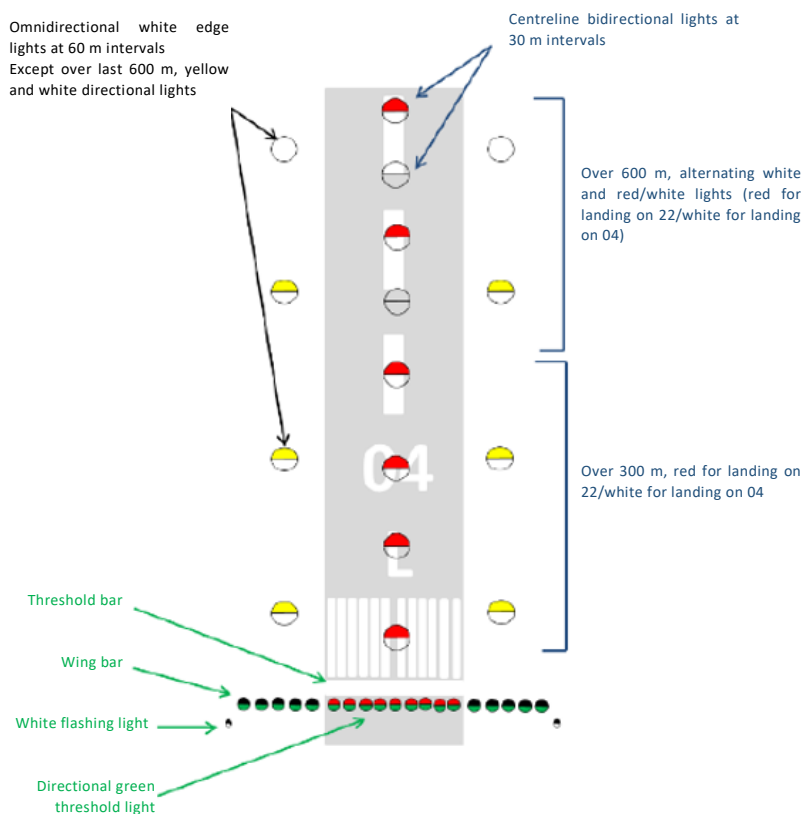
Figure 7: diagram summarizing the lighting available on runway 04L
(source: DSNA - Nice tower operations manual)

At the time of the occurrence, the runway identification flashing lights (RTIL) were illuminated (the brightness level was not recorded). The threshold lights, wing bar lights, runway end lights, edge and centreline lights and the PAPI were illuminated at brightness level 1 (minimum brightness of four levels available). No anomalies were noted regarding the condition of the lighting on this runway at the time of the occurrence. There was no work in progress on runway 04L or on its lighting. The last runway inspection carried out between 17:08 and 17:11 UTC had found no anomalies with respect to the runway 04L lighting.

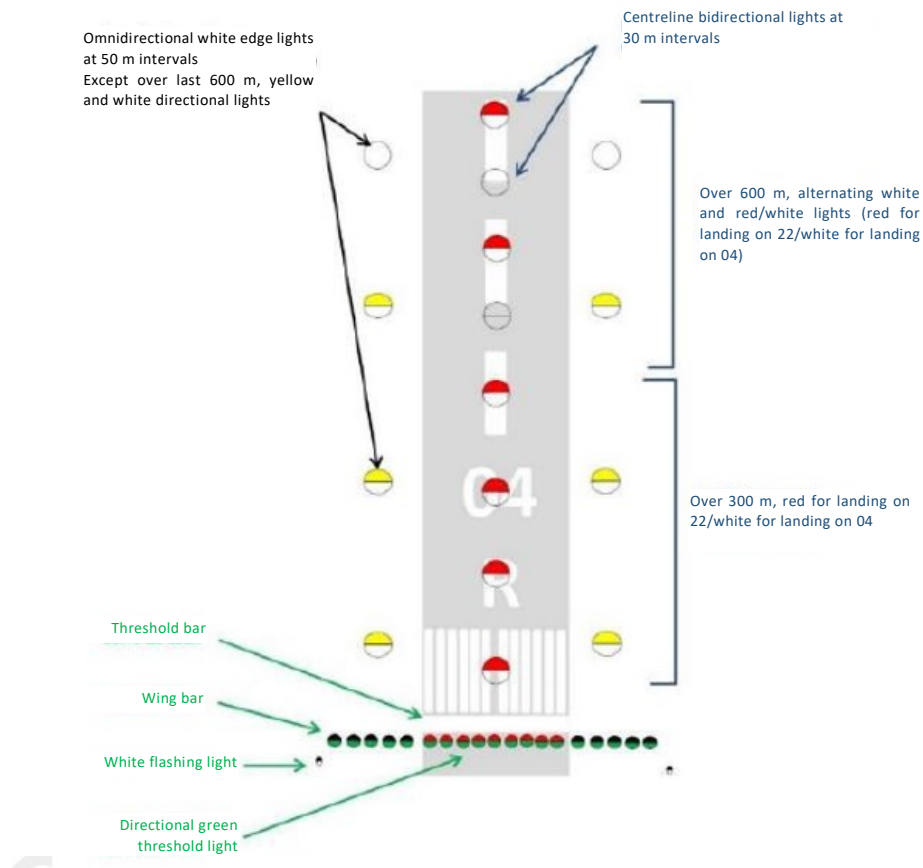
Figure 9: diagram summarizing the lighting available on runway 04R
(source: DSNA - Nice tower operations manual)

At the time of the occurrence, the runway end, edge and centreline lights were illuminated at brightness level 1 (four levels available). The 04R PAPI, threshold lights, wing bar lights and threshold identification flashing lights were extinguished. No anomalies were noted regarding the condition of the lighting on this runway at the time of the occurrence. There was no work in progress on runway 04R or on its lighting. The last runway inspection carried out between 17:12 and 17:16 UTC had found no anomalies with respect to the runway 04R lighting.
