**Accident** to the JONKER JS1B  
registered **ZS-GDE**  
on 15 July 2022  
at Château-Arnoux - Saint-Auban (Alpes-de-Haute-Provence)

<b>Time</b>	Around 14:15 <sup>1</sup>
<b>Operator</b>	Centre National de Vol à Voile (CNVV)
<b>Type of flight</b>	Local
<b>Persons on board</b>	Pilot
<b>Consequences and damage</b>	Glider substantially damaged
This is a courtesy translation by the BEA of the Final Report on the Safety Investigation. As accurate as the translation may be, the original text in French is the work of reference.

## Collision with trees on short final

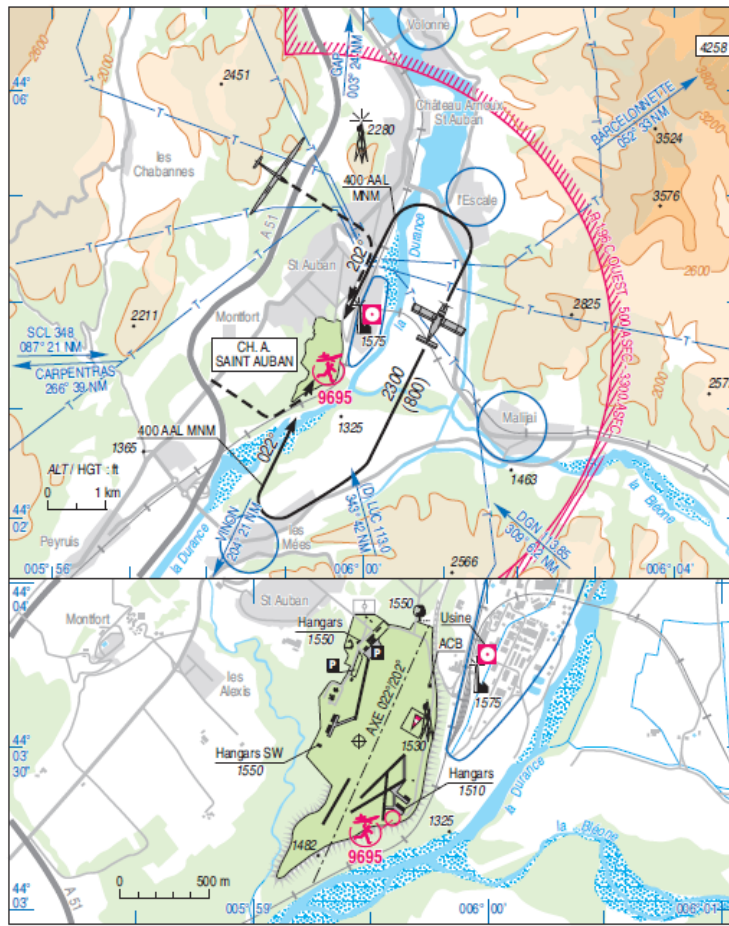
Figure 3: Château-Arnoux - Saint-Auban aerodrome VAC chart (Source: SIA)

The chapter on air navigation hazards on the VAC chart mentions the existence of severe downdrafts in the presence of northerly winds.
