# Report

Accident on **9 August 2007**  
off **the coast of Moorea (French Polynesia)**  
to the **DHC6-300**  
registered **F-OIQI**  
operated by **Air Moorea**

**BEA**

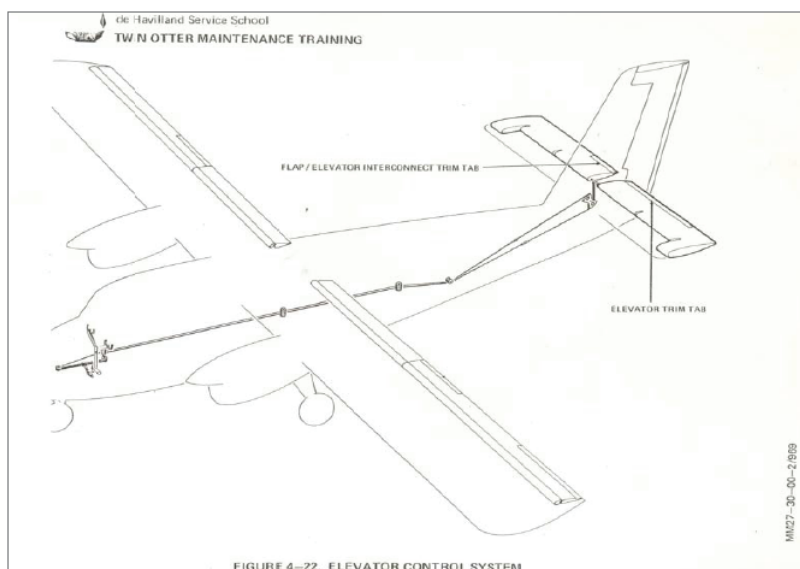
Note: Each cable, pitch up and pitch down, of the elevator control system is composed of a forward and aft section, connected by a stretcher situated between stations 421 and 436. These two cables form a closed loop. The failure of one cable makes it impossible to actuate the elevator.

On the day of the accident, the elevator cables, reference TBE069053-3 (pitch-down) and TBE069053-4 (pitch-up), totalled 1,181 hours and 6,370 aeroplane cycles.

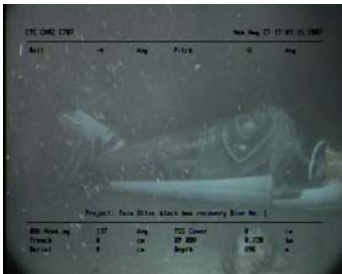
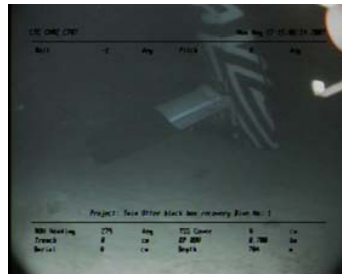
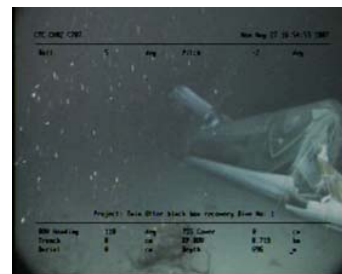
The rear part of the aeroplane, from the baggage hold to the tail, was in one piece. It was resting on the complete left half fuselage (fixed and mobile parts). A part of the right half of the fuselage was ripped off.

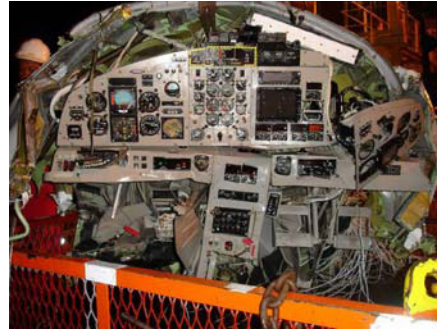
Raised instrument panel

- HSI and RMI: heading 120°
- Left and right VSI: - 3,000 ft/min
- Left gauge: 210 lb
- Right gauge: 190 lb
- Boost pump Aft and Fwd: ON
- Right air speed indicator: 100 kt
- Tank selectors: Aft and Fwd
- Autofeather pushbutton: pressed

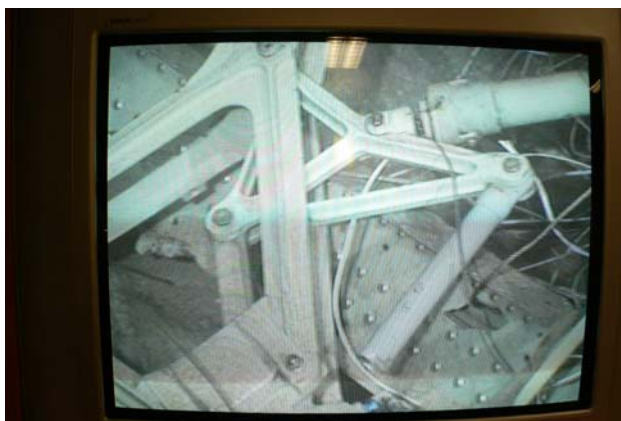
The flap actuator was also raised on 2 September, and was in the flaps retracted position.

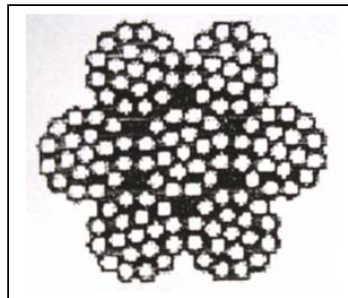
Cross section diagram of cables

The elevator control cables were made of stainless steel, they were made up of seven strands of nineteen wires. Six outside strands were spiralled around a central strand with a pitch of about 23 millimetres. Each strand was made up of a core wire around which was plied a first layer of six wires then a second layer of twelve wires. The wires all had the same diameter. The cable's outside diameter was 1/8 inch (roughly 3.2 mm).

The two cables showed several signs of wear in the zones of contact with elements of the aeroplane: the rear quadrant, the rear partition passage and the cable guides attached to a vertical strut at the level of station 436. The formation of flat spots was observed on the section of the cables in contact with these elements and the presence of failed wires.

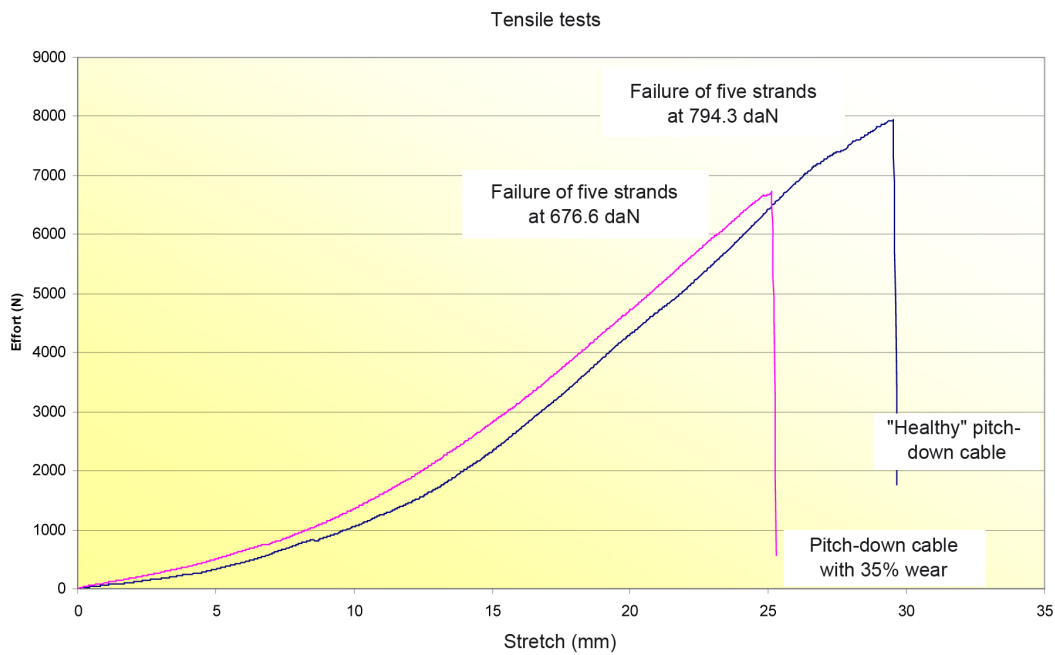
The second test was performed on the aft pitch-down control cable. The loads were centred on the zone located in line with the cable guide whose rate of wear was estimated at 35%.

The tension curves from these tests are presented hereafter as well as the photo of the pitch-down control cable after the test.

Note: For safety reasons, the test stopped when the drop in the load detected by the machine was above 80%. In both cases, two outer strands remained unbroken after the test.

By assessing, through extrapolation of the test results obtained on the pitch-down cable, the residual resistance that the pitch-up cable had in the area worn to 50%, this resistance appears to be much greater than in-service loads: the wear on the cable cannot in itself explain its failure.

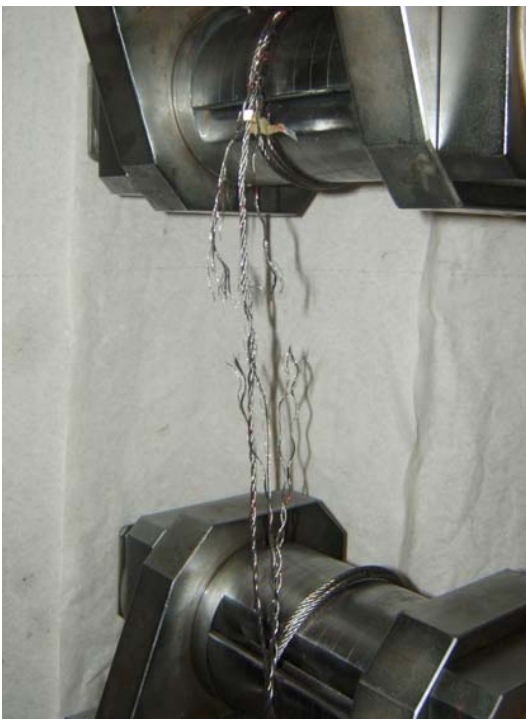
View of pitch-down cable on traction machine : high degree of untwisting

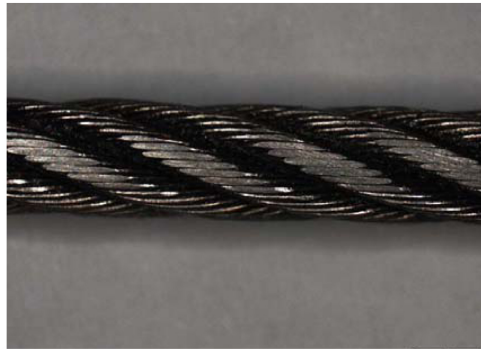
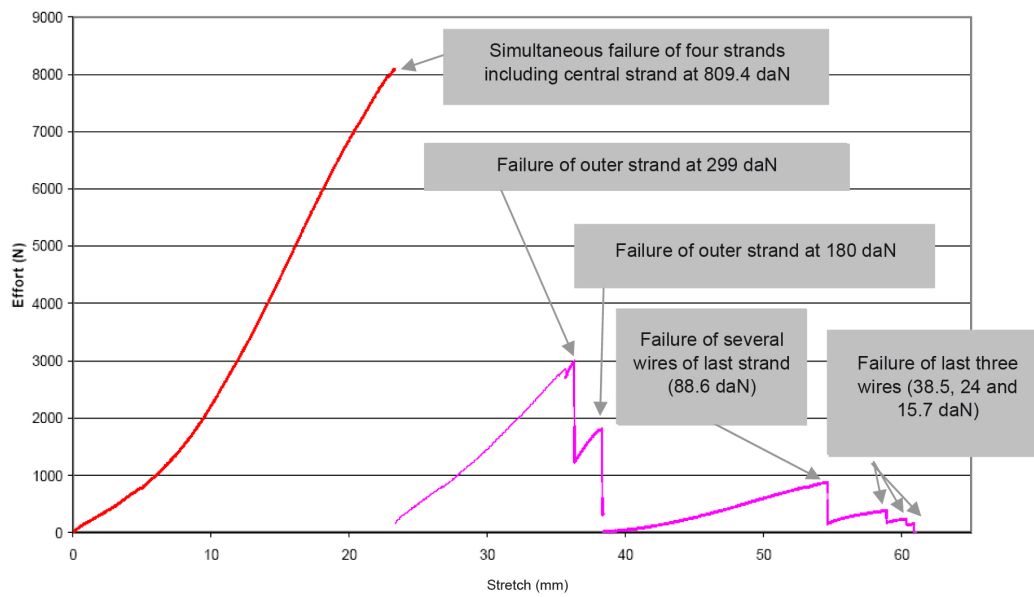
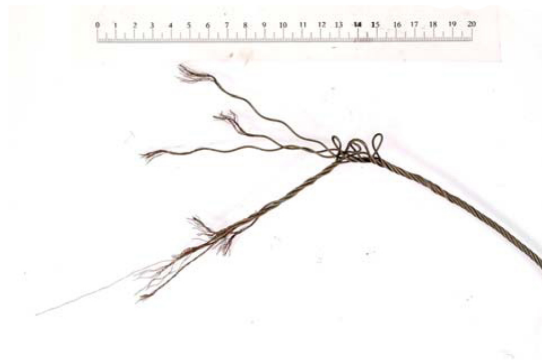
*Tensile test on a slightly worn cable*

On a slightly worn cable, the failure occurred in the worn area, located in the middle of the section between the attachments.

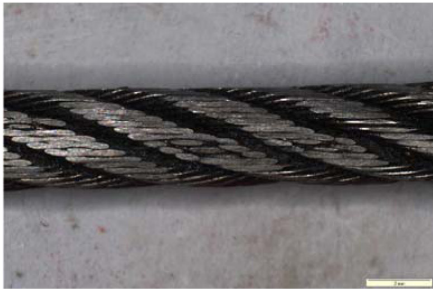
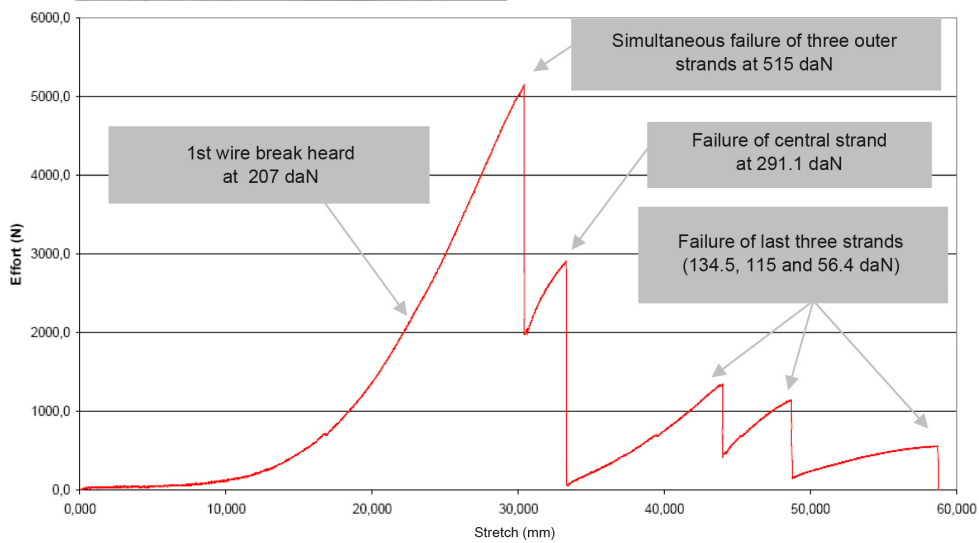
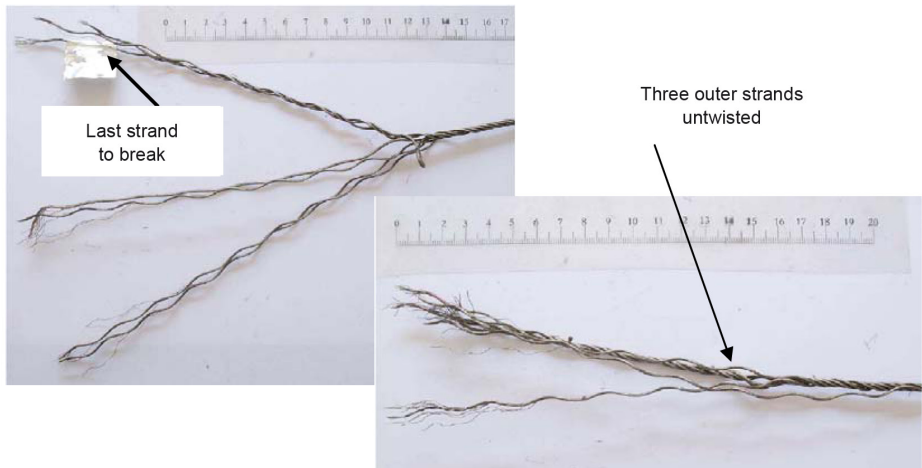
*Tensile test on a cable showing similar wear to that of F-OIQI's pitch-up cable*

On a cable worn like the F-OIQI aft pitch-up cable, the failure also occurred in the worn area between the attachments.

- ❑ The failure load of the first wires was in the order of 210 daN.
- ❑ The failure load of the first strands was in the order of 500 daN.
- ❑ The failure load of the last strand was in the order of 55 daN.
- ❑ The lengthening of the cable after the central strand failure was in the order of 35 mm.
- ❑ The lengthening of the cable at the time of the final failure was in the order of 55 mm.

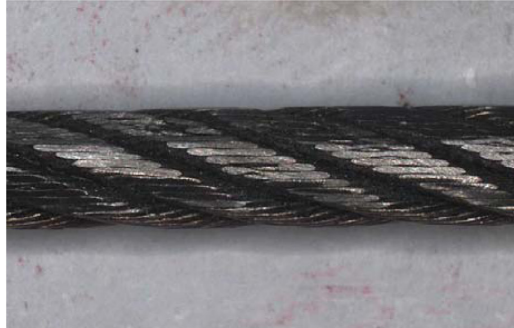
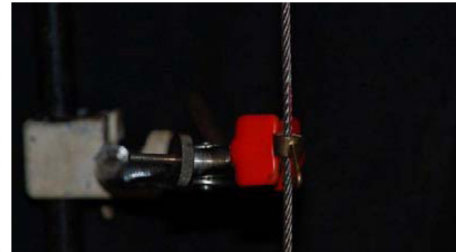
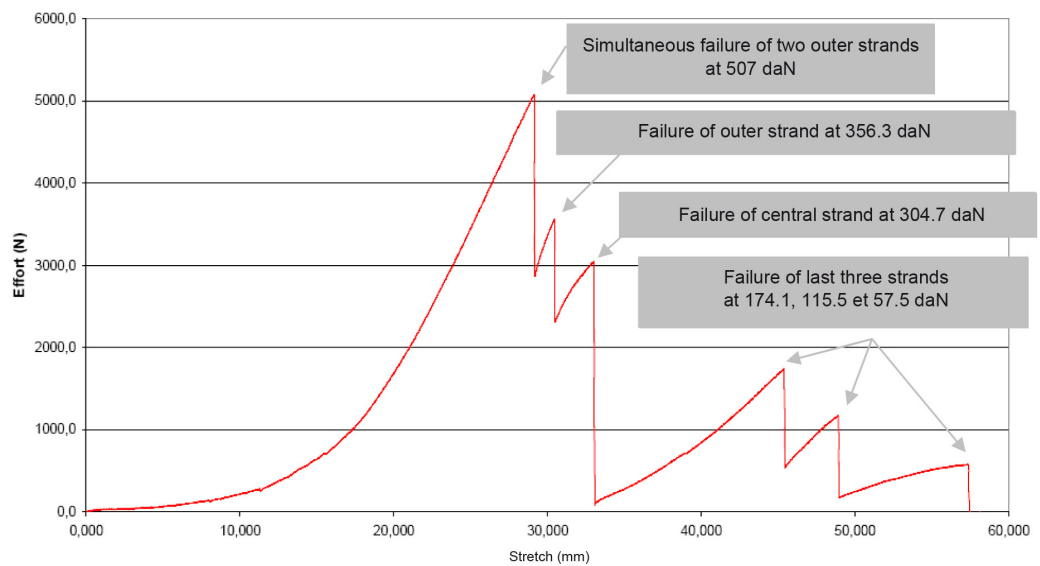
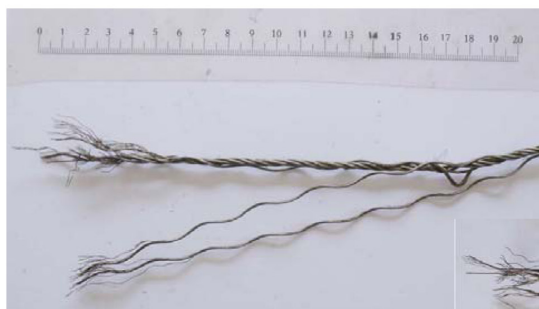
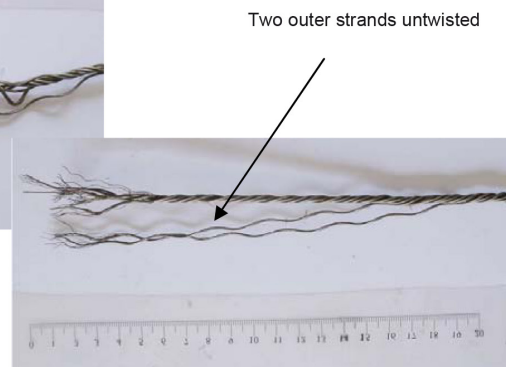
Tensile test on a cable showing similar wear to that of the F-OIQI's pitch-up cable with a system simulating the presence of the cable guide

In addition to the set-up for the previous test, a system with a diameter, thickness and rigidity all similar to those of the cable guide was placed in contact with the cable in its worn section. The failure occurred at this point.

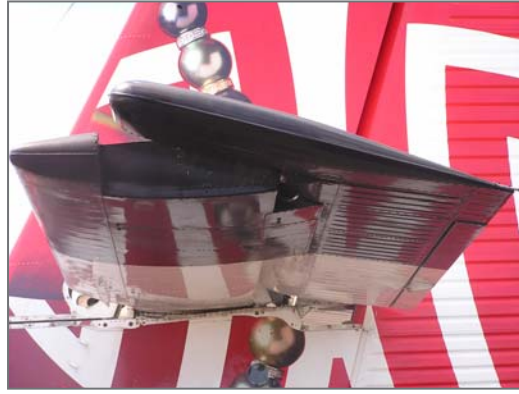
Elevator in locked position

The aileron and elevator flight control surfaces are locked by means of a device that links the pilot wheel and column to the structure of the flight instrument panel. Originally, the elevator was locked in neutral position. Some flights having taken place with the lock system in place, the manufacturer modified the system so that the elevator control was maintained in maximum forward position (elevator fully pitch-down position). It should be noted that this position does not correspond to the mechanical stop on the elevator; a possible movement or an elongation of up to 34 mm of the cables would be necessary to move the elevator to its stop.

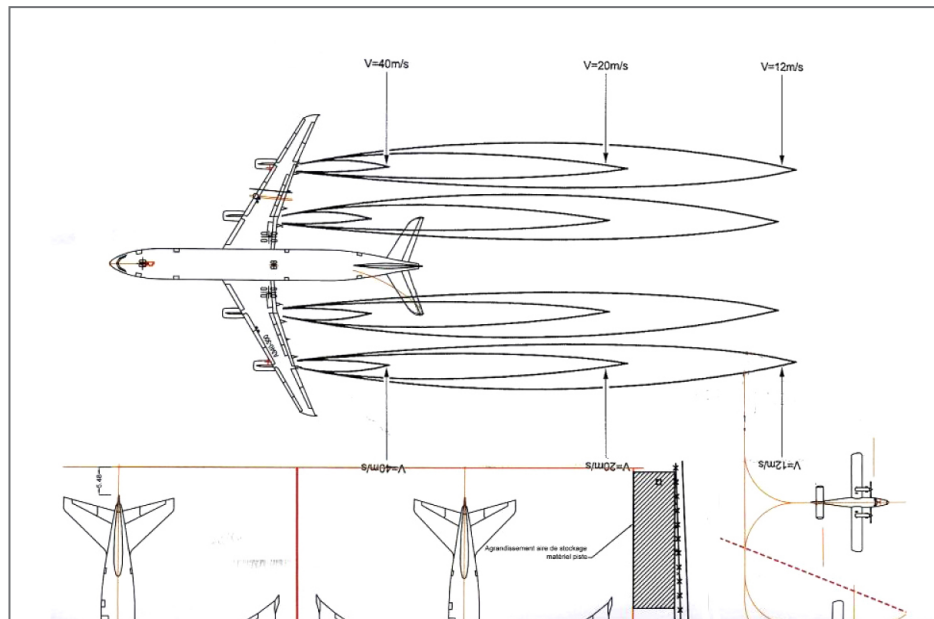
In the configuration presented, the engines of the A340 are about eighty metres away from the tail of the DHC6. Nevertheless, the above is only a theoretical drawing. In practice, it is possible that pushback can bring the A340 further to the east; the aeroplane can also be slightly out of line. Thus, for example, if the A340 is turned by about 15° to the north, the DHC6 parked most to the north is touched by the exhaust cone.

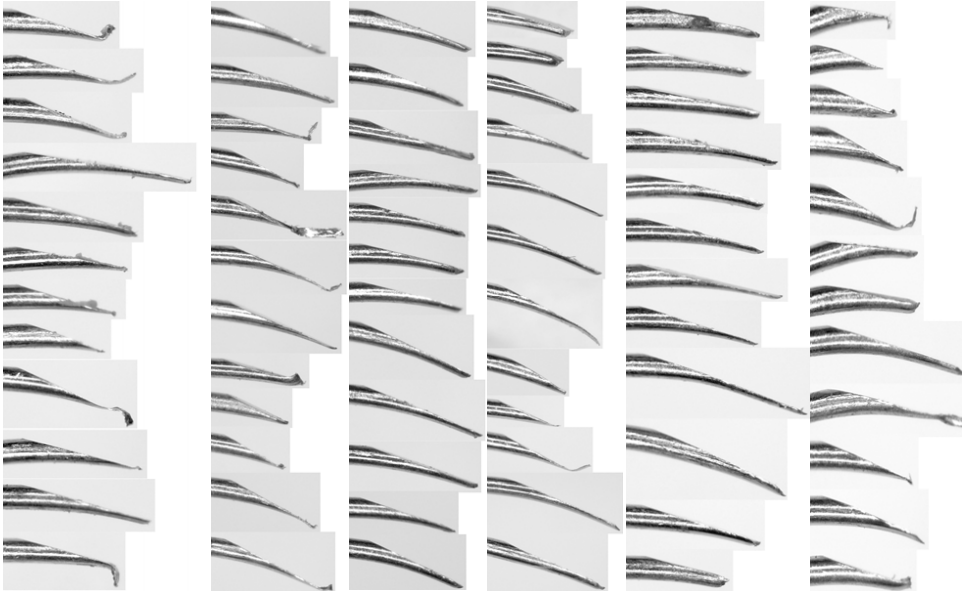
Profils d'usure des fils appartenant aux couronnes extérieures des torons externes

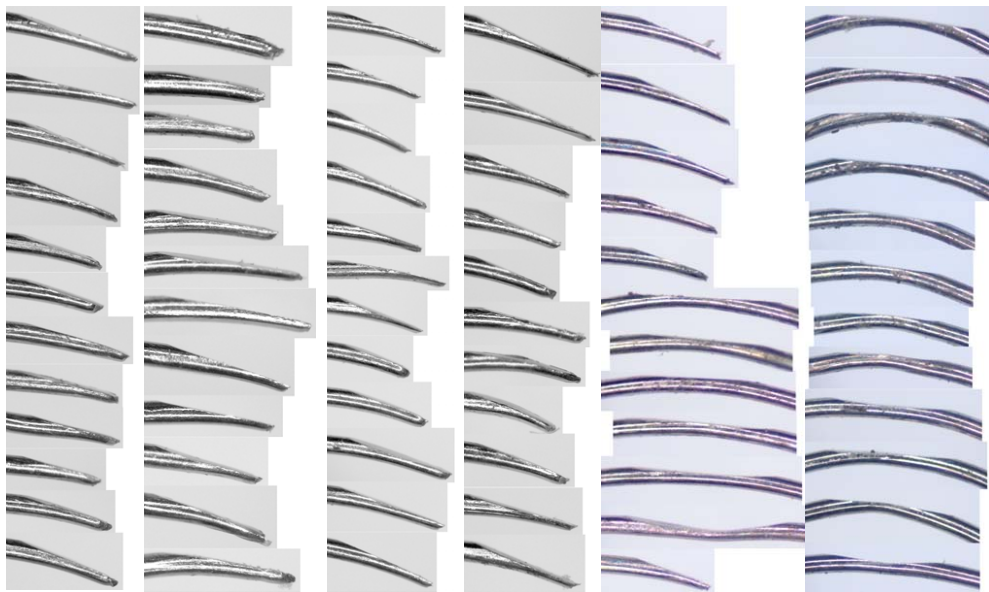
**Annexe 2 : Usure observée sur le câble de commande de profondeur à piquer du F-OIQI  
( taux d'usure évalué à 35% )**

Profils d'usure des fils appartenant aux couronnes extérieures des torons externes

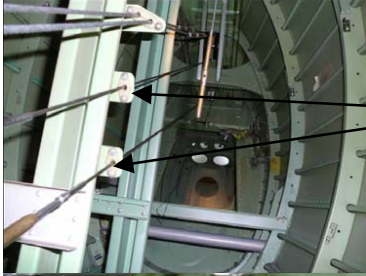
Fairleads at STA 436.0

1. Cause of cable wear (stainless steel) is mainly confined to routing at pulley locations only. Type of wear include: shiny (which is monitored within limits), fraying: (which constitute an immediate replacement – usually caught at 1-3 wires in one strand), flattening (which is cause for replacement – hardly ever detected).
2. The most likely explanation for excessive wear (stainless steel) at STA 436.0 fairlead is incorrect rigging; one needs to be careful that the cables coming off the pulleys at STA 333.25 line up with the pulleys at STA 378.13 – the floor boards need to be lifted up to ensure each cable is placed on the correct pulley. If the elevator control cables at STA 378.13 are installed on the wrong pulley, the cable will chafe on the fairlead at STA 436.0.

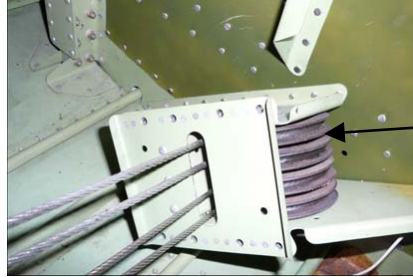
Pulley cluster located at STA 378.13

3. Any aircraft that is operated in a hot humid climate has accelerated wear (carbon steel) at the pulley at STA 378.13. This is due to condensation running down the cables and then collecting at the pulleys. The condensation causes oxidation on the control cables. The control cables transit back and forth through the pulleys during normal flight operations. The pulleys wear off the oxide, leaving a bare surface. This allows another layer of oxide to form, creating a cycle that accelerates cable wear.

4. Experience has indicated that it is beneficial to tension cables to the low end of the range in the rigging specifications (less wear).
5. Replacement interval on cables is sufficiently short to detect cable damage before failure.

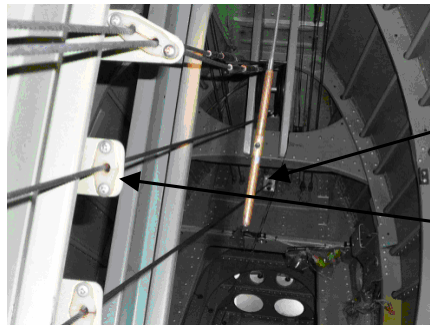
Fairlead at STA 486.34

6. The fairlead at STA 486.34 if not relocated as per TAB 646/9 has been found to show signs of wear or found worn out and the elevator cable rubbing on P/N C6FS1714-3 (MOD 6/1458).

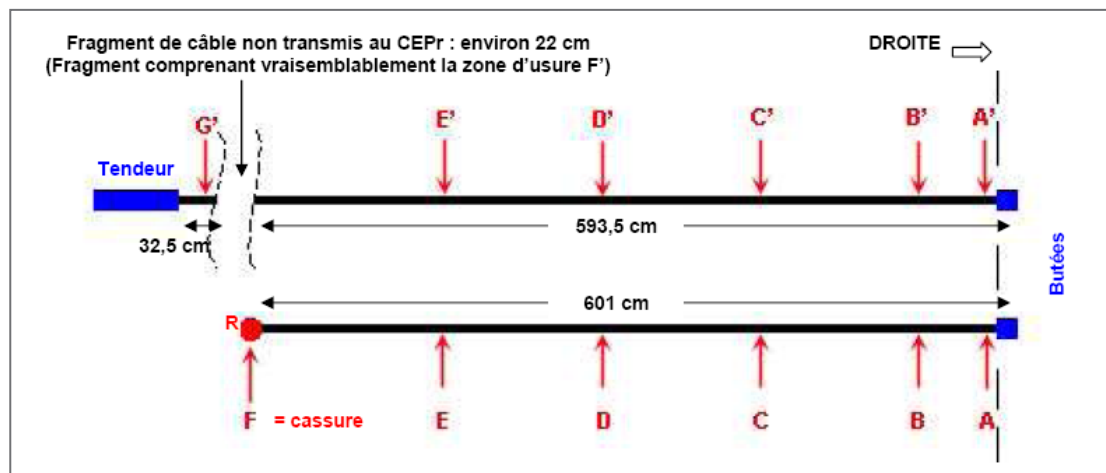
The following identifies the wear observed on the cables:

The wear noted on the lower and upper cables was located exactly the same distance from the stops and had the same appearance.

- The wear zones A and A' extended about 3 to 4 cm and on a lower sector at 180°. They were characterised by the formation of flat spots on the outer wires.
- The wear zones B and B' extended about 3 to 10 cm and on a lower sector at 90°. They were not characterised by flat spots but rather by small tears on the outer wires.
- The wear zones C, C', D, D', E and E' had the same appearance. They extended between 3 and 6 cm and were identified on the whole outside of the cable. This wear was very significant and was characterised by the formation of flat spots on the outer wires.

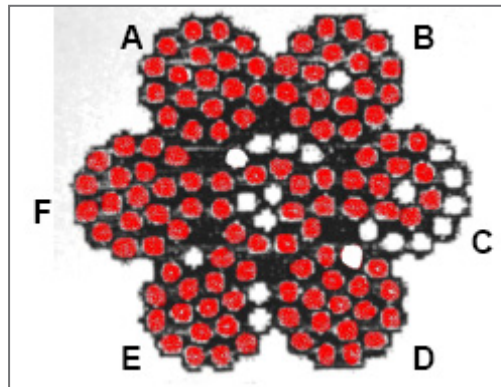
On the cross-section below (strands identified arbitrarily from A to F), the broken wires in line with wear are identified in red, that is to say 113 wires from a total of 133. This wear was characterised by the formation of flat spots, with traces of chafing parallel to the cable axis.

The twenty other wires failed under twisting traction with a striction of the wires in line with the failure surface. Several of them, part of strand C, showed wear behind their wear. This wear was of the same type as those noted in line with the breaks.
