# INVESTIGATION REPORT

## Serious incident to the ATR 42-600 registered V2-LIK

on 14 October 2014

## Martinique Aimé Césaire airport

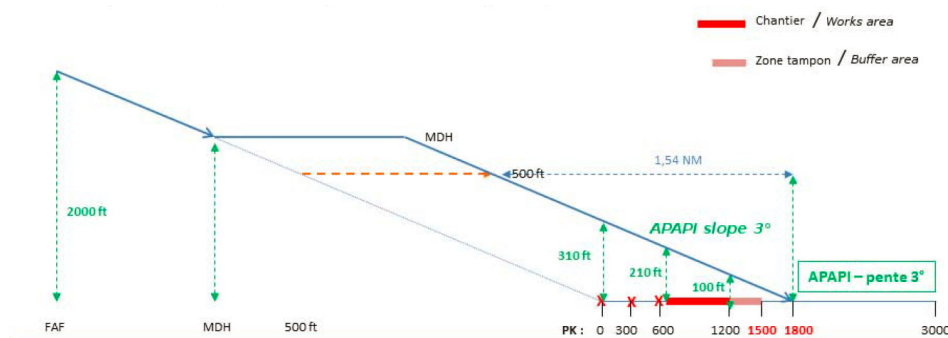
Figure 3: Vertical profile of approach procedure to reduced runway 10

In final, once the MDH has been reached and the runway visual references acquired, the pilots must fly above 500 ft until intercepting and following the glidepath defined by the APAPI (glidepath at 3°) associated with the temporary displaced threshold.

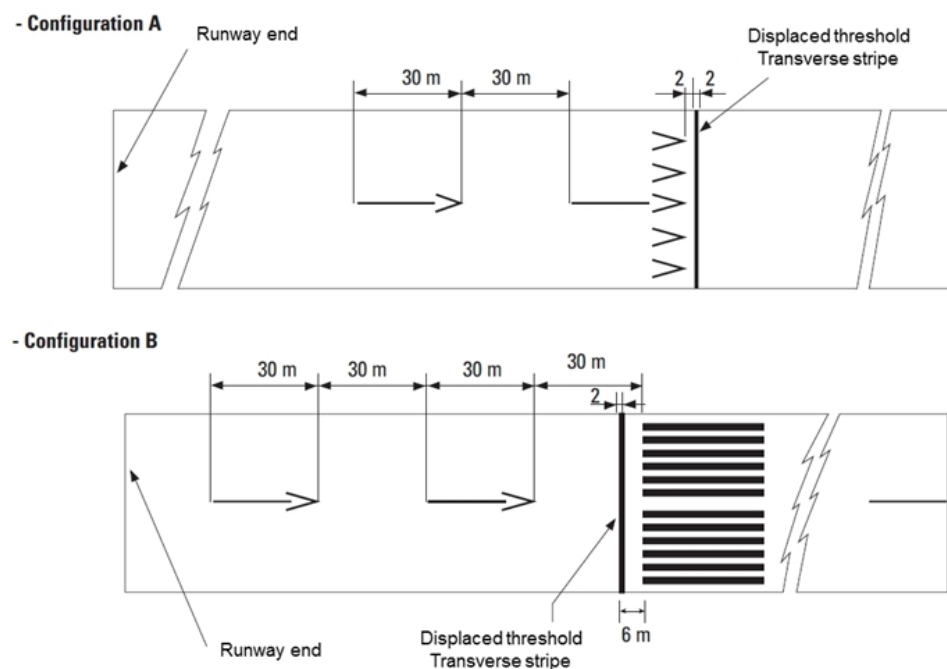
Figure 5: Offset threshold markings (excerpt from CHEA)

- ❑ Configuration A is adopted for work of a short duration on account of it being simple and quick to implement. A 2 m-wide band is affixed over the whole width of the runway; it is preceded by arrows spaced at 30 m intervals and arrow heads, the tips of which are 2 m from the threshold.
- ❑ Configuration B is identical to that adopted for a permanently displaced threshold. It is the configuration to be used for work of a long duration.

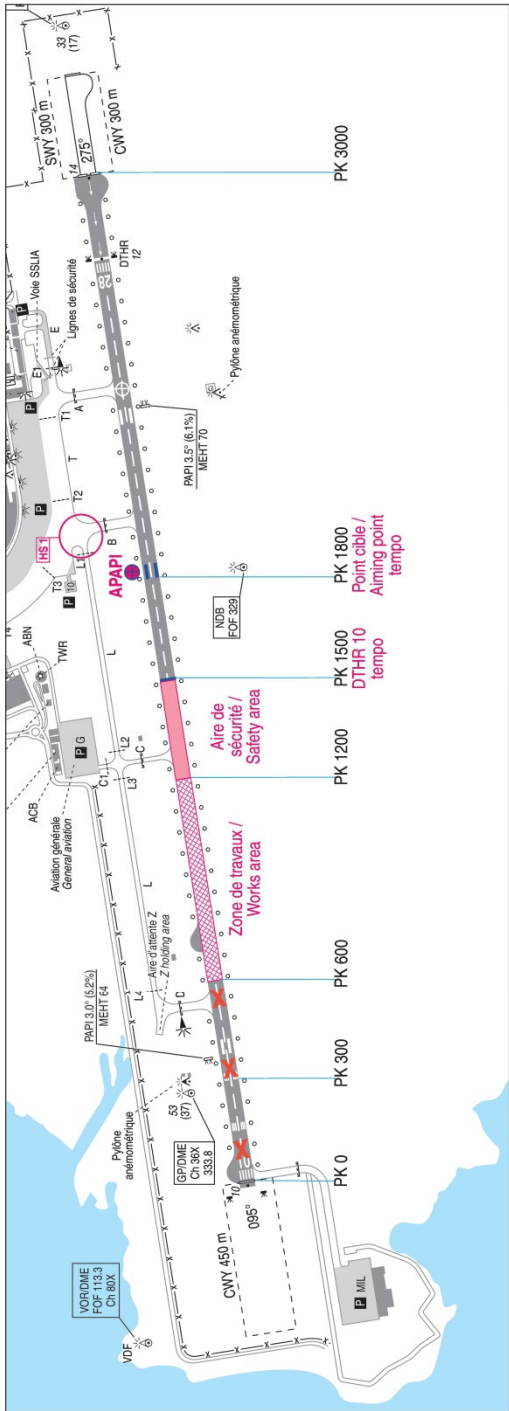
ANNEXE 3A / APPENDIX 3A :  
PROCEDURE D'APPROCHE PISTE 10 REDUITE – POSITION DTHR / APPROACH PROCEDURE ON REDUCED RWY 10 – DTHR POSITION

Descente jusqu'à la MDH publiée à l'AIP pour acquérir les références visuelles. / Descend to the MDH published in the AIP to acquire the visual references.  
Une fois les références visuelles acquises, pas de descente en dessous de 500ft / When the visual references are acquired, do not descend below 500 ft avant d'intercepter et suivre le plan de l'APAPI installé au PK 1800, before intercepting and following the path of the APAPI installed at PK 1800.  
L'utilisation du QFU 28 nécessite un préavis d'1h30 auprès de la TWR. / The use of QFU 28 requires a 1h30 PN to the TWR.
