Accident to the Cirrus SR22⁽¹⁾ registered **N19BV** on 16 May 2016 at Ailly sur Somme (Somme)

This is a courtesy translation by the BEA of the Report on the Safety Investigation. As accurate as the translation may be, the original text in French is the work of reference.

Decrease in engine power in cruise, activation of emergency parachute, collision with ground

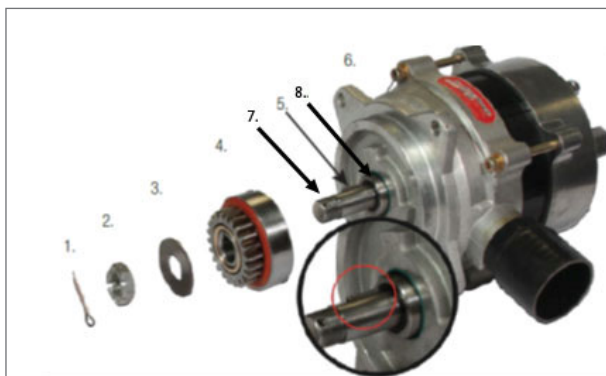
Figure 3: schematic installation diagram of alternator driven assembly

The alternator driven gear (No 4 on Figure 3), situated at the front right side of the engine was found embedded in the inner left wall of the engine housing which was pierced, also puncturing a machined oil duct in the housing (see Figure 4).

During the examination, it was found that the housing contained practically no oil. A large quantity of debris was found inside the engine housing. The thrust washer (see Figure 5 and No 3 on Figure 3) was found around the fractured alternator shaft (No 7 on Figure 3) with its copper colour face on the nut side (No 2 on Figure 3). The Continental documentation specifies that the washer must be installed with its copper colour face towards the alternator⁽⁵⁾.

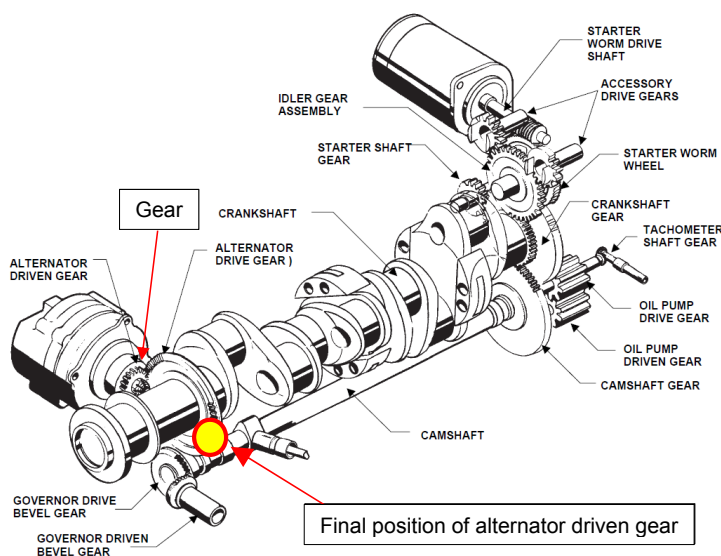
Figure 6: initial and final positions of alternator driven gear with respect to crankshaft

The following illustration shows the position of the mechanical coupling between the crankshaft and alternator shaft. Several parts were closely examined at the BEA, in particular, the alternator shaft, thrust washer and driven gear.

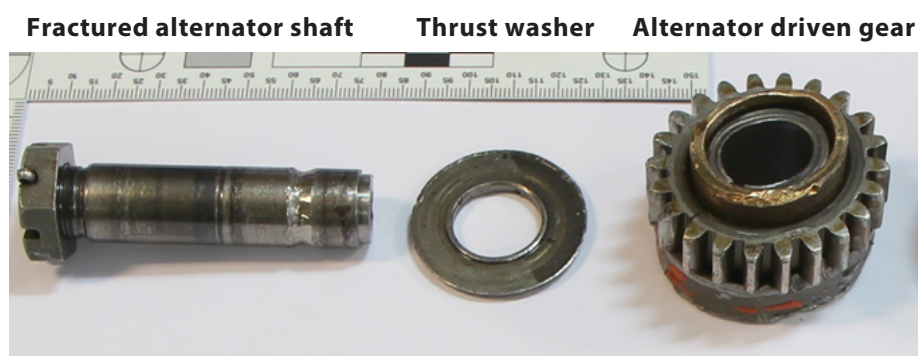
Figure 7: parts examined in BEA laboratory

The alternator driven gear is nominally positioned on the shaft using a key. The latter was found sheared with part of it still in its keyway in the shaft. The keyway on the gear side had substantial wear.

The thrust washer has a copper colour face which was heavily damaged and showed heterogeneous wear. The metal colour face on the other hand, had little damage.

The alternator shaft was found broken into two parts, one of which was found loose in the bottom of the housing. The fractographic analysis of the fracture found the characteristics of a fatigue fracture caused by rotating bending. The characteristics of the material from which the alternator shaft was made, were checked at the BEA and were consistent with the manufacturer's specifications.
