# Report

Serious incident on **24 May 2011**  
**during descent to Kuala Lumpur Airport (Malaysia)**  
**to the Dassault Falcon 7X**  
registered **HB-JFN**  
operated by **Jet Link AG**

**BEA**

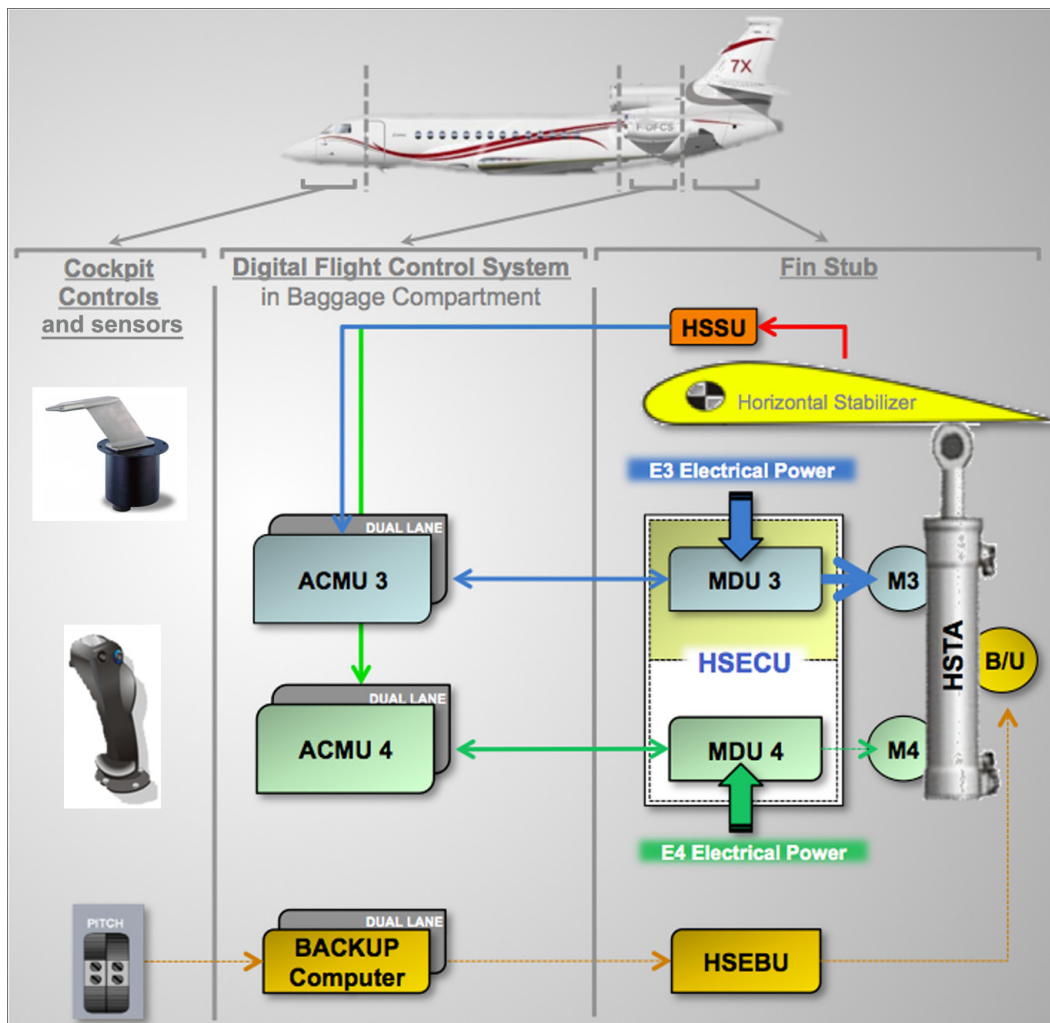
Figure 5 - THS control

- channel 3, which is the active channel in normal operating conditions. In this case, MDU3 controls motor 3 based on commands from ACMU3. Motors 4 and B/U are not powered and auto-trim is active;
- channel 4, which is activated when a problem is detected on motor 3. The HSECU then switches over to MDU 4 which controls motor 4 based on the commands from ACMU 4. The auto-trim function remains active;
- the backup channel is used when a problem is detected on motors 3 and 4. In this case, the auto-trim function is lost. The THS is then controlled manually by the crew via the control in the cockpit.

A number of checks are designed to detect THS runaway depending on the cause of the malfunction (HSSU, ACMU or HSECU). The checks used to detect runaway caused by an HSECU malfunction consist in verifying the consistency between:

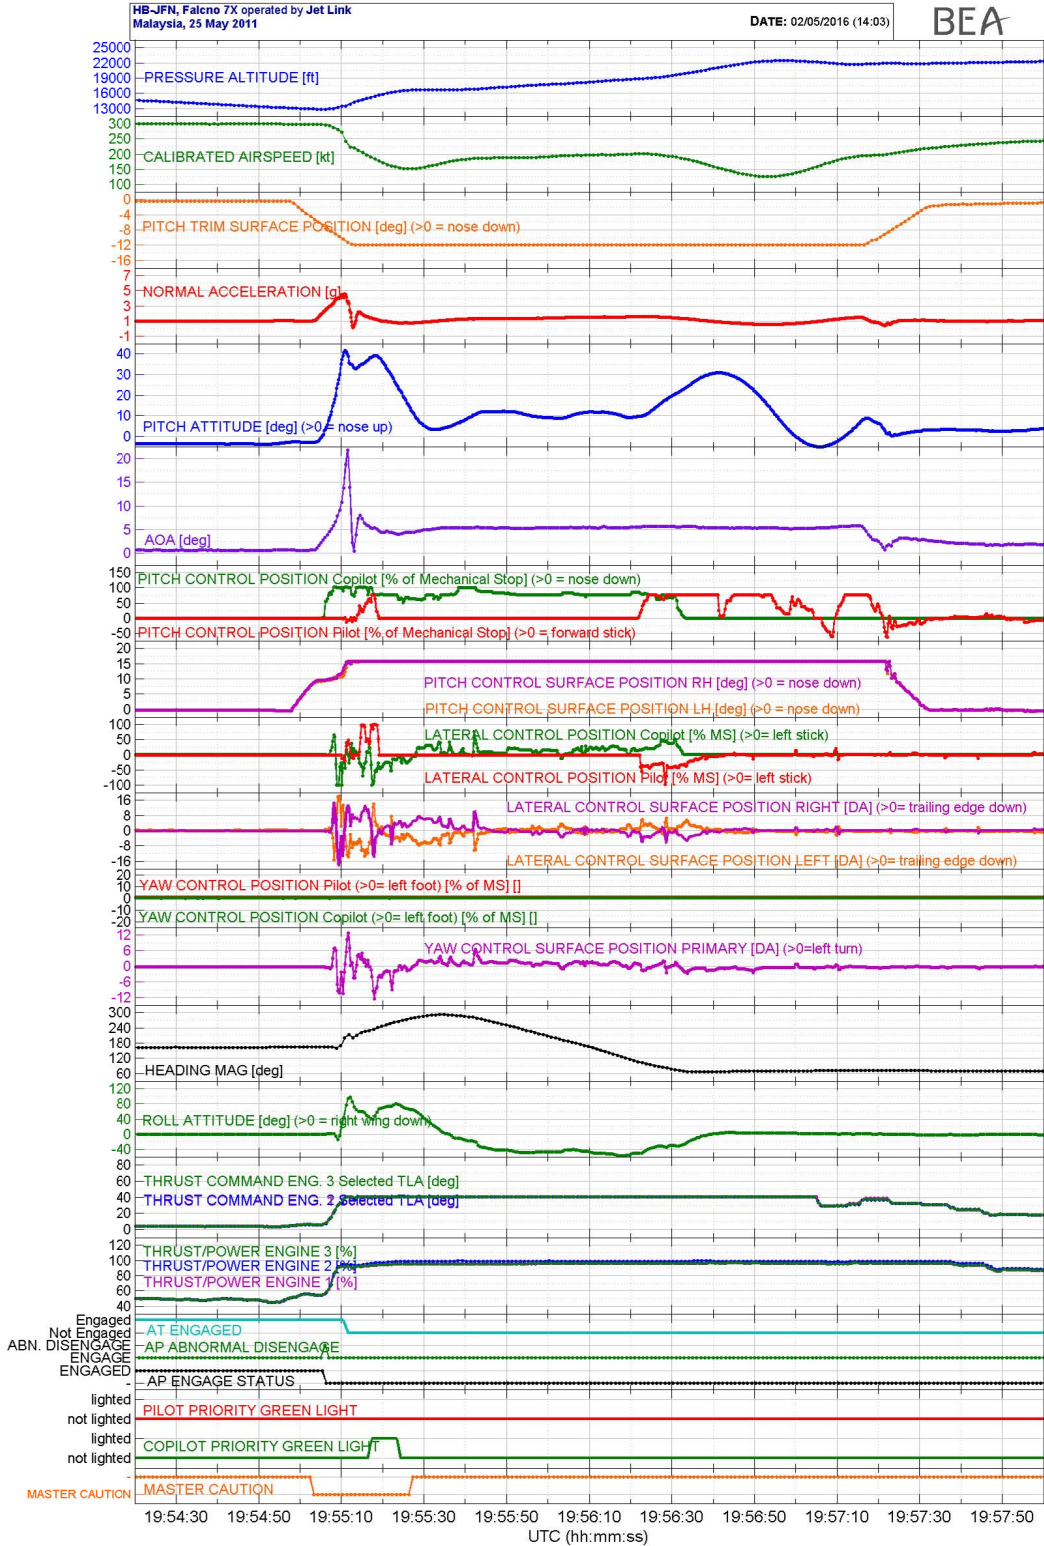
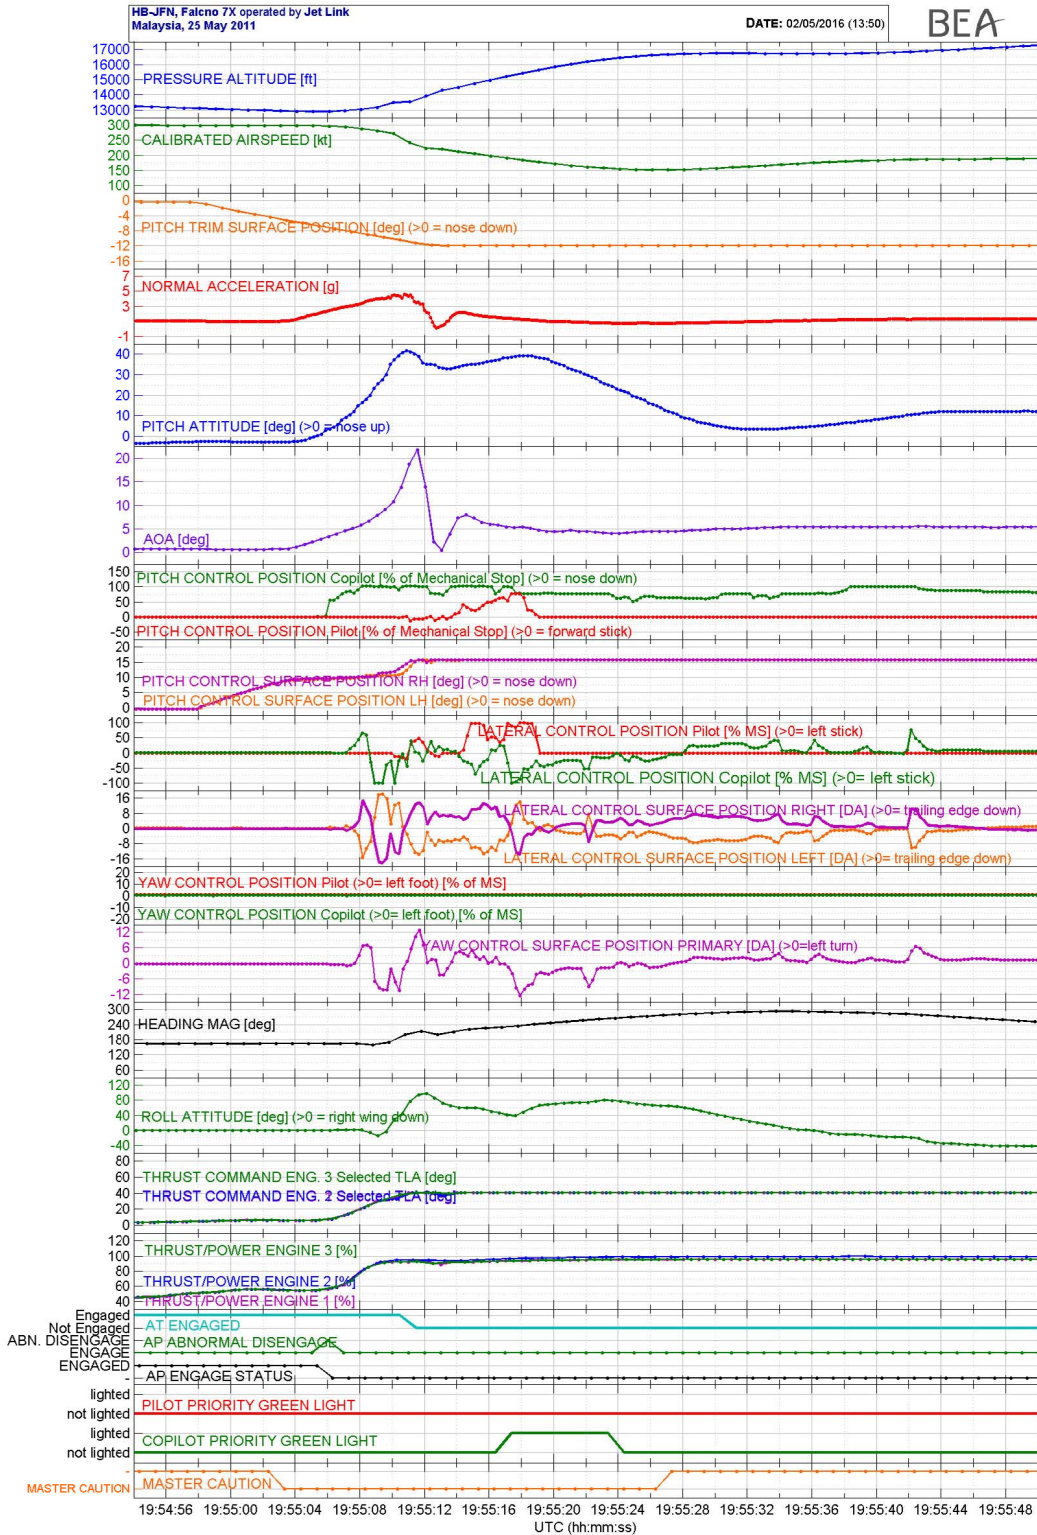
## FDR parameters

Thus, during the incident, based on the FDR parameters (see appendix 1), the only condition that could have caused the AP to automatically disconnect was the nose-down input of the co-pilot on his sidestick.
