# **FINAL INVESTIGATION REPORT**

**ACCIDENT OF PIA FLIGHT PK-661 ATR42-500 AIRCRAFT  
REG NO AP-BHO NEAR HAVELIAN 24 NM NORTH  
OF BBIAP PAKISTAN ON 07 DECEMBER 2016**

Dated: 16 November 2020

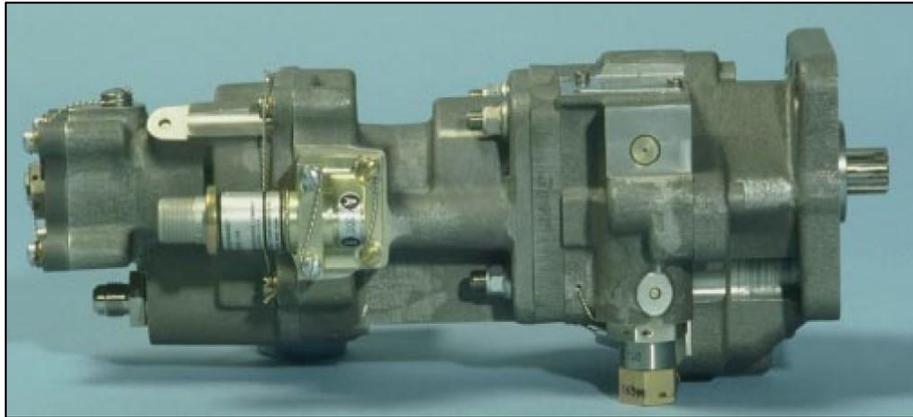
Figure 1-4: Serviceable Overspeed Governor (OSG)

1.1.4.4 The second pre-existing technical anomaly was a fractured pin inside the same side (ie left hand side) Overspeed Governor (OSG). This defect occurred during some maintenance activity performed on it. Advanced technical analysis has revealed that such defect alone (unless combined with abnormal metallic contamination leading to increased friction inside the pilot valve) may not have any impact on the performance of OSG. Figures hereunder show a serviceable OSG and cross section view of the area inside OSG which had a broken pin.

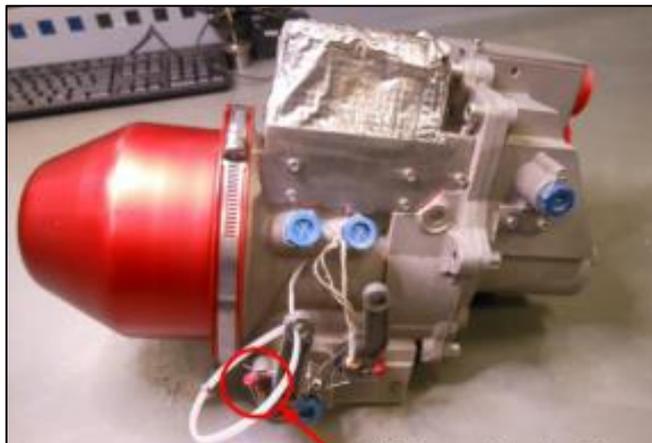
Figure 1-6: Serviceable Propeller Valve Module (PVM)

1.1.4.5 PVM contamination was most likely a pre-existing condition since contaminants, based on their size, could not go through filters / restrictions and were therefore not possibly due to engine contamination. This contamination was likely introduced when the propeller system LRU's were not installed on the gearbox. Figures hereunder show a serviceable PVM and debris found in overspeed line during CT scan.

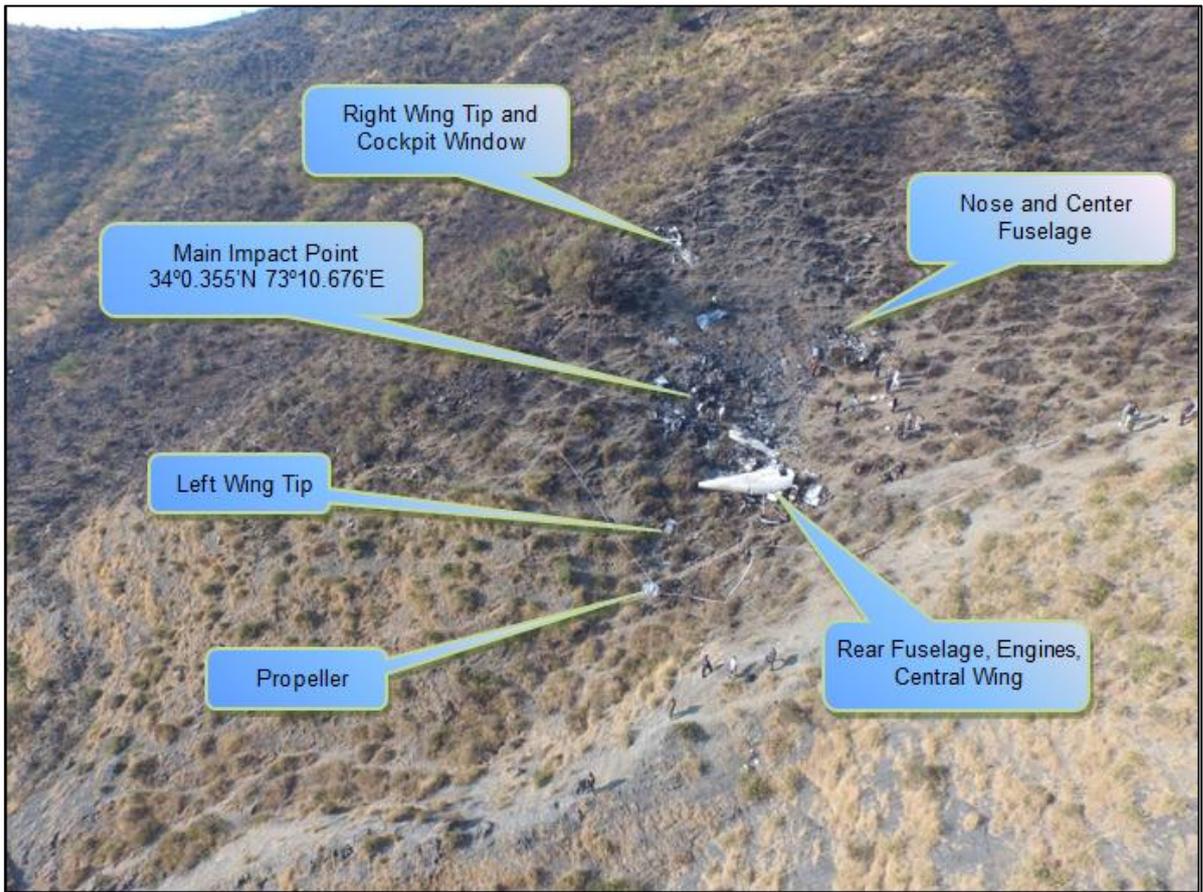
Figure 1-28: Overview of the Wreckage Spread at Crash Site

1.12.1 **Impact Information:** The wreckage site indicated that the aircraft was at a high angle low speed when it impacted the mountain shoulder. Overview of the wreckage spread at crash site is depicted in figure hereunder: -

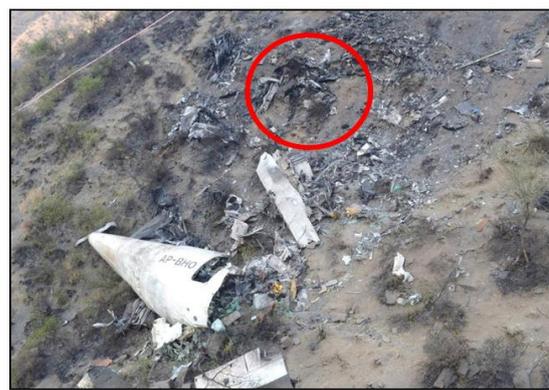
Figure: 1-30  
Sign of Fire Around MIP

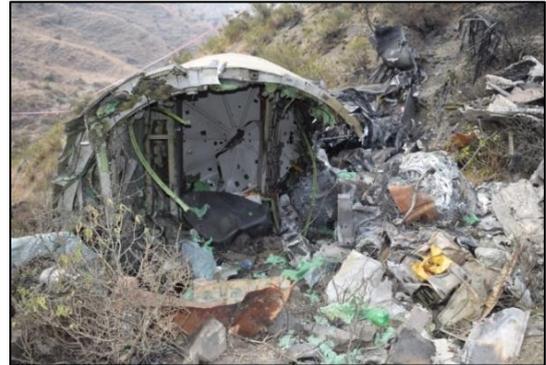
Figure: 1-32  
Rear Fuselage Detached on Impact

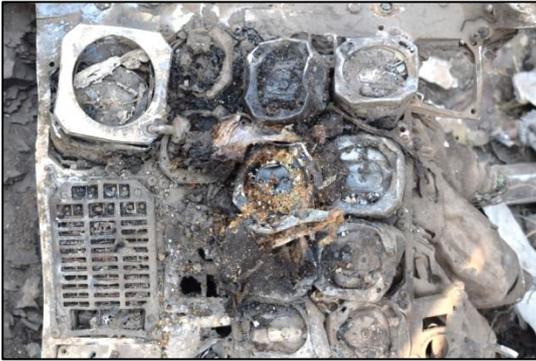
11.	Center Instrument Panel (including crew alert panel) and Power Levers (PLs) and Control Levers (CLs) were also recovered in extensively damaged state

Figure: 1-37  
Center Instrument Panel

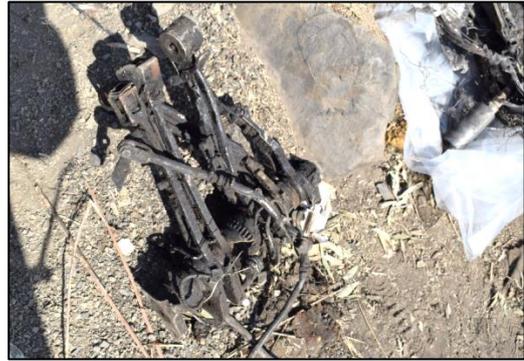
Figure: 1-38  
Power Levers and Condition Levers

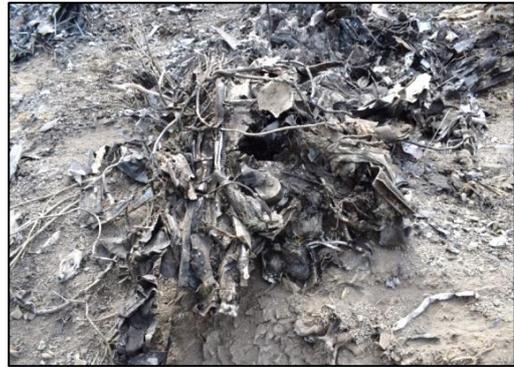
(d) Apart from power plant and its associated parts / components, efforts were also made to recover and identify all major structural parts. Hence, portion of Left & Right Wings, Centre Wing, Landing Gears and portion of Vertical Tail along with Rudder (burnt) were also recovered. The extensively burnt / damaged parts / portions / pieces of passenger cabin and cockpit were also recovered. Similarly electrical looms and harnesses in burnt state beyond identification were also recovered.

Figure: 1-44  
Burnt Electrical Looms and Parts

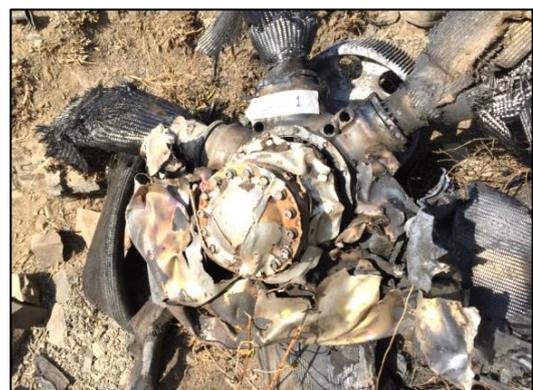
Figure: 1-46  
No 1 Propeller Blades Damaged due to  
Post Impact Fire

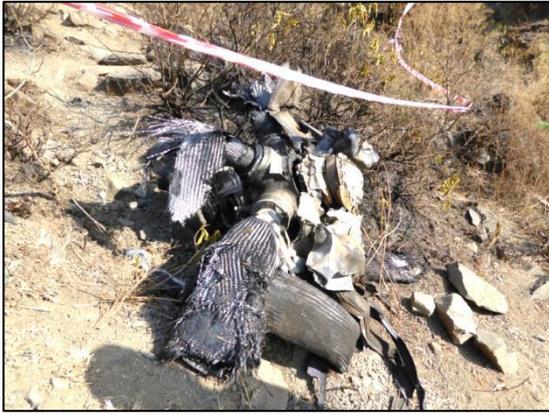
Figure: 1-47  
No 1 Propeller Blades Damaged due to Post Impact Fire

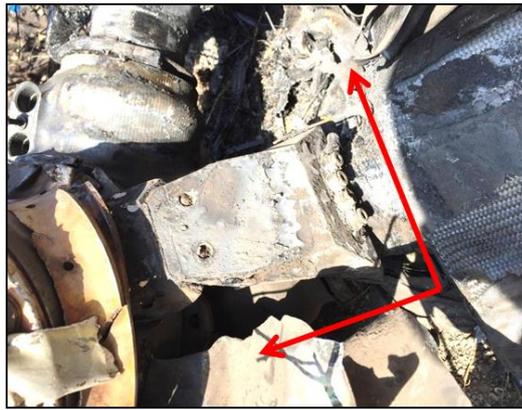
Figure: 1-49  
No 1 Propeller Counter Weight and Blade Depicting 90°- Fine Pitch

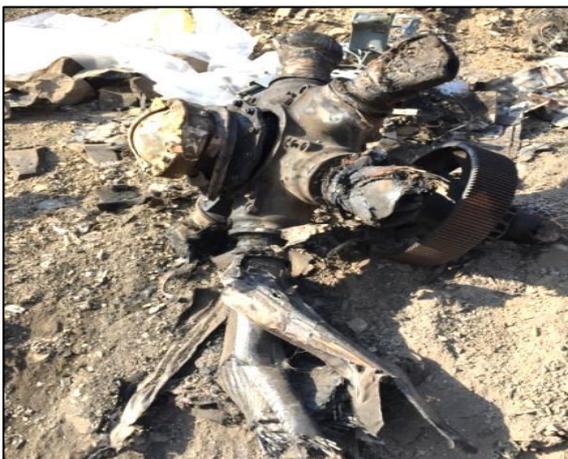
(b) **No 2 Propeller Assembly:** The propeller assembly was detached from the engine. It received severe post impact damage and heavy ground fire signatures were also visible. All the blades were detached near their roots on impact with ground. It generally indicates that blades were rotating at high RPM on impact with ground. Similarly, the Counter Weights position indicated that blades were at fine pitch angle. The last known positions of blades were marked on propeller for reference. Bull gear of RGB was found attached with the propeller.

Figure: 1-50  
No 2 Propeller with Blades Detached on Impact

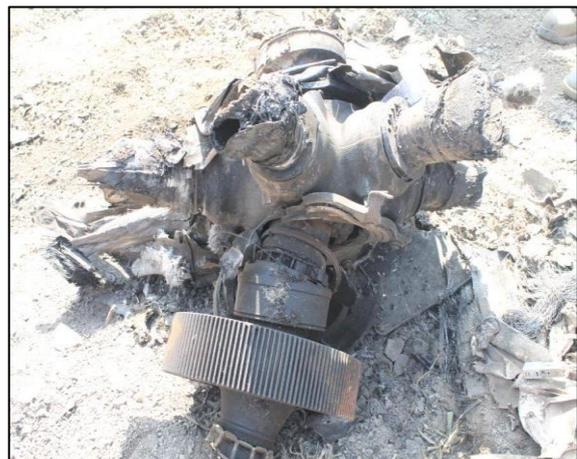
Figure: 1-51  
Bull Gear of RGB Attached with No 2 Propeller

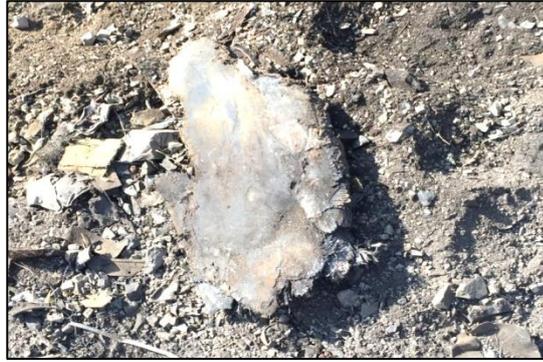
Figure: 1-52  
A Detached Blade of No 2 Propeller

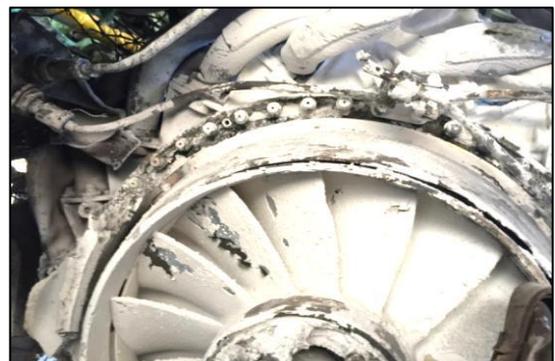
Figure: 1-56  
No 1 Engine Impeller – No Damage

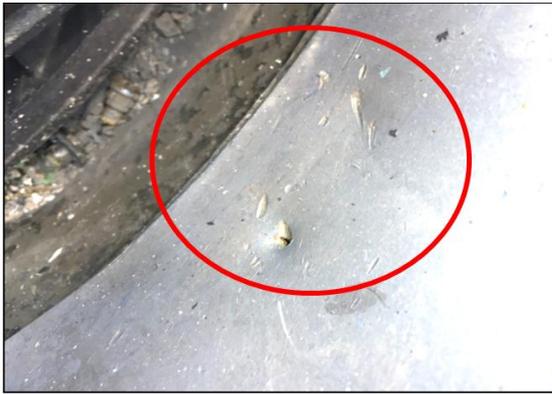
Figure: 1-57  
No 1 Engine Exhaust Duct – Indentation Marks

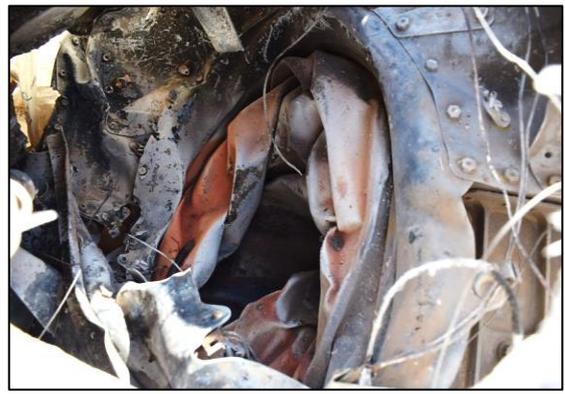
(c) **No 1 Engine (Turbo Machinery):** The engine was lying in vicinity of detached tail portion of aircraft towards left of main impact point. The exhaust duct was recovered in separated condition from engine. The visual examination indicated no apparent damage on 'LP Compressor' blades. The associated components were mostly found detached from the engine. The post impact damages were visible. The 2<sup>nd</sup> stage Power Turbine blades were found severely damaged. Similarly, sign of metallization (brownish colour) were consistent in the exhaust duct area as well, which got detached from the engine on impact with ground. Hence, it appears that this metallization was most probably caused in flight.

Figure: 1-58  
View of Tail Pipe – Sign of Metallization in Folds (Brownish Color)

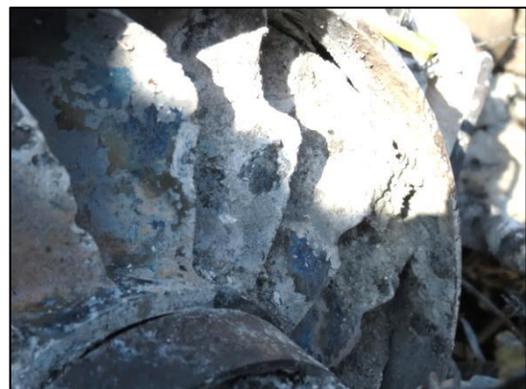
(d) **No 2 Engine (Turbo Machinery):** The engine was co-located with No 1 Engine most probably because it was moved during rescue operation. The visual condition of LP Compressor revealed bending of blades opposite to rotation. It generally happens when compressor is rotating at high RPM on impact with ground. No damage was observed in rear portion ie on Power Turbine blades. Similarly, exhaust duct got separated on impact and was recovered with no specific observation. The engine components installed on casing got detached on impact.

Figure: 1-61  
No 2 Engine Damaged LP Impeller

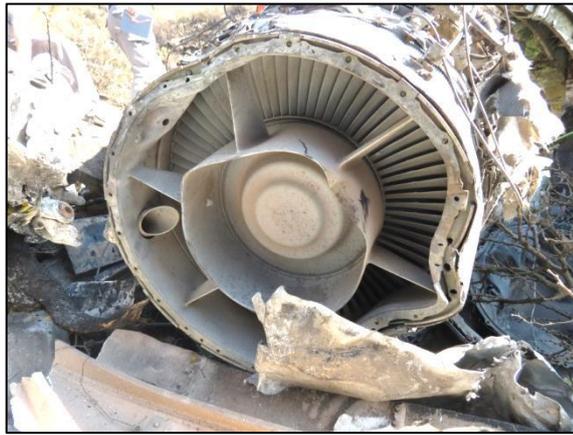
Figure: 1-62  
No 2 Engine Power Turbine - No Damage

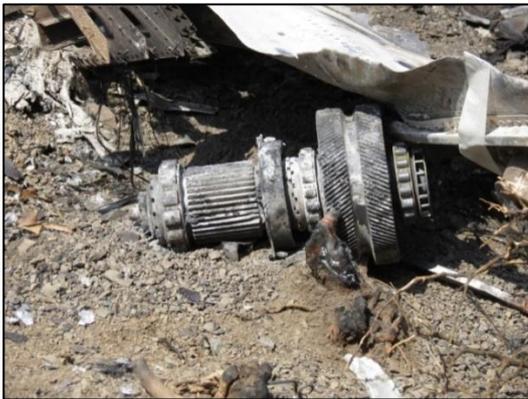
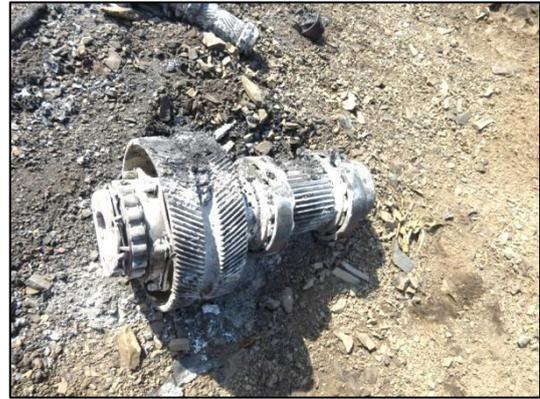
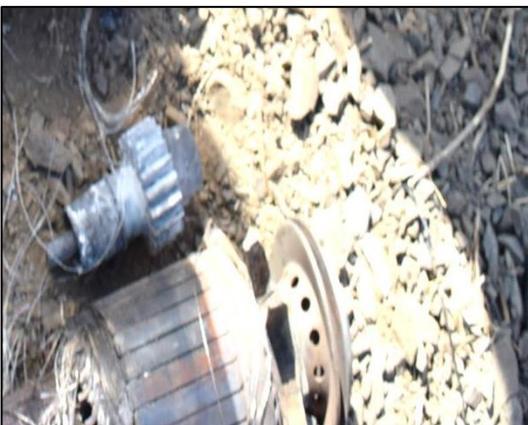
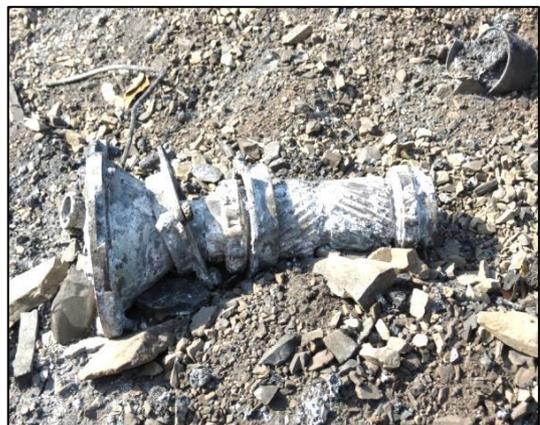
(e) **Reduction Gear Box(s) & Accessory Gear Box(s):** The RGB and AGB of both Engines could not be recovered in one piece as their casings got burnt due to ground fire. However, various drive shafts and gear train parts were recovered from the wreckage. These parts could not be identified on site and were secured for identification later on.

Figure: 1-63  
Gear Trains Detached from Main RGB Assemblies

Parts of Gear Train

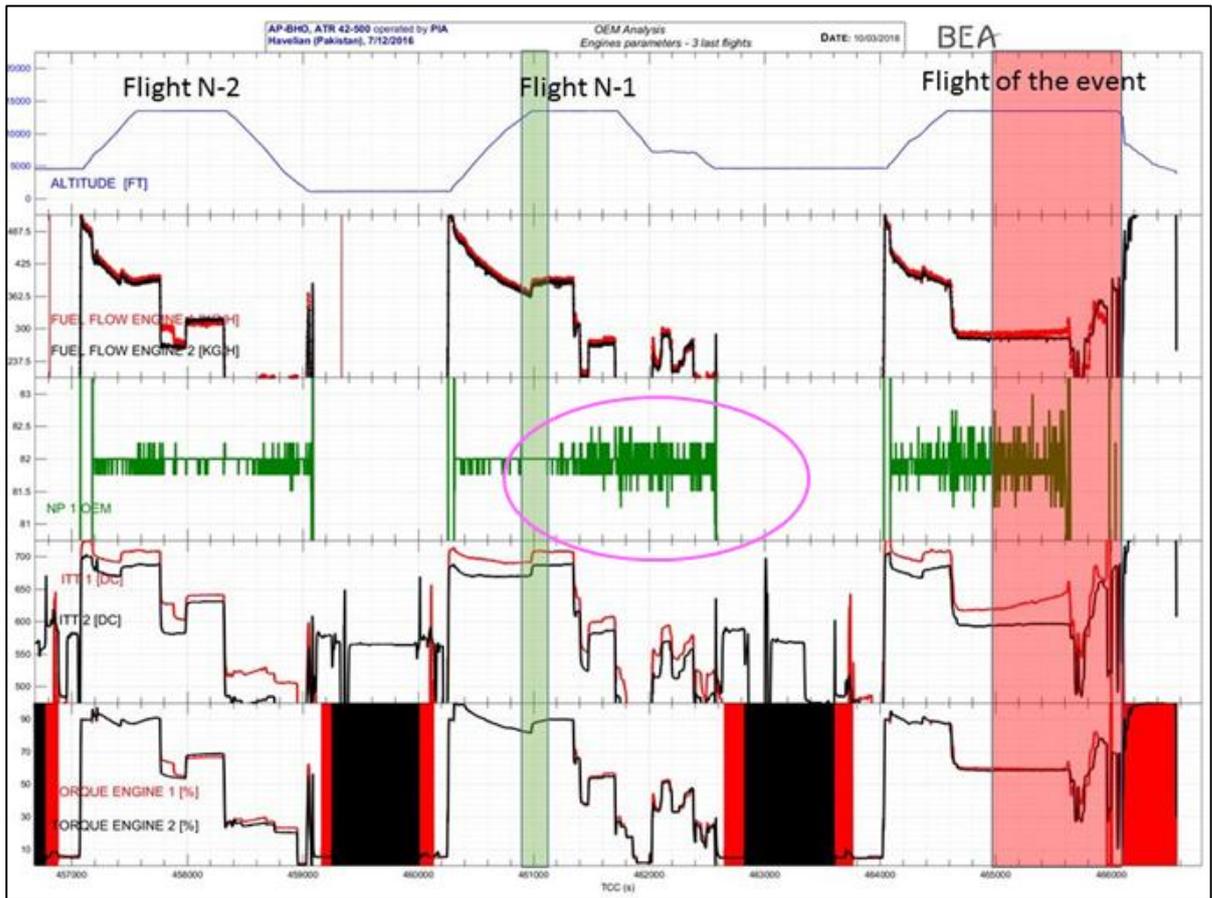
Figure 2-4: Engine Parameters During the Last 3 Flights

(b) The BEA studied the flights before the flight of the event. A focus on the propeller behavior is displayed in figure hereunder (limited set of parameters). The propeller speed (Np-1) regulation stayed inside the design specification (margin of 1%), however the oscillations of the propeller speed is not usual and the flight of the event did not show any linear regulation during the whole flight. During the flight N-1, the last area of linear regulation occurred during 3 minutes (in light green inside the figure hereunder). During the flight N-2 and the previous flight, several period of linear regulation existed during the cruise phase. During the flight of the event, the ITT and the fuel flow of No 1 Engine showed a clear trend to increase (area in light red inside figure hereunder). It was not possible to determine the time of the PT-1 blade fracture prior to the event. The increase of the ITT and of the fuel flow indicated that the No 6 bearing seal had already failed. The fracture of the blade occurred before this. As the degradation of the Np-1 regulation started during the flight prior to the flight of the event, the most probable scenario for this fracture / dislodging of the blade can be during that flight.

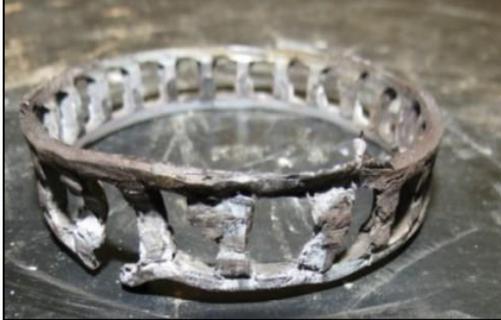
Figure 2-6 : No 6 Bearing Cage

(c) **Engine No 6 Bearing:** No 6 bearing was heavily damaged. The bearing rollers were no longer in the cage pockets. A total of 08 out of 22 rollers were recovered. They were severely worn and reduced in diameter. The front labyrinth seal was fractured. Particles were found in the last chance strainer of the oil pressure tube, mainly composed of phosphorous residues from burnt oil with metallic nickel based particles similar to Inconel 718.

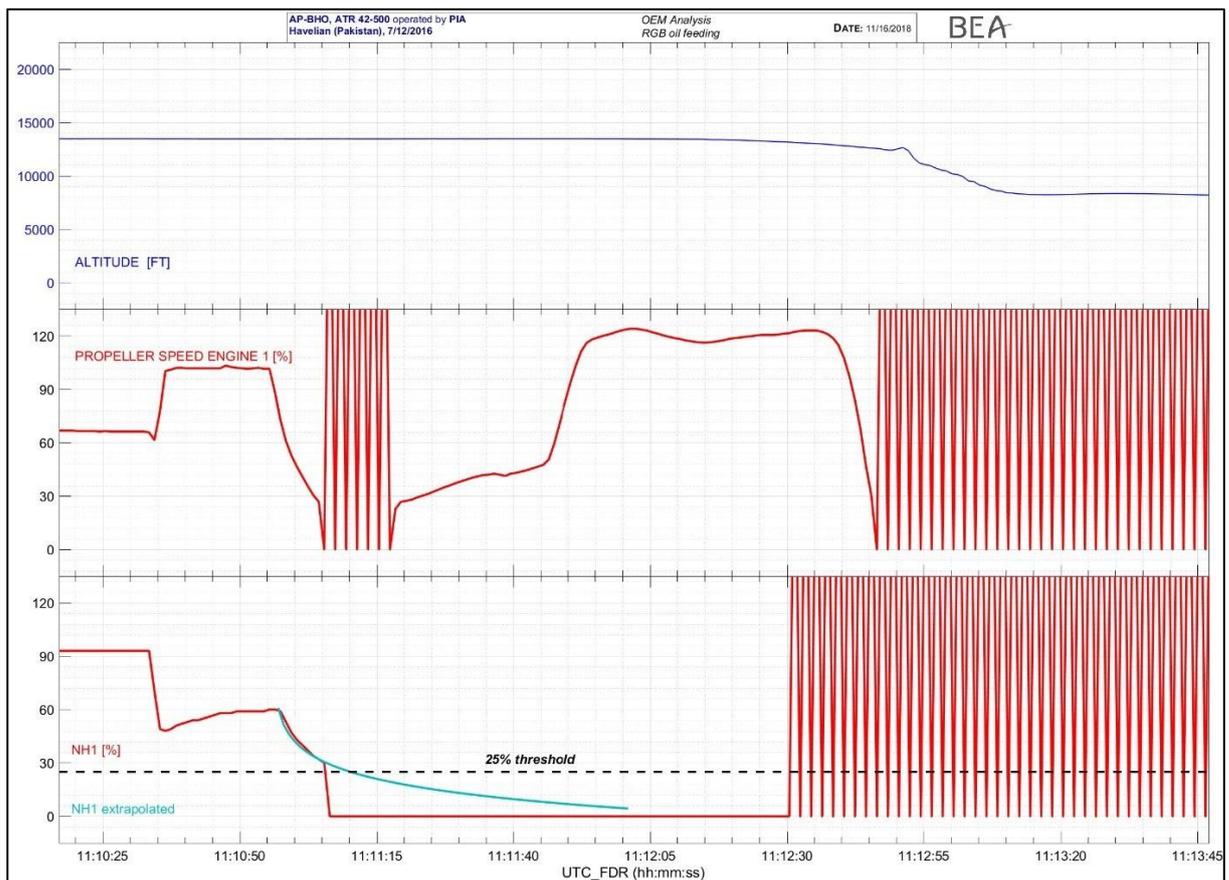
Figure 2-8: RGB Oil Feeding

(f) **Impact of Filter Clogging on RGB Oil Feeding:** A fully clogged filter would have led to an oil starvation inside RGB as soon as NH values got lower than 25% (before beginning of phase 5). The decreased rate of  $\beta$  from phase 5 to 7 computed by the manufacturer indicated a fully clogged filter before IFSD is extremely remote but a partially clogged filter with filter bypass before IFSD was likely. However, the decrease rate of the propeller speed during the phase 8 was higher than the decrease rate when propeller goes onto feather without any hydraulic supply. The probability of a lack of oil feeding at the start of phase 8 is extremely remote.

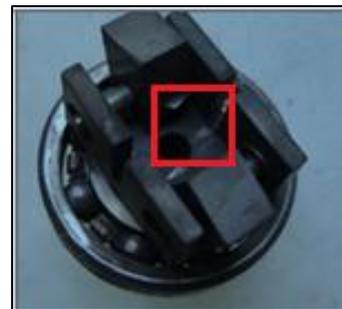
Figure: 2-12

- Flyweight broken at the toes (figure 2-12).
- Broken toes were missing, but the flyweights were still inside the carrier.
- The carrier ball bearing was rotating freely.
- The rotational pin was broken during an overspeed governor reassembly, as evidenced by markings on top of one flyweight (figure 2-13) and fractured pin (figure 2-14) material analysis (figure 2-15).
- The broken toes and the broken pin were not found inside the OSG.

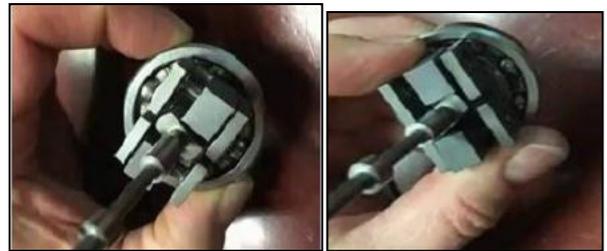
Figure: 2-16

- Contact occurred between the flyweights and the valve in 2 opposite directions.

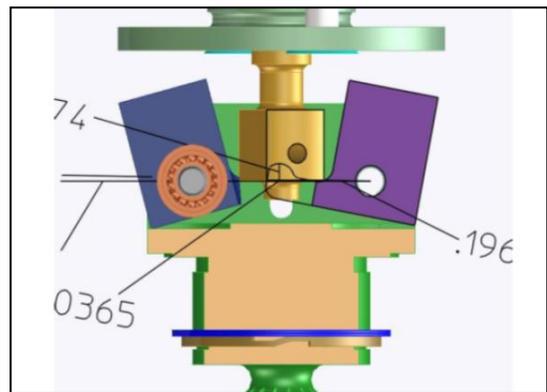
Figure: 2-17

- With both flyweight toes broken (as they were), it was possible to regulate the propeller speed at a value close to the expected values of 102.5% (tests realized by the manufacturer).

*Note: in this case, the “purple” flyweight (Figure 2-17) pulls the valve in rotation and does not push it. During the tests, the manufacturer blocked the valve on the flyweight.*

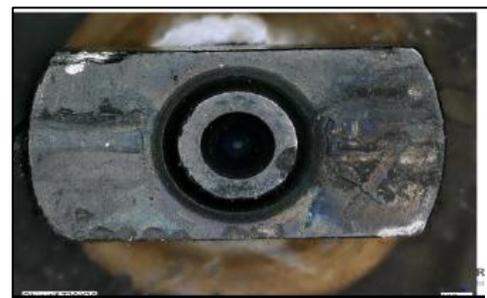
Figure: 2-18

- The “purple” flyweight pulling the valve in rotation would be consistent with the wear on bottom surface of the pilot valve (Figure 2-18).

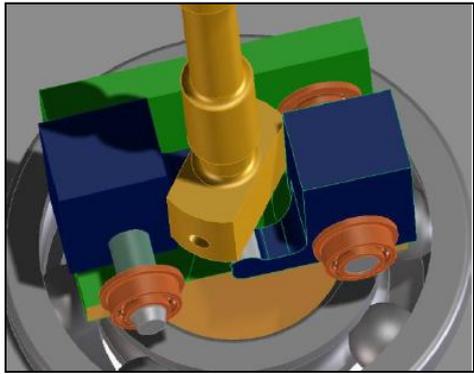
<p>- When friction is added to the pilot valve, the driving flyweight may become vertical due to the loading. It lifts up the valve, connecting partially the overspeed line to the drain. The quantity of oil drain was computed as 1 QPM.</p>

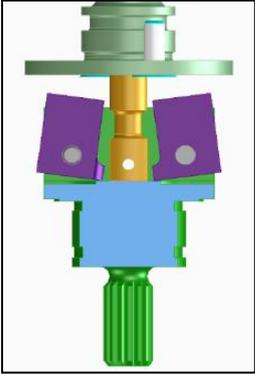
<p>Figure: 2-19</p>
<p>- With both flyweight toes broken (as they were), when rotational speed was reduced (propeller going into feather), flyweight force was reduced and spring pushed plunger past the flyweight toes. The overspeed governor was in a constant under-speed condition. Later flyweights could not lift the valve when propeller speed increased.</p>

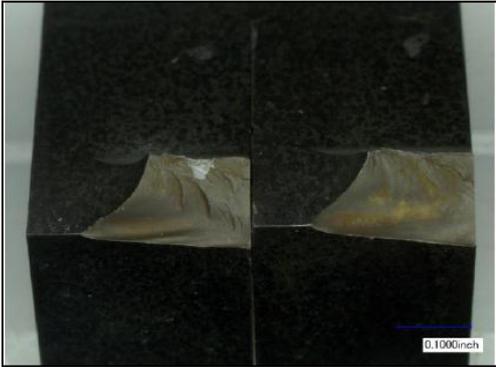
<p>Figure: 2-20</p>
<p>- Flyweight fracture path: propagation direction from above the toe. It is not evident if the fracture was caused by tensile overload or fatigue loading.</p>

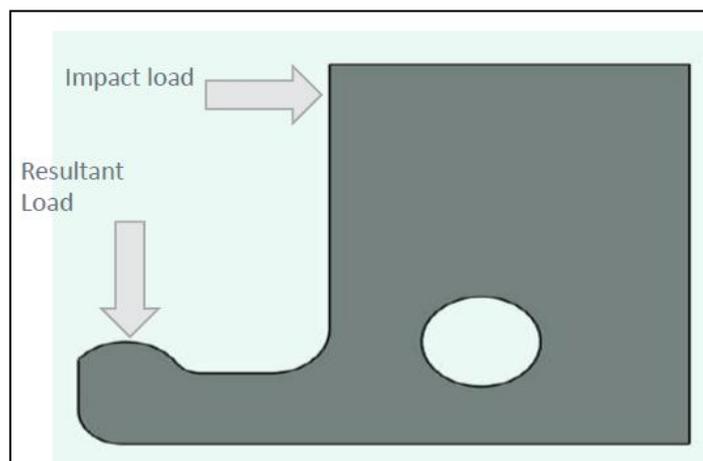
Figure 2-26: Loading Most Likely Caused by Drag on Valve

(iv) At the beginning of phase 2, due to oil contamination, the drag of the pilot valve increased and the driving flyweight moved in a vertical position (figure 2-27), lifting up the pilot valve. The valve was then between the overspeed condition and the under-speed condition. The overspeed pressure ( $P_{OSG}$ ), driving the behavior of the protection valve, was then a combination of the supply pressure ( $P_S$ ) coming from the main pump and a leakage to the drain. As tested by the propeller manufacturer, this configuration led to an improper  $P_{OSG}$ , leading to a move of the protection valve between the protected mode and the unprotected mode. The pressure sent by the EHV (inside PVM) was no more controlling the blade pitch angle alone. The actuator driving the blade pitch angle gradually moved aft requesting a blade pitch angle increase and the No 1 Propeller speed decreased.

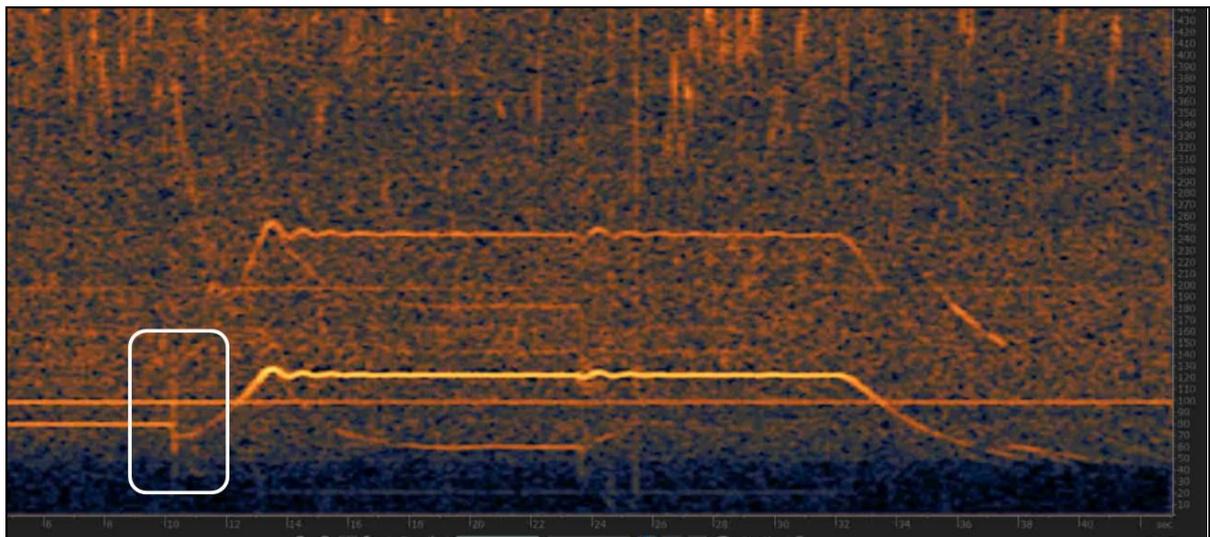
Figure 2-28: Sharp Decrease of the No 1 Propeller Speed

(v) At the end of the phase 2, the sudden decrease of the propeller speed was recorded. The spectral analysis at that time clearly underlined a sharp drop of the propeller speed (figure 2-28 white box). This sharp decrease could not be the result of a blade angle change and might be due to the engine power loss. Most probably at that time, the last toe broke. The pilot valve was not lifted anymore and went down, on the broken part of the toes (figure 2-29). With this movement, the overspeed line was not connected to the drain line anymore and the  $P_{OSG}$  increased again and reached the  $P_S$  value.

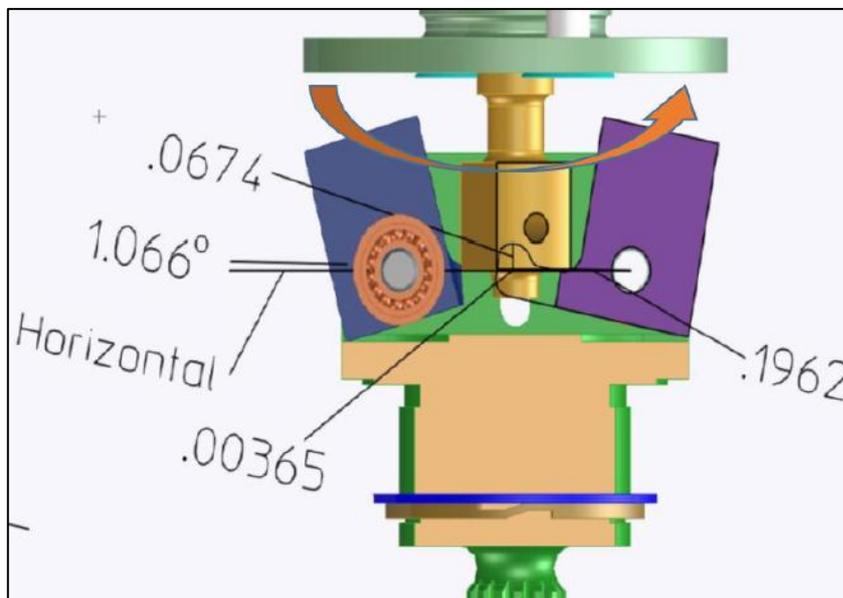
Figure 2-32: Illustration of OSG Operation with Broken Flyweight Toes

(vi) As the  $P_{OSG}$  increased, the protection valve moved to the unprotected mode and  $P_{FINE}$  was piloted by the EHV position only. At the end of the sharp No 1 Propeller speed decrease, the blade pitch angle decreased (EHV bias request) and the propeller speed increased. The pilot valve was stuck on the fracture part of one flyweight and this flyweight pulled the valve in rotation. This part of the scenario is consistent with the wear marks observed on the bottom face of the pilot valve (figure 2-31). The fractured flyweight No 1 (figure 2-32 in blue) could not lift the valve and slipped away from the bottom of the valve. The corner of the fractured flyweight No 2 (figure 2-32 in purple) contacted the bottom of the valve and pulled it in rotation.

The loss of the toes changed the behavior of the flyweight: the moment arm changed and the moment applied by the valve to the flyweight is reduced. At a given speed, the loss of the toe induced an increase of the centrifugal force (the gravity center of the flyweight changed). As a combined effect, a single broken flyweight in contact with the pilot valve resulting in a short moment arm, may behave quite like 2 non fractured flyweights, provided the valve stays stuck on one flyweight. Computation performed with a valve stuck on the broken flyweight No 2 and tests performed with flyweights broken like the flyweight No 2 of the event demonstrated that the threshold of the overspeed regulation was, in this particular case, between 101% and 103%. During the flight of the event, at the end of the phase 2, both toes were broken. The valve stayed stuck on the corner of the fractured flyweight No 2

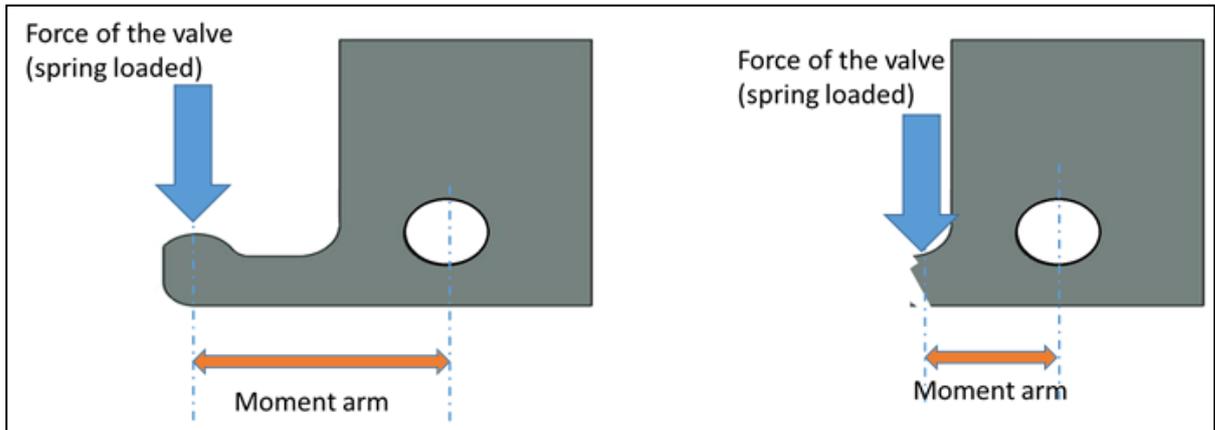
Figure 2-33: Force of the Valve on Fractured / Non Fractured Flyweights

that pulled the valve in rotation. No 1 Propeller speed increased during the phase 3. When the No 1 Propeller speed reached 102%, the overspeed governor regulated the speed as if the overspeed governor was in good shape. At the beginning of the phase 4, the cockpit crew requested the feathering of the No 1 Propeller. As No 1 Propeller speed decreased, the broken flyweight No 2 force decreased. The force of the spring pushed plunger past between the broken flyweights. From that time, the overspeed governor remained in an under-speed condition and no longer contributed to the propeller regulation.

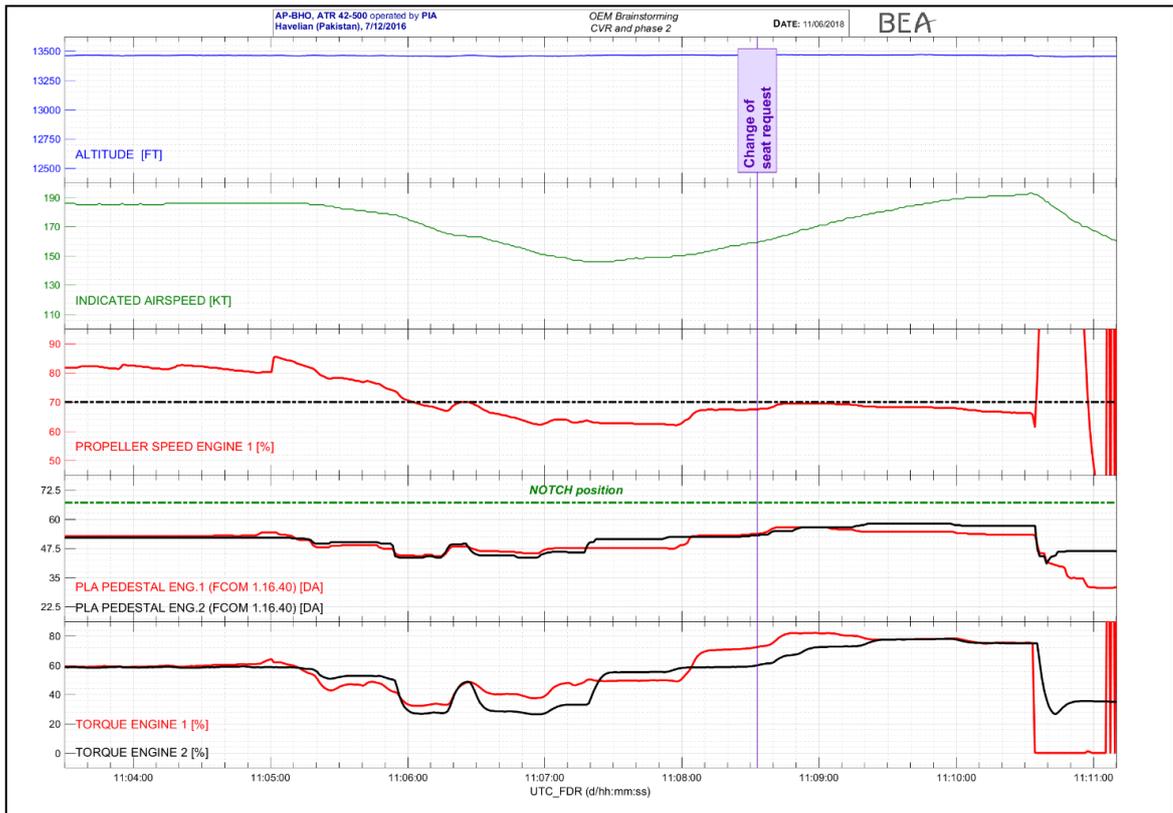
Figure 2-35: Engines Parameters During Phase 2

(b) **Phase 2:** The CVR information does not reflect discussions about the propeller system out of in flight Np values. From DFDR recorded data, the recorded Np-1 values were below 70% from 11:06:02 and stayed below that threshold until the engine breakdown. Three PEC reset attempts reflect that the pilots may have noticed un-expected results due to propeller system out of in flight Np setting value. At 11:08:33 FO(B) questioned the Captain on the replacement of FO(A). Nothing was said about Np-1 setting.

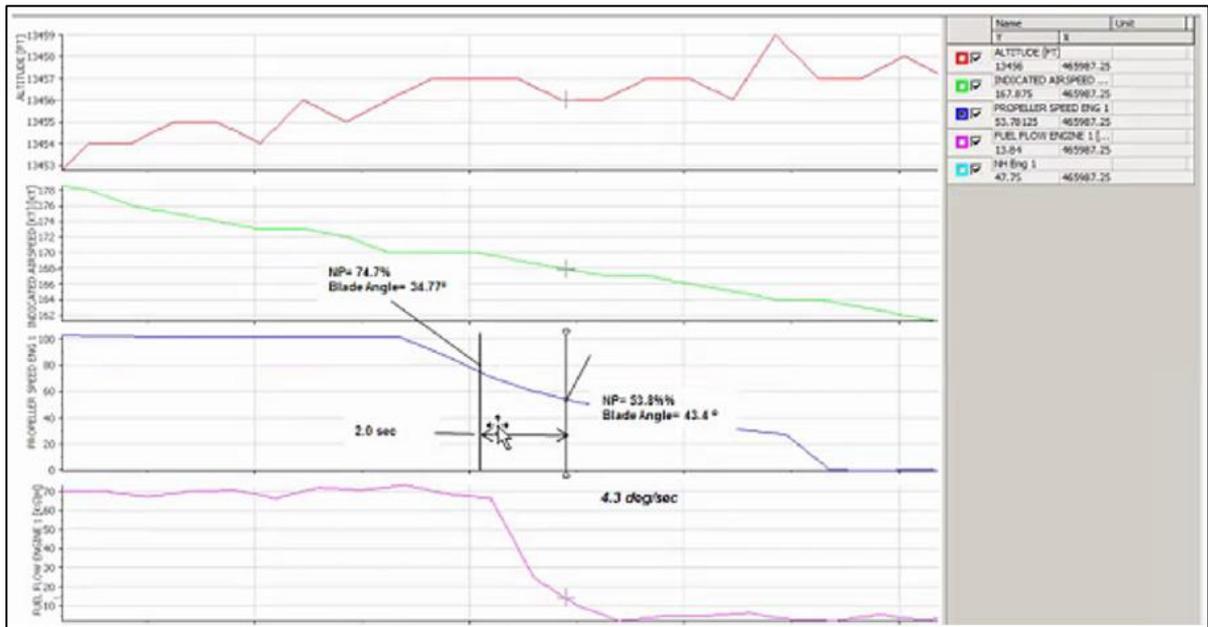
Figure 2-36: Feathering Sequence During the Flight of the Event

(i) Flight tests performed at aircraft level in conditions equivalent to the event flight (PEC OFF, altitude, speed) confirmed that feathering experienced by AP-BHO was abnormally slow compared to a PEC OFF feathering through feather solenoid. Moreover, it confirms that un-feathering experienced by AP-BHO was also abnormally slow compared to an engine OFF / PEC OFF un-feathering through feather solenoid de-energizing. Thus, it allows to exclude that loss of feather solenoid input would have led to the observed AP-BHO slow feathering / un-feathering. The decrease of the propeller speed between 74.7% and 54% lasted 2 seconds, leading to a pitch increase rate of  $4.3^{\circ} \text{ sec}^{-1}$ , rate which is between a feathering with nominal hydraulic power and a feathering without any hydraulic power.

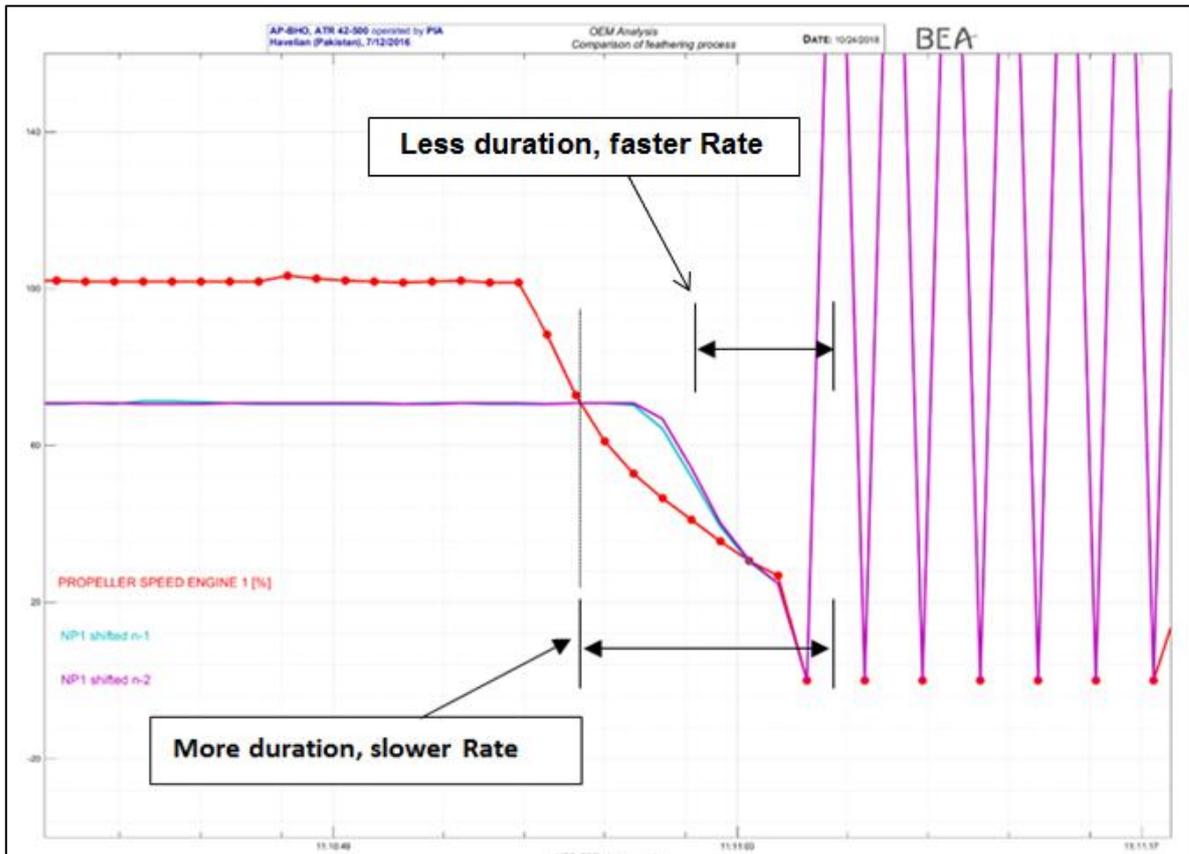
Figure 2-36A: Comparison of the Feathering During the Flight of the Event (in Red) with Feathering During Previous Flights (in Blue and Magenta)

(ii) This feathering of event flight was also compared with the previous feathering of the propeller, on ground. On ground, the PEC does not command pitch increase. This PEC's function is inhibited, to force the use of the feather solenoid in order to avoid a pre-existing failure. The feather solenoid function was validated during the N-1 and N-2 flights. During the flight of the event, the true airspeed and the altitude on the blade had an impact on the forces applied on the blades. This is especially true at the beginning of the feathering process when the propeller speed was the most important and the blade pitch angle was at the lowest angle. However, the counterweights are designed to counteract these forces in the whole flight envelope. The behavior of the propeller during the feathering sequence of the flight of the event underlined that: -

- Was consistent with the expected pressure at the beginning of the feathering process.
- But decreased with the time.

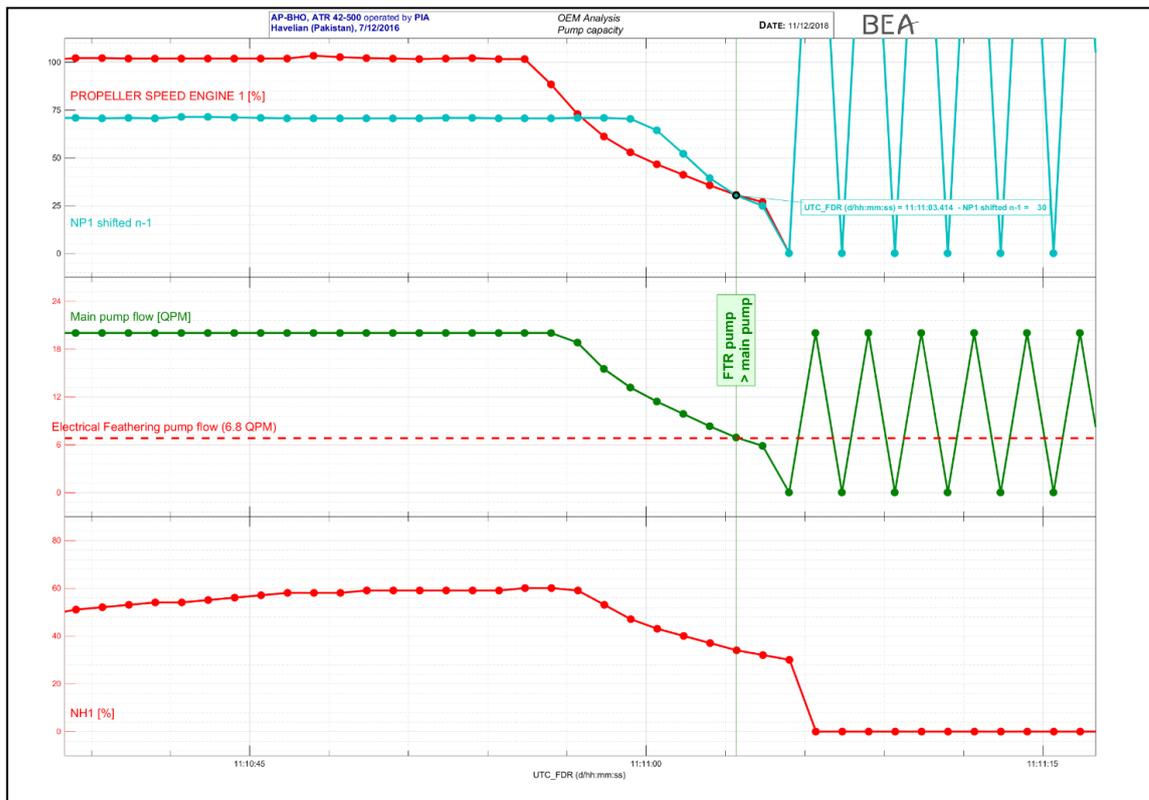
Figure 2-37: Pumps Capacity During the Feathering

(c) **Case of a  $P_S$  Lower than Expected:** When in flight feathering is requested, the  $P_S$  relies on the main pump capability and / or the electrical feathering pump capability. Both the pumps are connected to the oil pressure supply line through check valves and only one pump feeds the system at a given time. The analysis shows that before 11:10:57, the main pump should have had the control of the pressure supply  $P_S$ . Just before feathering, the NH-1 recorded value was greater than 30%; the main pump provided sufficient oil flow and pressure to feed RGB.

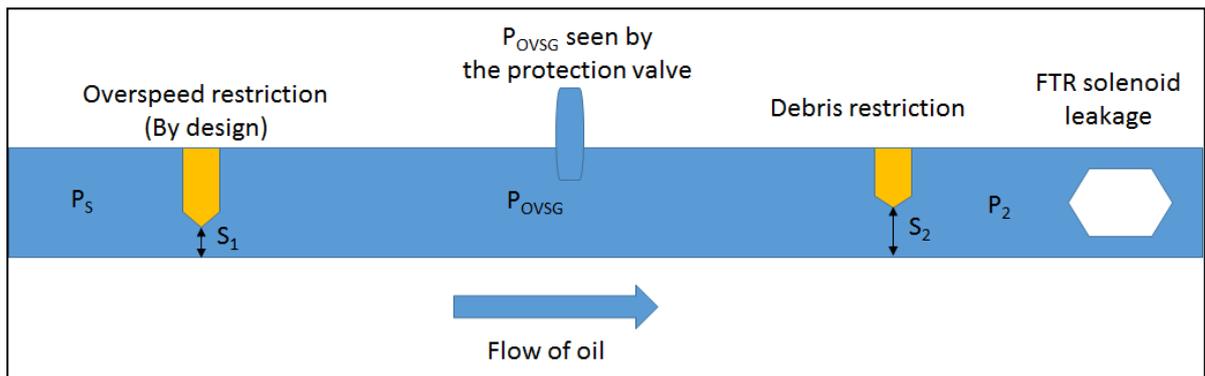
Figure 2-39: Restriction in Flow of Oil Caused by Debris

(iii) If a restriction occurs inside the PVM overspeed line, after the protection valve, the pressure ported at the protection valve would be affected.

(iv) If  $S_2$  decreases, the pressure  $P_{OSG}$  may increase. When the surface  $S_1$  is greater than the surface  $S_2$ , the pressure  $P_{OSG}$  increases and reaches  $P_s$ . The second possibility to make the protection valve move is to decrease the  $P_s$  ported at the protection valve. The  $P_s$  provided by the main pump feeds the PVM through the filter. During the CT scan examination, no contamination was detected inside this filter. Even if nonmetallic contamination might have occurred, such a contamination would not have disappeared during the remaining time

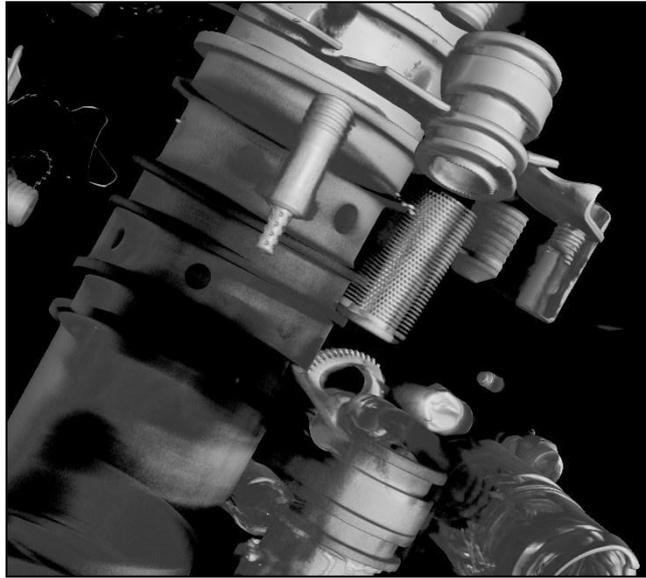
Figure 2-40: CT Scan - Input Strainer (PVM-1)

of the flight. During the phase 7, the propeller speed had increased up to more than 120%. The probability that this filter was clogged and impacting on the system behavior is then remote.

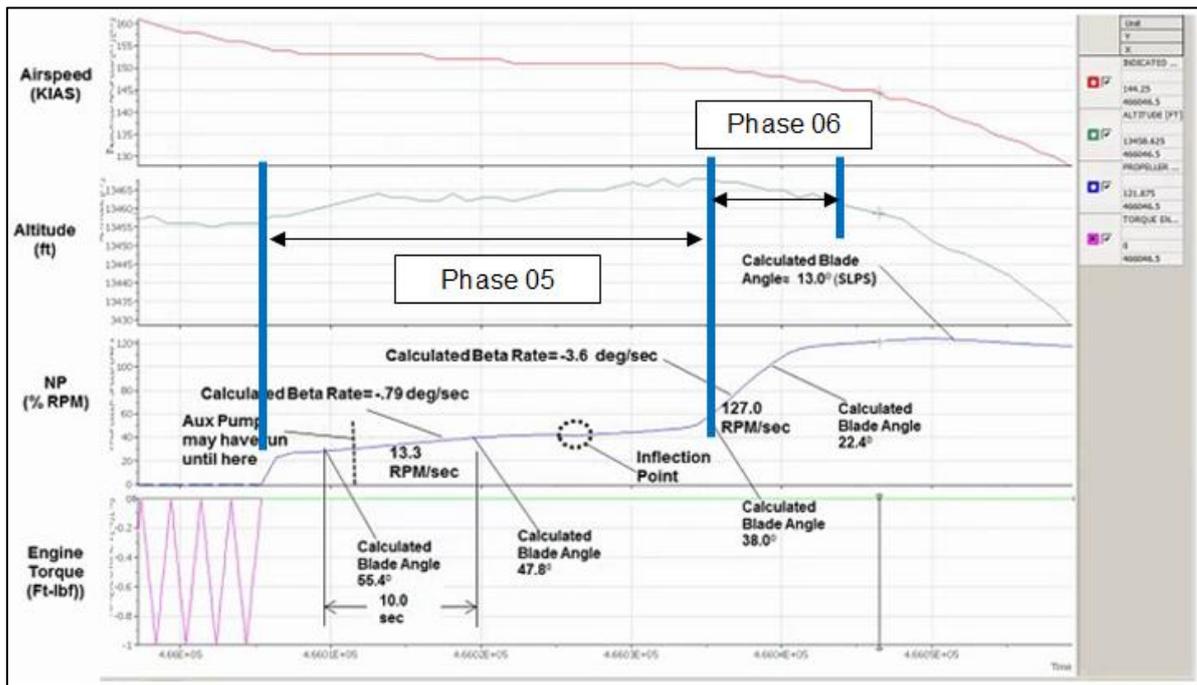
Figure 2-41: Slow Un-Feathering - PEC OFF

(i) The propeller speed change is linked with the change of the blade pitch angle ( $\beta$ ). In the case of the event, the  $\beta$  variation started at less than  $-1^\circ\text{sec}^{-1}$  and reached a maximum of  $-4^\circ\text{sec}^{-1}$ .

(ii) This  $\beta$  variation was lower than the nominal decrease rate thus underlined limited oil flow associated with limited pressure sent to the actuator (Tech Finding 4).
