# **FINAL INVESTIGATION REPORT**

**ACCIDENT OF PIA FLIGHT PK-661 ATR42-500 AIRCRAFT  
REG NO AP-BHO NEAR HAVELIAN 24 NM NORTH  
OF BBIAP PAKISTAN ON 07 DECEMBER 2016**

Dated: 16 November 2020

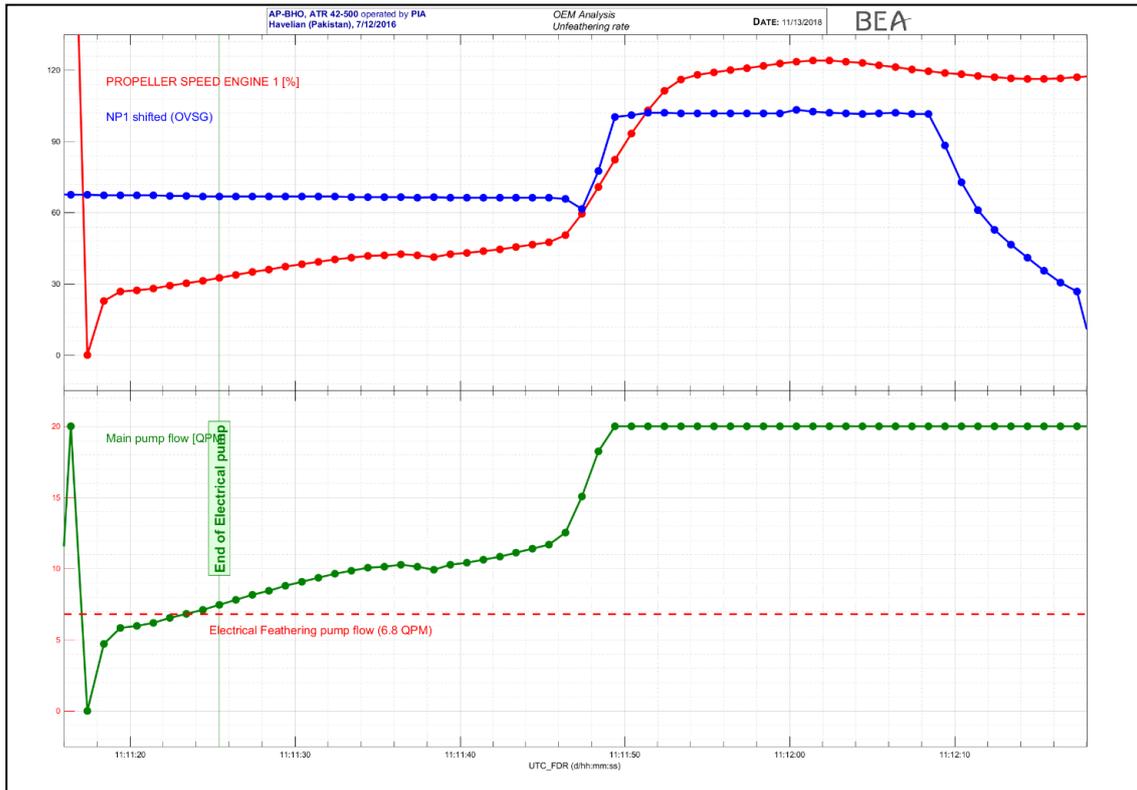
Figure 2-42: Comparison Between the Propeller Speed in the Beginning of Phase 3 and During the Un-Feathering Process

(iii) During the flight of the event, the bias of the EHV would have requested the decrease of the blade pitch angle (PEC was OFF). This already occurred during the phase 3. The No 1 Propeller speed, at the start of this phase, moved onto the overspeed governor degraded setting close to regulation one at 11:10:34. The increase of the propeller speed rate of change during the un-feathering process clearly

showed that the rate was lower than during the beginning of the phase 3, especially at the beginning of the un-feathering sequence. In the case of a feather solenoid closure, the increase of the propeller speed rate would have been greater than the recorded one.

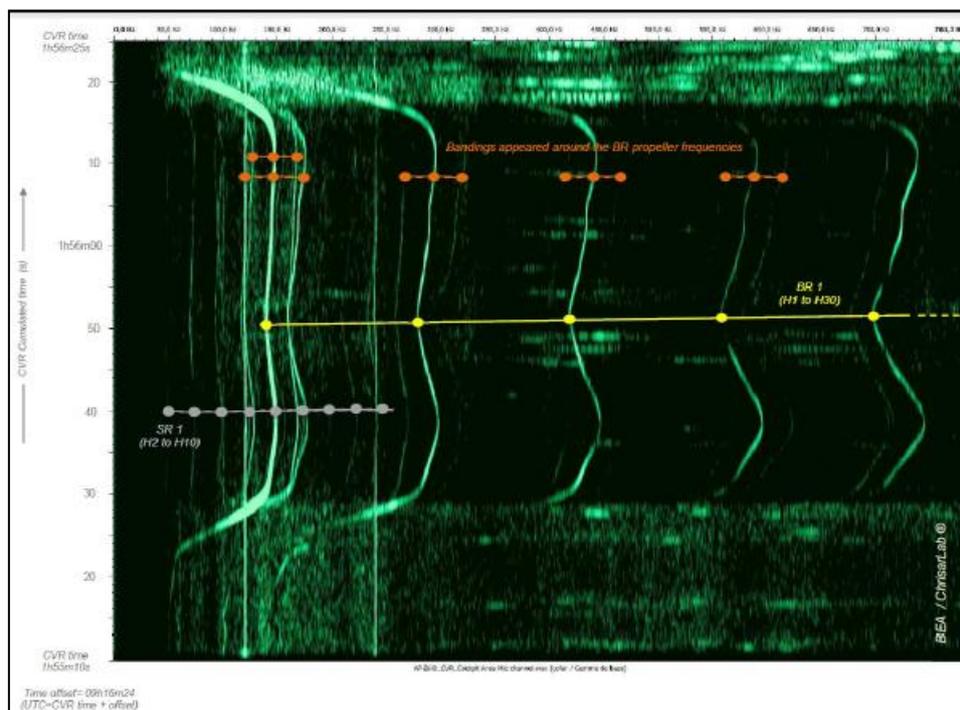
Figure 2-43: Spectral Analysis of the 120% Phase

(a) After the feathering phase (phase 4), due to broken flyweights, the overspeed governor was no longer able to contribute to the propeller speed regulation and the 102.5% Np threshold of propeller speed was not overshoot. With the scenario of the phase 5 and 6 where Np-1 had started to increase, the blade pitch angle would have decreased down and reached to the low pitch in flight, regulated by the SLPS (Secondary Low Pitch System) protection. This assumption is consistent with the propeller manufacturer computation, which underlined in that case, that the propeller would have provided a level of power greater than the usual power absorbed by an unpowered engine. Indeed, the engine absorbing more power than expected is consistent with the spectral analysis (figure 2-43) that underlined a high level of power of the propeller, associated with the banding phenomenon. The spectral analysis of the beginning of the phase showed some oscillations of the propeller speed. However, these oscillations cannot be interpreted. Bandings phenomenon occurred at the same time and mechanical events might have been the cause of these oscillations.

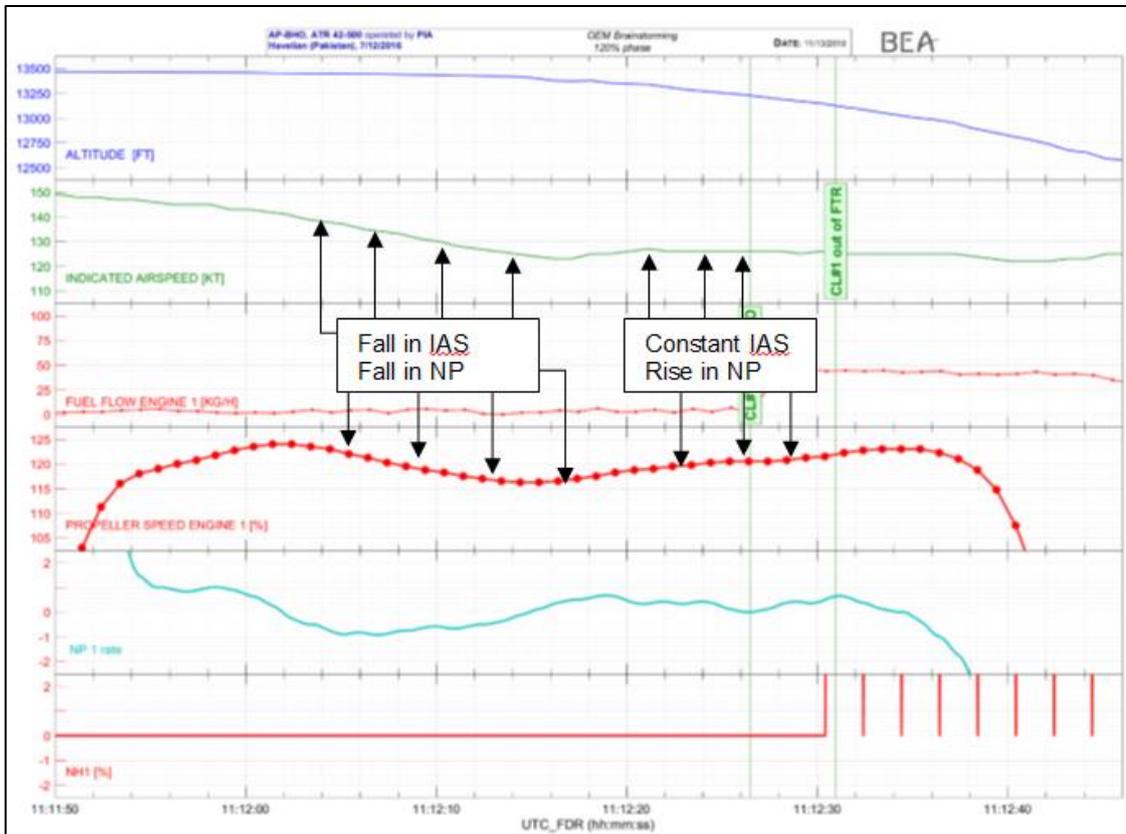
Figure 2-44: The 120% Phase (Phase 7 and 8)

(b) From 11:12:02 until 11:12:15, the altitude of the aircraft was quite constant and the IAS was decreasing. The propeller speed changes followed the IAS changes, which was consistent with a blade pitch angle quite constant. The CL was put outside of the FSO position around 11:12:26. As identified during CVR listening, a feathering attempt was heard (however a restart attempt cannot be ruled out). At 11:12:31 decrease of the Np-1 was observed.

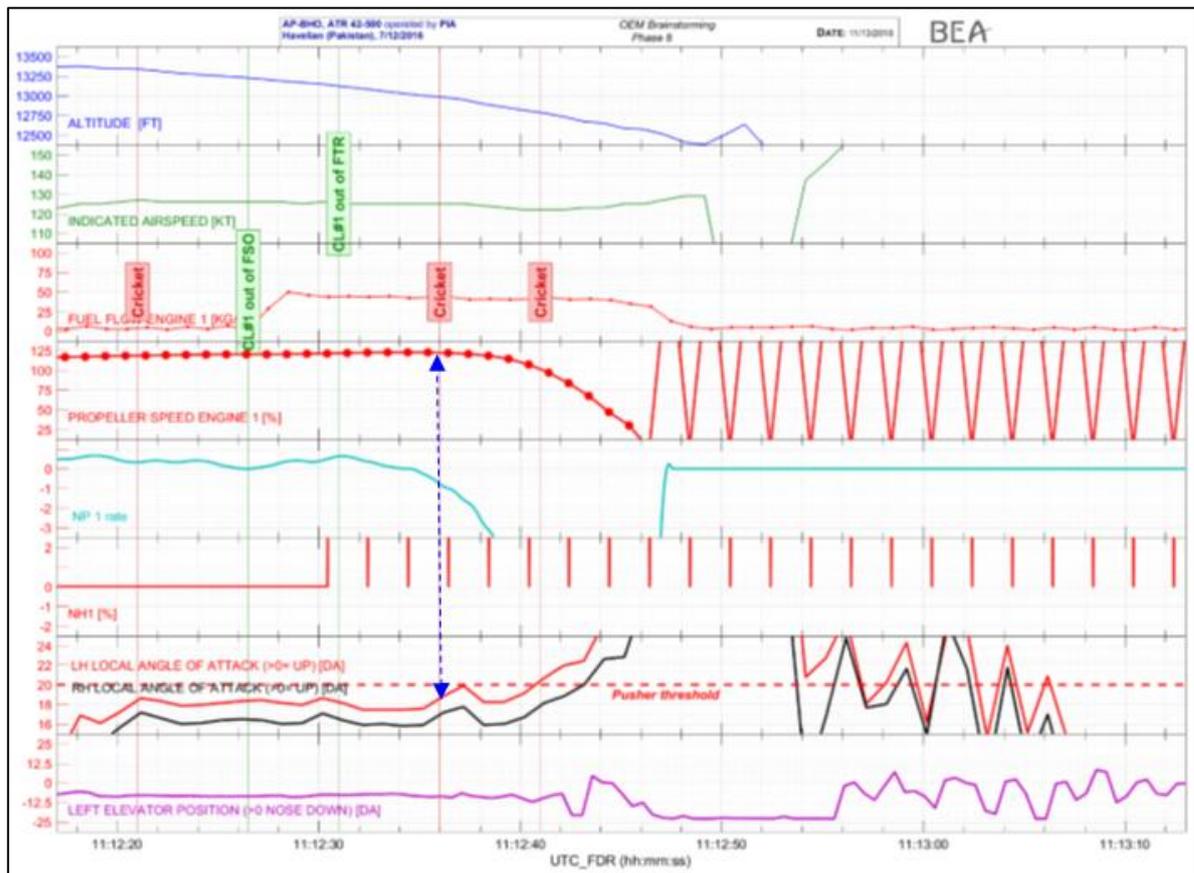
Figure 2-45: Phase 8

2.3.4.6 **Study of Phase 8:** During phase 7, the blade pitch angle reached low pitch in flight. At that time, the oil flow was drained on the feather solenoid and the SLPS solenoid. During the first part of the phase 7, the propeller blade stayed at a fix position – low pitch in flight, underlying that SLPS regulation worked during this part. During the second part of the phase 7, Angle of Attack (AOA) of aircraft increased and feather solenoid closed due to likely engine re-feather attempt (restart is less likely). Then, the propeller speed rate decreased. The SLPS protection may have been overridden. The blade pitch angle decreased and the propeller speed increased despite a decrease of the true airspeed. Even if the angle of attack impacted the propeller speed (wind-milling), the propeller speed rate remained stable between 11:12:20 and 11:12:30. Then the propeller speed started decreasing before the increase of the AOA.

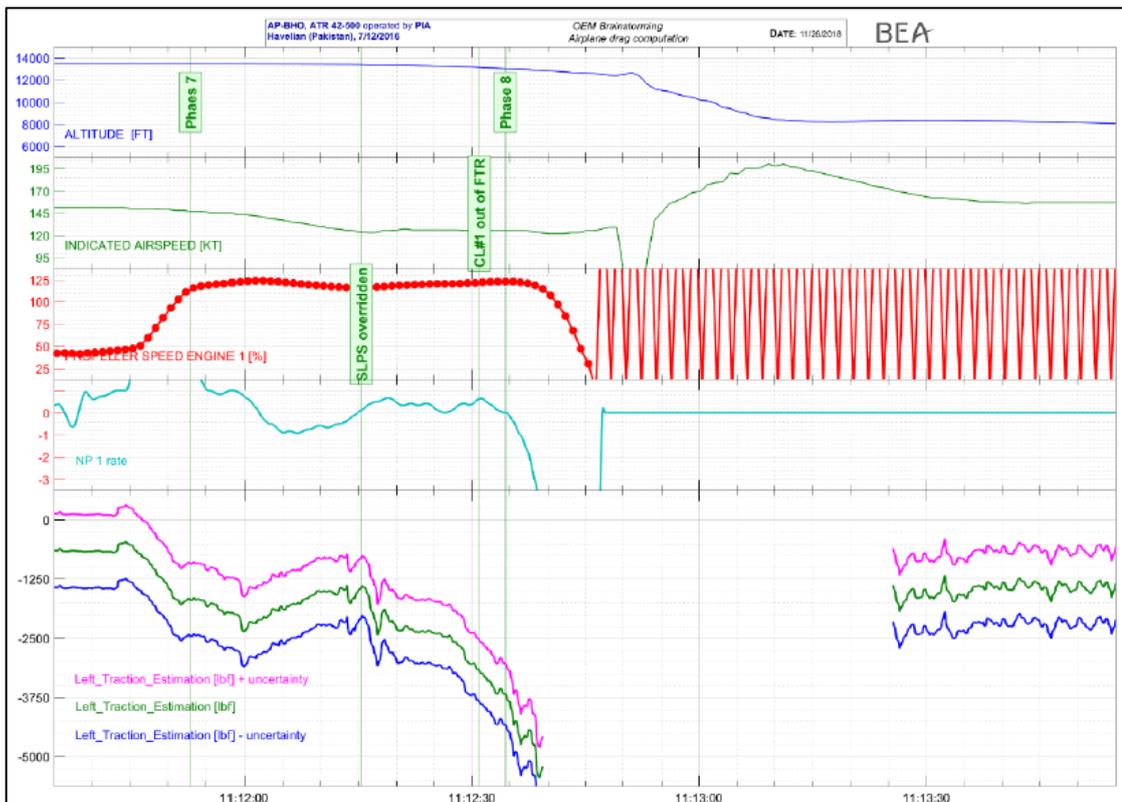
Figure 2-46: Aircraft Drag Computation

(i) The drag applied on the aircraft during the flight of the event was computed by the aircraft manufacturer. The increase of the drag (decrease of the force - figure 2-46) started before the CL-1 move outside of the FTR position. The closure of the feather solenoid was then not a key point to explain the propeller behavior. Following the CFD computation of the thrust, such increase of the drag may be consistent with the decrease of the blade pitch angle below the low pitch in flight. This blade angle decrease below the low pitch in flight would then imply that the SLPS protection was overridden. During the propeller hardware evaluation no failure of the SLPS system was identified after reviewing of all of the components of this protection system. Also an automated test of the SLPS is performed on aircraft during the first un-feathering after initialization of the PEC. Therefore, the SLPS was successfully tested the day of the accident. During the second half of the phase 7, except the previously mentioned details (SLPS overridden), no other condition explaining the huge increase of the drag computed by the aircraft manufacturer simulation tool was found.

- This balanced position of the system should provide a drag of the propeller consistent with the drag computed by the aircraft manufacturer: a drag between 700 lbf and 2,200 lbf (average values in Figure 2-46). Following the extrapolation provided by the propeller manufacturer, it implies a propeller speed lower than 5% with a blade pitch angle close to either the low pitch stop or the aerodynamic 0 total twisting moment pitch position.

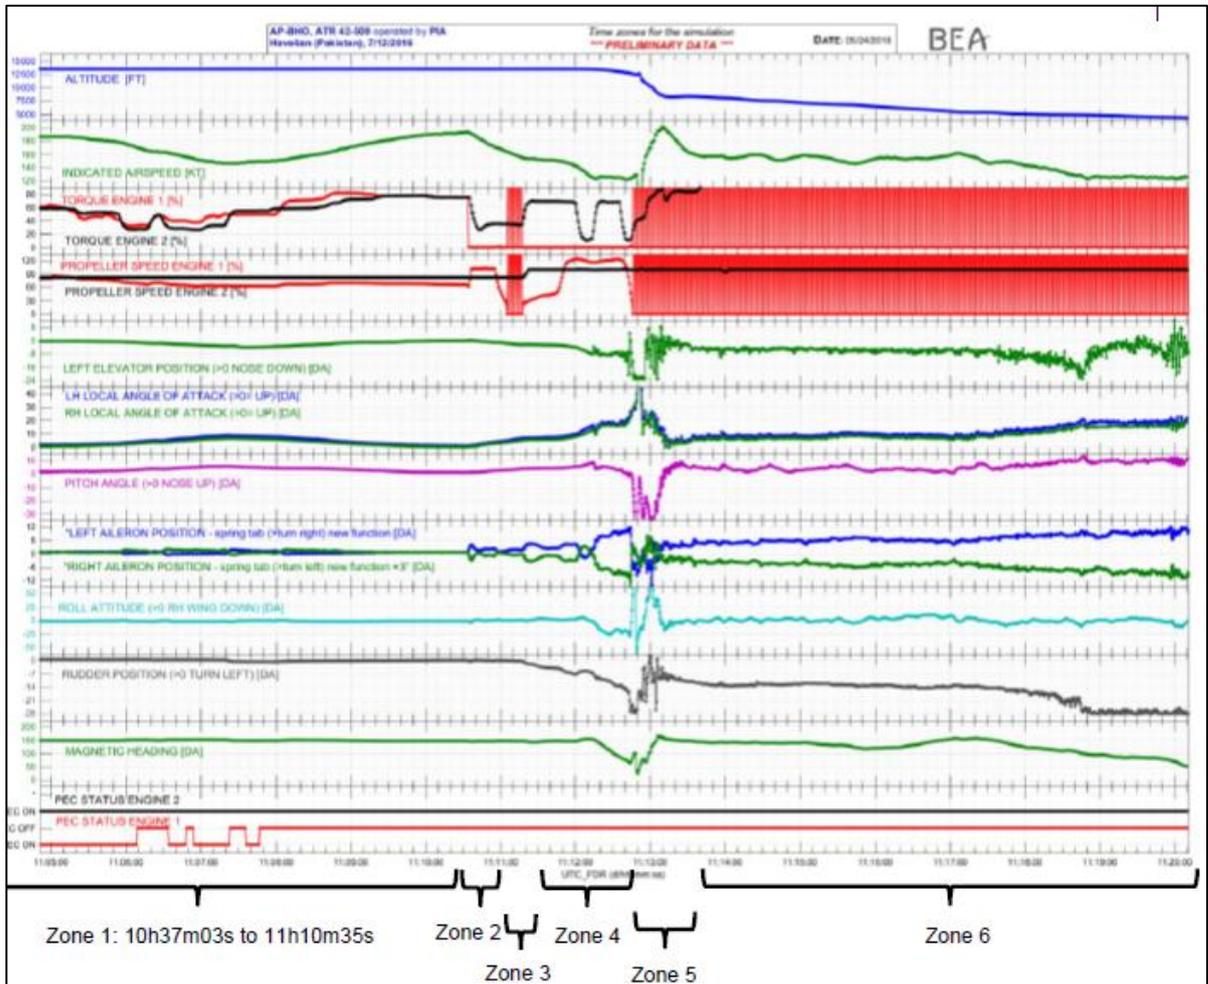
Figure 2-48: Drag Estimation

2.4.3.2 **Drag Estimation:** The simulation period was split into several time zones to ease the analysis: -
