EGYPTIAN MINISTRY OF CIVIL AVIATION

FINAL REPORT
OF
THE ACCIDENT INVESTIGATION

Flash Airlines flight 604

Boeing 737-300 SU-ZCF

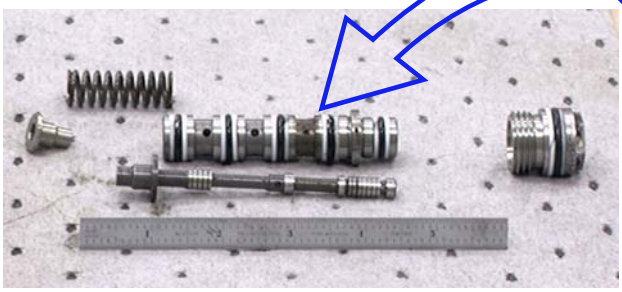
- Some corrosion and contamination on bypass valve sleeve
- Samples retained for chemical analysis

- Metal sliver found on outside of sleeve
- Origin uncertain, retained for chemical analysis

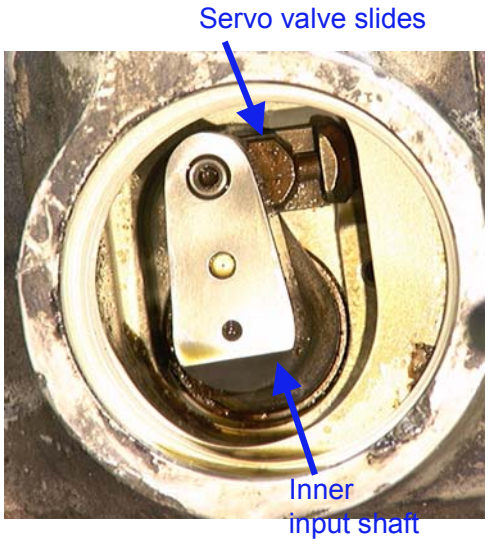
Input Shafts

- Linkage cavity cover removed
- Some contamination noted in linkage cavity – samples taken for analysis
- View shows end of inner shaft and shaft and mating ends of servo valve slides

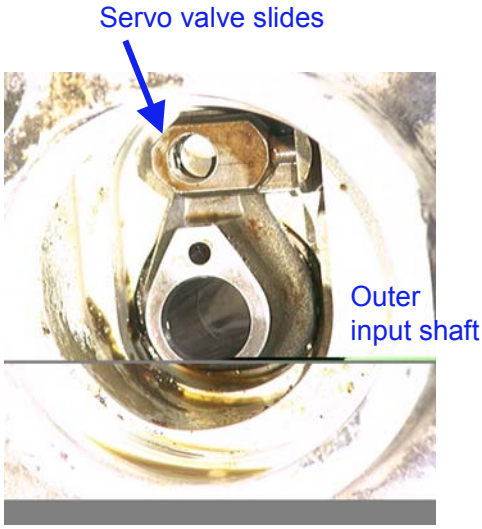
Input Shafts

- Inner input shaft pressed out (required removal force much higher than normal)
- View shows outer shaft and mating ends of servo valve slides (inner shaft has been removed)

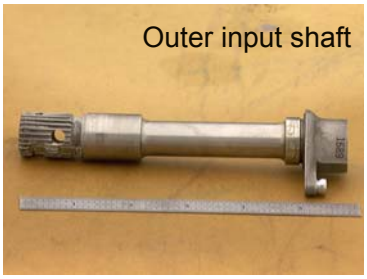
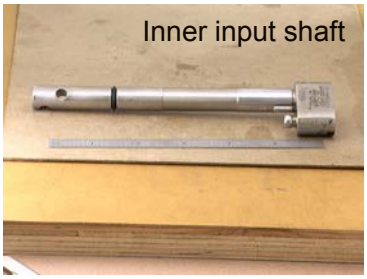
- Both shafts found to be bent
- Some corrosion found on shaft bearings, but none on shafts
- Deformed shafts consistent with high removal forces
