OXYGEN FIRE IN COCKPIT - STUDY

Context

Following the accident on 19 May 2016 over the Mediterranean Sea, involving an Airbus A320 registered SU-GCC, the first factual information collected (CVR and FDR recorders, debris from the wreckage) revealed that a fire had broken out on board the aeroplane and had been identified by the crew.

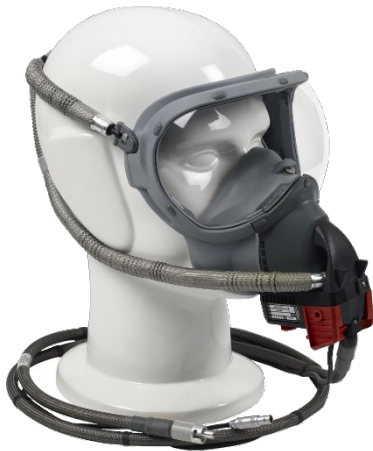
Quick-donning oxygen mask

In the event of depressurisation or in the presence of smoke, the pilots may need to use oxygen. For this eventuality, they have quick-donning masks at their disposal, stowed in storage boxes on both sides of the cockpit.

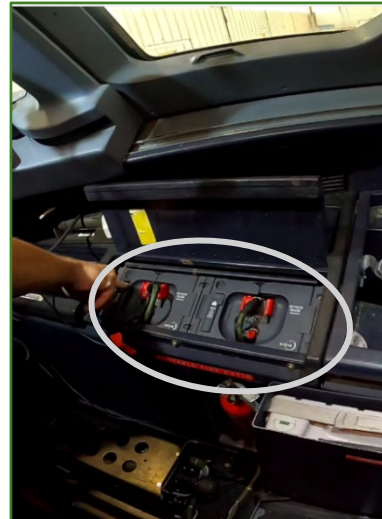
Oxygen mask storage boxes on commercial air transport aeroplane
