Piston engine induction system icing - Summary

1- INTRODUCTION

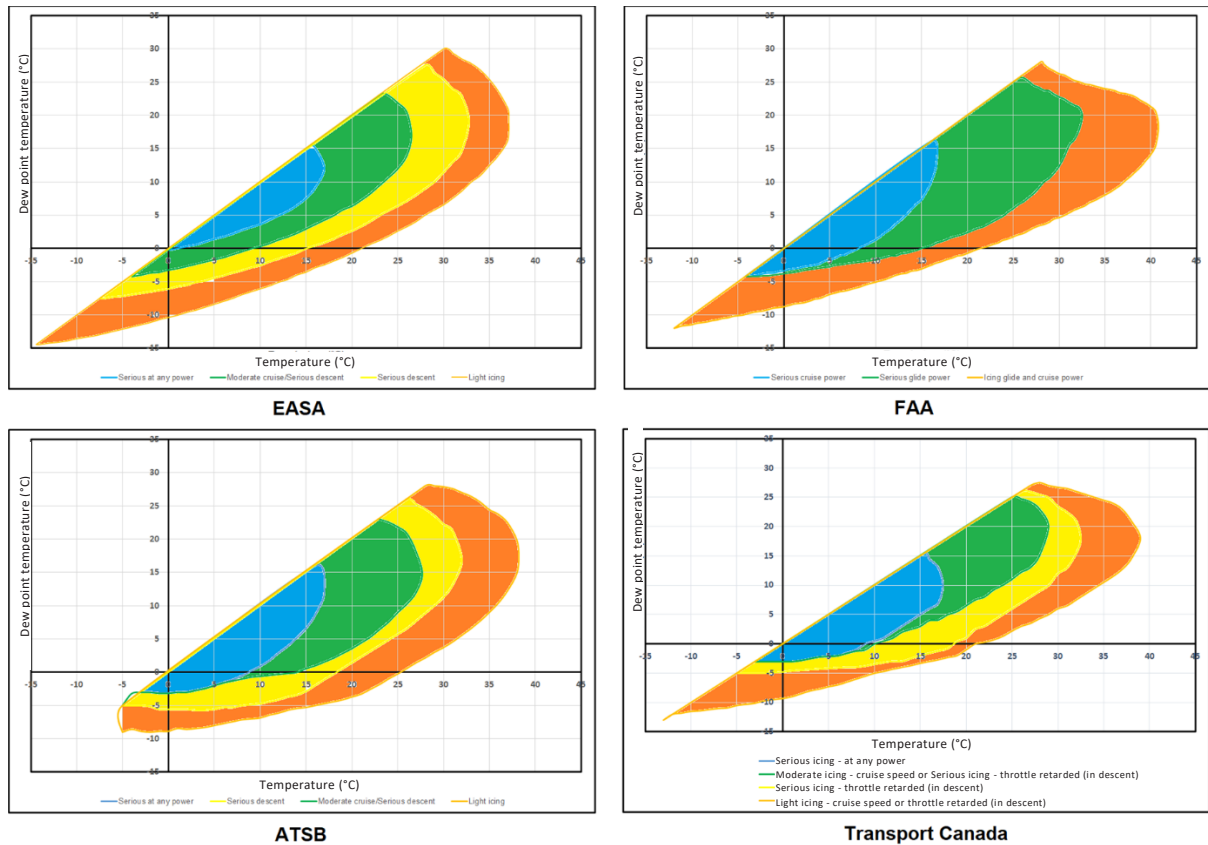
Figure 4: graphs proposed by the authorities

In these graphs, the criteria for determining the different risk zones are not defined objectively; they are limited to a qualitative statement, i.e. "severe" or "light". In addition, the data used to draw up these graphs is either unknown or very imprecise. Lastly, no mention is made of the scope of application of these graphs, especially with regard to the variability of existing powerplants.

A zone-by-zone comparison of these four graphs reveals a few differences, suggesting that different data was used in their construction.

The nature of the phenomenon means that investigators rarely observe it or identify its physical evidence on the wreckage. To justify the use of this hypothesis, when engine data is not recorded and accidents are fatal, the estimated meteorological conditions at the time of the event are generally compared with a "Temperature/Dew Point" graph showing zones corresponding to different levels of icing probability/severity (see Figure 4). Several models of these graphs exist and are widely available.

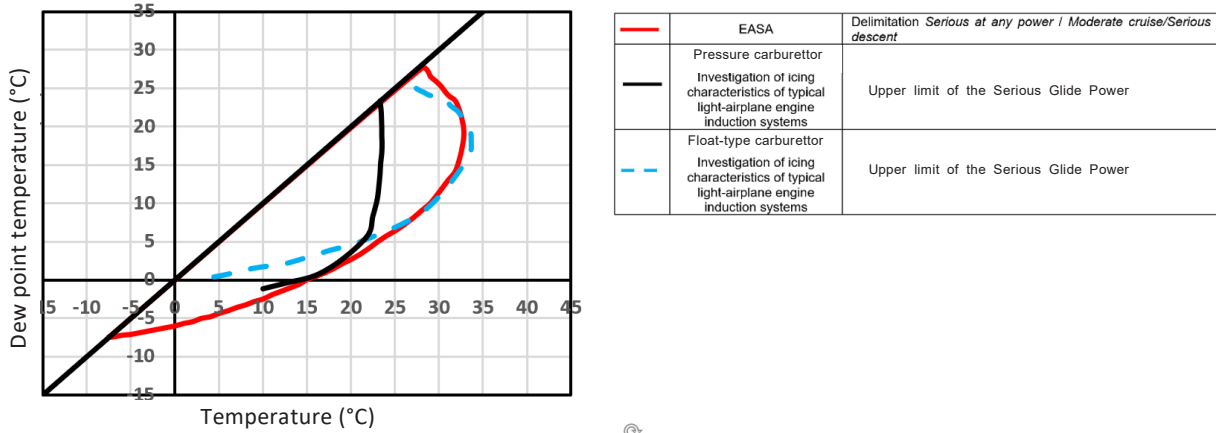
The BEA also compared the charts constructed from the data in the scientific articles with the chart currently published by EASA. To do this, the BEA determined equivalences for the icing zones, which differ according to the data sources. In particular, this comparison work shows that the EASA chart is consistent with the results available from tests carried out with a float carburettor, but only for the upper part of the temperature envelope.

Figure 5: comparison of the graph proposed by EASA with that constructed based on the data from the two studies listed (source: BEA)

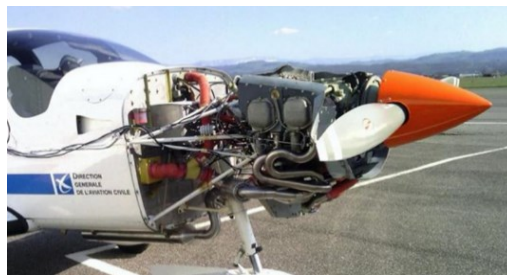
A complete powerplant comprising the engine, propeller and aircraft cowlings was chosen as the specimen for these tests. The test setup corresponded to the powerplant of the Socata TB10, with the exception of the propeller. The latter was replaced with a specific propeller for tests on the engine stand which had the particularity of having four blades and a smaller diameter. The engine was a Lycoming O-360-A1AD fitted with a Marvel-Schebler MA4-5 carburettor positioned under the engine, close to the exhaust system.

Figure 6: TB10 powerplant (source: Aerobuzz)

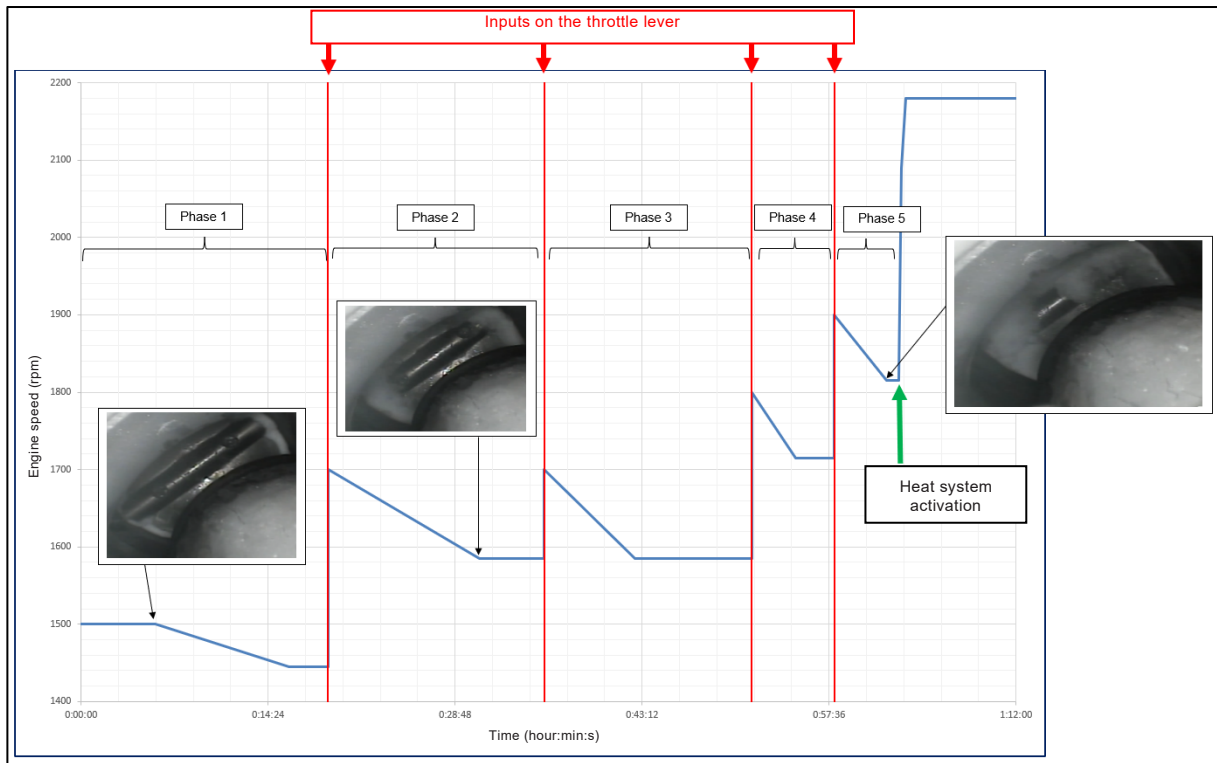
The following diagram shows the behaviour of the phenomenon during this test sequence for **case No. 1**.

Figure 10: variation in engine speed during the 1st case of identified icing (source: BEA)

It can be seen that when the phenomenon has started, drops in engine speed of around 150 rpm are observed within a few minutes. When the heat system was activated, the ice build-up was destroyed almost instantaneously, accompanied by a very brief drop in engine speed, followed by an increase in speed. It should be noted that during this test sequence, the engine power was increased several times although the ice was present, without knowing the equivalent position of the throttle lever without icing. As a consequence, the post-icing engine speed was not known.

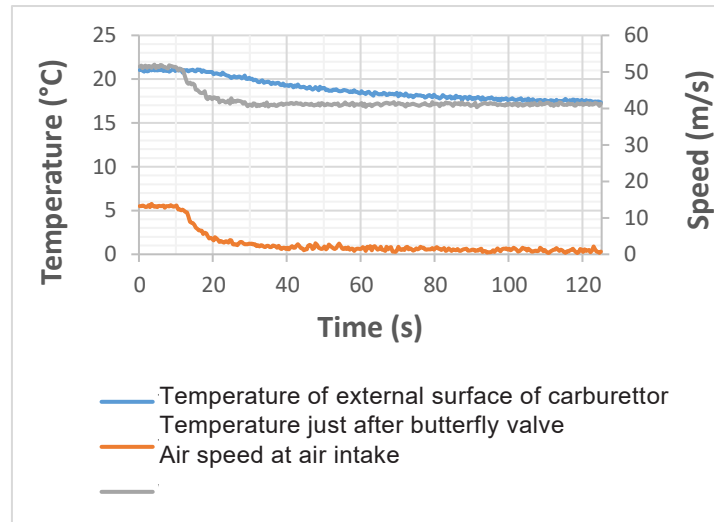
The tests showed a correlation between the **speed at the air intake** and these temperatures:

- the temperature of the external surface of the carburettor evolved progressively in the same direction;
- the temperature downstream of the butterfly valve evolved in the same direction, with a similar profile to the speed curve.

Figure 11: evolution of external surface temperature and temperature downstream of butterfly valve as a function of air speed at air intake (source: BEA)

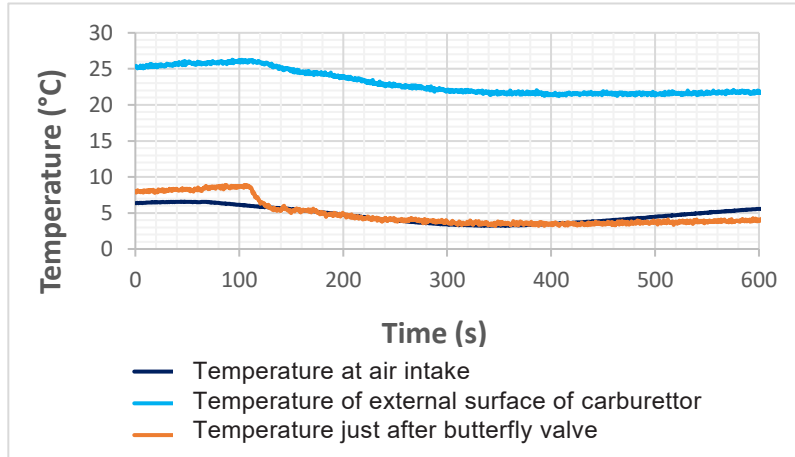
The general trend shows that the temperature of the external surface and the temperature downstream of the butterfly valve increases when the **air temperature at the air intake increases**, and vice versa. The variation in temperature after the butterfly valve was particularly marked.

Figure 12: evolution of the temperature of the external surface and the temperature downstream of the butterfly valve according to the temperature at the air intake (source: BEA)

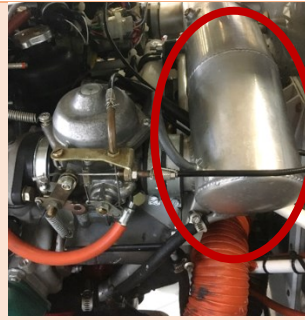
Type 1: air filter (912 series)	Type 2: airbox (912 and 914 series)
<p>Each carburettor is equipped with an air filter. The air that is sucked in by the engine is the air present under the cowlings. It is a mix of outside air (the position and size of the air intakes is different according to the aircraft) and the air heated in the engine environment.</p>	<p>The carburetors are connected to a shared airbox which is in turn connected via a flexible hose to an air intake. The air that is sucked in by the engine is the outside air. The air heat system introduces air heated around the exhaust muffler into the airbox.</p>

Figure 14: Tecnam P2008 powerplant
(source: BEA)

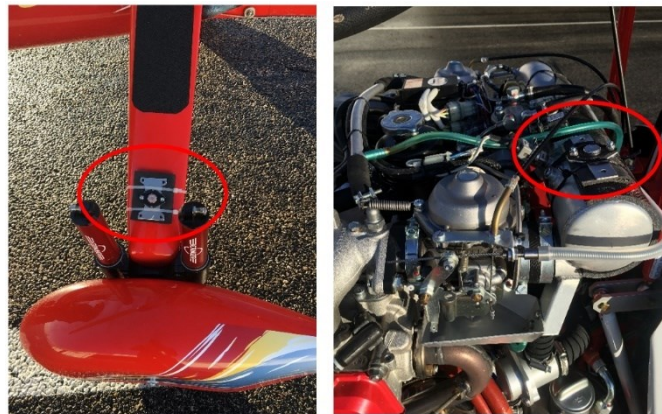
Figure 15: position of sensors (source: BEA)

For engines with carburetors equipped with filters (“type 1”), the temperature and relative humidity in the immediate vicinity of the carburetors was measured whereas for the engines with carburetors associated with an airbox (“type 2”), the temperature inside the box was measured. (The relative humidity could not be measured inside the box.)

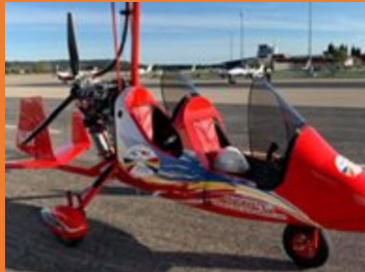
- Rotax 914
- Unducted powerplant
- Carburettors with airbox (type 2)

Figure 16: Magny M16
(source: Vaucluse ULM)

- On the ground, once the engine start-up had been completed, the temperature in the immediate vicinity of the engine was initially higher than that measured away from the engine. From the start of taxiing and then in flight, the temperature in the immediate vicinity of the engine gradually decreased until it was similar to that measured away from the engine (relative humidity evolved inversely). We can assume that the time required for the temperatures to balance varies according to external conditions.

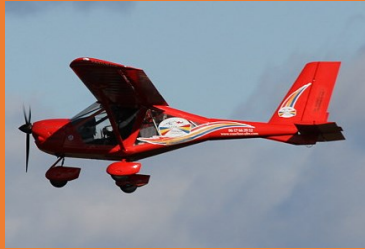
Figure 18: Aeroprakt A22
(source: Vaucluse ULM)

- The temperature in the engine compartment was always at least 5°C higher than the outside temperature. This difference increased very markedly at shutdown.
- Conversely, the relative humidity under the engine cowling was always around 10% lower than at the struts.
