ACCIDENT

involving the motorised glider registered D-KIVP

Event:	Take-off with airbrakes extended, missed field landing.
Probable cause:	Inadequate checks before take-off.

Consequences and damage:	Aircraft severely damaged.
Type of aircraft:	Schempp Hirth "Ventus" CM motorised glider.
Date and time:	Wednesday 20 June 2001 at 11 h 50.
Owner:	Private.
Place:	Fayence (83).
Type of flight:	Local.
Persons on board:	Pilot.
Licenses and experience:	Pilot, aged 77, VV issued in Germany, 4,049 flying hours of which 13 in the previous 30 days and 13 on type in the previous 3 months.
Meteorological conditions:	Estimated at the accident site: Wind 220°/8 to 15 kt, visibility over 10 km, FEW at 3,000 feet, temperature 26 °C.

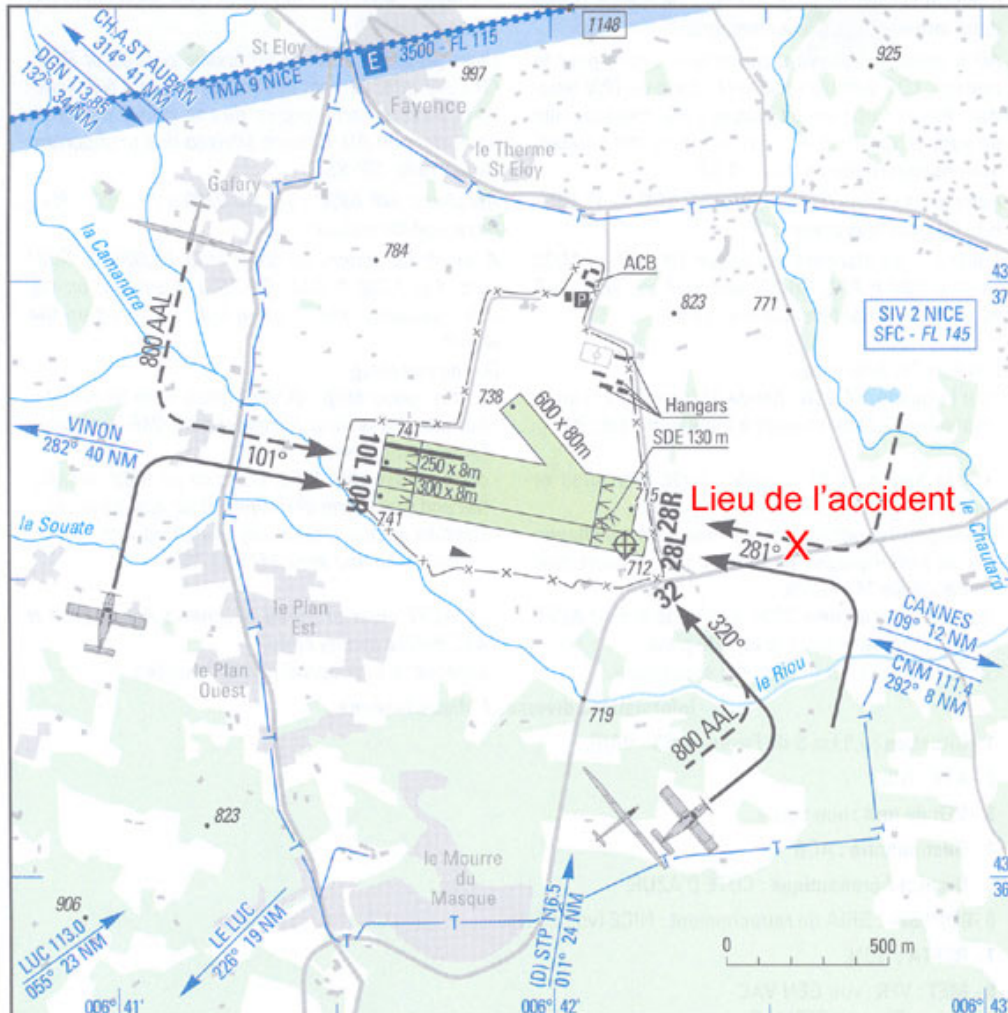
01 FAYENCE LFMF

ATTERRISSAGE A VUE Visual landing

RWY	QFU	Dimensions Dimension	Nature Surface	Résistance Strength	TODA	ASDA	LDA
10R	101	830 x 50	Non revêtue Unpaved	-	830	830	725
28L	281				830	830	690
10L	101	800 x 160	Non revêtue Unpaved	-	800	800	695
28R	281				800	800	680

The pilot took off at 11 h 45 from runway 10 at Fayence aerodrome. The pilot positioned the flaps at "-1°" during the take-off roll, then "+1°" during initial climb. The motorised glider climbed to about 30 feet then lost height progressively. The pilot veered 180° to the right in order to return to the aerodrome. The motorised glider continued to lose height and the pilot was obliged to land in vines located on the runway 10 extended centreline at 120°.
