Smoke in cabin during boarding, evacuation of passengers

Aircraft	Boeing 777-300 registered F-GSQA
Date and time	28 July 2013 at about 23 h 00 ⁽¹⁾
Operator	Air France
Place	Paris Charles de Gaulle Airport (95)
Type of flight	Public transport
Persons on board	Captain, 2 co-pilots, including one reserve, 14 cabin crew, 298 passengers
Consequences and damage	1 passenger seriously injured

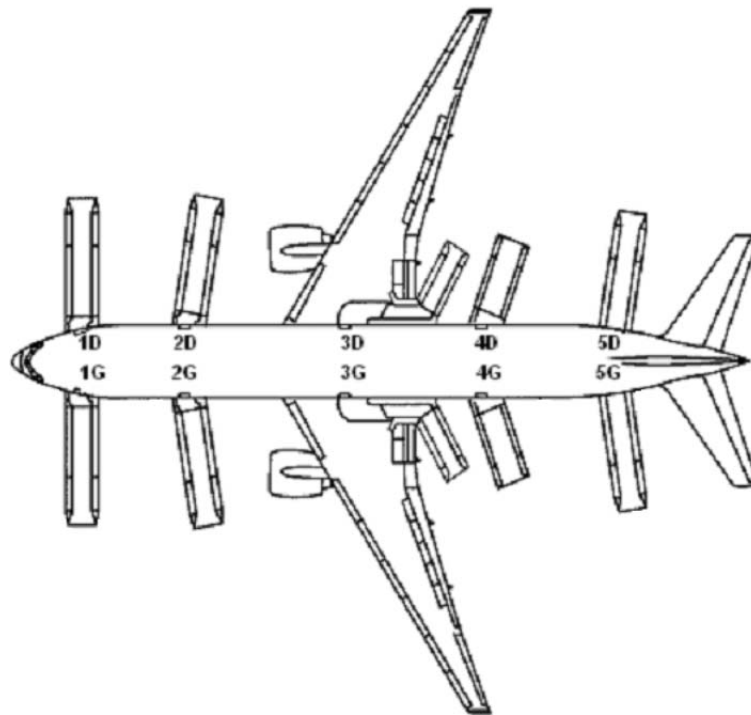
Diagram of the evacuation doors on a Boeing 777
(the doors are always fitted with emergency chutes)

The passengers started to board about twenty minutes after the arrival of the crew and entered via doors 1G and 2G (see diagram below).
