## Accident to the Cessna F172M registered F-BUEQ

on 29 March 2019

at Semur-en-Auxois (Côte-d'Or)

## Loss of control during go-around, collision with ground

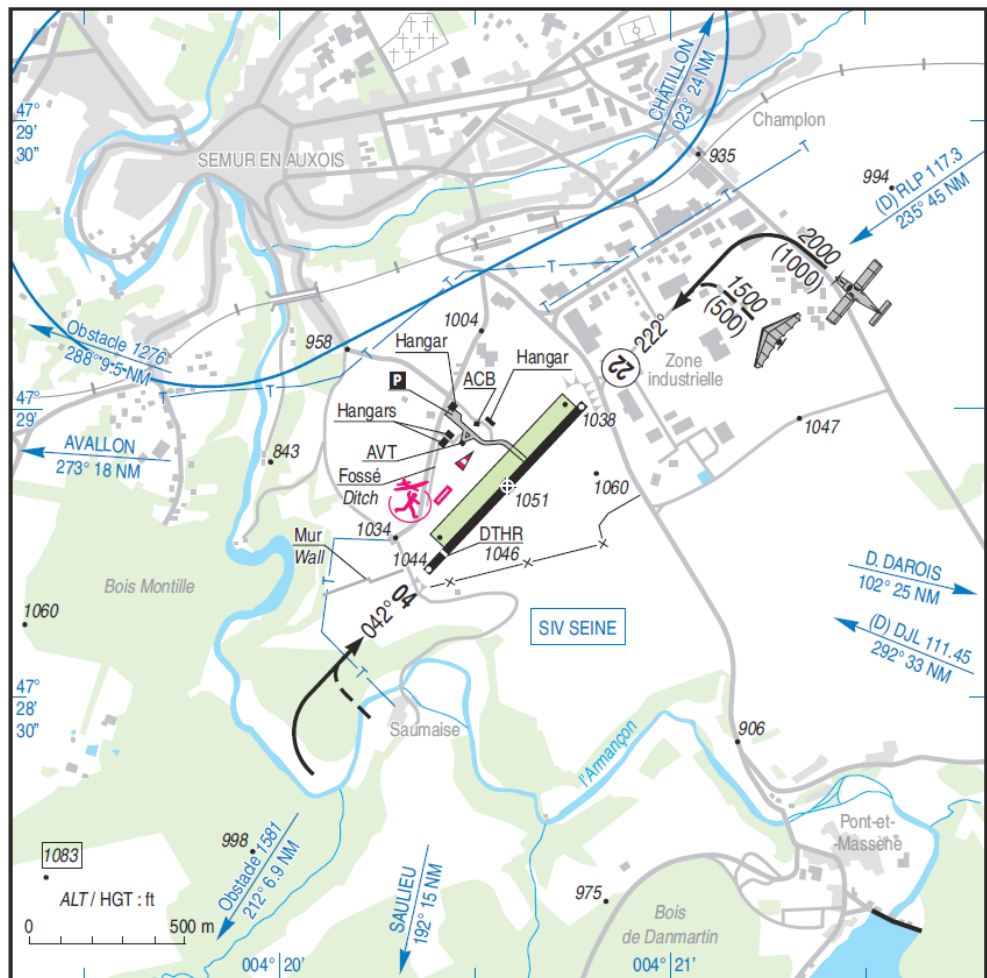
Excerpt from LFGQ VAC chart

Source: AIS

On arriving at his destination, the pilot overflew the aerodrome, to check, in particular, the windsock. After analysing the latter and observing that there was no other traffic in the aerodrome circuit, he joined the circuit for paved runway 22.
