Incident to ATR 72-201
registered **F-GVZG**
on 11 September 2011
at Marseille

MFC⁽⁴⁾ 1B+2B fault during landing run, emergency braking, runway excursion

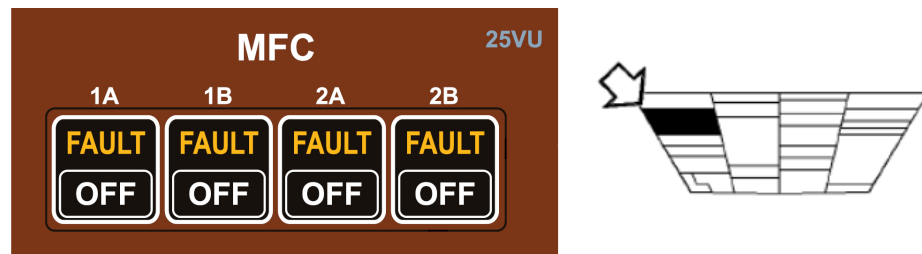
Figure 1: Alert on overhead panel

Inspections carried out after the incident found hard braking marks on the runway and reported that the MFC 1B and MFC 2B FAULT lights were on.

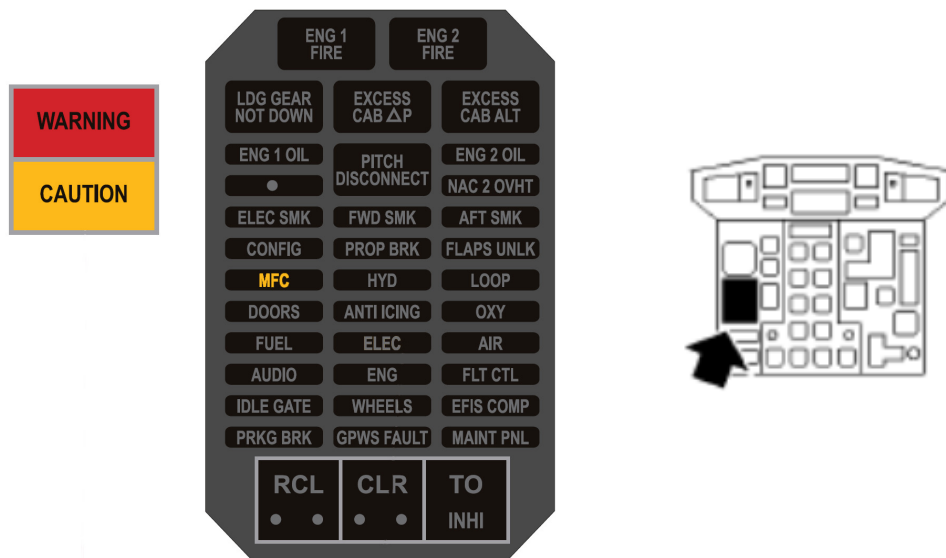
Figure 2: Alert on CAP (position in cockpit)
