Accident to the GAZ'AILE 2 identified W16US⁽¹⁾

on 15 April 2017

at the La Broue microlight strip (Charente)

Collision with vegetation then the ground during take-off, fire, during test flight

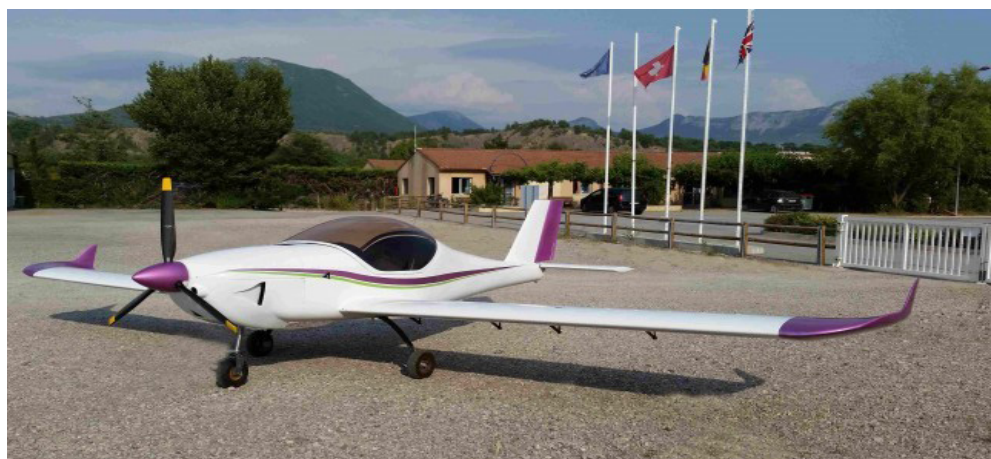
The Gaz'aile 2 is an amateur-built microlight made principally of wood and carbon.

The flight manual indicates that the take-off distance is 250 m with a low-pitch propeller. It is equipped with an underslung carbon tank under the instrument panel.

He explained that the pilot had equipped his Gaz'aile with a BMW 100 hp engine and stated that he had recently replaced the original propeller with a high-pitch propeller to obtain a faster cruising speed. This modification altered the microlight's performance, including the extension of the take-off distance. He also indicated that the pilot had slightly modified the engine's longitudinal axis downwards to eliminate contact with the cowling. He and other members of the association had remarked that the take-off run distance was significant. He stated that the pilot had, until this point, flown his test flights from Saint-Jean-d'Angély – Saint-Denis-du-Pin aerodrome, which has an 850 m long runway. The pilot had decided to complete his last test flights from La Broue as it was closer to his home, and despite being aware that the runway was shorter. His friends at the association had been unable to make him change his mind.
