Accident to the ITV WINGS BOXER 2M identified 83AWI

on 14 December 2020
at Fréjus (Var)

Loss of control in flight at low height over an urban area, collision with a pontoon

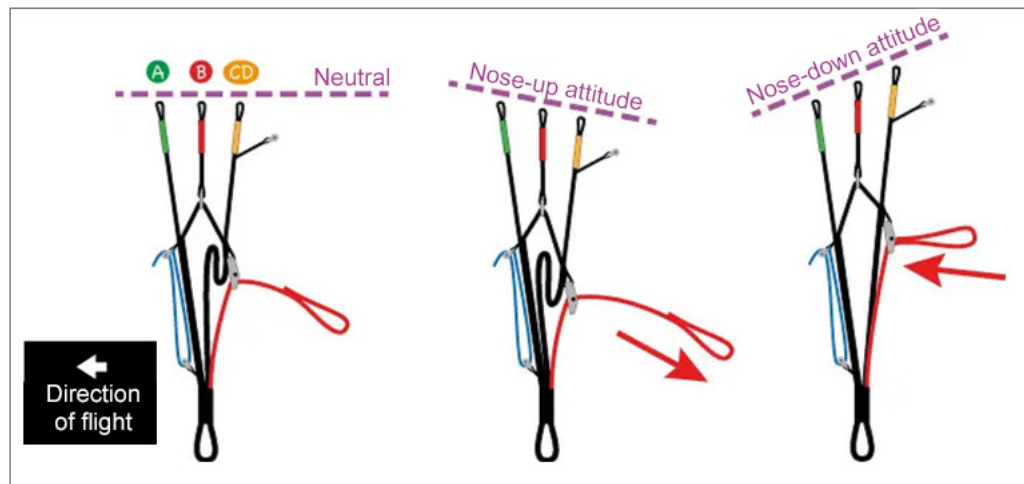
This is a system that allows you to vary the wing setting in flight and lock the risers in a specific position. This system is usually located on the rear risers. Most of the time, the system only allows the pilot to give the wing a nose-down setting by releasing the rear risers⁽⁶⁾ (see Figure 2).

Figure 2: Principle of trim operation

The examination of the trim settings⁽³⁾ showed that, at the time of the accident, the wing was trimmed with a nose-down setting. A slightly asymmetric setting between the left and right trims was observed.
